Tree Condition Report Arboricultural Impact Assessment Method Statement and Tree Protection

Land at 22 Hawthorn Road, Shrewsbury

Site Visit: 30th January 2024

Written by: Zoe Adlington MSc, MArborA

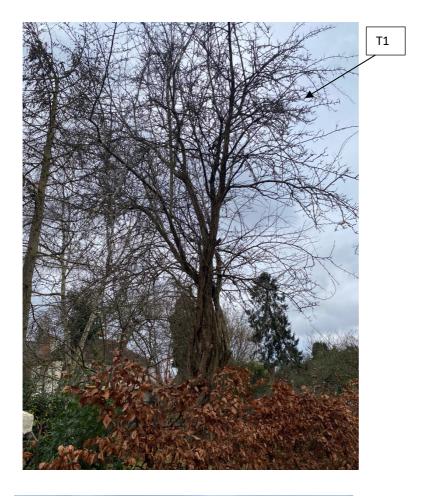
Existing driveway will provide ground protection during the construction. Vehicles will still require this for parking.

- Install section of Heras fence barrier positioned as indicated on the tree protection plan. Specification as recommended in BS5837 (2012) fig.3 appended.
- The existing driveway will provide adequate ground protection during the construction
 of the extension. Parking for the owners will still be required during the construction, as
 there is no parking available along the road side.
