## APPENDIX A – Structural Reports Referred

ISSUED FOR INFORMATION	By	LRS	Date	07.06.23	Rev.	P1
<b>ISSUED FOR INFORMATION</b>						
Title <b>PLAN SHOWING INITIAL CONDITION ASSESSMENT - SHEET 3 of 3</b>						
Project <b>MTR PROJECT MADEIRA TERRACES, BRIGHTON</b>						
Client <b>BHCC</b>						
<b>HOP</b>		HOP House, 41 Church Road Hove, East Sussex BN3 2BE www.hop.uk.com ask@hop.uk.com +44 (0)1273 223900				
Drawing No. <b>MTR-HOP-01-XX-DR-S-S003</b>						Status <b>S2</b>
						Rev. <b>P1</b>

<b>PROJECT:</b>		Project No:	12719-6
Madeira Terraces		Site Visit No:	14
<b>SUBJECT:</b>			
Visit to Cast Iron Welding Services to review Grit Blasting Trail			
Date of Visit:	2 <sup>nd</sup> May 2023	Arrival Time:	10.30
Record prepared by:	Nigel Hosker	Departure Time:	15.30
Weather conditions:	Generally dry and sunny		
Site visited by:	Nigel Hosker (NJH)	Representing:	HOP Consulting Limited (HOP)
Visitor accompanied by:	Neil King (NK) – Purcell; Lian Harter (LH) – Purcell; Ian Graham (IG) - B&HCC CIWS Hosted the visit at their Offices and other facilities.		
<p>The purpose of the visit was to visit Cast Iron Welding services yard to meet the team and review grit blasting of components already

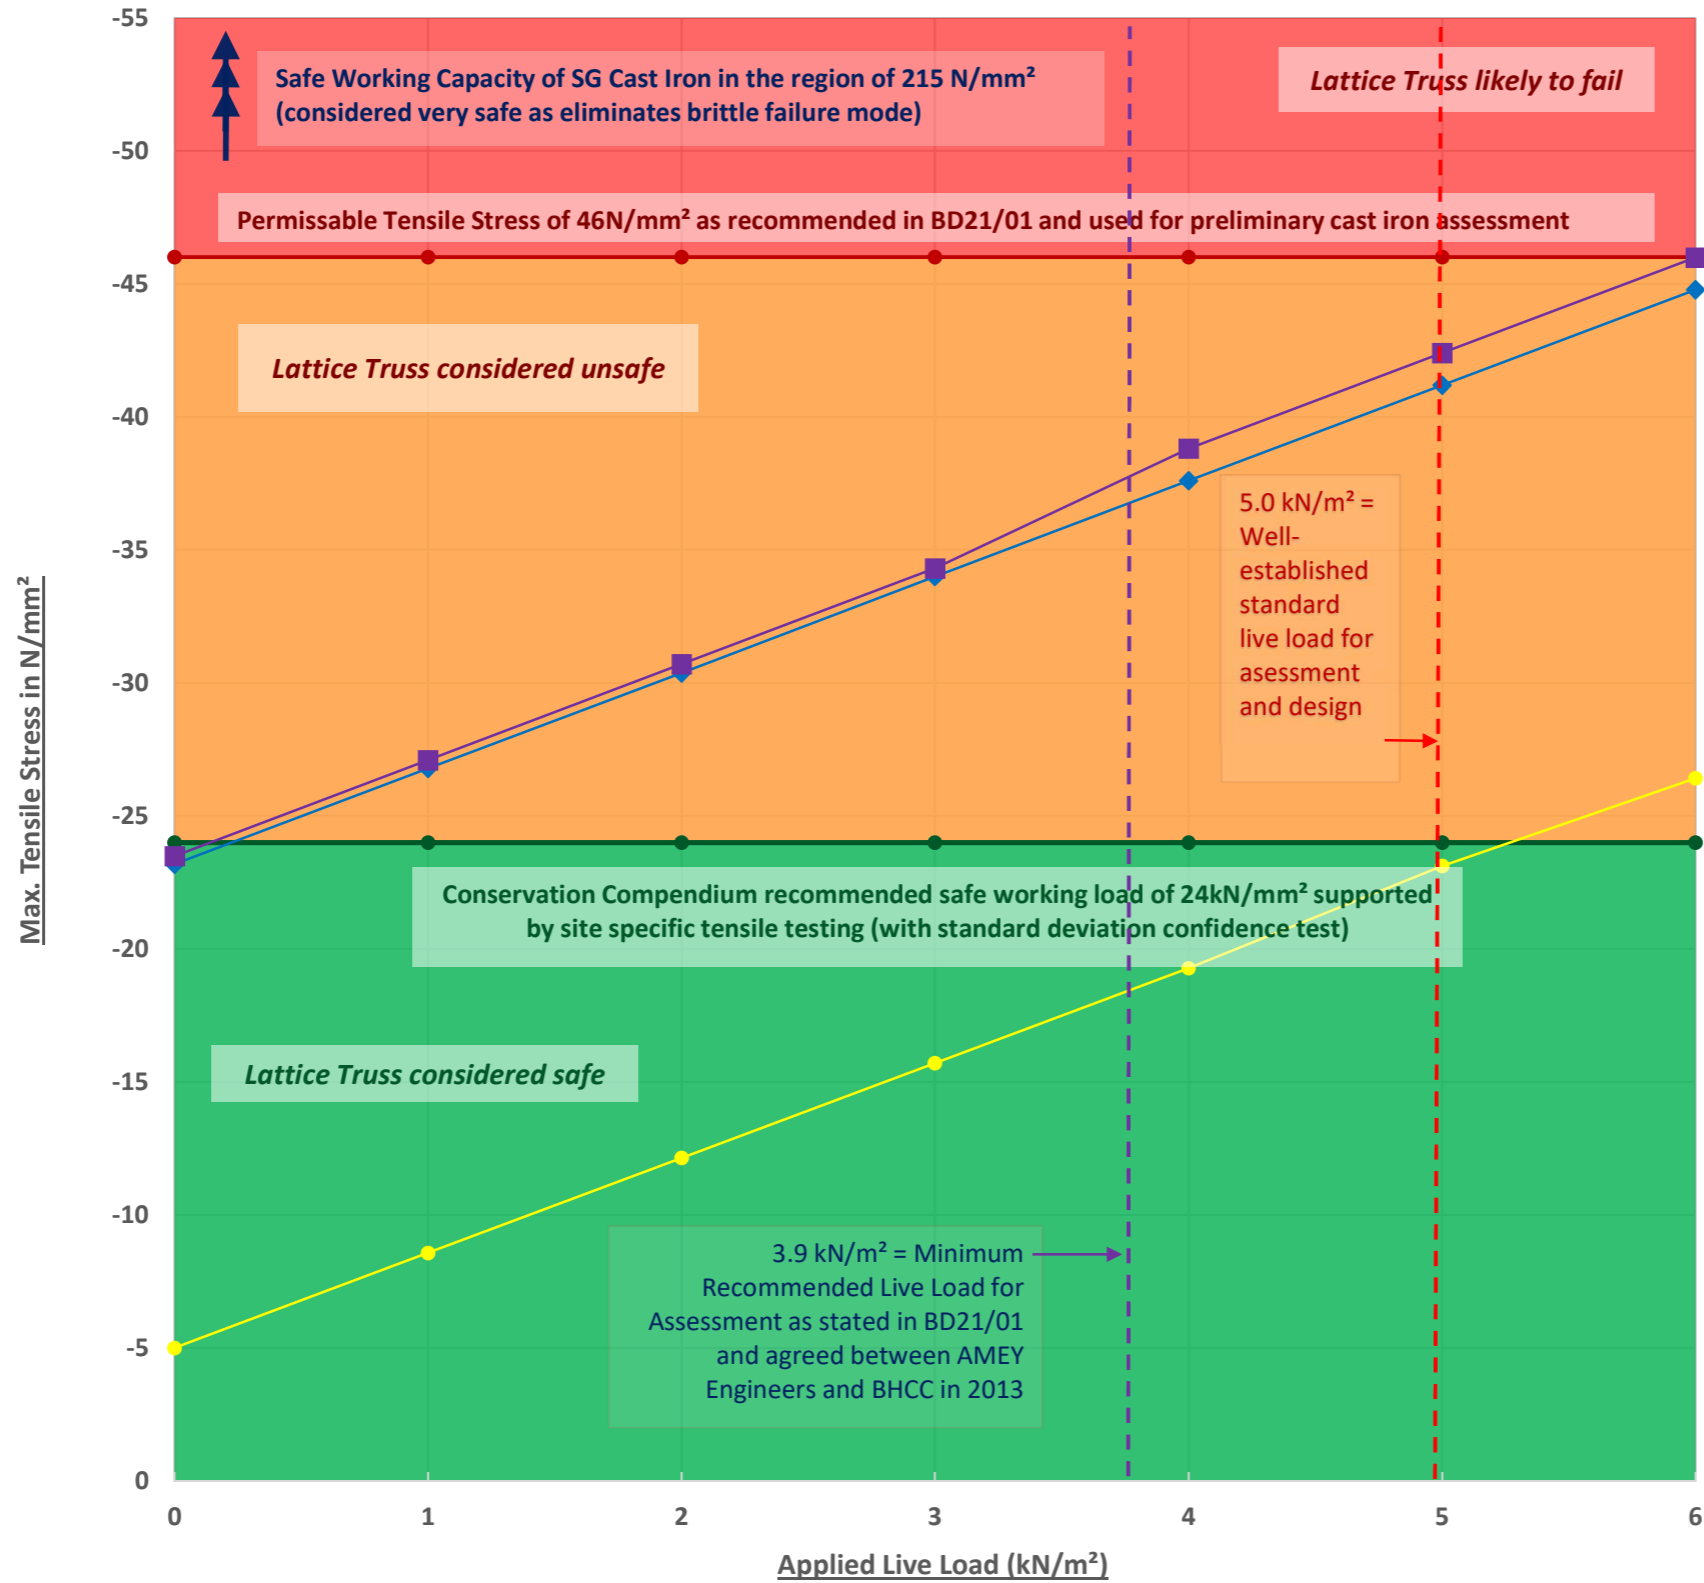
Tensile Stresses in Diagonal Strut (Governing)  
(varying applied Live Load)

- ◆ HOP determined tensile stresses considering existing arrangement
- HOP determined tensile stresses considering new lightweight aggregate RC deck
- Interpolated Mann Williams Modelling\*

\*(interpolated from Tensile Stress of 23.12 N/mm² when applied live load = 5 kN/m²)

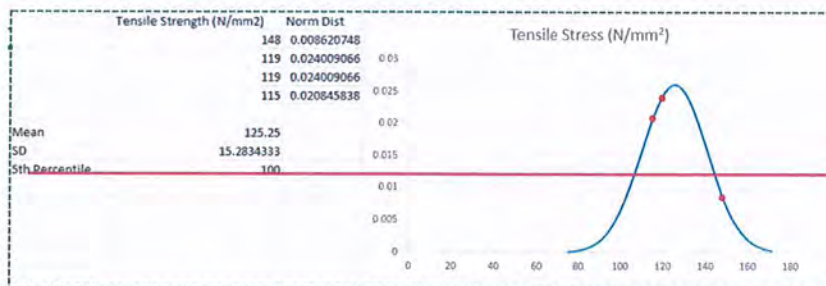
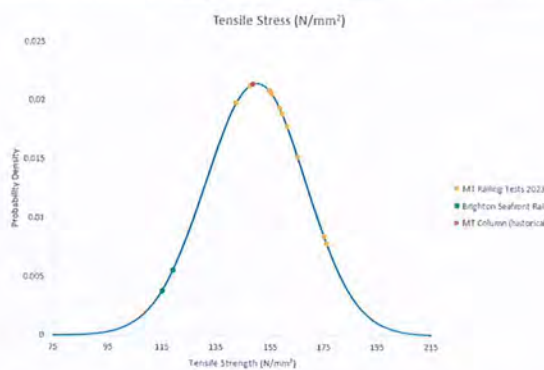
An existing infill has been recovered from site and inspected by magnetic particle inspection (MPI) this revealed significant and consistent casting defects to principal horizontal spanning transoms which provide the only horizontal spanning members between supporting balustrade standards. This calculation assumes these defects are identified and repaired to full parent iron strength.

Tensile samples obtained from an infill have been taken (2023). Standard deviation analysis is provided below to derive an appropriate permissible stress

Element	Tensile Strength (N/mm²)	Probability Density
MT Column (historical)	148	0.021
Brighton Seafront Rails	119	0.006
	119	0.006
	115	0.004
	161	0.018
	176	0.008
	158	0.019
	155	0.021
	147	0.021
MT Railing Tests 2023	142	0.020
	154	0.021
	175	0.008
	165	0.015
	142	0.020
	158	0.019
	159	0.019

Permissible Stress say  $\frac{119}{5} = 23.8 \text{ N/mm}^2$

This adopts a Factor of Safety of 5.0 as per recommendations in Historical Structural Steelwork handbook w Bates CEng FStructE

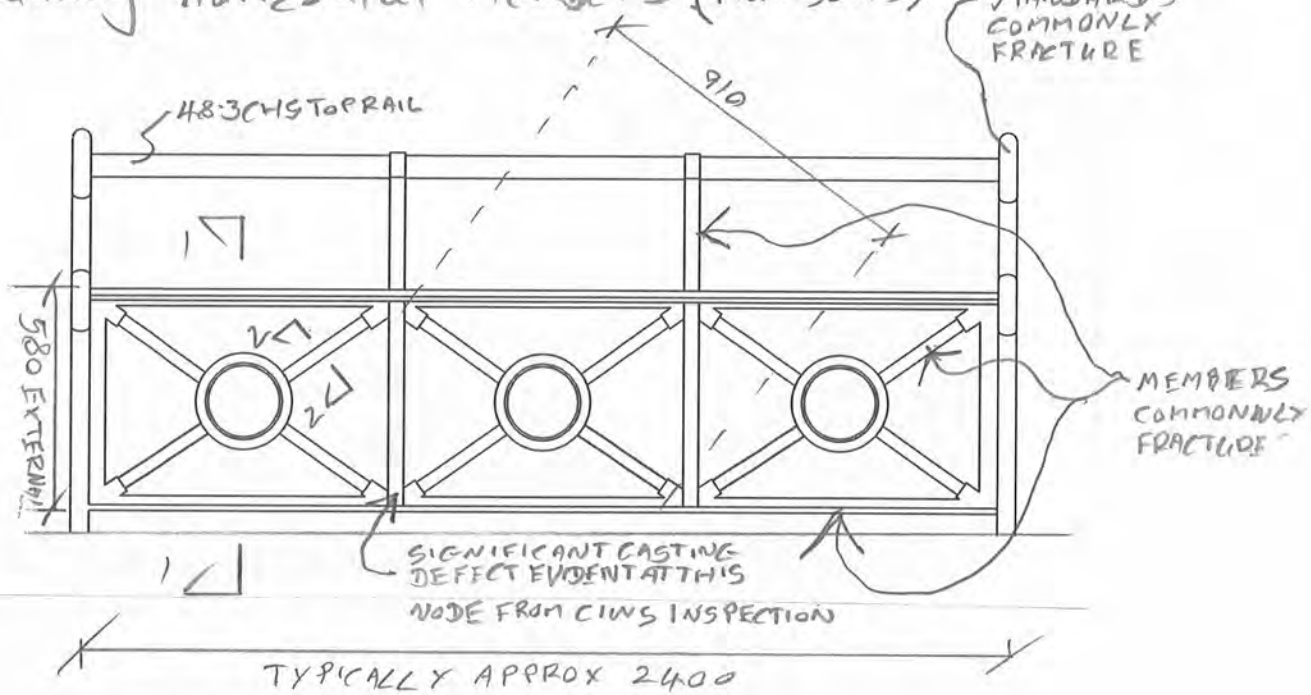
TYPICAL BALUSTRADE ARRANGEMENT

Assigned idealised section properties of principal spanning horizontal members (Transoms)
