# MADEIRA TERRACES REFURBISHMENT, BRIGHTON

## IRON REUSE STRATEGY REPORT

31 OCTOBER 2023

Ref: MTR-HOP-ZZ-XX-D2-6003

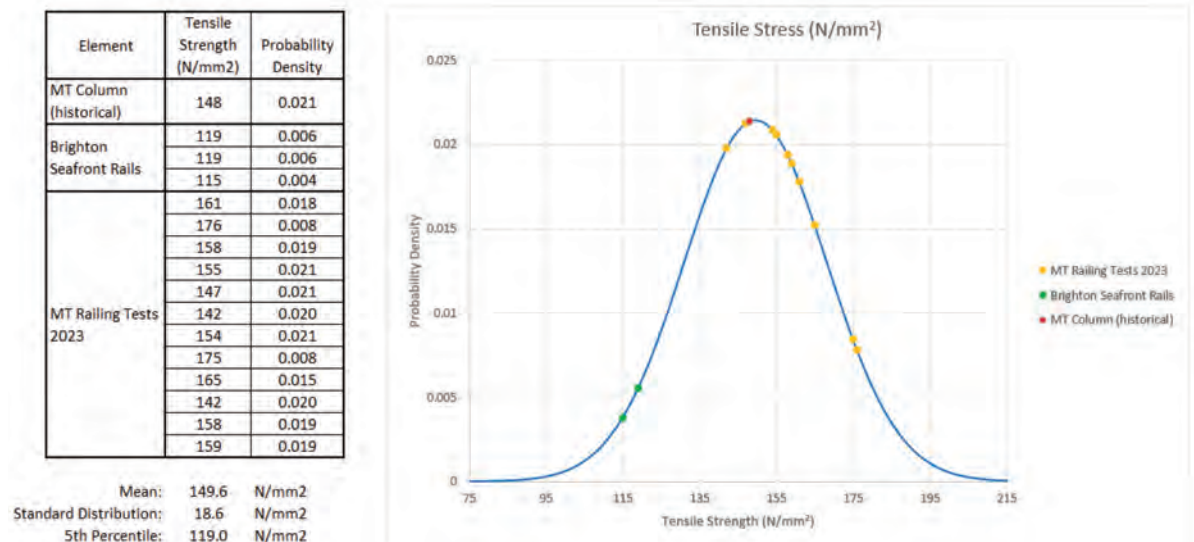
Figure 2 - statistical analysis of Iron tensile strength of iron sampling results.

- 4.1.13 The permissible tensile stress adopted for Grey Cast Iron in the sensitivity analysis is therefore considered to be 23.8N/mm<sup>2</sup> based on the 5<sup>th</sup> percentile, with a minimum applicable factor of safety of 5.0.
- 4.1.14 Coincidentally, use of a FoS of 5.0 results in a permissible stress that is similar to that published in the ‘The Structural Engineer, Conservation Compendium Part 3: Historic wrought iron, cast iron and mild steel’ which adopts a permissible stress of 24N/mm<sup>2</sup> hence some confidence this can be taken as at or around the right order of things.

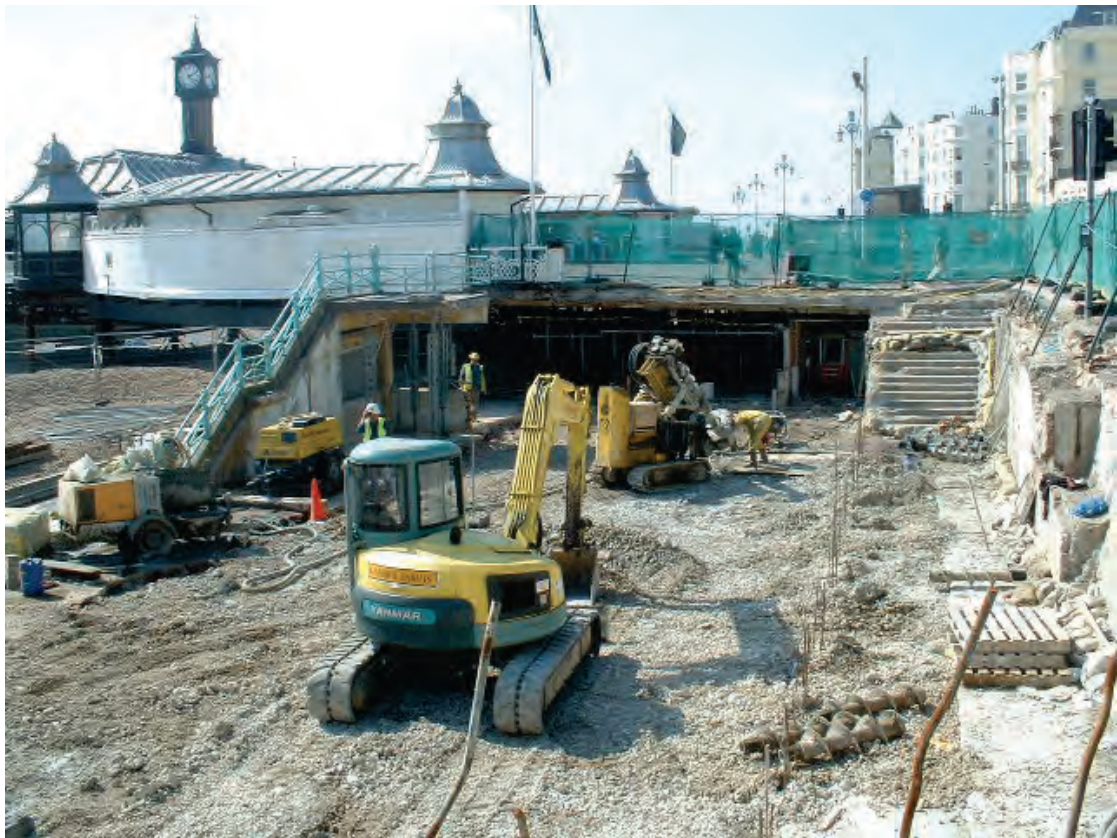
4.6.5 Photograph 1 below indicates the Aquarium Colonnade frontage and serves to indicate how the frontage has developed south over the years, noting the original old sea wall (Pre-Circa 1930) can be seen right of frame.

*Photograph 1 - Indication the Aquarium Colonnade frontage immediately east of Brighton Palace Pier circa 2001 during reconstruction. Note original sea wall right of frame with associate steps and more modern on current southern sea frontage alignment steps left of frame.*

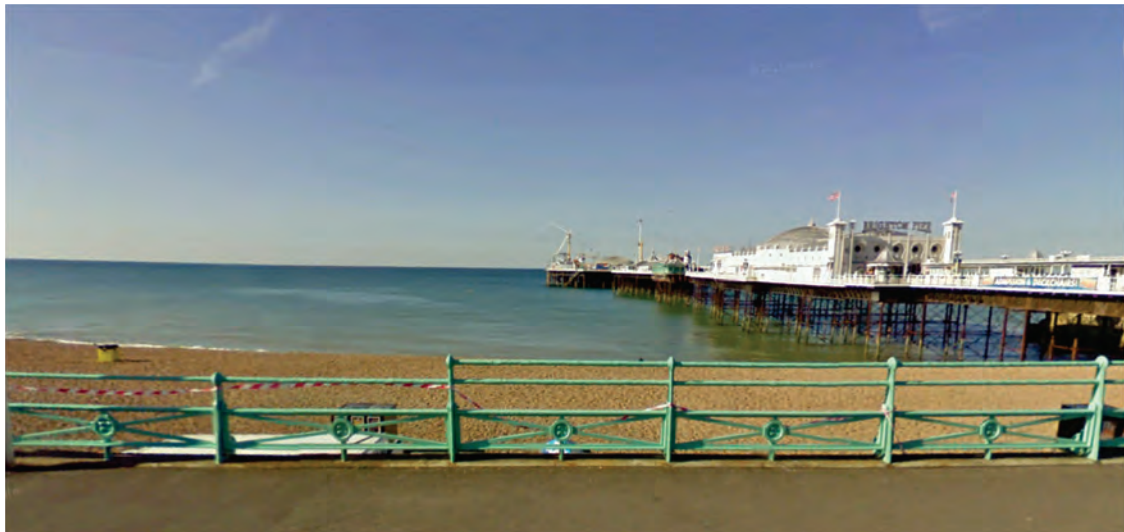
- 4.6.11 Photograph 2 below indicates the completed works to the Aquarium Colonnade and the junction of new and refurbished seafront railings.

*Photograph 2 - indicating Junction of Seafront railings at the Aquarium Colonnade. Left are the original seafront railings, right extended railings adopting similar detailing and connections, baseplate connection concealed.*
