Validation Letter

Date: 6 October 2023

Our Ref: M41977-JNP-XX-XX-RP-G-0020-P01

Re: Former Sunninghill Gas Works – Validation of Capping Layer for Plots 13 - 26 (Block C)

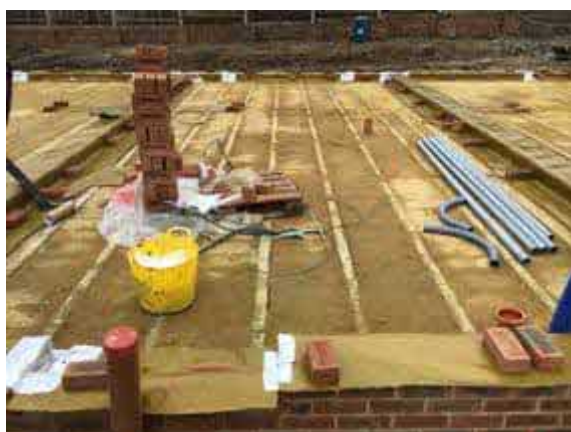
Plot 6 overview of installed membrane.

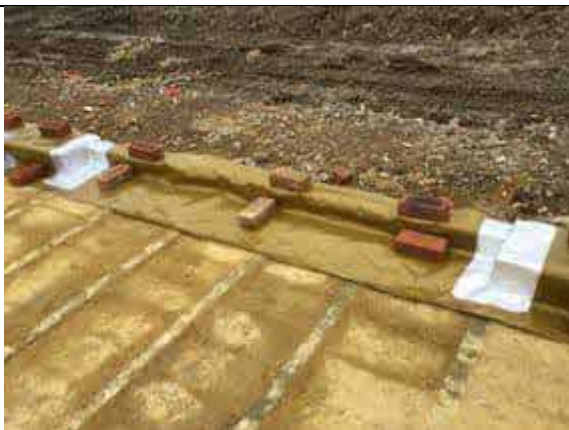
Plot 6 typical door threshold seal using SAGM.

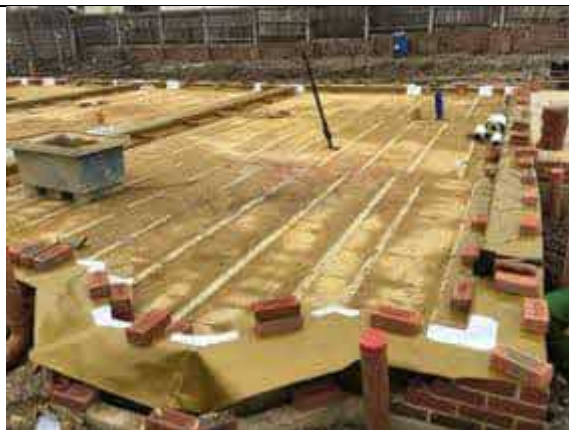
Plot 7 overview of installed membrane.

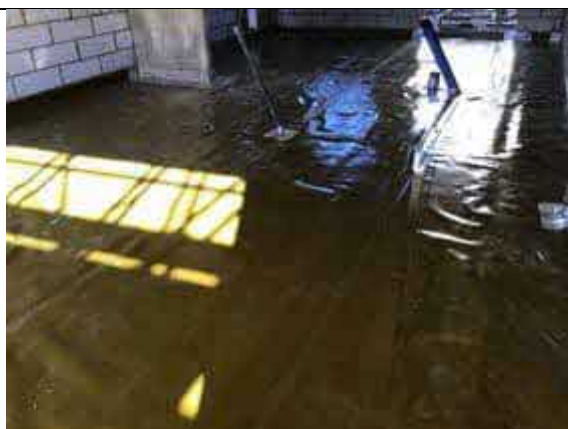
Plot 2 overview of installed membrane.

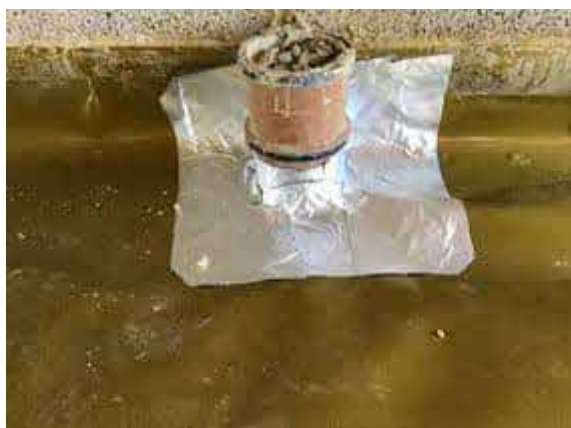
Plot 2 typical pipe penetration seal using SAGM.

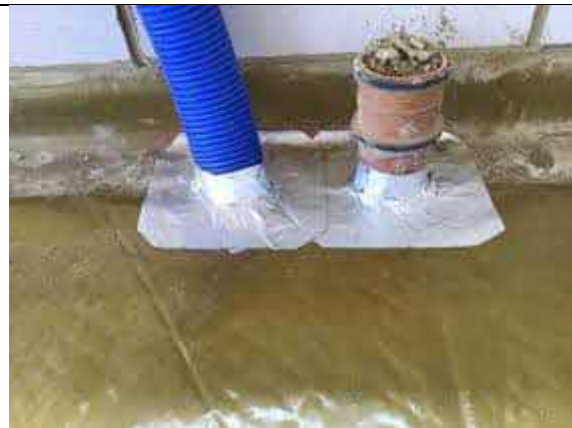
Plot 75 typical double pipe penetration seal using SAGM.

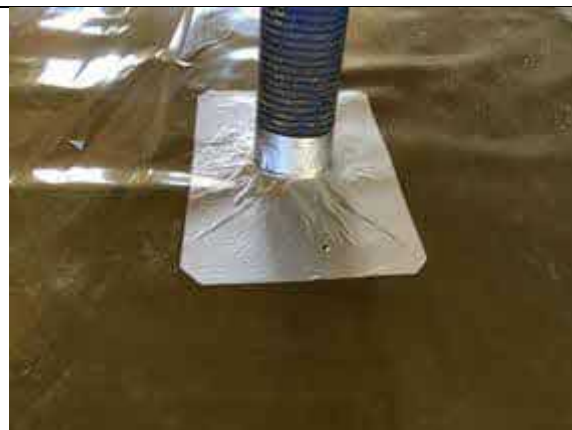
Plot 4 typical pipe penetration seal using SAGM.

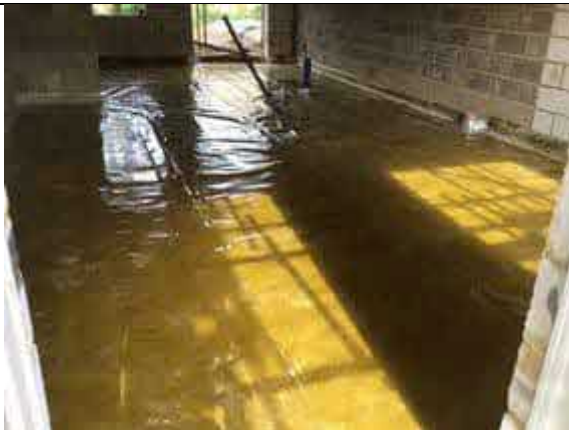
Plot 7 overview of installed membrane.

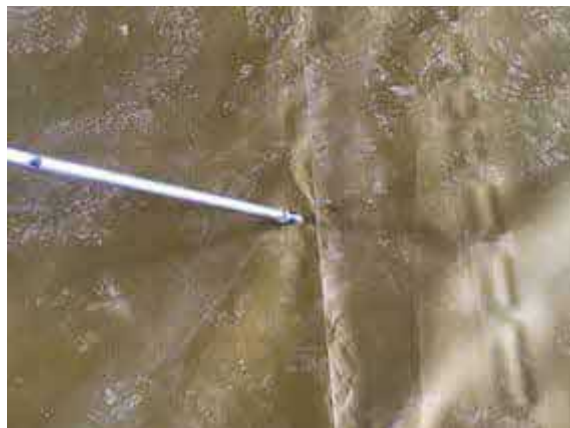
Plot 7 air lancing all welded membrane laps.

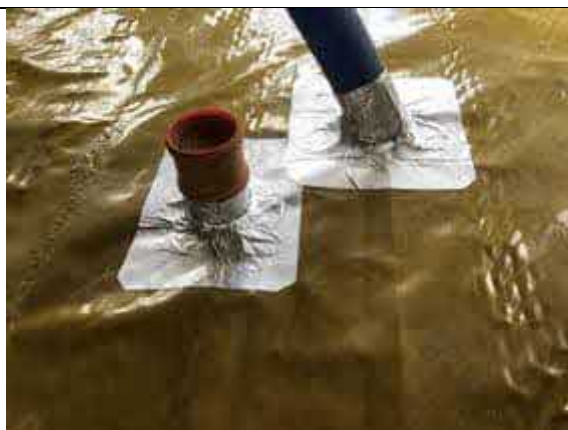
Plot 35 typical double pipe penetration seal using SAGM.

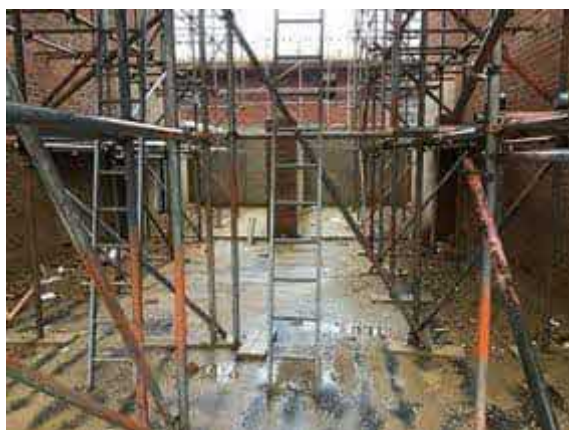
Plot 40 was incomplete at the time of our inspection due to being used as storage.

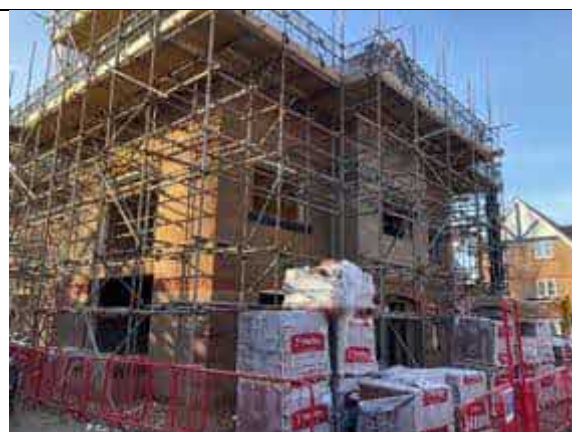
Plot 74 Overview where installation took place.

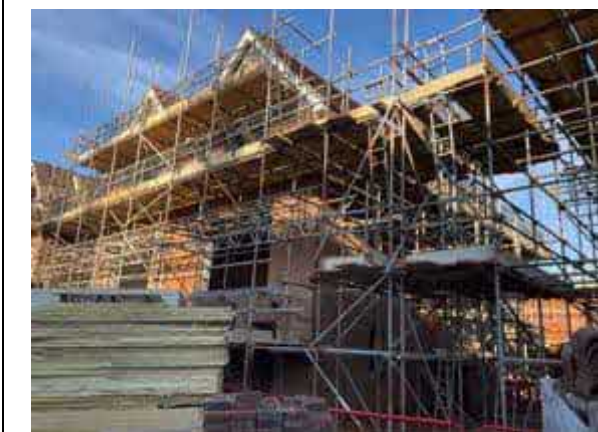
Plot 40 overview of where the installation took place.

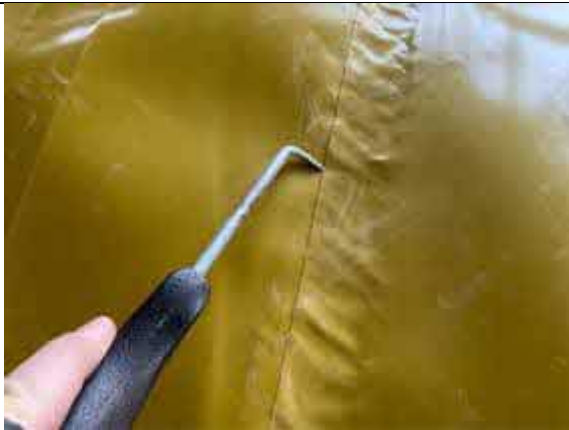
Plot 74. Pick test upon hand welded membrane lap joint.

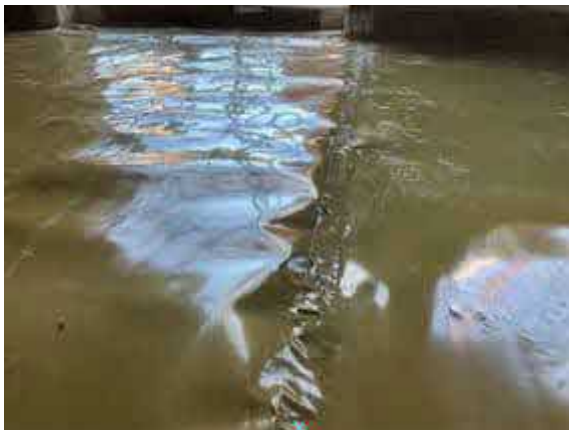
Plot 40. Hand welded membrane lap joint.

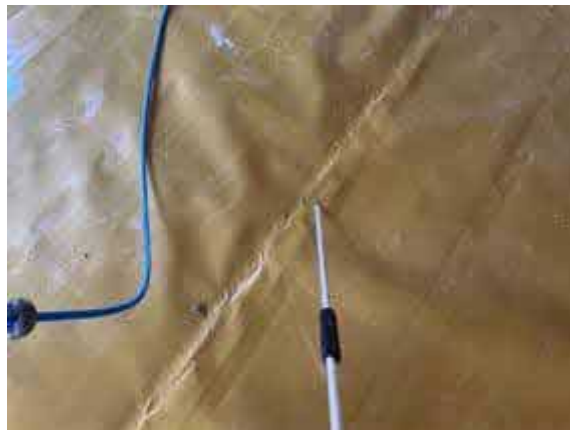
Plot 40. Air lance integrity conducted upon all welded membrane lap joints.

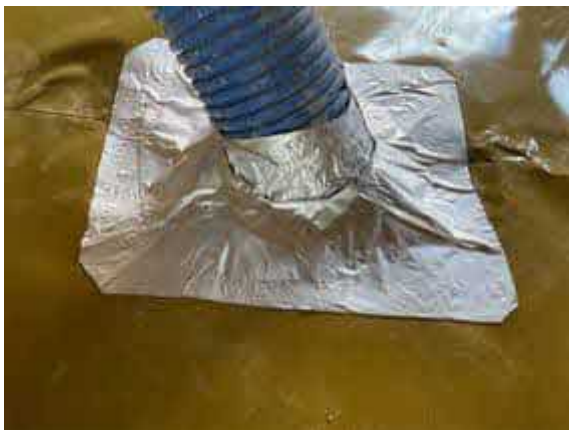
Plot 40. Typical pipe penetration sealed using SAGM.

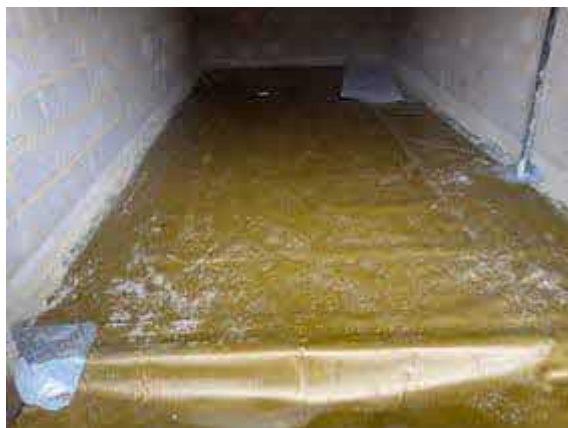
Overview of Visqueen HC Blok infill installation to Plot 32 FOG Unit Garage.

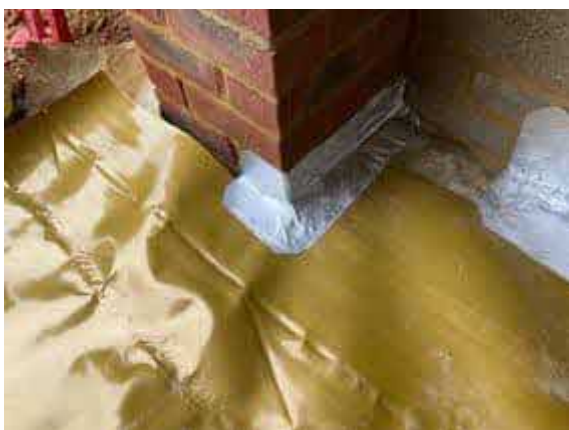
Plot 35 garage. Corner detailing sealed using SAGM.

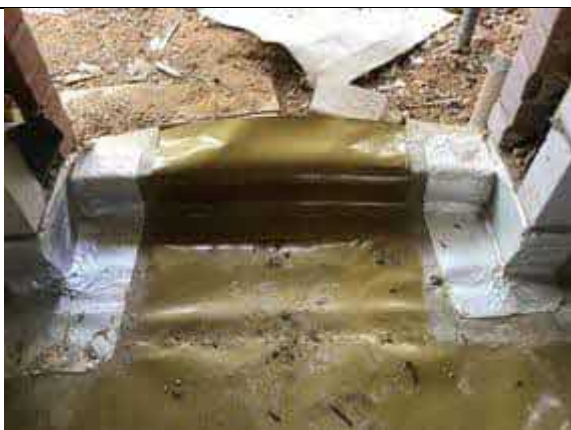
Sealed door threshold using SAGM.

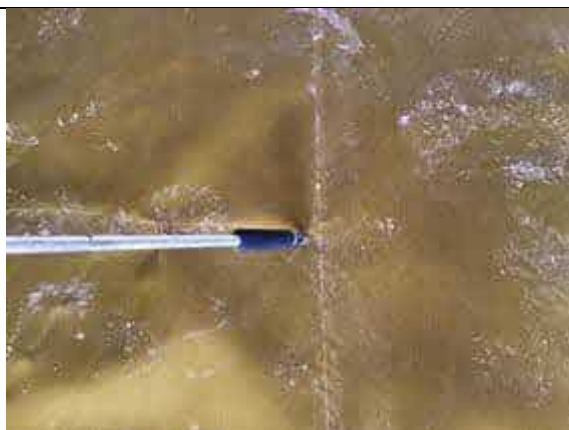
Air lancing all hand welded membrane laps.

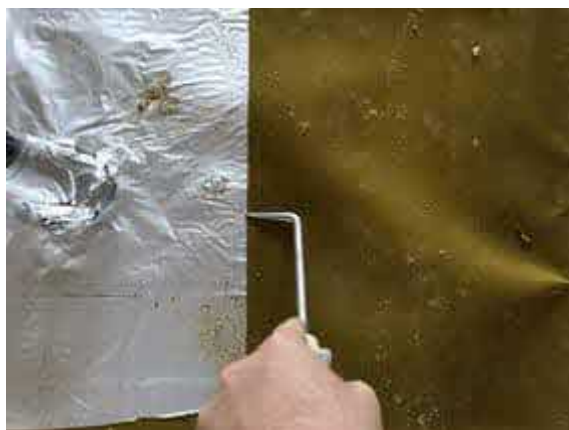
Pick testing all SAGM detailing.

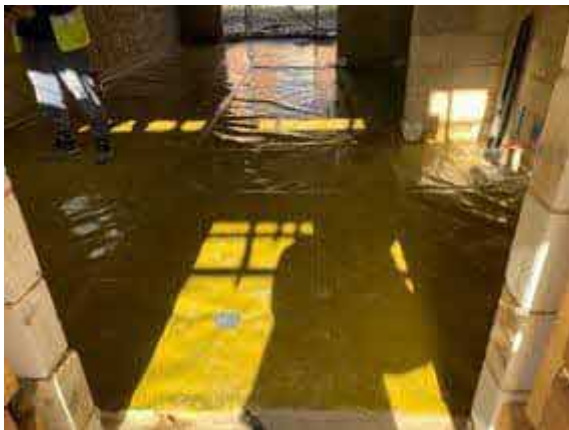
Plot 43 overview of installed membrane.

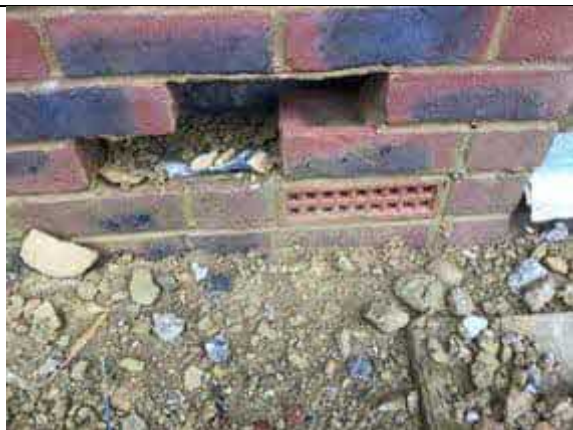
Air brick in place at the time of our inspection to plot 49.

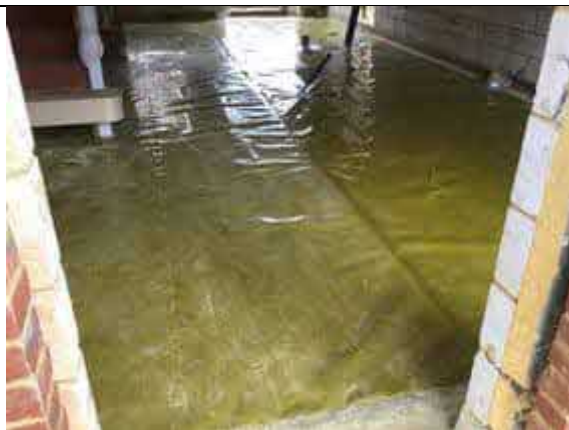
Overview of installed membrane to plot 50.

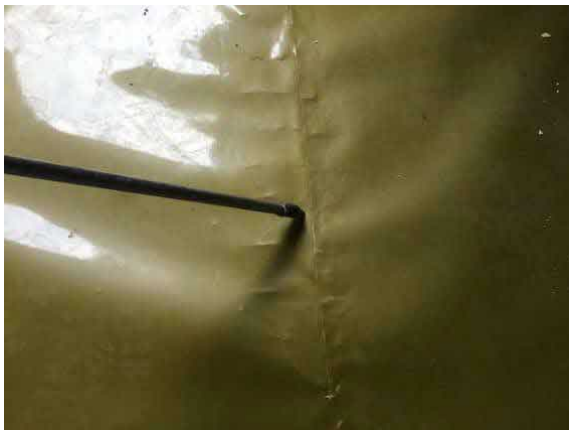
Air lancing all hand welded membrane laps.

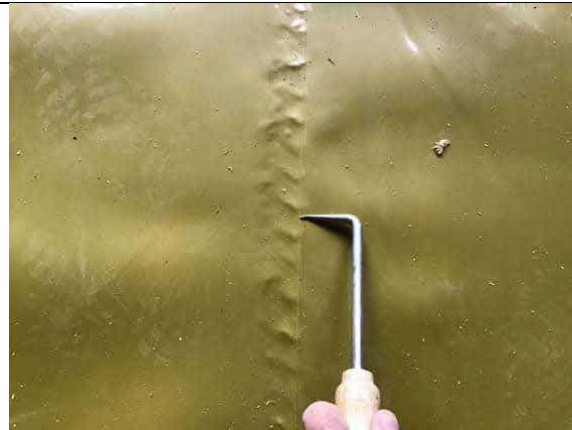
Pick testing all hand welded membrane laps in plot 51.
