Contaminated Land Phase One Desk Study for proposed residential development at 767 Market Street, Whitworth, Rochdale, OL12 8LS.

Prepared for

James Campbell Associates Ltd,
173 Rochdale Road,
Firgrove,
Rochdale,
OL16 3BN

October 2022

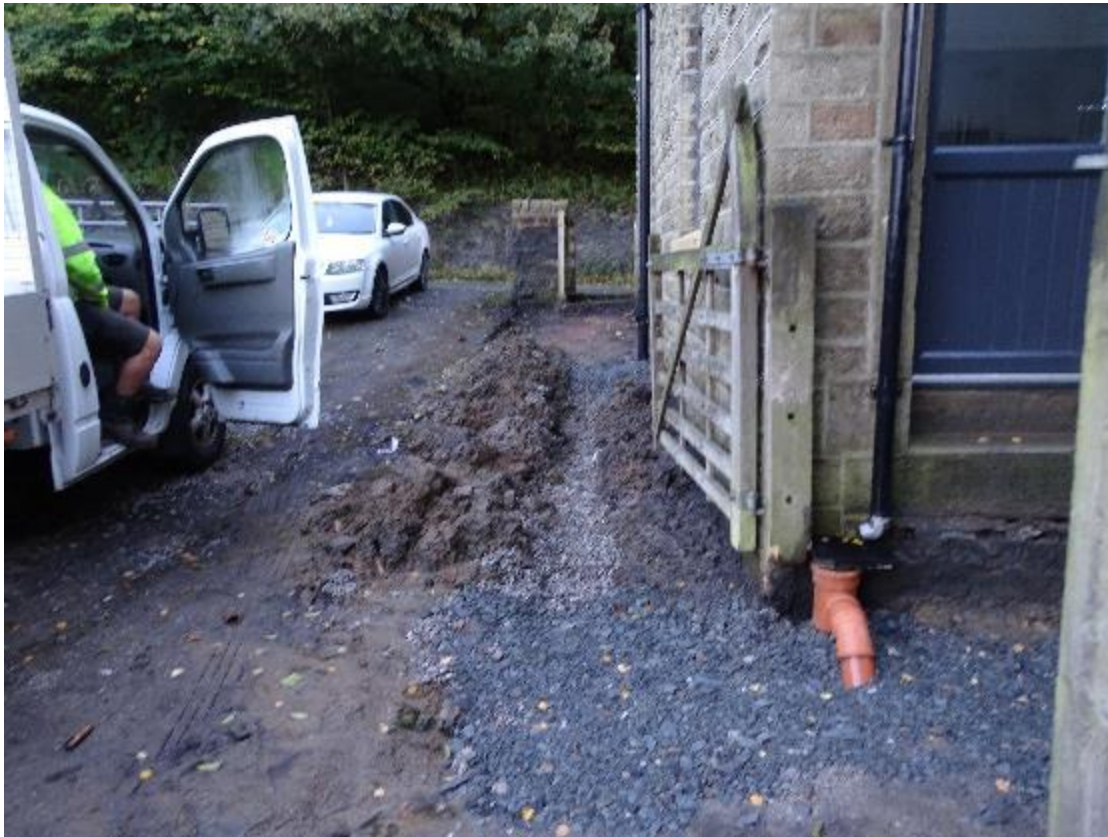
The rear "Garden", plus a trench that has been dug showing the topsoil.

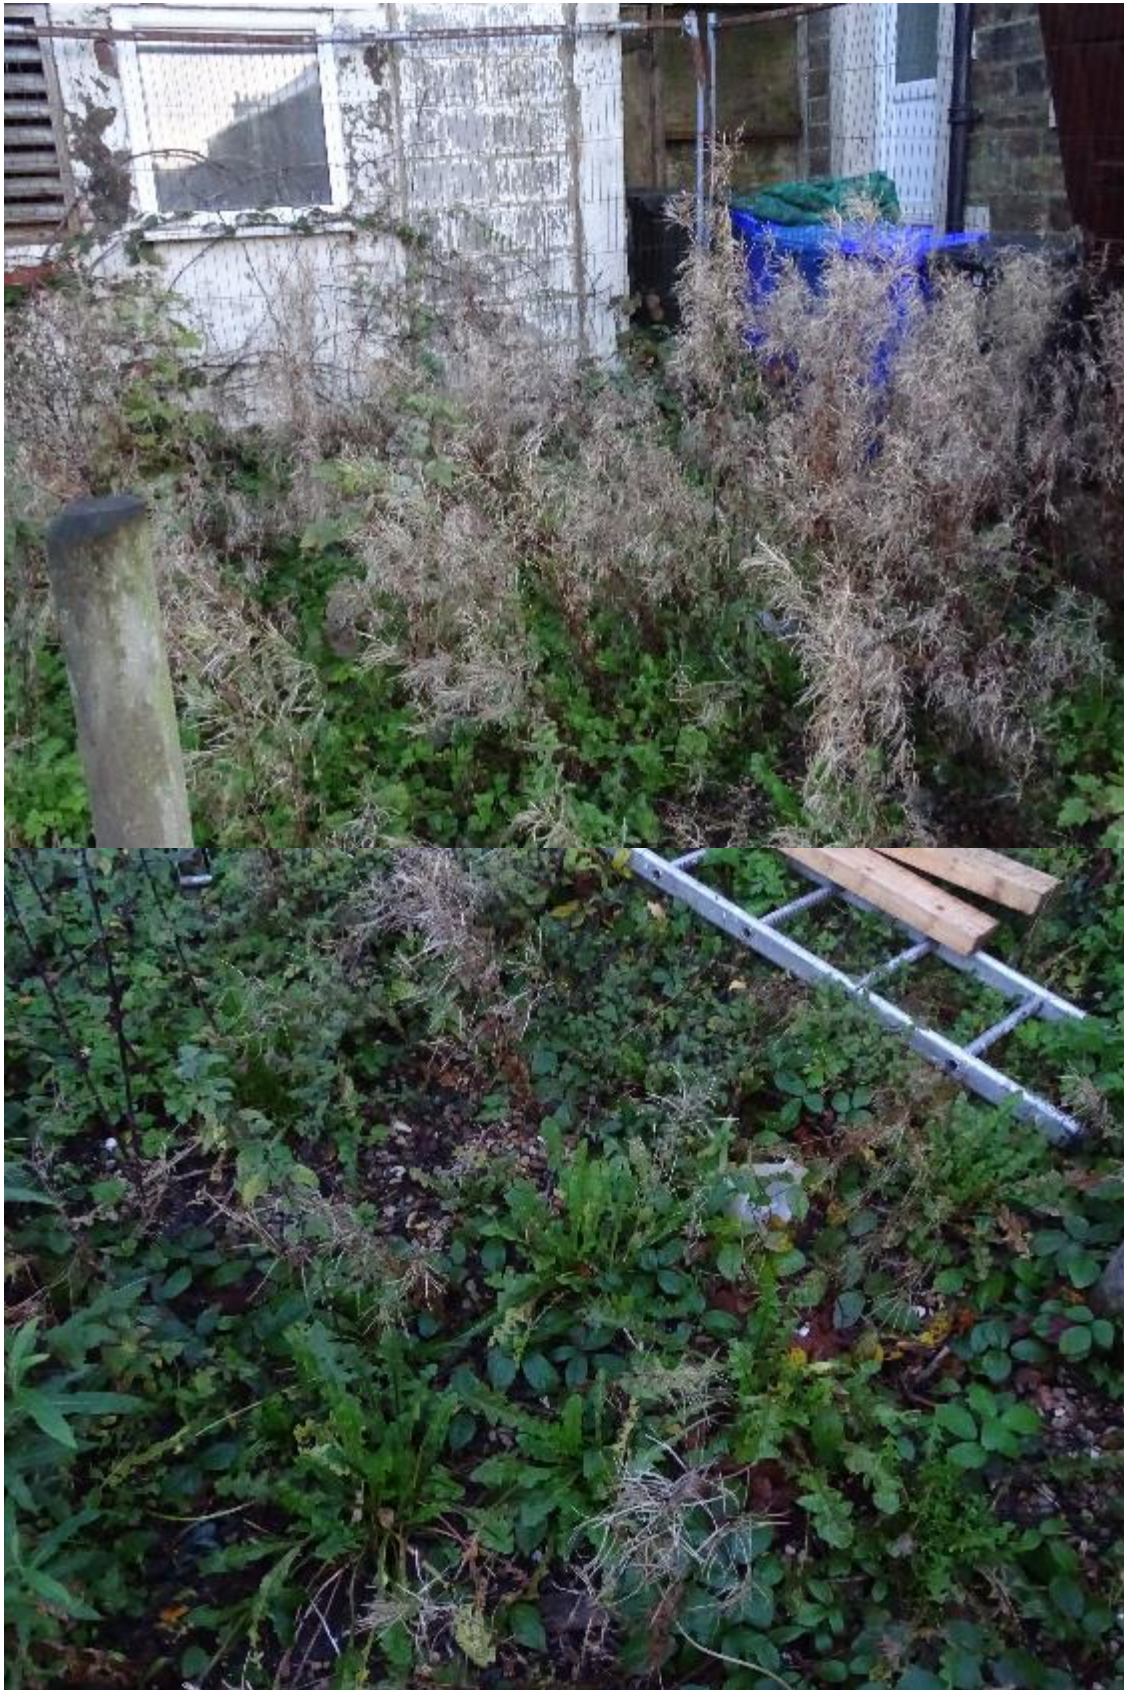
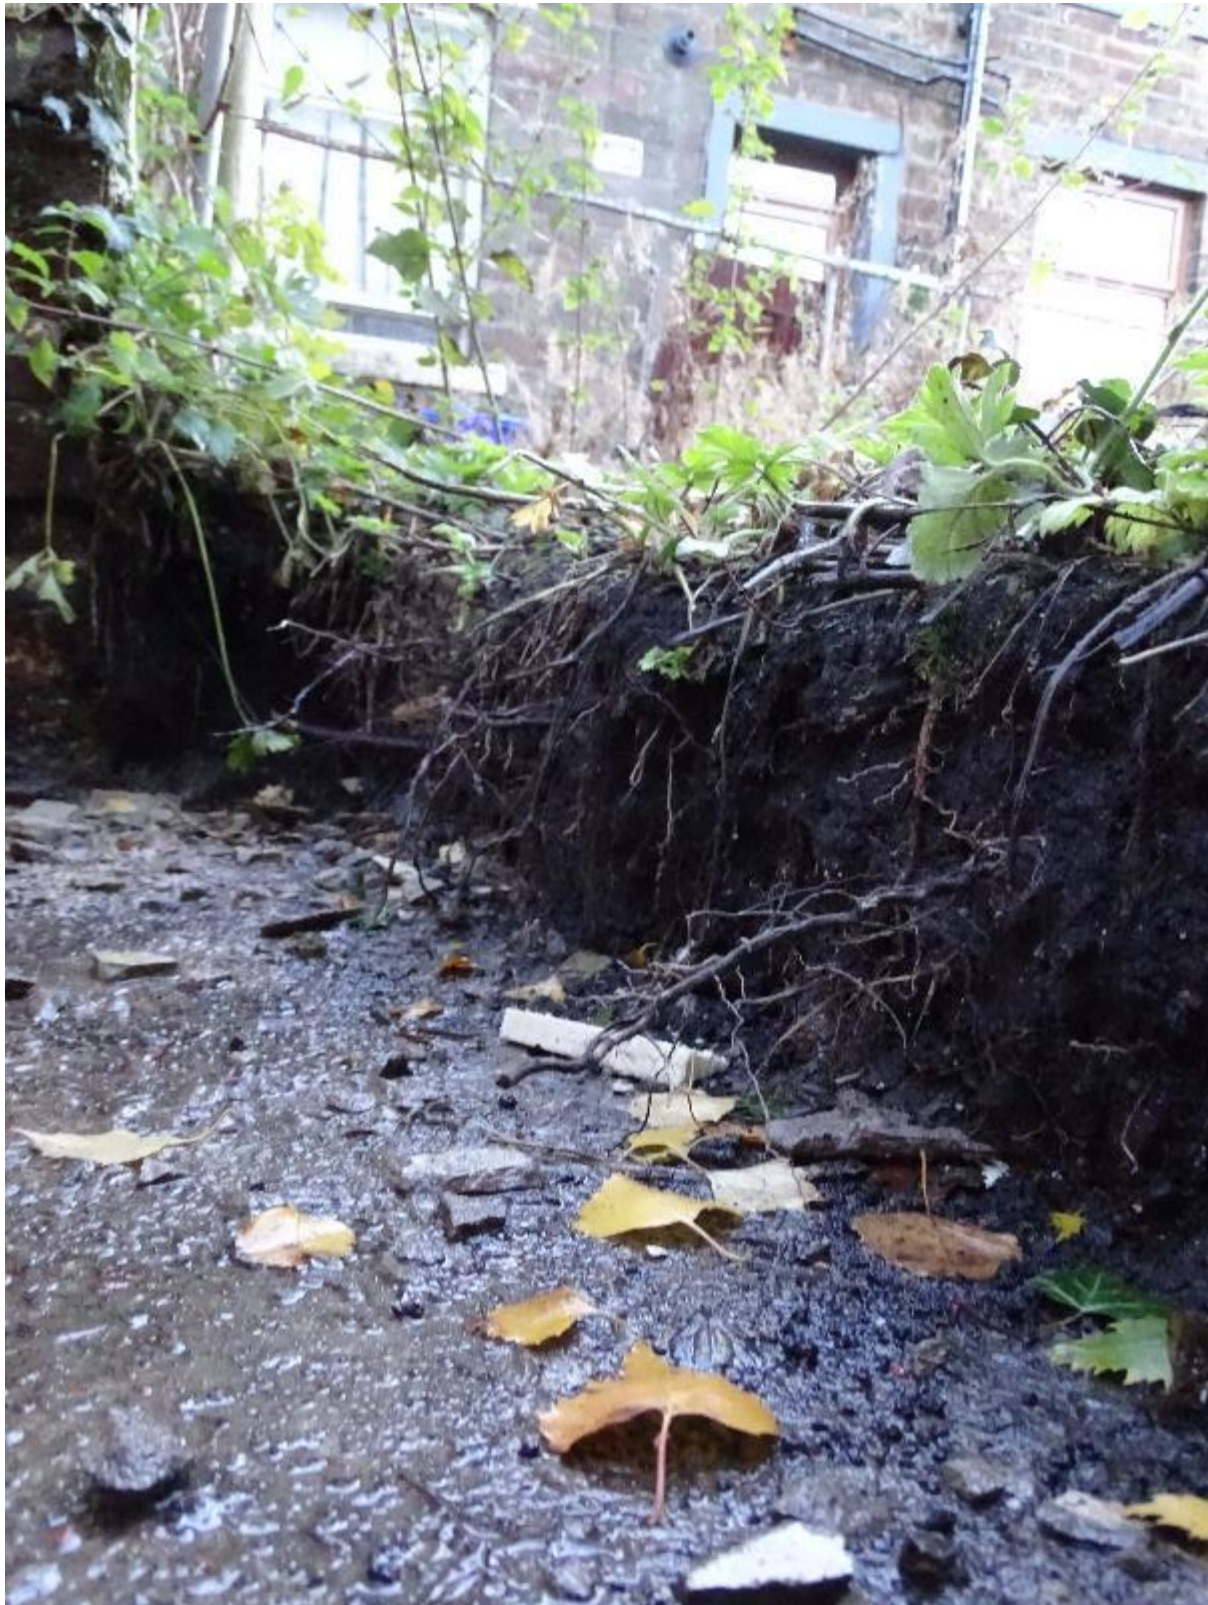
Inside the building ground floor

In the centre is the stable block to be converted. This is a two-storey building with a slate roof and floor. The flooring is to be replaced as part of the conversion.
