Our Ref: 23518/JL/PLA

Date: 19 January 2024

**Re: Lallows Boatyard, 3 Medina Road, Cowes**

We visited the above property, at your request, on 6<sup>th</sup> December 2023 to undertake a structural assessment of the rear right hand side structure of the site.

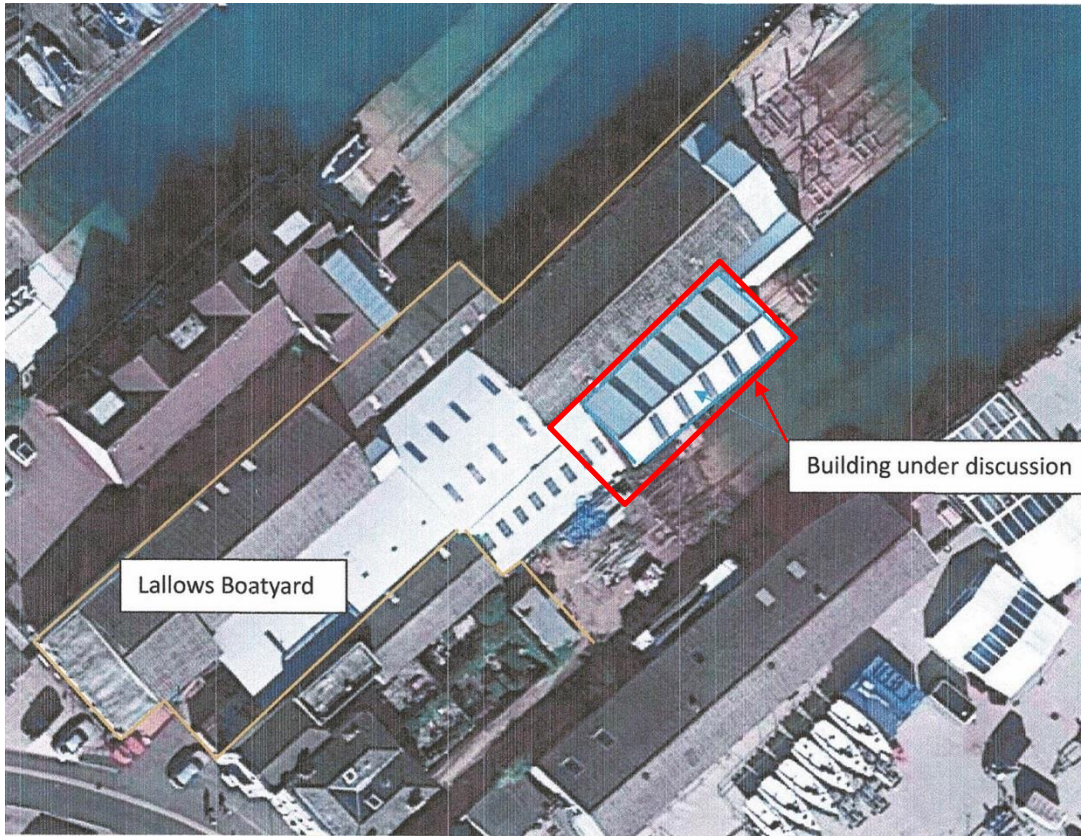
**Image 1** Plan of site.

The boatyard is formed of a collection of buildings and adjacent shipways, refer to Image 1. The building under discussion is highlighted in red.
