# Engineers Report

**Risk Address** 90 Hayes Lane  
BECKENHAM  
Kent  
BR3 6SP

**360 Reference** DLG-SN-22-004722  
**Insurer Reference** 084239680  
**Policy Holder** Mrs Caroline Millard

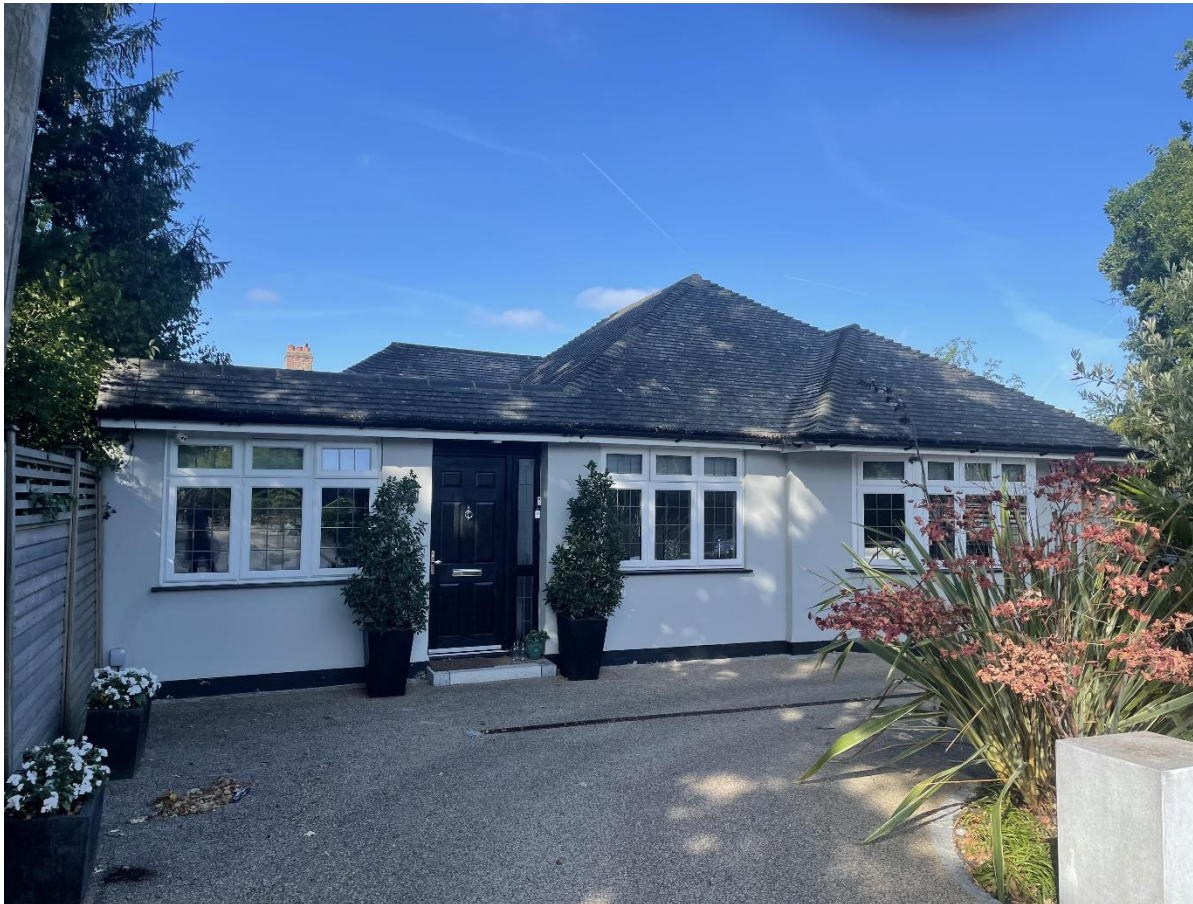
The insured property is a 3 bedroom, single storey detached bungalow. It was constructed circa 1970 from masonry cavity walls, under a pitched, clay tile covered roof. The property has a single storey extension, to the rear left area of the property.

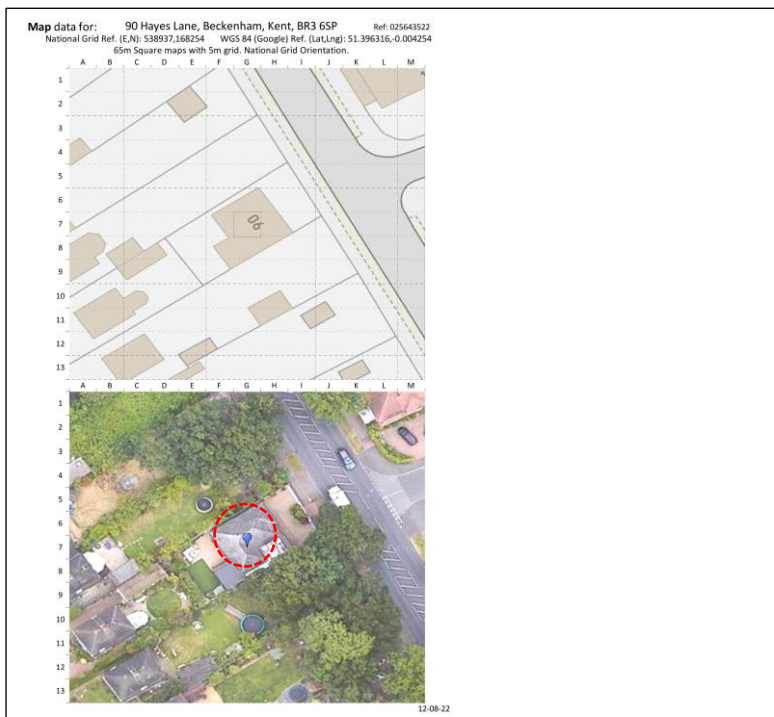
This document addresses damage notified to insurers in relation to minor internal and external cracking to the property, generally orientated towards the left, rear & right-hand areas of the property. All directions are stated when viewing the property from the front.
