## Proposed Tree Works

76 - 105 Crofton Close  
Forest Park  
Bracknell  
RG12 0UT

Proposal prepared by Matthew Wilkes - February 09, 2024

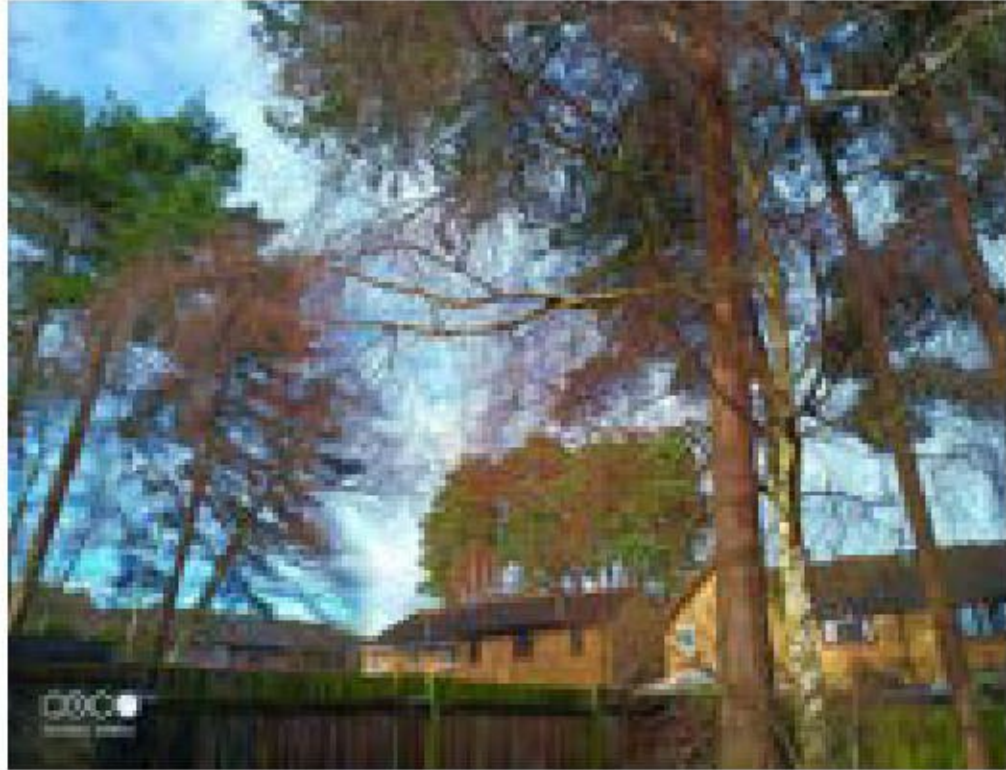
Ref	Species	Photo	Notes	Required works
1	False Acacia	02	In good condition, some branches have been previously removed. Large lower branch encroaching on building.	Remove the lowest branch that extends towards the building.
2	Maple	01	In good condition with tall narrow crown, overhangs car park. Foliage touches tops of vehicles in some places	Remove lowest branch overhanging car park and crown lift to 4m over car park. Crown thin above car park by 20%
3	Maple	01	In good condition, some branches overhang car park	Remove the lowest branch that extends over the car park. Crown lift to 4m above car park. Crown thin above car park by 20%
4	Silver Birch	03	In good condition, leaning towards building. Some branches overhang car park	Remove two lowest branches and crown lift to 4m over car park
5	Sweet Chestnut	04	In good condition. Some branches overhang the car park. Branches and foliage touch vehicles in some places	Remove 3 lowest branches and crown lift to 4m above the car park. Crown thin above the car park by 20%

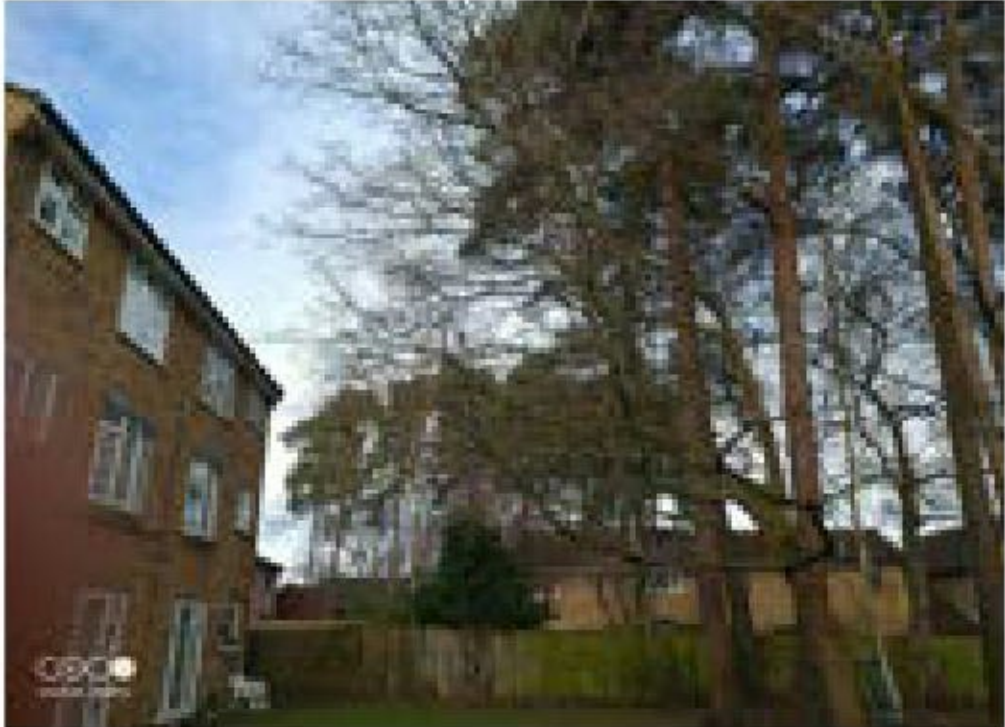
6	Silver Birch	04	In good condition. Some branches overhang car park	Crown lift to 4m over car park
7	Silver Birch	05	In good condition. Some branches overhang car park	Crown lift to 4m over car park
8	Oak	06	In good condition, leaning and lower branches starting to encroach on the building	Remove the lowest 3 branches. Cut back/tip reduce growth to 4m from branches below building gutter height.
9	Silver Birch	07	Small tree in good condition encroaching on building (Not affected by Tree Preservation Order 106).	Fell tree
10	Silver Birch		Dead tree (Not affected by Tree Preservation Order 106).	Fell Tree
11	Silver Birch	08	Good condition, branches starting to encroach on building	Crown lift to 4m
