# ROSE DOBSON

## FORESTRY LTD

This document is prepared at the request of Mr Gareth Hart and dated Monday 19<sup>th</sup> February 2024.

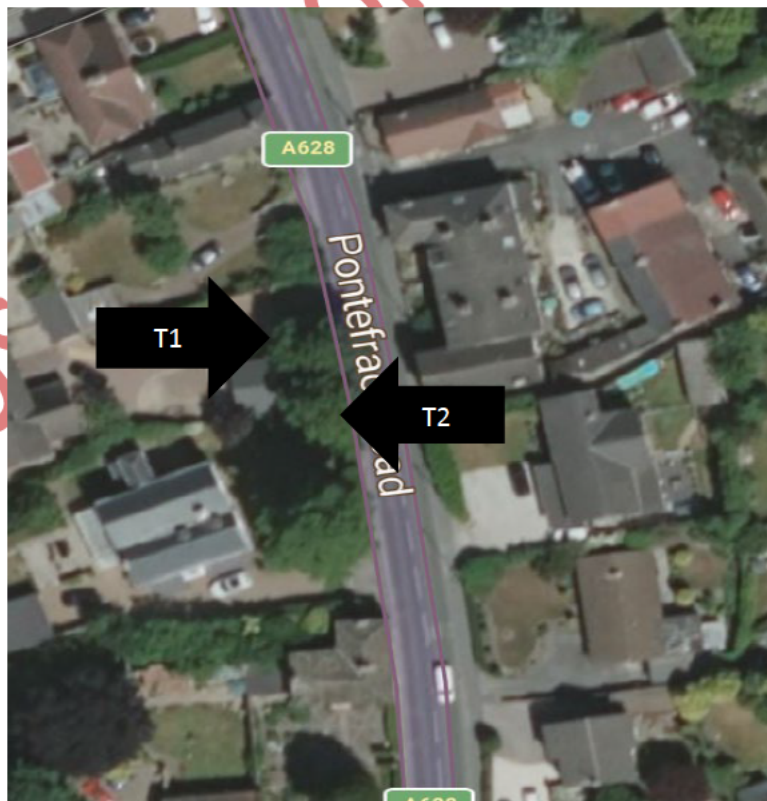
On this date, a site visit was conducted, and both trees were inspected. These are identified as T1 and T2. Both are well established specimens, with ample crown coverage and well balanced in all directions.
