# South Street, Elgin, Moray: Historic Building Recording Report

*AOC Project: 70787  
16th February 2024*

On Behalf of:	Robertson Property Ltd 10 Perimeter Road Pinefield Elgin IV30 6AE
Planning Reference Nos:	Pre-planning
OASIS Ref:	aocarcha1-522526
National Grid Reference (NGR):	NJ 21559 62774
AOC Project No:	70787
Prepared by:	Fiona Jackson
Illustration by:	Fiona Jackson
Date of Fieldwork:	14th – 19th December 2023
Date of Report:	14th February 2024

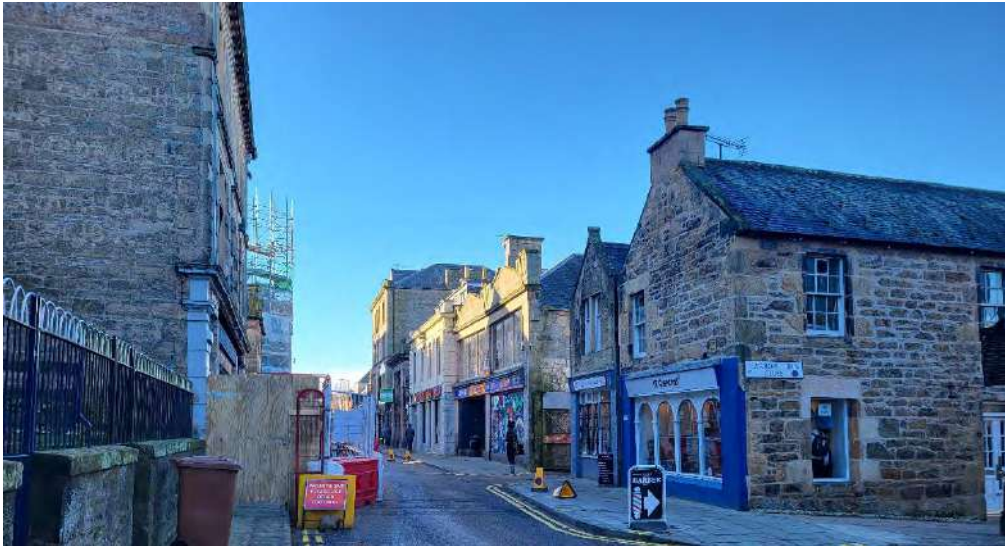
Plate 1: Setting shot of development area looking west along South Street

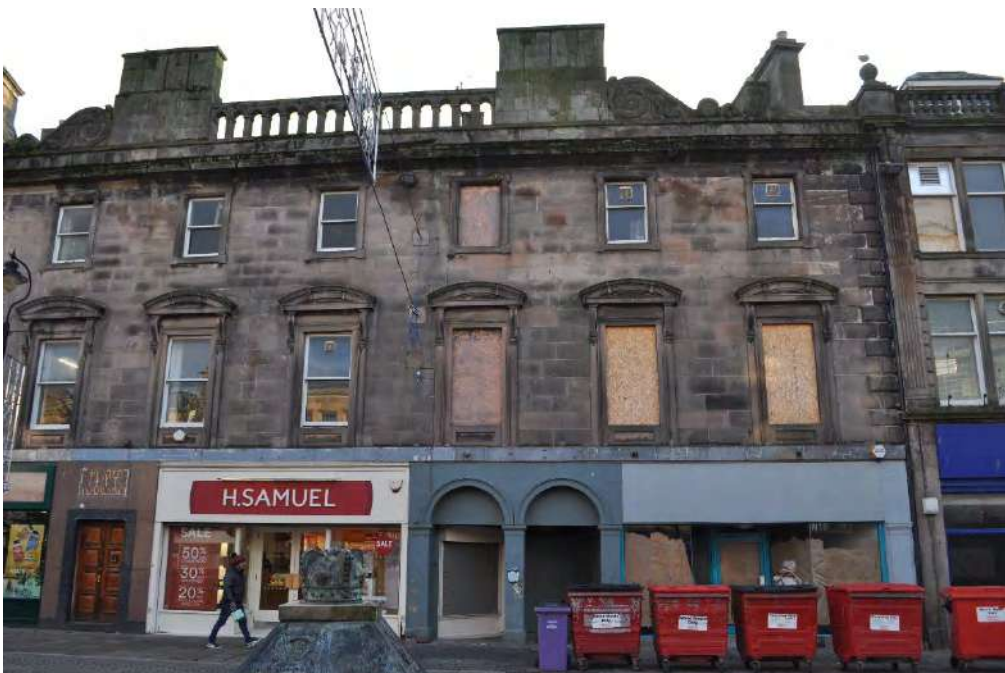
Plate 2: Setting shot of High Street entrance to development area, looking south

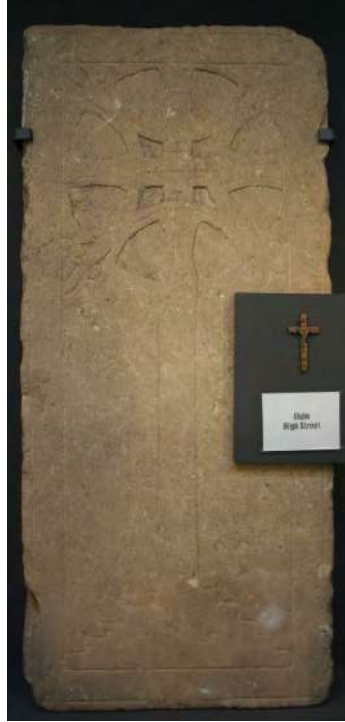
- 4.10 A medieval stone cross-slab was discovered in 1996 during excavation works in the cellar area of Building 4 (HER No. NJ26SW0127) along with part of a clay-built wall on the line of the original medieval close. The cross-slab had been used as paving within the structure (Plate 3).

Plate 3: Medieval stone cross-slab currently on display in Elgin Museum

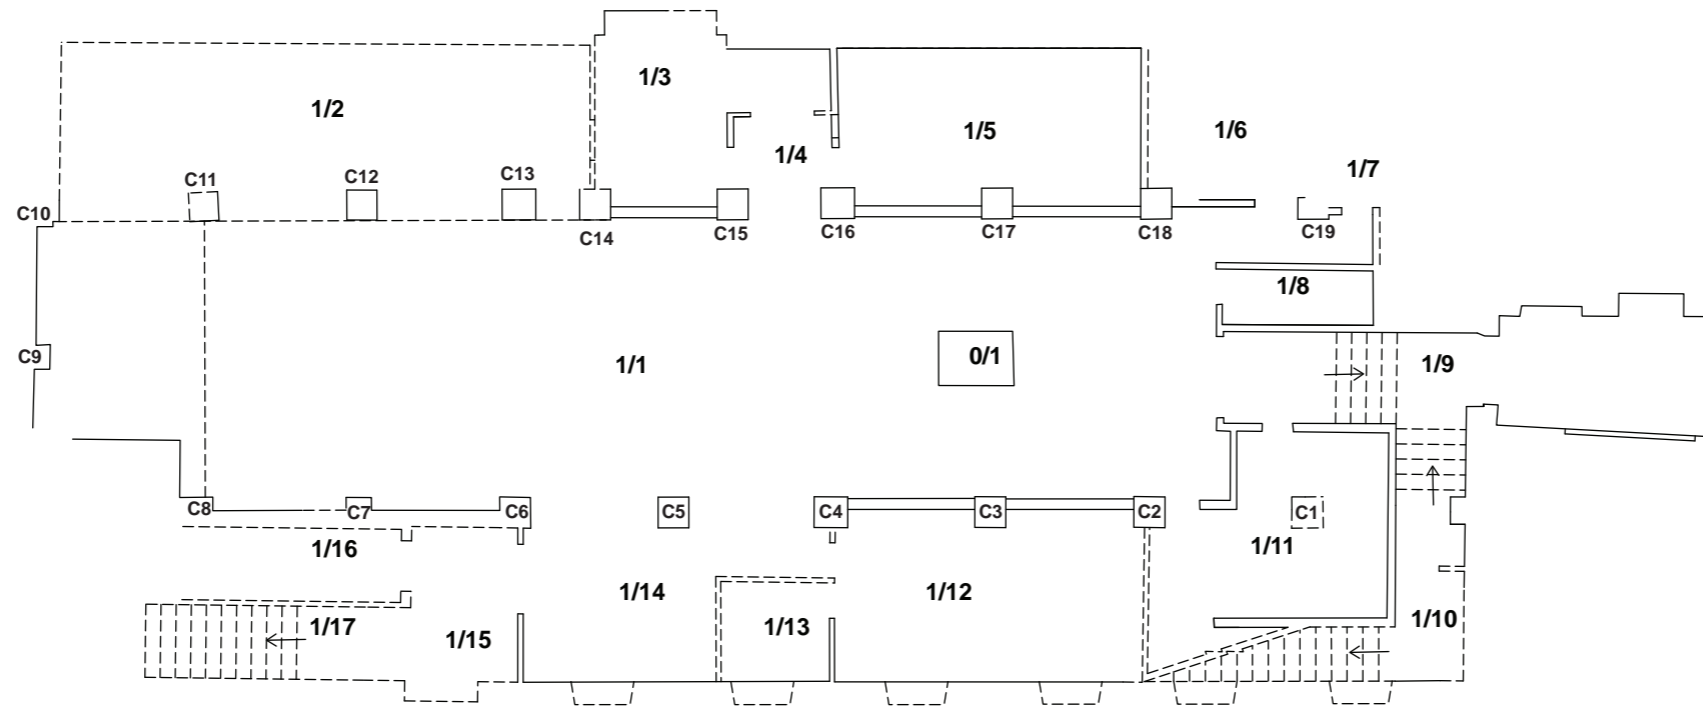
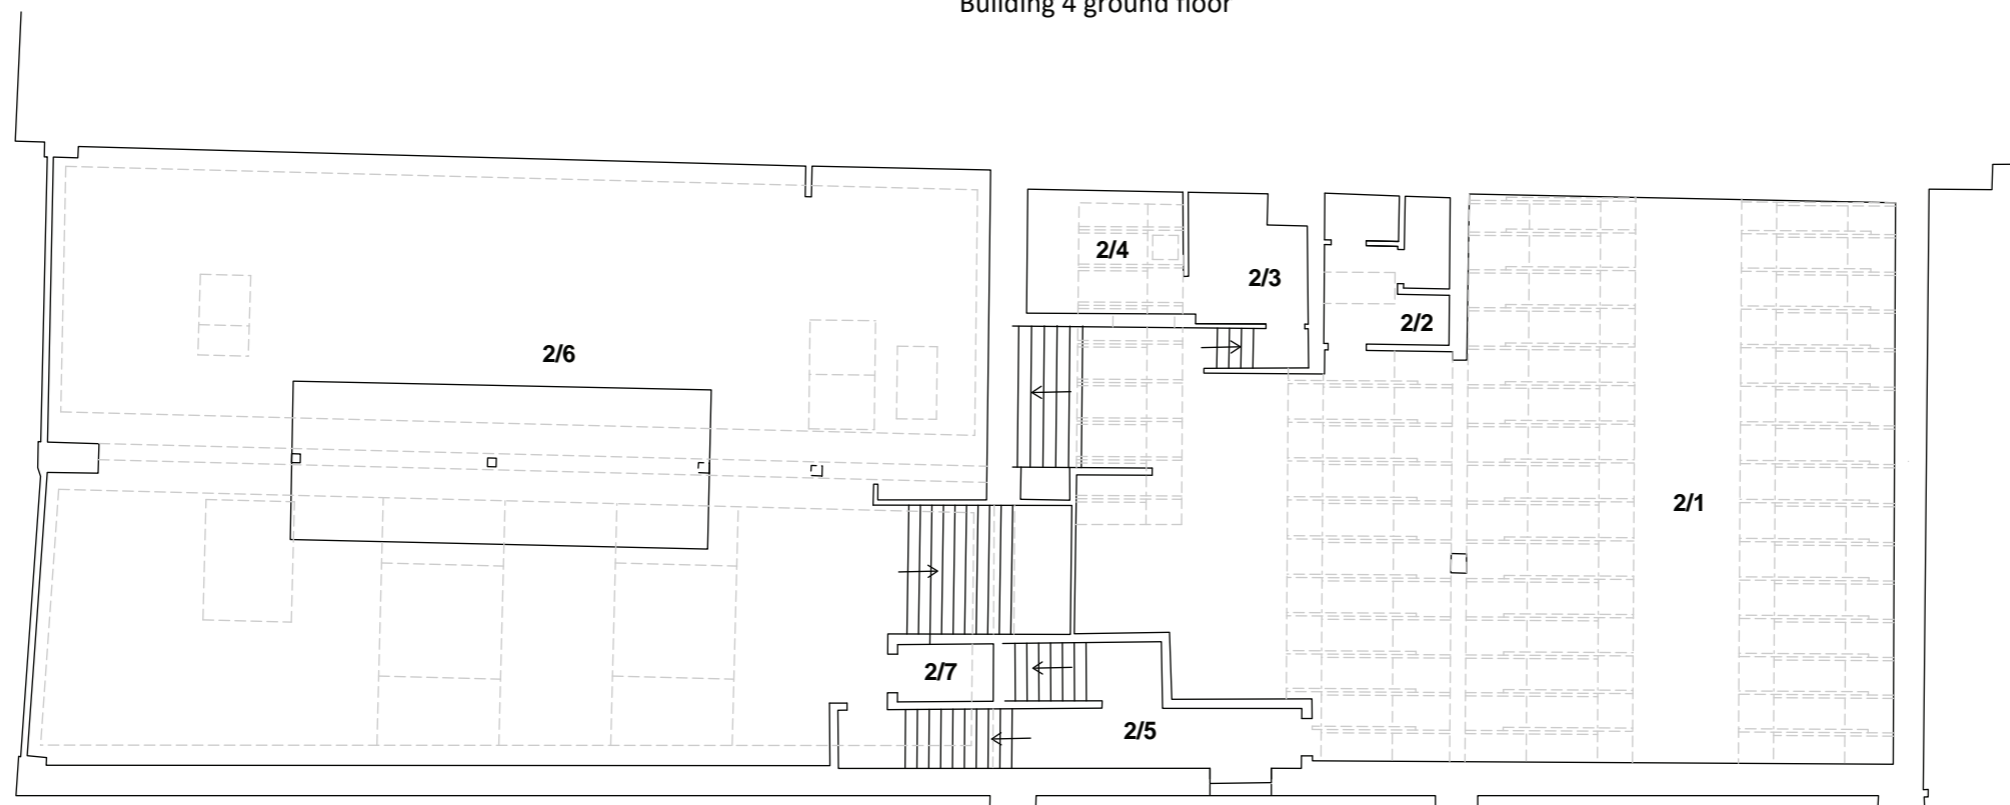
Figure 13: Building 1, first floor plan and Building 4, ground floor plan

Building 4 is a two-storey NNW-SSE aligned rectangular structure with basement, which originally formed the north end of the 1851 market building (Figures 11 & 13; Plates 148 – 201). The structure has been weakened due to fire damage in the late 1990s. The roof structure is almost entirely missing resulting in damp conditions, stone erosion, and vegetation growth across most of the ground floor area. Remnants of the first floor structure are intact towards the south, but were inaccessible at the time of the survey, with only I-beams remaining to the majority of the structure. The recording of Rooms 1/2, 1/5, 1/6, 1/7 and 1/8 was restricted to details visible from exterior openings due to the presence of ceiling collapse within these rooms. Stairwells located in Rooms 1/10 and 1/17 were only partially accessed due to health and safety concerns regarding damage visible on the upper stairs. Following on from its use as a market the building has most recently been used as a nightclub and, whilst the majority of the original warehouse features can be seen, a large number of I-beams have been placed across the building to provide additional flooring including a mezzanine floor still visible on the west side of the building. Due to restricted access, the floor plan provided was incomplete hence where possible additional measurements have been taken to add further detail to the plan. The approximate locations of windows on the east wall have been noted on the floor plan via information gathered from the photographic record. Access to the rooms located to the north-west of the main entrance was not available at the time of the survey.

It was not possible to access the basement at the time of the survey, with a view only available through the access point which was located in the centre of Room 1/1 (Figure 13; Plate 155). Room 0/1, which is assumed to be the only basement room, is accessed by near vertical metal steps on the south edge of the access point. Visible features comprised a long rectangular room with breezeblock walls with a concrete floor.

Room 1/1 is the largest room central to the structure (Figure 13; Plates 155 – 172). It is a large NNW-SSE aligned rectangular room which corresponds with the long hall area of the market building shown on the 1868 OS map (Figure 7). The room is defined by the modern breezeblock walls of Rooms 1/8 and 1/11 to the north, stone columns C2-C8 to the east, a breezeblock wall with central stone column (C9) to the south and stone columns C10-C18 to the west. The floor constructed of concrete with a ca. 150mm step down towards the south between columns C5 and C15. A low rectangular breezeblock structure is located to the north end of the room covering the entrance to the basement (Plate 160).

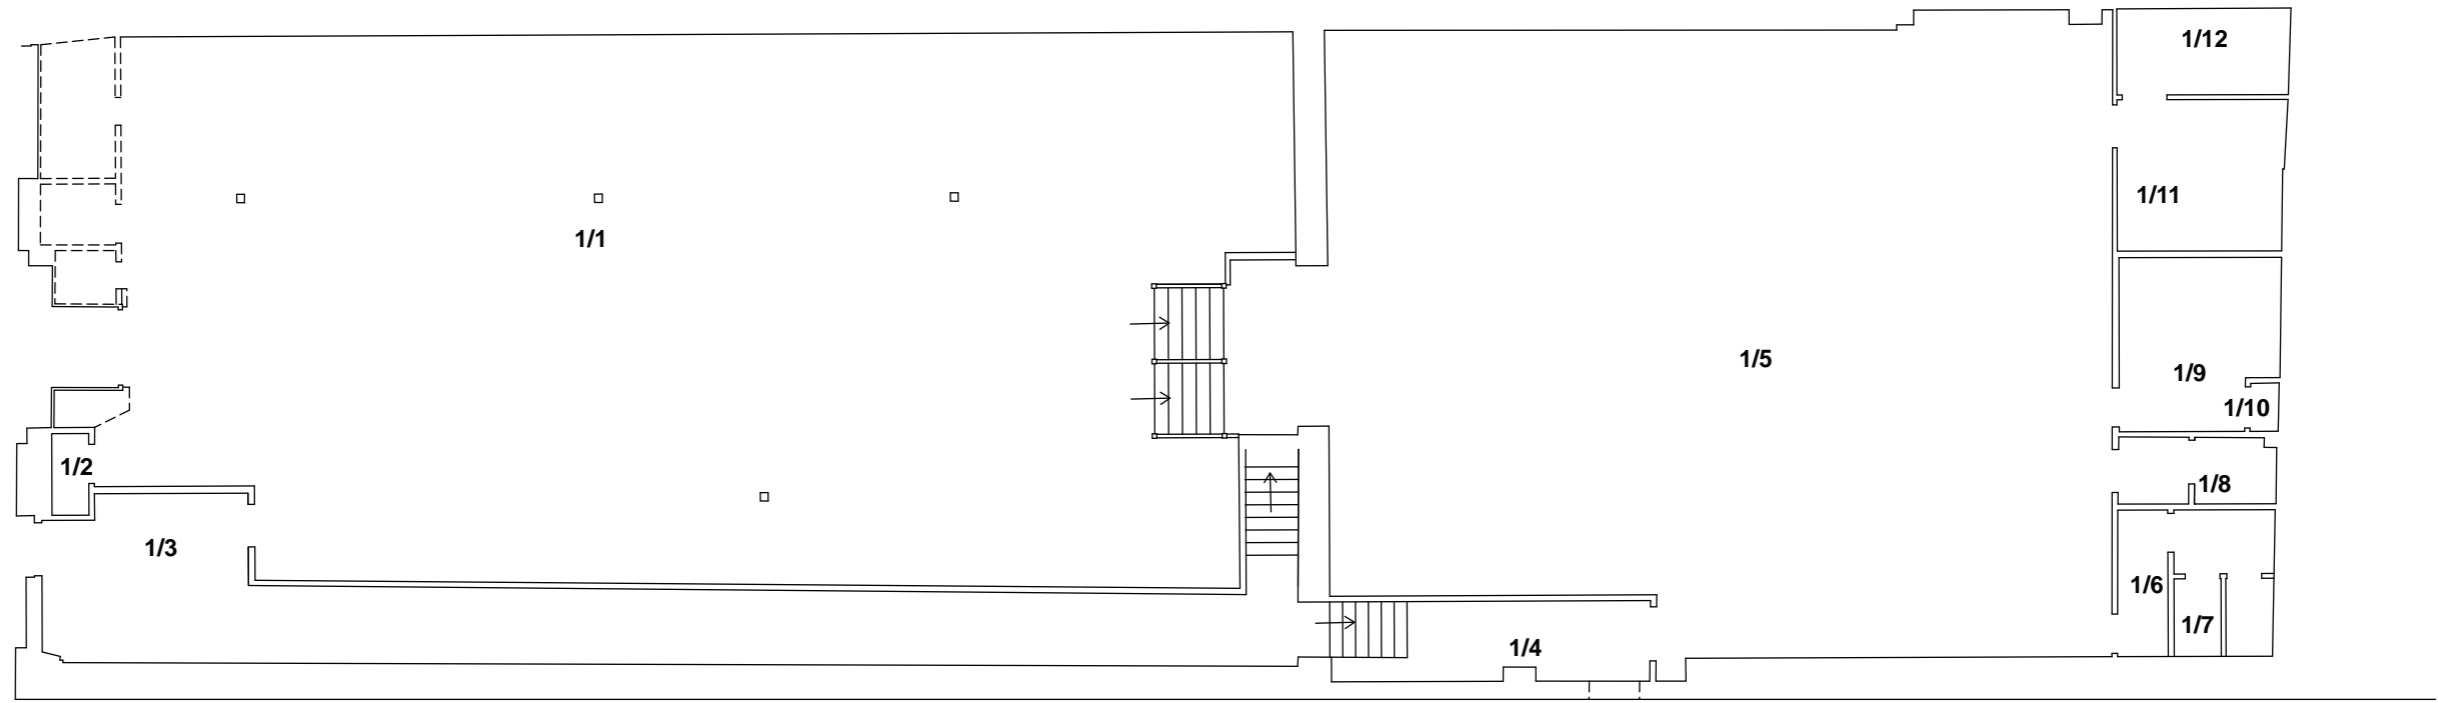
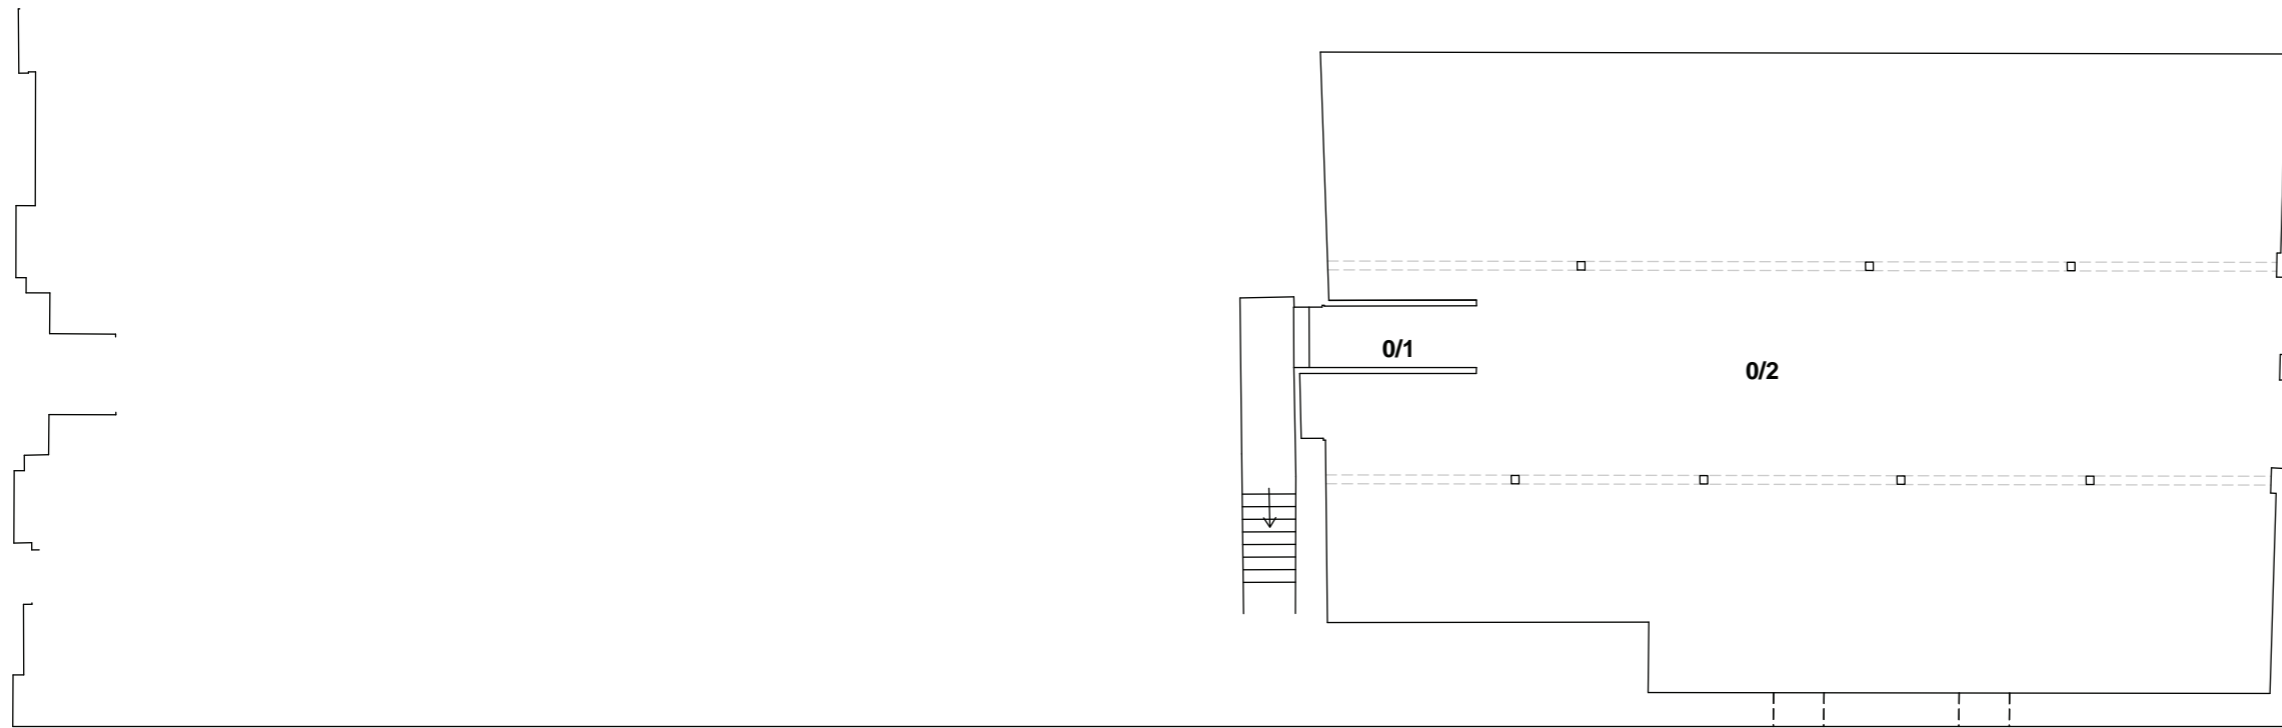
1.1.5 Building 3 – Junners, 57-61 South Street. This was constructed in ca. 1851. It currently comprises a single-storey building, the frontage forming the Elgin Market entrance which is a Class C Listed building (Ref: LB30886). The building was in use for retail purposes until 2016. It is in relatively good repair, with occasional areas of damp visible within the building.
