► PROJECT Proposed Window Replacement
Grove Farmhouse, Grove Lane
Little Wenham, Suffolk, CO7 6QB
CLIENT Mr. N. Brown
► STATUS **PLANNING**

► TITLE Timber Condition Evidence
► SCALE 1:100 SHEET SIZE A3
ISSUE DATE 16/02/2024
AUTHOR FDS CHECK CW

| JOB No. | DRAWING No. | REVISION |
|---|---|---|
| 5836 | PA_16 | |

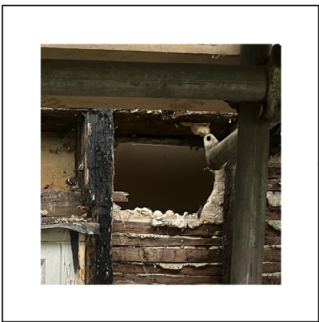
Inconsistent existing build up showing, timber laths, plaster board and galvanized metal laths within the historic timber frame.

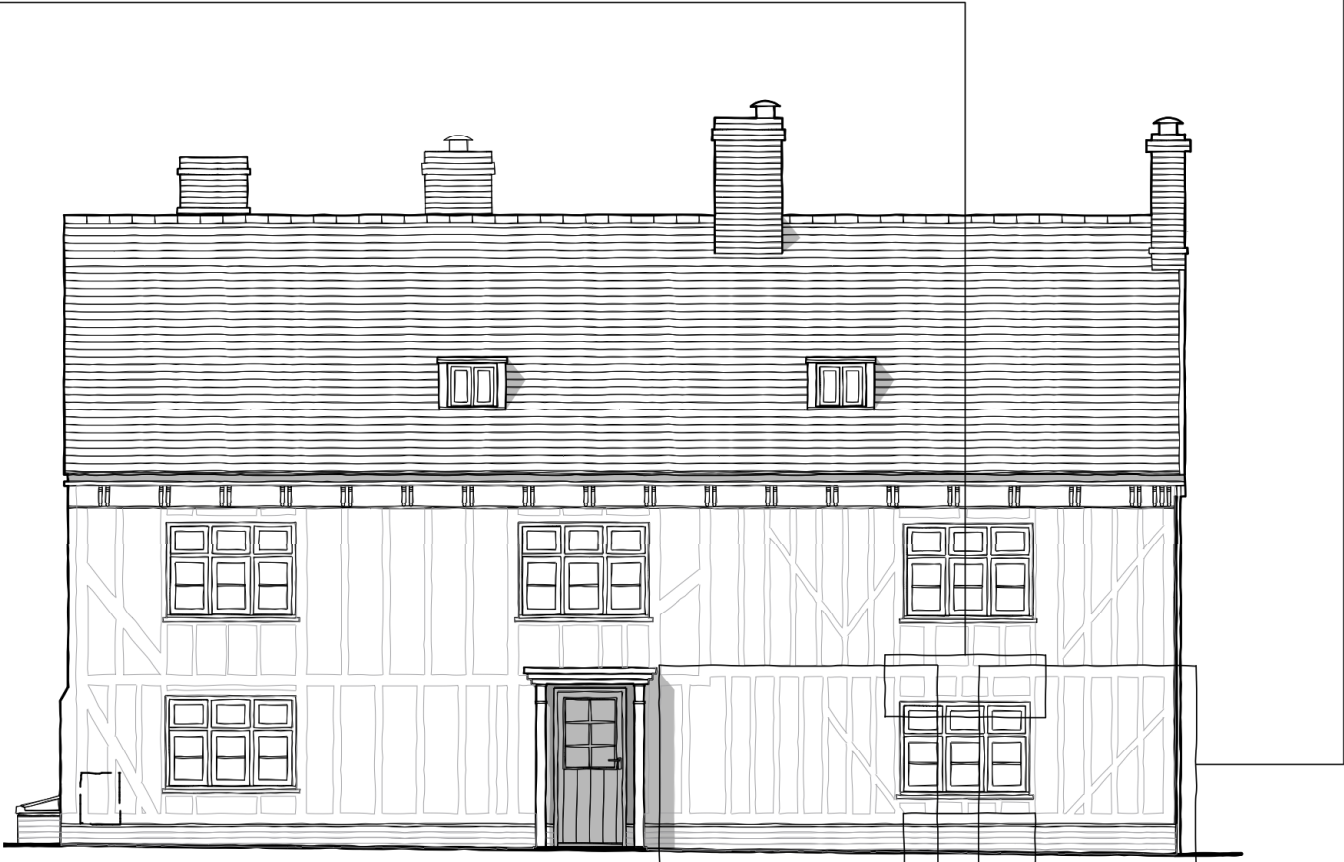
PROPOSED WEST ELEVATION
Scale: 1:100

Brick plinth is currently in an extremely poor condition.

Refer to structural engineer details prepared by Revel Architecture & Engineering.
