Job N°: SLP/23/003

1st March 2023

**STRUCTURAL REPORT
FOLLOWING
A
VISUAL INSPECTION
OF
2 N° STEEL FRAMED BARNs
AT
OAK FARM
GREEN BARNs LANE
LITTLE HAY
LICHFIELD
WS14 0QN**

**Prepared by:
S L Pountney, BEng, CEng, MICE, MStructE, FFB.
For SLP Consultants**

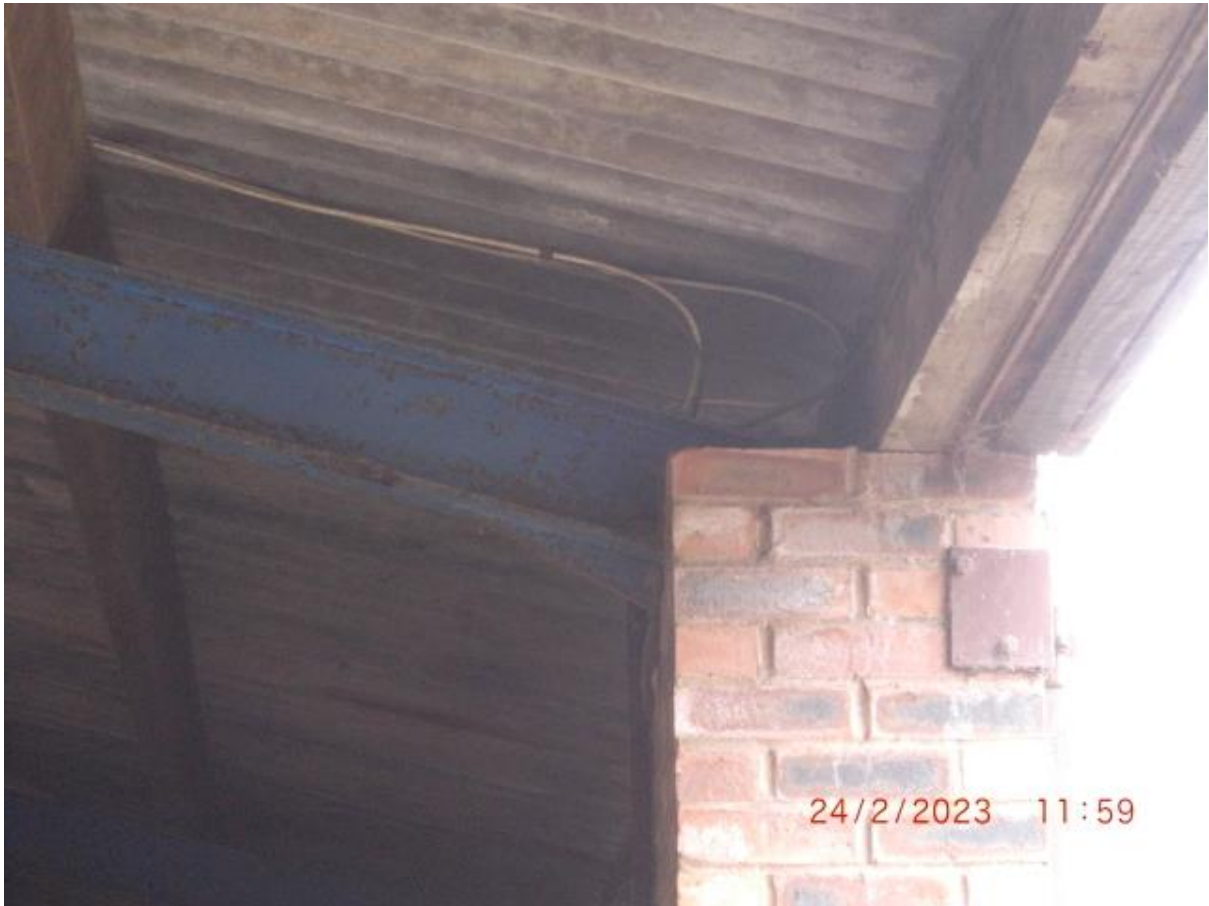
Photograph 4

horizontal and is covered with deep profile corrugated fibre cement roof sheets. The steel portal frames are located at approximately 4.5 metre centres using 178 x 102 x 19 UB rafters supporting 220 x 75 timber rafters at approximately 1200mm centres. *(Photographs 3 & 4)* It was not possible to see the steel column sections to the portal frames due to the fact that they are fully encased within 460mm square face brickwork piers. *(Photograph 5)* However, I anticipate that these members are most probably either 203 x 102 UB or 203 x 133UB sections. The west gable wall of Barn A is constructed as an infill masonry panel beneath the last steel portal frame. This wall appeared to be constructed using solid 190mm wide blocks incorporating a 460mm square vertical blockwork pier at the mid-point. *(Photographs 6 & 7)* At the opposite east end of the building there appeared to be no steel portal frame. Instead, this wall appeared to be constructed as a load bearing cavity wall with an outer leaf of face brickwork and an inner leaf of 190mm wide blockwork. The internal division walls between and at the front and back of the stable units were all found to be constructed using 190mm solid blocks to a height of approximately 1600mm above the finished ground floor level.
