CCTV REPORT FOR: 1 IVYDENE GARDENS  
DORRITA AVENUE  
WATERLOOVILLE  
PO8 8NP

Insured: Mr R Davison  
Reference: 084431824

Site Visit: 09-Mar-23  
Report Date: 18-May-23

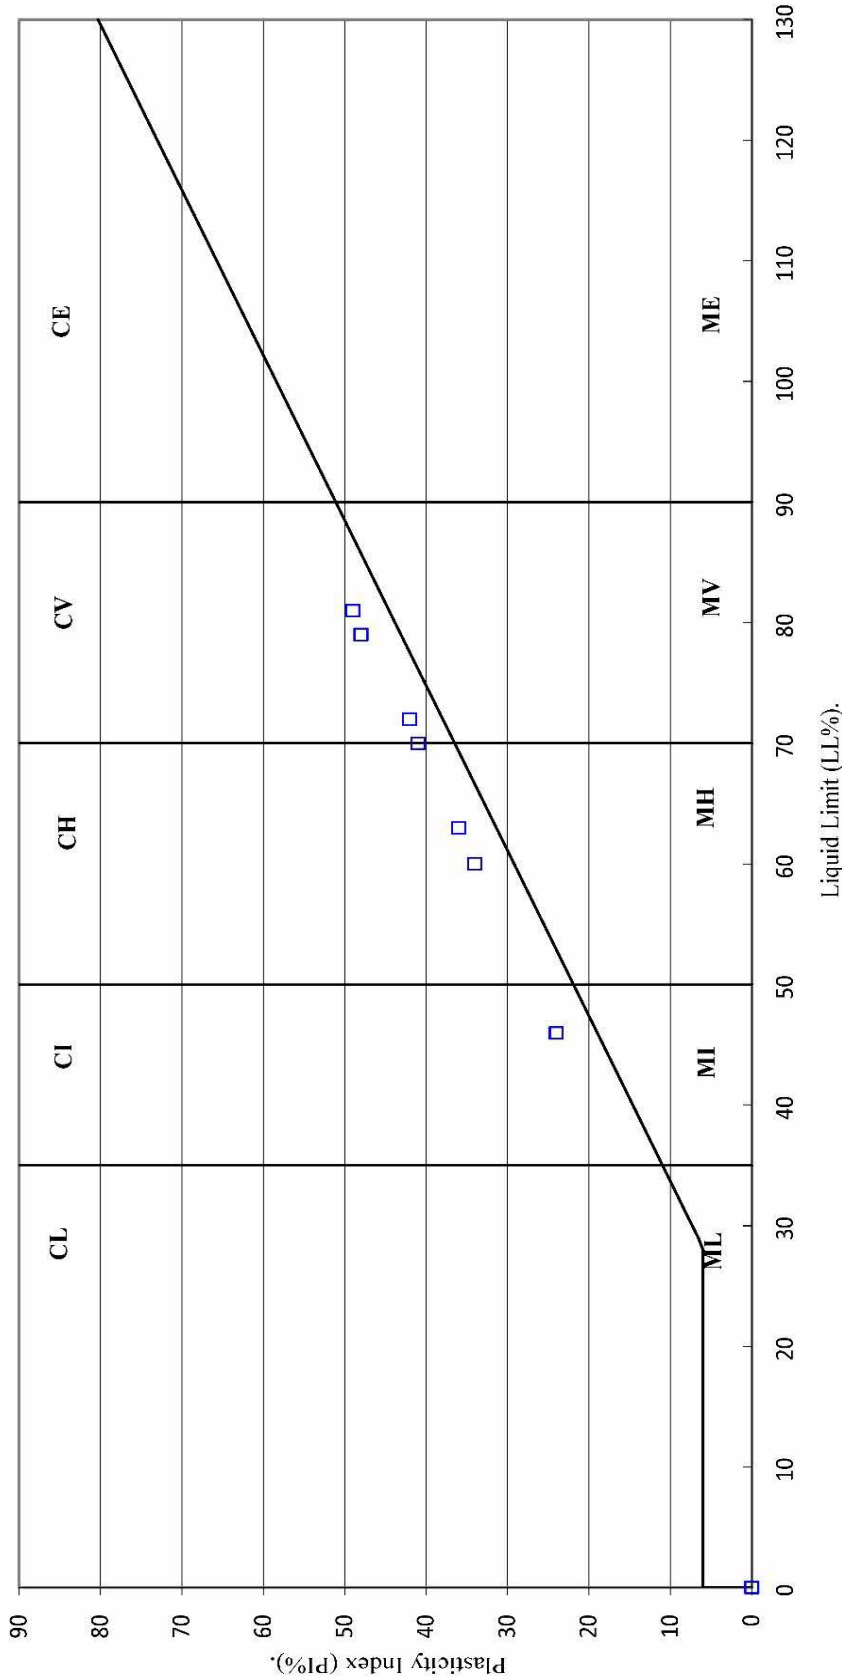
**PLASTICITY CHART FOR CASAGRANDE CLASSIFICATION.**

Hole Number	Sample Number	Sample Type	Top Depth m	Base Depth m	Moisture Content % Clause 3.2	Linear Shrinkage % Clause 6.5	Particle Density Mg/m <sup>3</sup> Clause 8.2	Liquid Limit % Clause 4.3/4	Plastic Limit % Clause 5.3	Plasticity Index % Clause 5.4	Passing .425mm %	Remarks
TP/BH1			0.40	1.00	22			46	22	24	100	Intermediate Plasticity CI
TP/BH1			1.00	1.50	29			60	26	34	97	High Plasticity CH
TP/BH1			1.50	2.00	28			63	27	36	98	High Plasticity CH
TP/BH1			2.00	2.50	31			79	31	48	100	Very High Plasticity CV
TP/BH1			2.50	3.00	31			70	29	41	100	Very High Plasticity CV
TP/BH1			3.00	3.50	30			81	32	49	100	Very High Plasticity CV
TP/BH1			3.50	4.00	26			72	30	42	100	Very High Plasticity CV

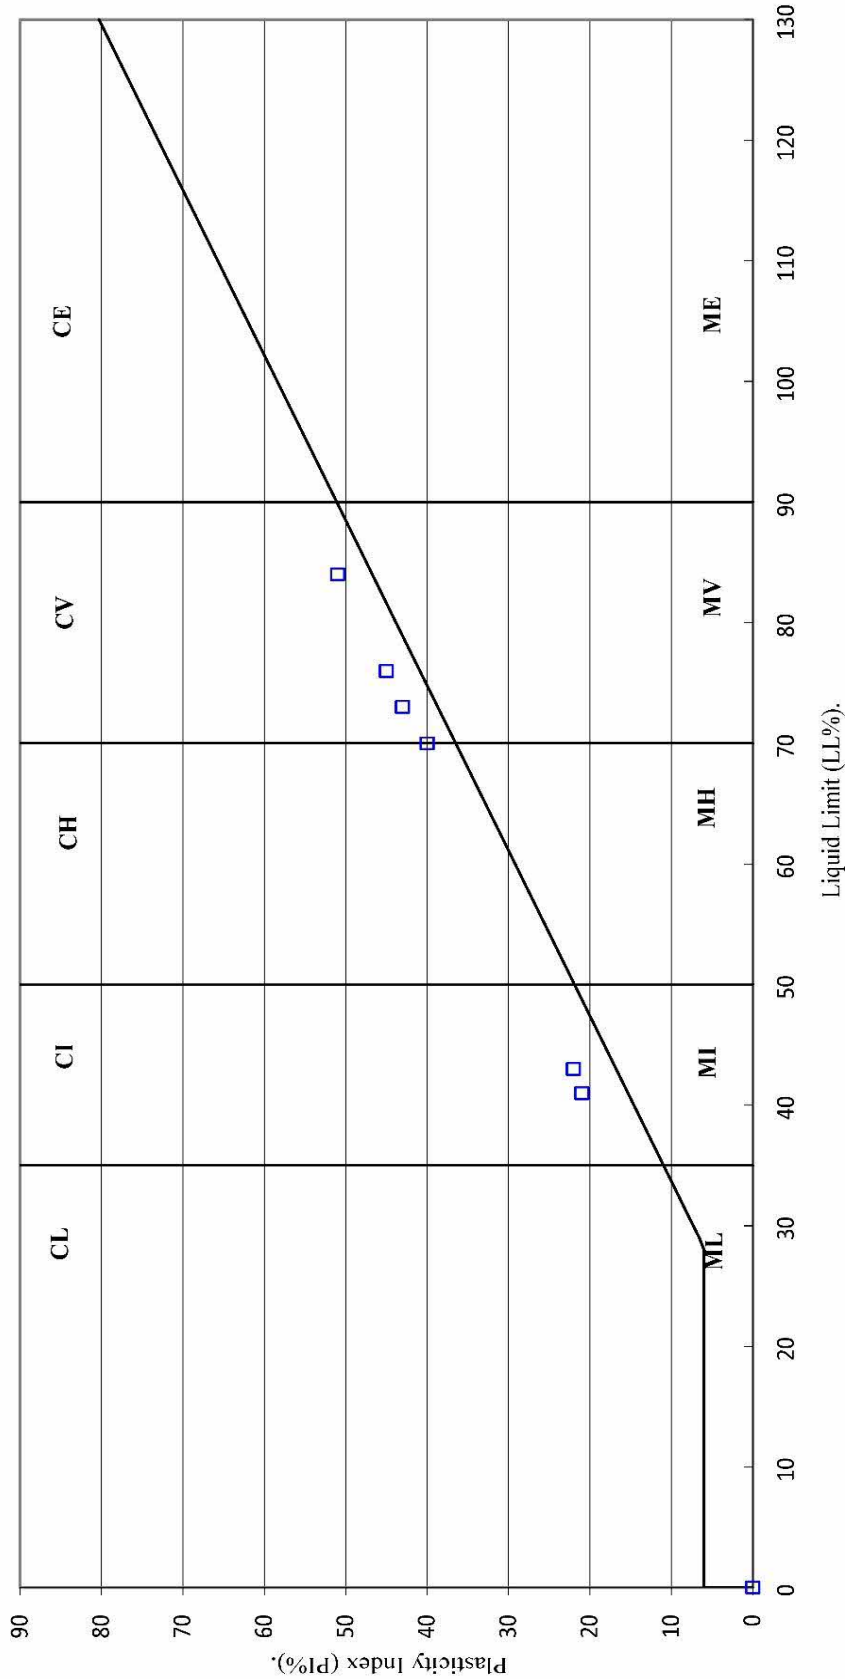
**PLASTICITY CHART FOR CASAGRANDE CLASSIFICATION.**

Hole Number	Sample Number	Sample Type	Top Depth m	Base Depth m	Moisture Content % <small>Clause 3.2</small>	Linear Shrinkage % <small>Clause 6.5</small>	Particle Density Mg/m <sup>3</sup> <small>Clause 8.2</small>	Liquid Limit % <small>Clause 4.3/4</small>	Plastic Limit % <small>Clause 5.3</small>	Plasticity Index % <small>Clause 5.4</small>	Passing .425mm %	Remarks
TP/BH2			0.40	1.50	24			41	20	21	87	Intermediate Plasticity CI
TP/BH2			1.50	2.00	24			43	21	22	88	Intermediate Plasticity CI
TP/BH2			2.00	2.50	35			84	33	51	100	Very High Plasticity CV
TP/BH2			2.50	3.00	31			76	31	45	100	Very High Plasticity CV
TP/BH2			3.00	3.50	30			70	30	40	100	Very High Plasticity CV
TP/BH2			3.50	4.00	27			73	30	43	100	Very High Plasticity CV
