**Project Name**  
873325 Waddesdon

**Project Date**  
02/02/2024

**Company:** Waddesdon Church of England School

### Project Drawing, Page '873325 Waddesdon'

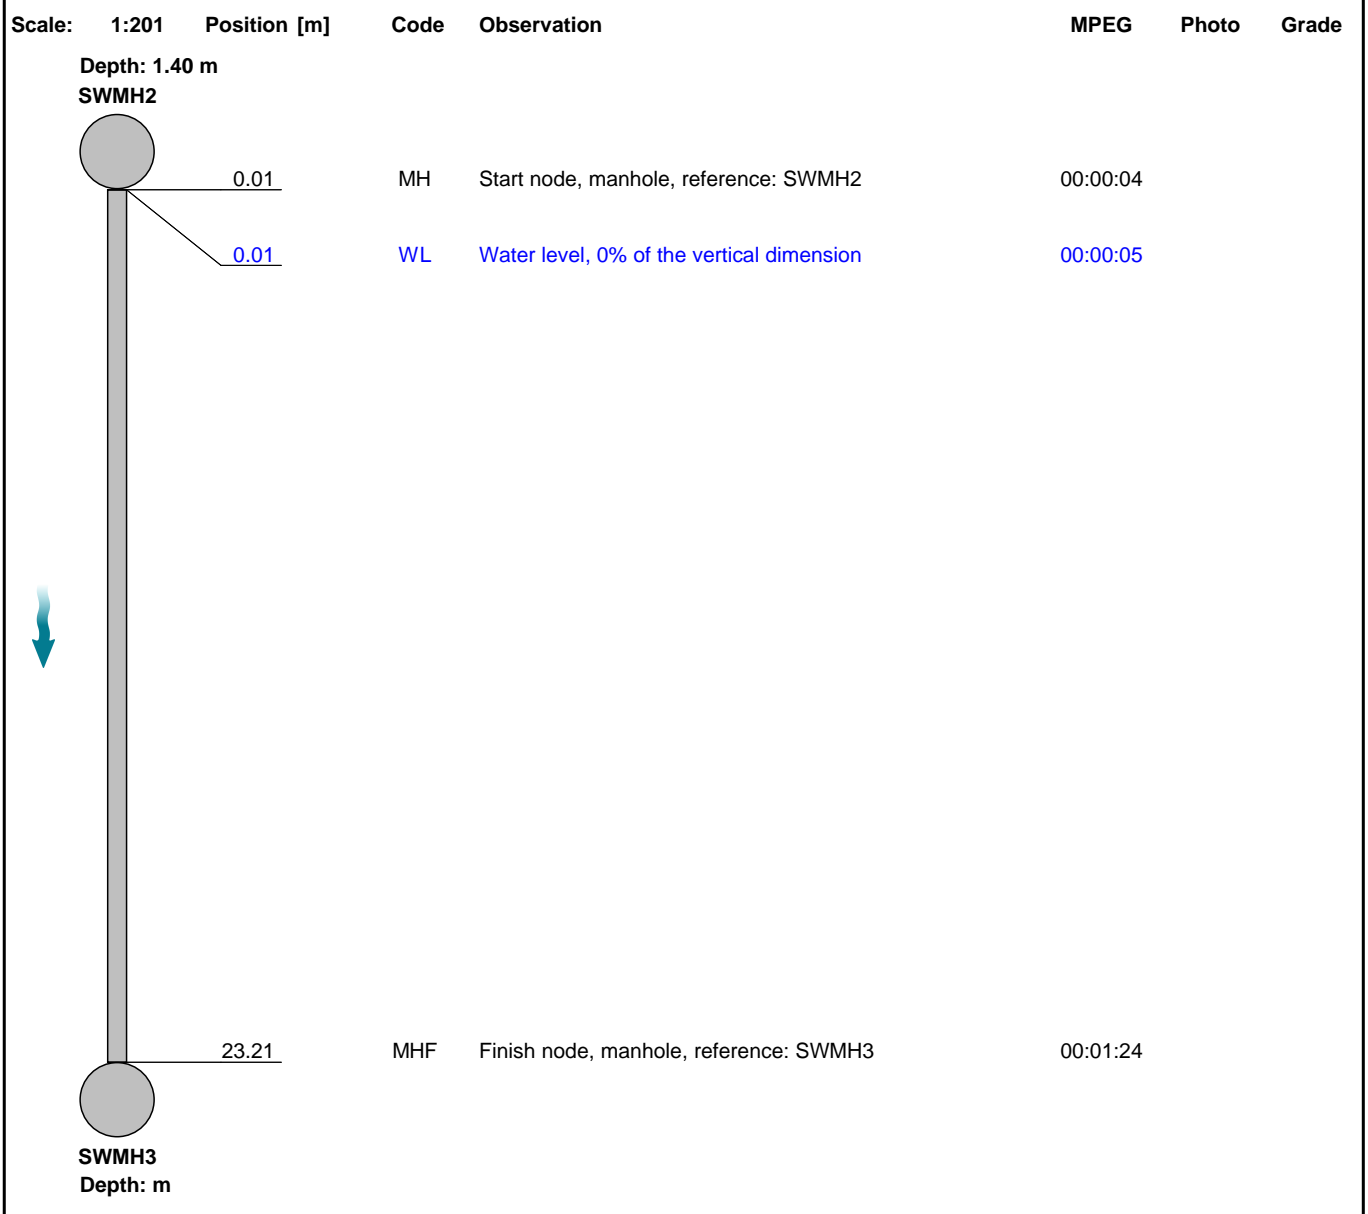
No.	m+	Code	Observation
1	0.01	MH	Start node, manhole, reference: SWMH2
2	0.01	WL	Water level, 0% of the vertical dimension

No.	m+	Code	Observation
3	23.21	MHF	Finish node, manhole, reference: SWMH3

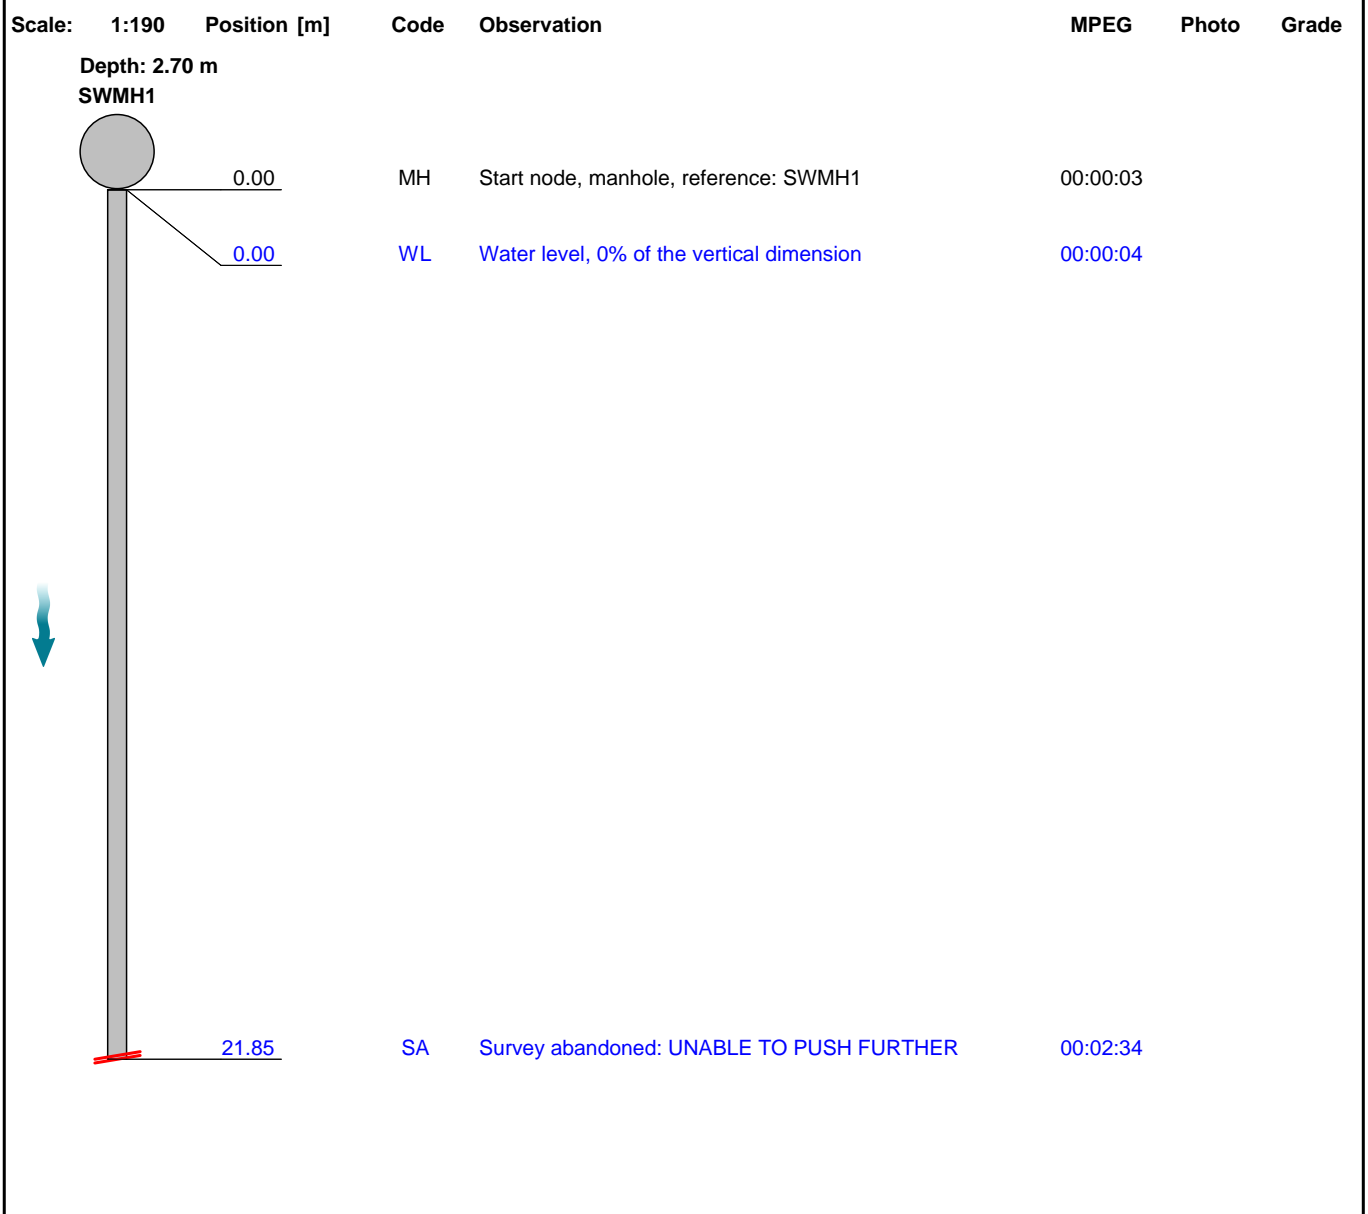
No.	m+	Code	Observation
1	0.00	MH	Start node, manhole, reference: SWMH1
2	0.00	WL	Water level, 0% of the vertical dimension
3	21.85	SA	Survey abandoned
