DESIGN AND ACCESS & HERITAGE STATEMENT

7 King Street

Sandwich

Recovering of roof, removal of render and structural repairs to brickwork

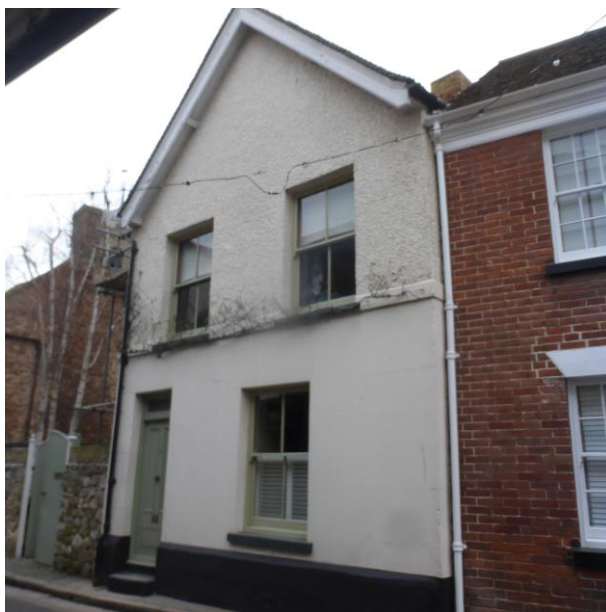
1. The Property

The subject property is a semi-detached listed building that is believed to be 17th century but with altered roof and front elevation to the street in the late 19th Century.
