Validation Letter

Our Ref: M41977-JNP-XX-XX-RP-G-0026-P01

Re: Former Sunninghill Gas Works – Validation of Capping Layer for Plots 54- 63 inclusive (Block H - Apartments)

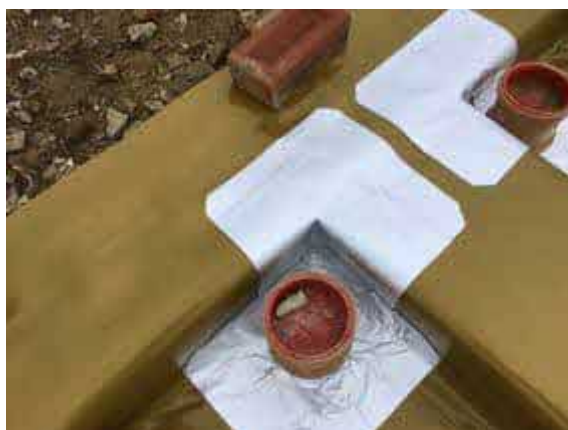
Plot 5 typical corner and pipe penetration seal using SAGM.

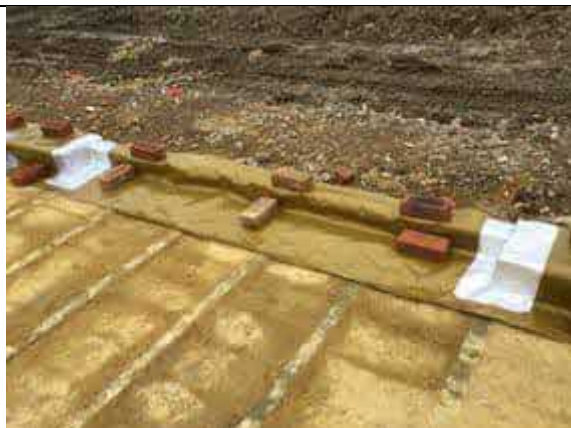
Plot 6 typical door threshold seal using SAGM.

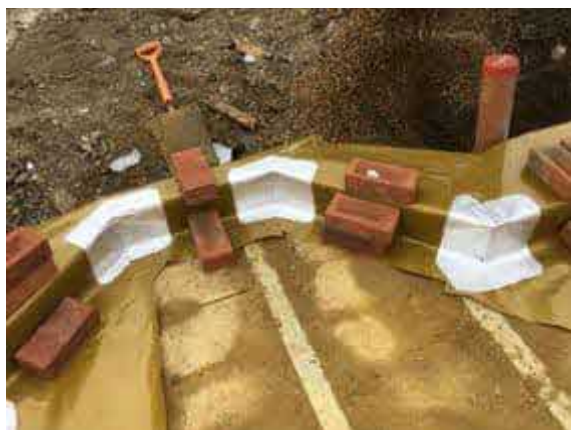
Plot 7 typical bay window corner seals using SAGM.

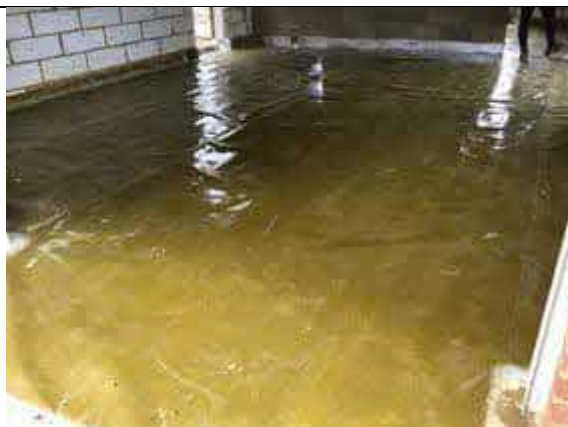
Overview of installed membrane.

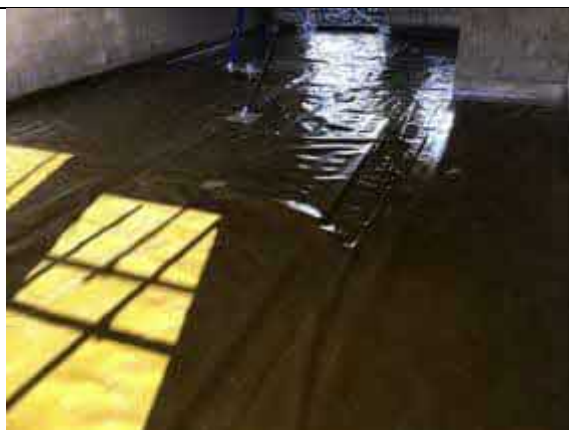
Plot 3 overview of installed membrane.

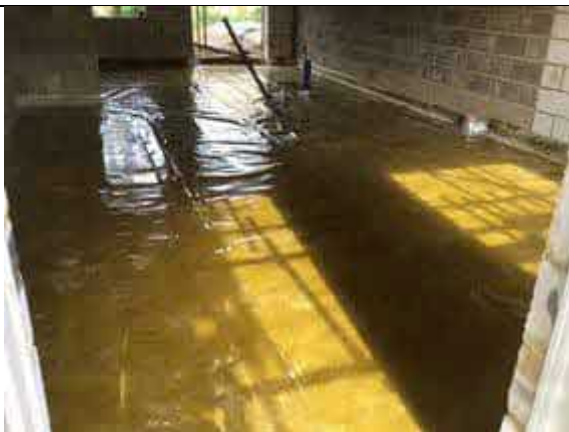
Plot 7 overview of installed membrane.

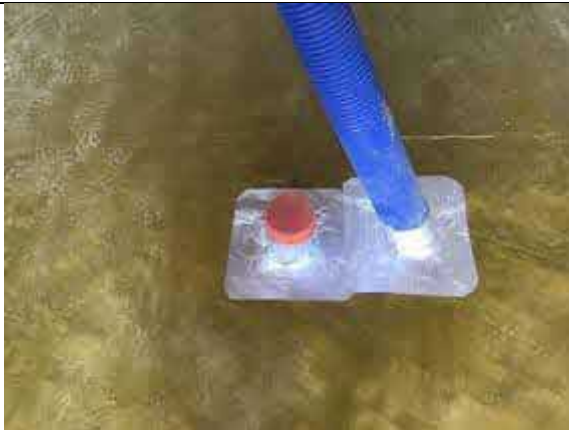
Plot 9 pipe penetrations sealed using SAGM

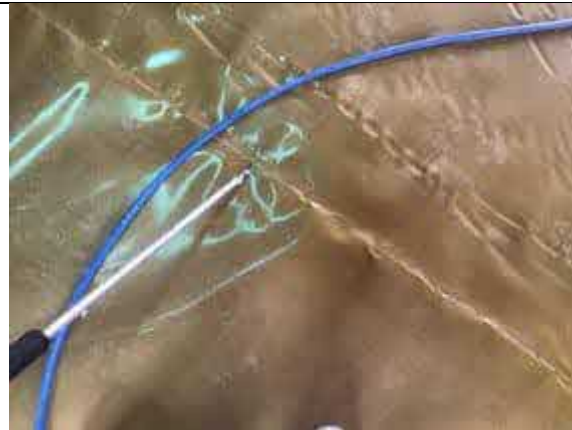
Plot 9 hand welded joint being air lanced

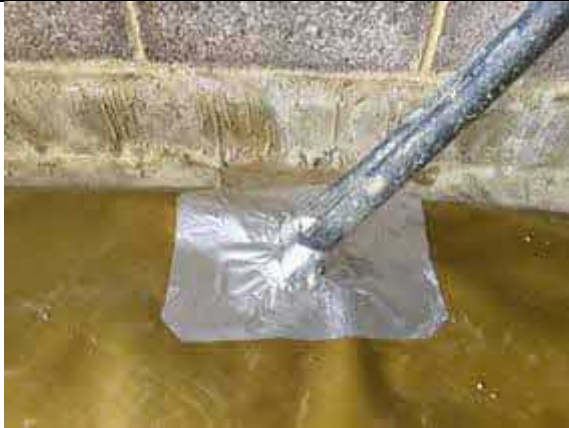
Pipe details within Plot 11 sealed with SAGM.

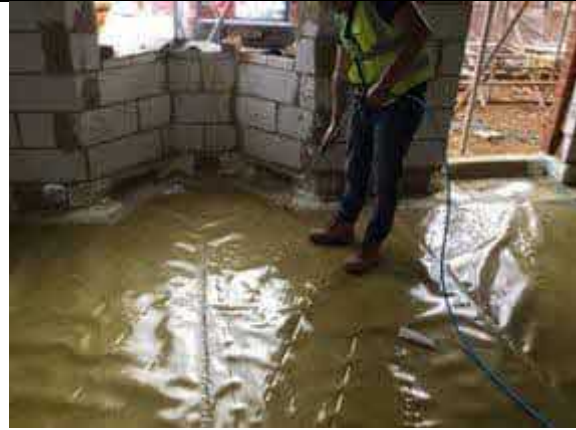
Air lance testing to Plot 10 lap joints.

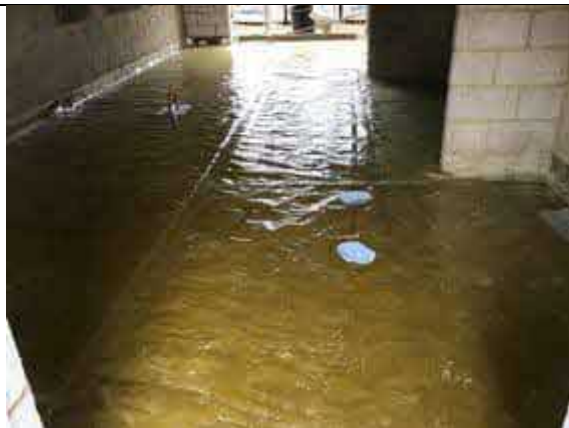
Plot 33 overview of installed Visqueen HC Blok Gas Barrier as an infill.

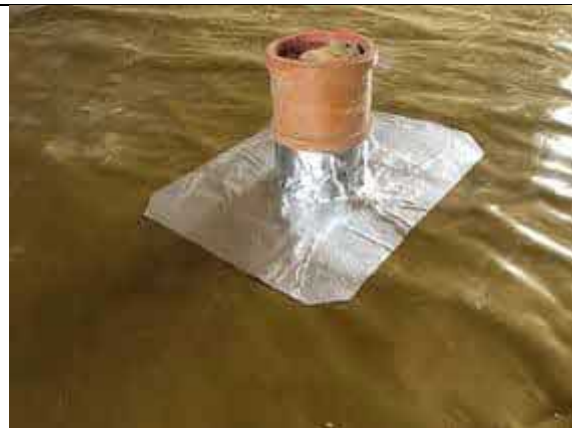
Plot 33 typical pipe penetration seal using SAGM.

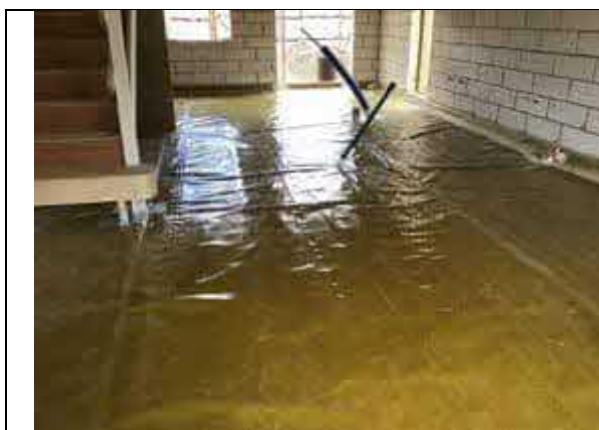
Plot 35 overview of installed Visqueen HC Blok Gas Barrier as an infill.

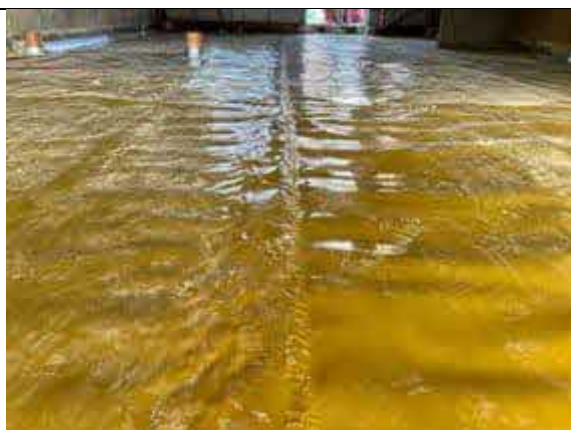
Plot 29 - Successfully hand welded membrane lap joint.

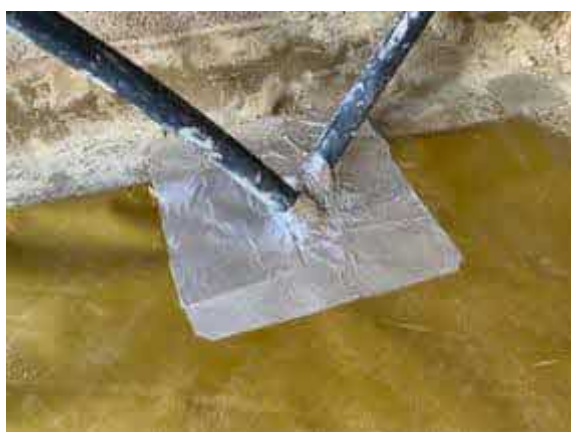
Plot 29 - Pipe penetration's sealed using SAGM.

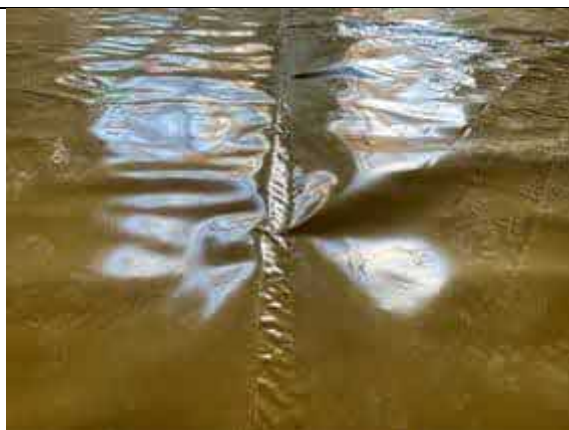
Plot 30 - Hand welded membrane lap joint.

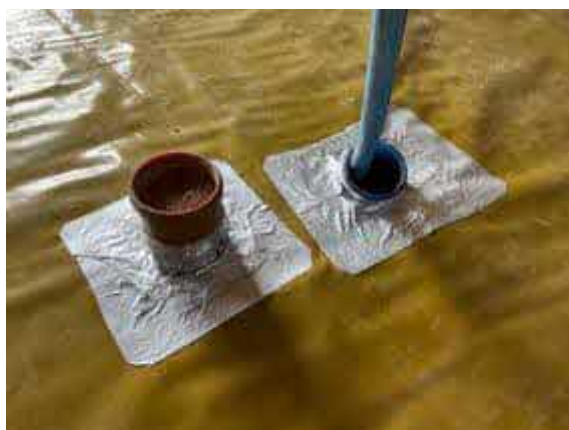
Plot 30 - Typical pipe penetration's sealed using SAGM.

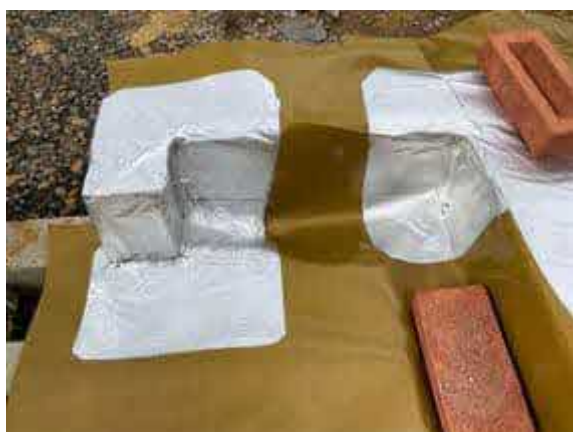
Plot 63 FOG Unit - Corner detailing sealed using SAGM.

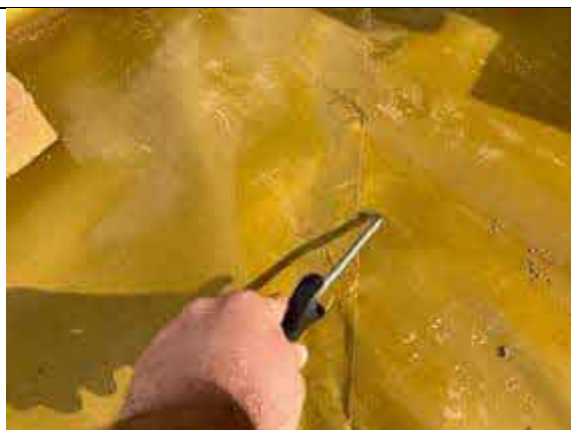
Plot 63 FOG Unit - Pick test upon a successfully hand welded lap joint.

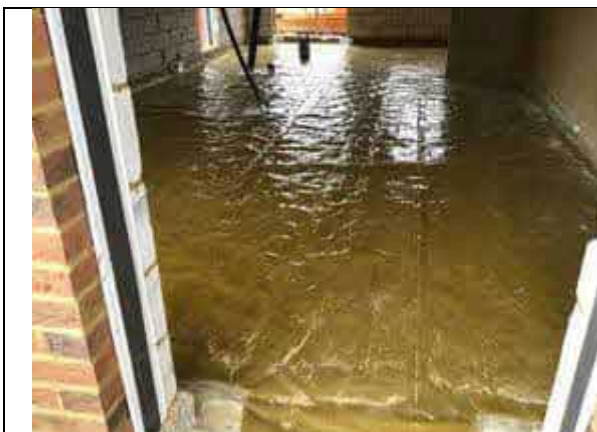
Overview of installed membrane to plot 27.

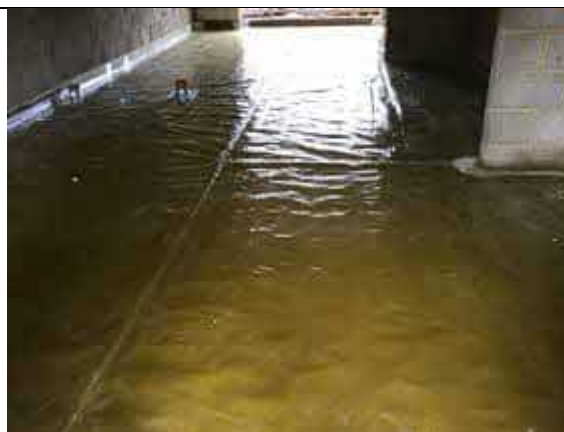
Overview of installed membrane to plot 28.

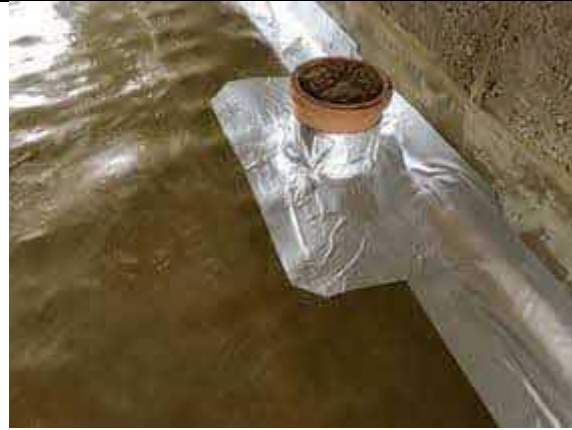
Plot 28 typical pipe penetration seal using SAGM.

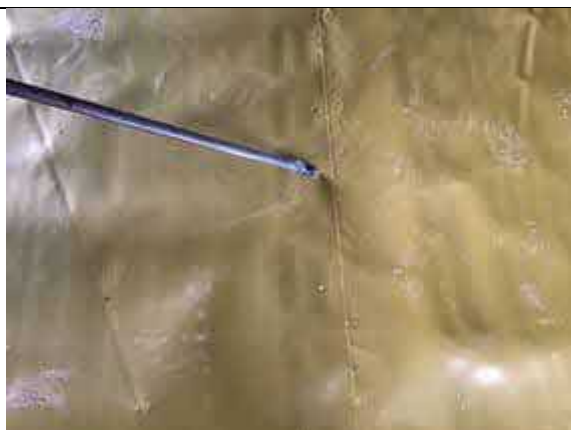
Air lancing all welded membrane laps.

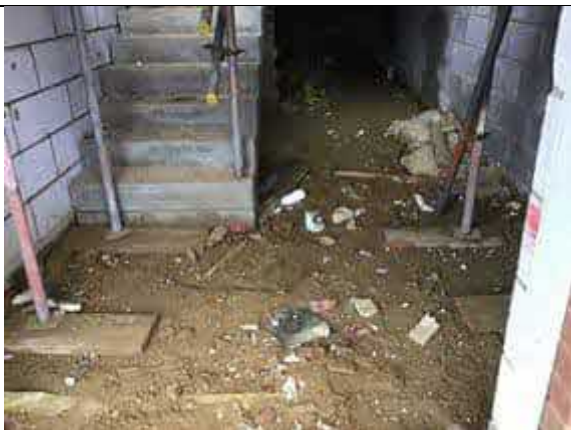
Incomplete stair lobby.

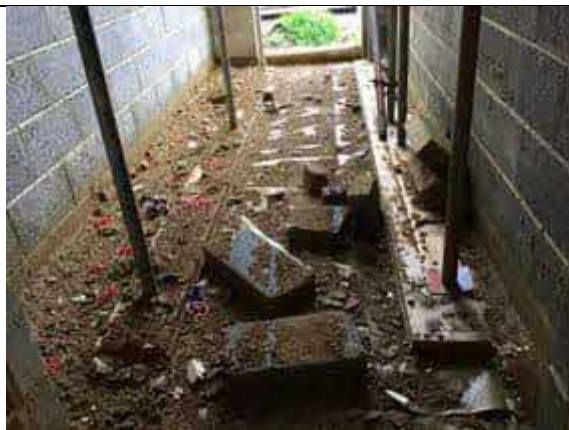
Incomplete cycle store.

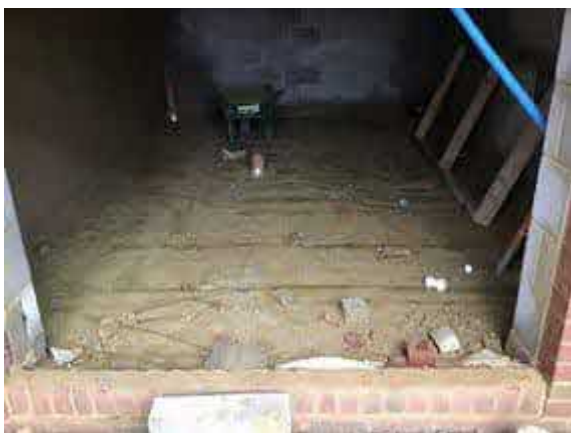
Incomplete bin store.

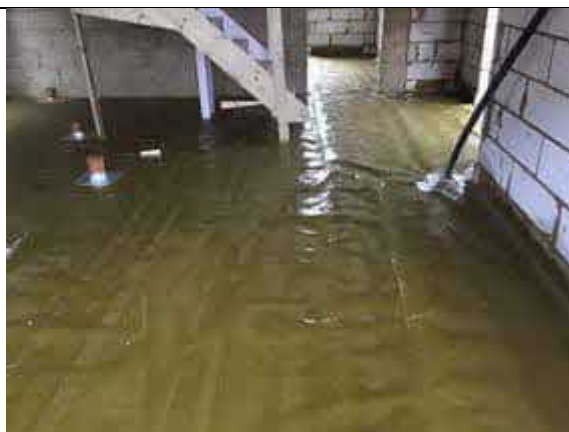
Overview of installed membrane to plot 36.

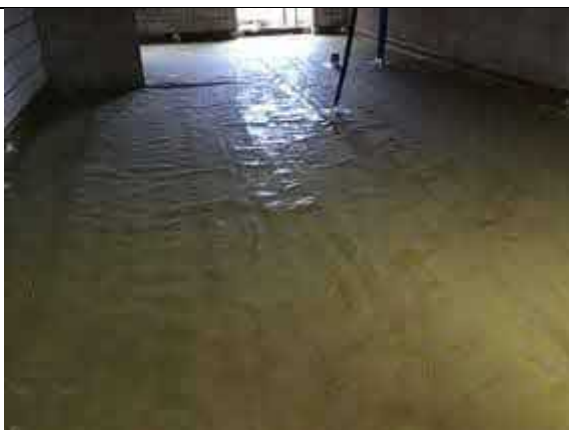
Overview of installed membrane to plot 37.

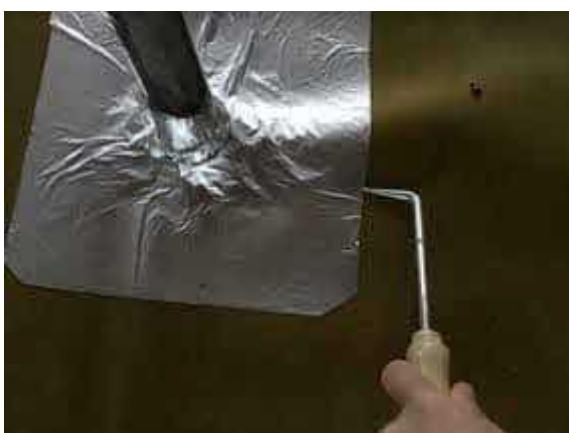
Pick testing all SAGM detailing to plot 38.

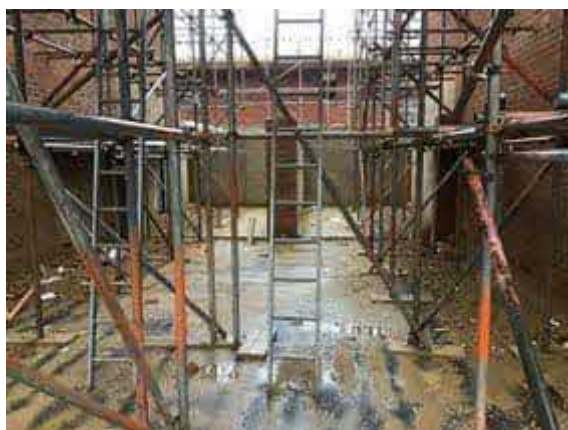
Scaffolding in place in all garages.

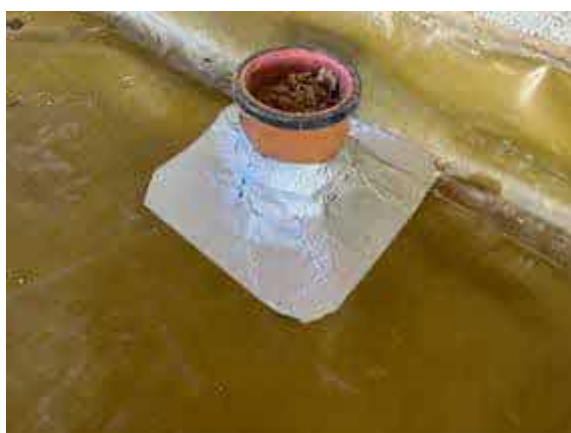
Plot 73. Typical pipe penetration sealed using SAGM.

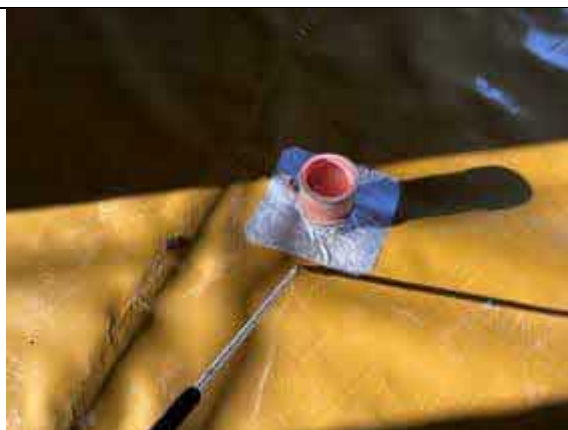
Plot 74. Air lance integrity test conducted upon sealed pipe penetration.

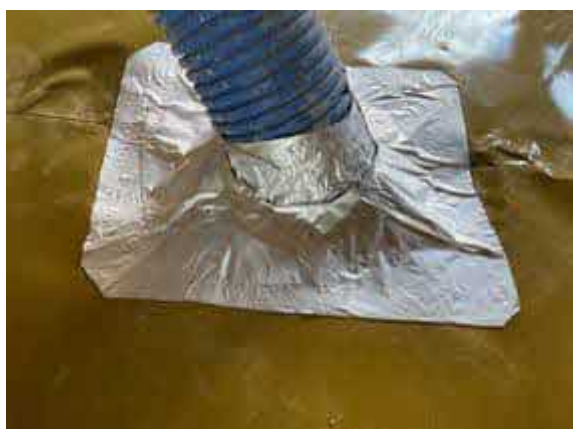
Plot 40. Typical pipe penetration sealed using SAGM.

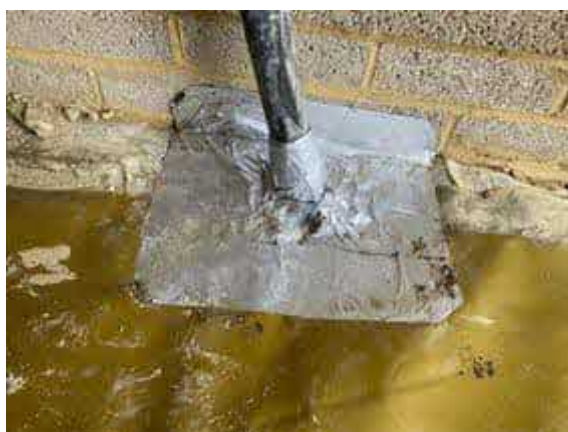
Plot 32 garage. Typical pipe penetration sealed using SAGM.

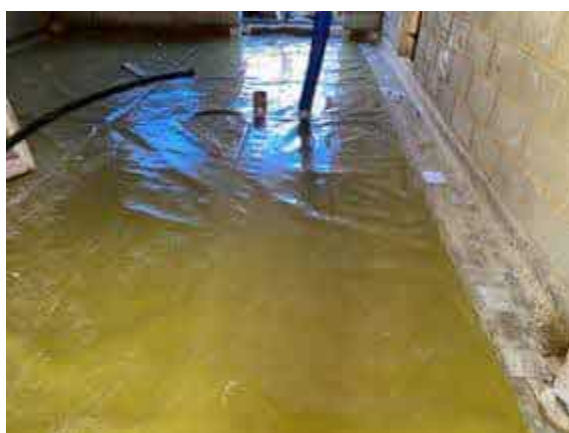
Plot 45 overview of installed membrane.

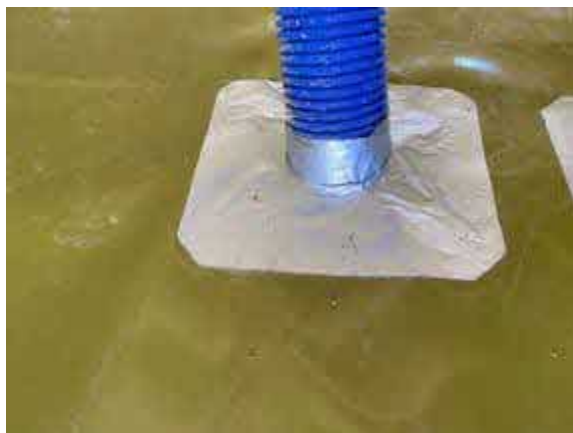
Plot 45 typical pipe penetration seal using SAGM.

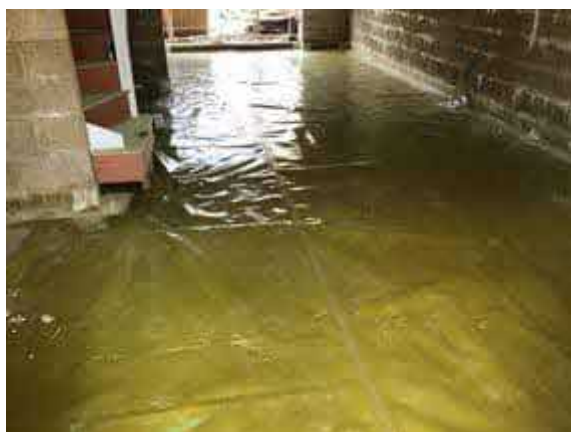
Overview of installed membrane to plot 49.

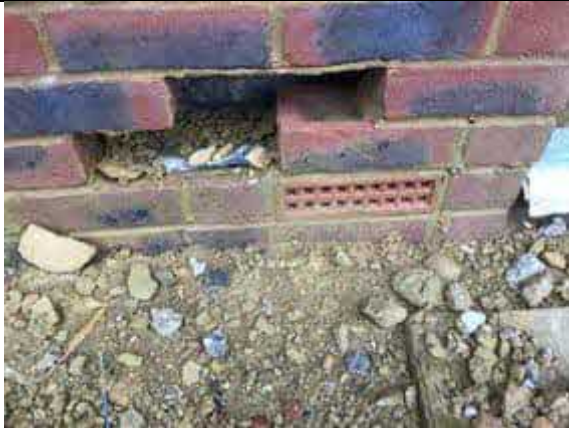
Air brick in place at the time of our inspection to plot 49.

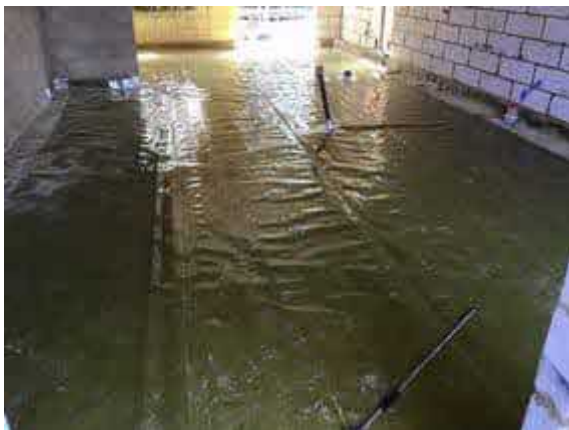
Overview of installed membrane to plot 67.

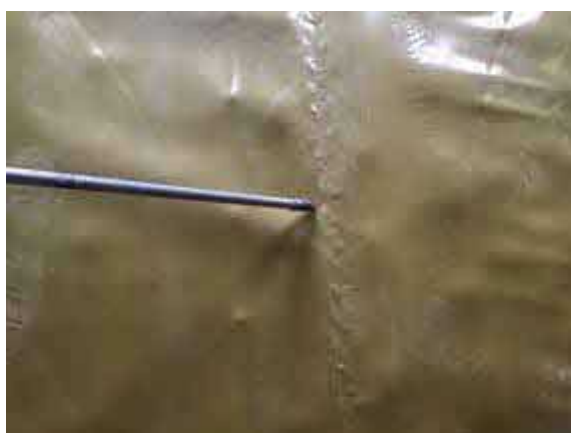
Air lancing all hand welded membrane laps to plot 64.

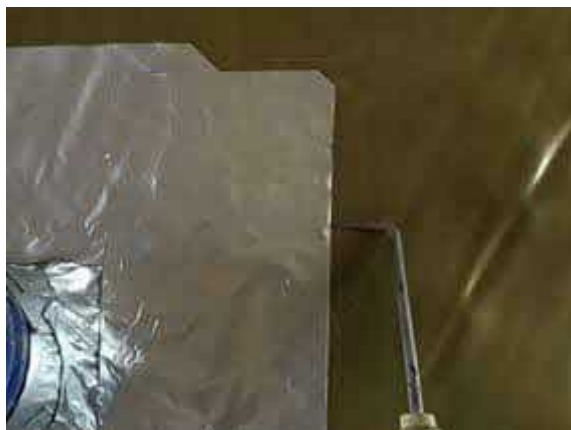
Pick testing all SAGM detailing to plot 64.

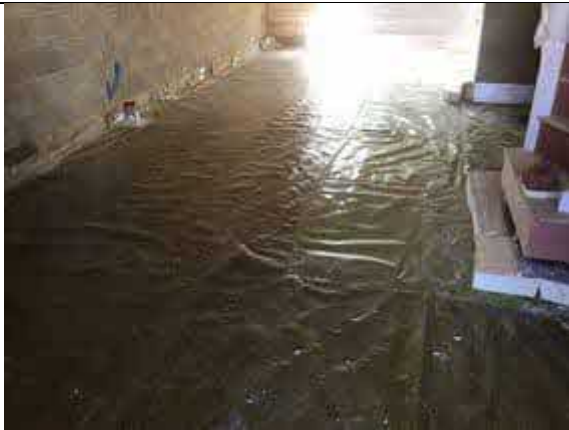
Overview of installed membrane to plot 65.

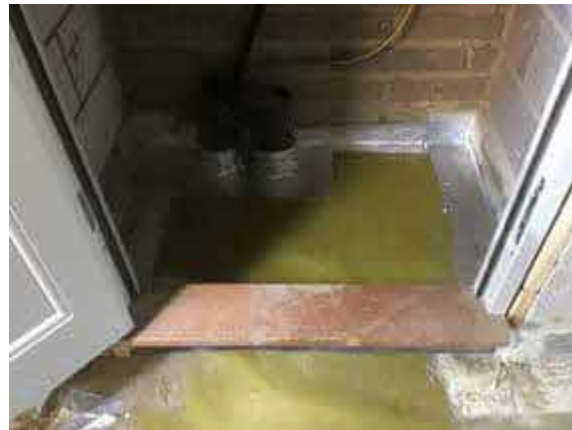
Sealed pipe penetrations in riser cupboard to apartment block c.

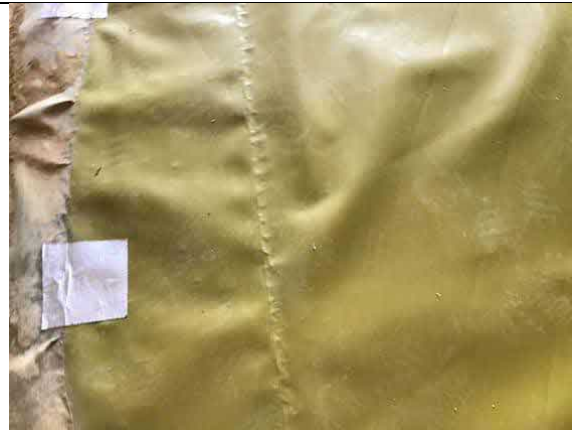
Hand welded membrane lap in garage plot 40.

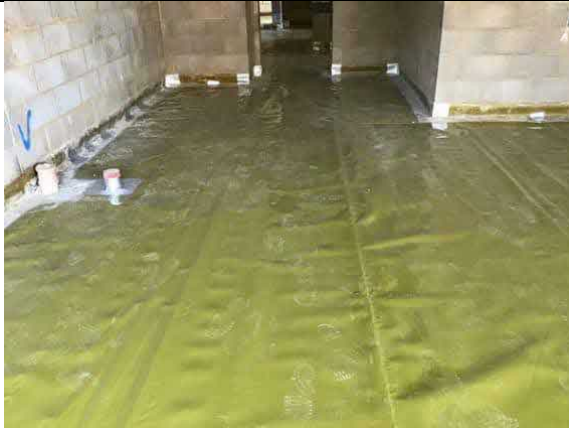
Overview of installed Visqueen HC Blok gas membrane, that has been installed as an infill to Apartment block H.

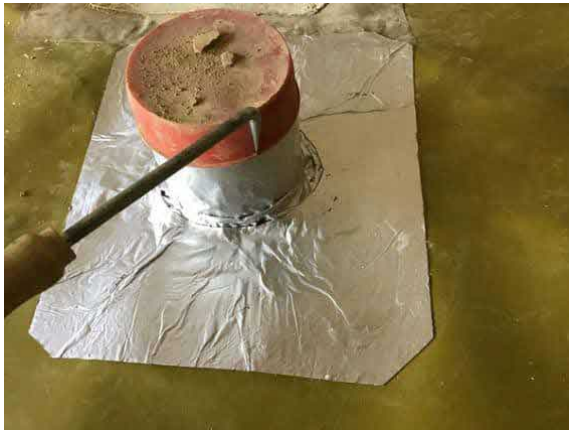
Pick testing all SAGM detailing in apartment block H.

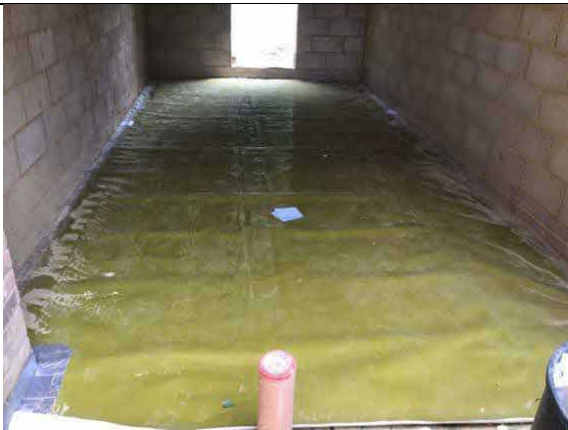
Overview of installed membrane to the garage, as an infill to plot 69.

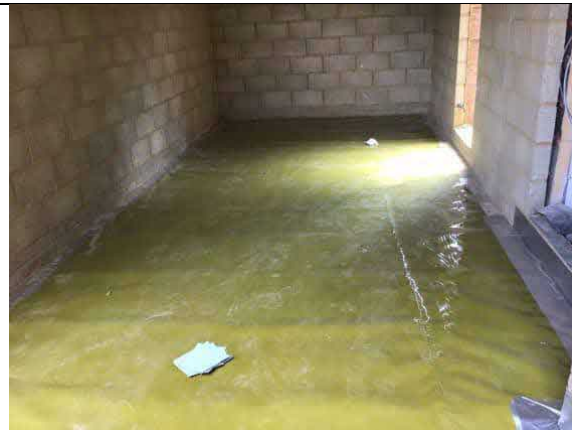
Overview of installed membrane to the garage, as an infill to plot 70.

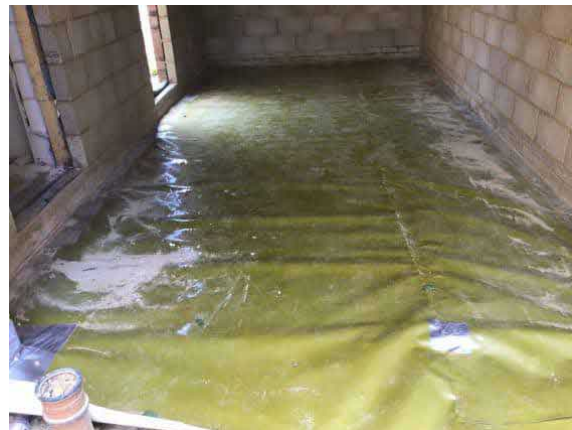
Overview of installed membrane to the garage, as an infill to plot 72.

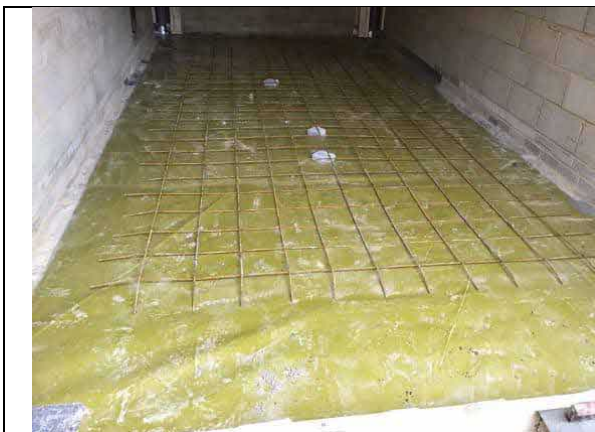
Overview of installed membrane to garage area in plot 45.

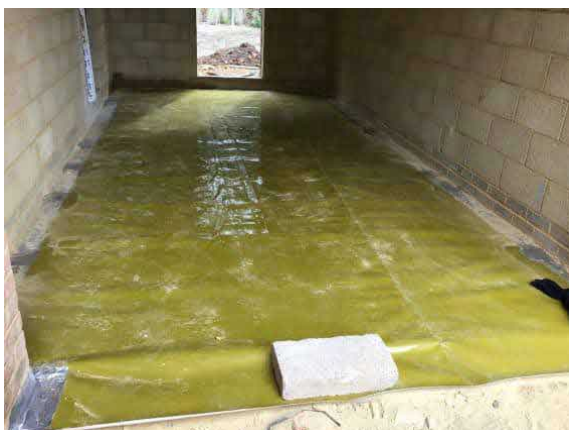
Overview of installed membrane in garage plot 67.

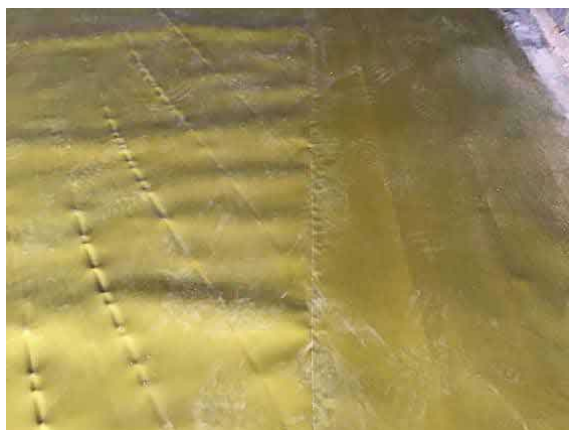
Typical hand welded membrane lap.
