Validation Letter

Date: 18 October 2023

Our Ref: M41977-JNP-XX-XX-RP-G-0021-P01

Re: Former Sunninghill Gas Works – Validation of Capping Layer for Plot 42 (Block C)

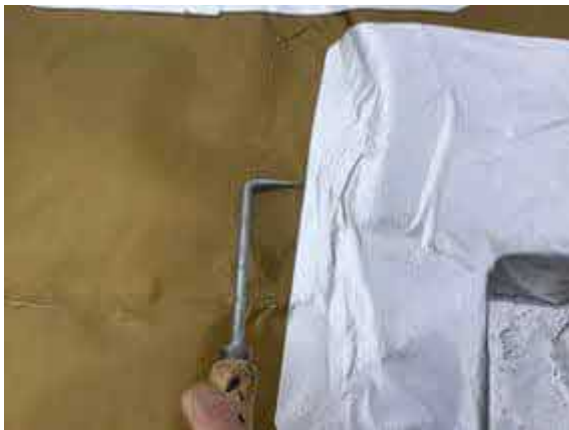
Plot 5 pick testing all SAGM detailing.

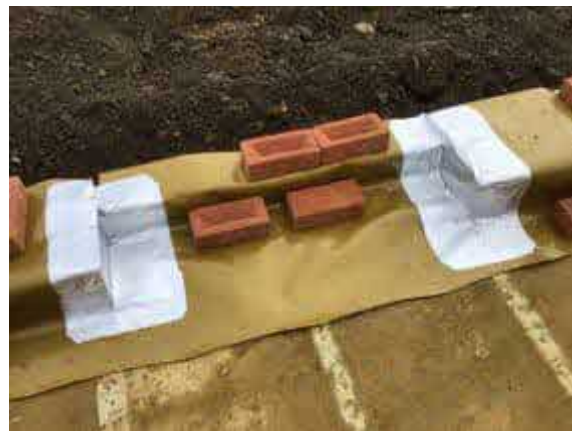
Plot 7 typical door seal using SAGM.

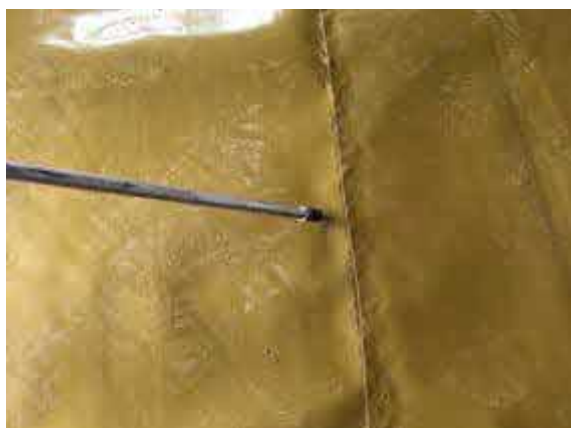
Air lancing all welded membrane laps.

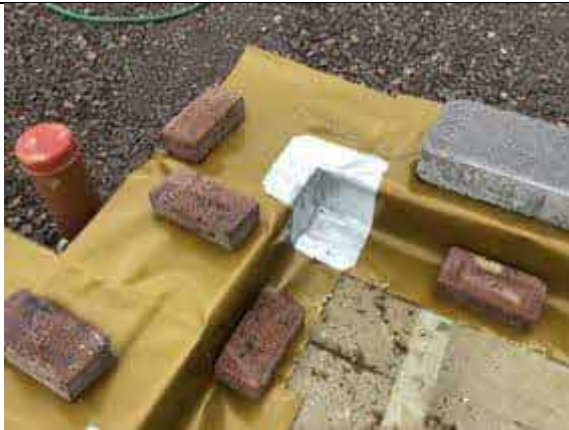
Plot 73 typical corner seal using SAGM.

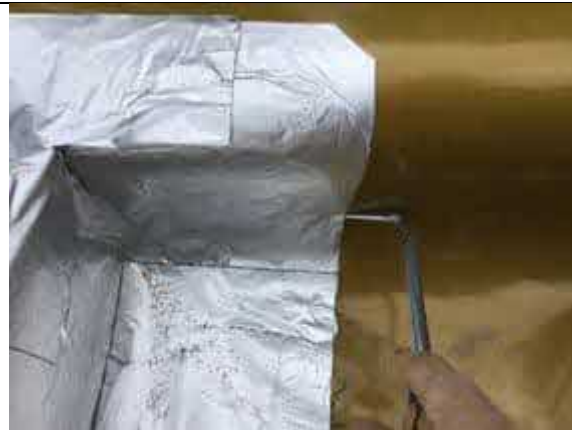
Plot 74 pick testing all SAGM detailing.

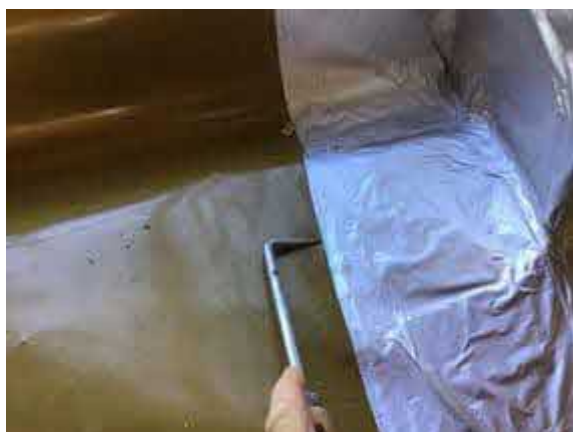
Plot 3 pick testing all SAGM detailing.

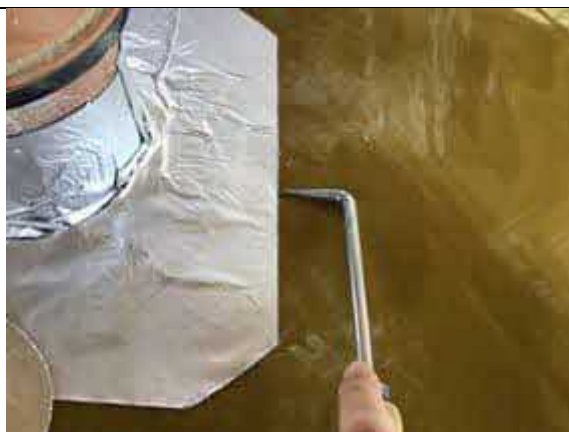
Plot 76 pick testing all SAGM detailing.

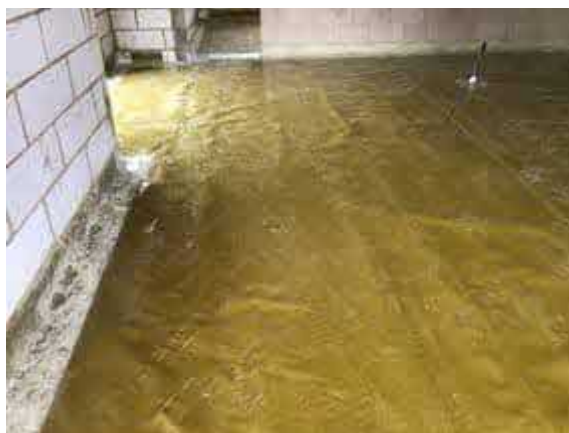
Plot 76 overview of installed membrane.

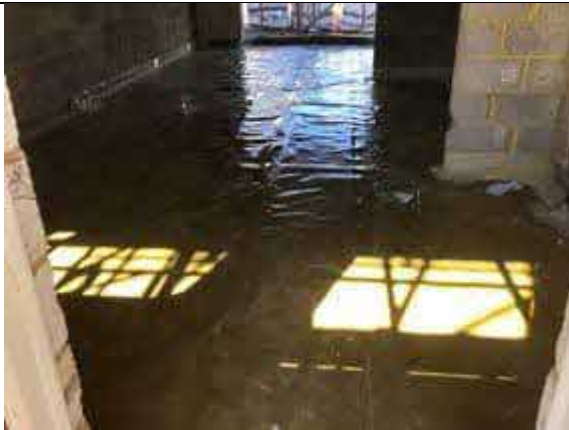
Plot 5 overview of installed membrane.

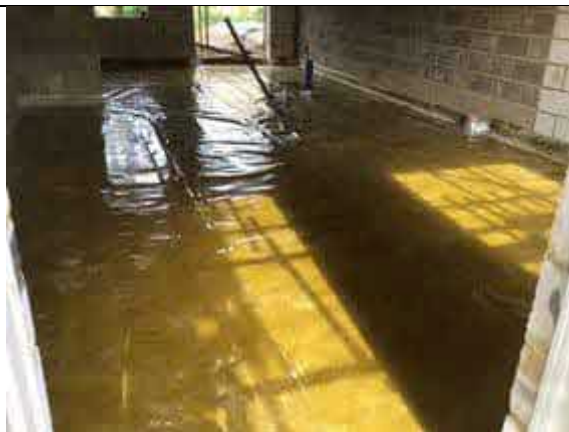
Plot 7 overview of installed membrane.

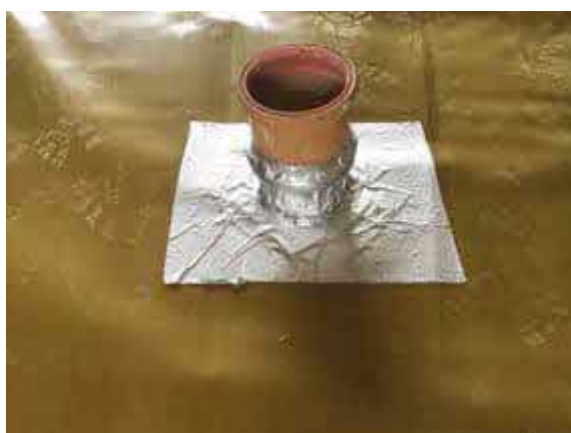
Plot 6 typical pipe penetration seal using SAGM.

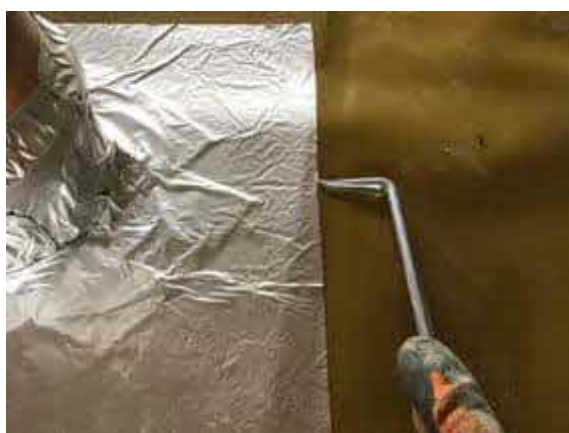
Plot 6 pick testing all SAGM detailing.

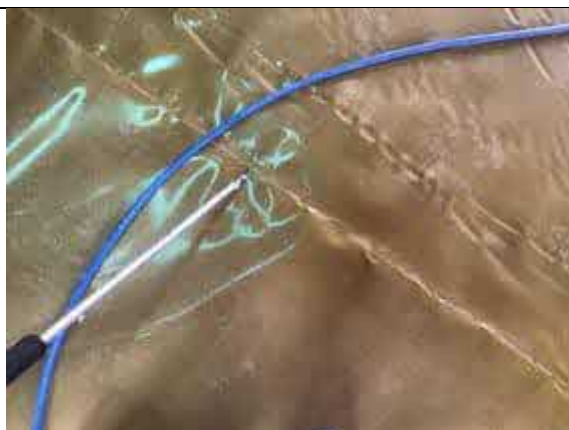
Plot 9 hand welded joint being air lanced

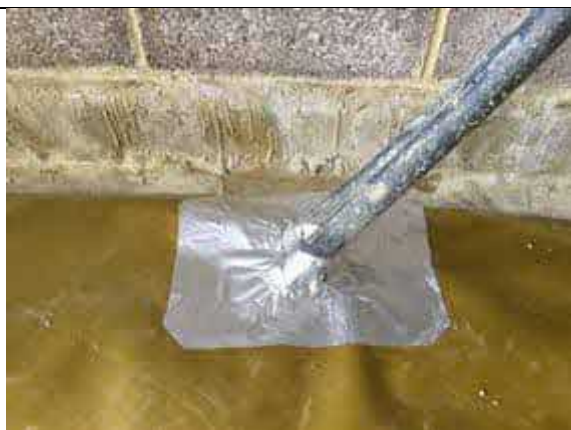
Pipe details within Plot 11 sealed with SAGM.

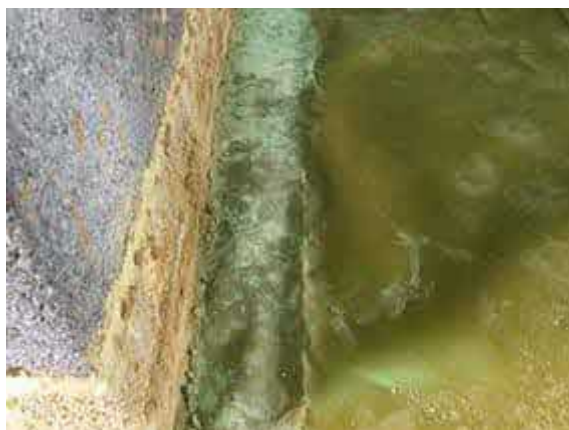
Overview to the perimeter membrane welded to the infill membrane.

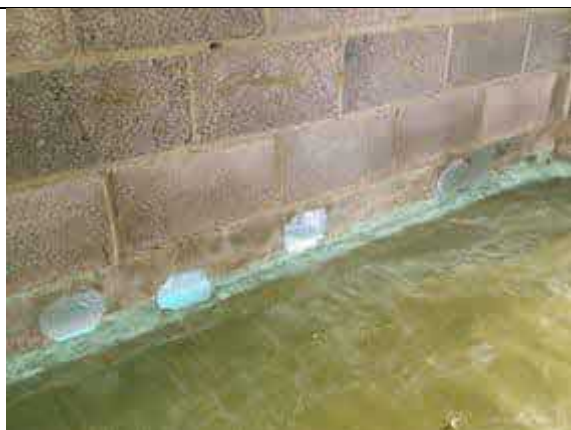
SAGM patches applied prior to inspection to the perimeter membrane within Plot 10.

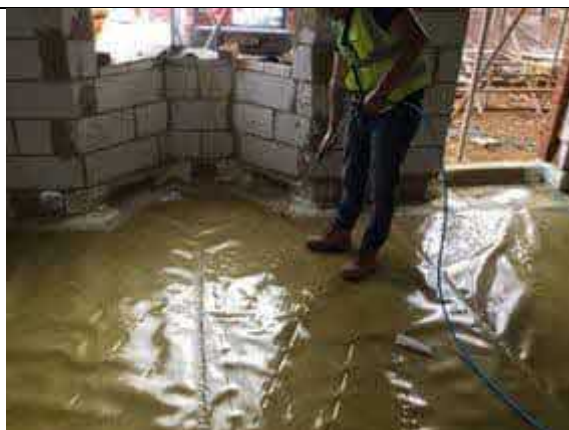
Air lance testing to Plot 10 lap joints.

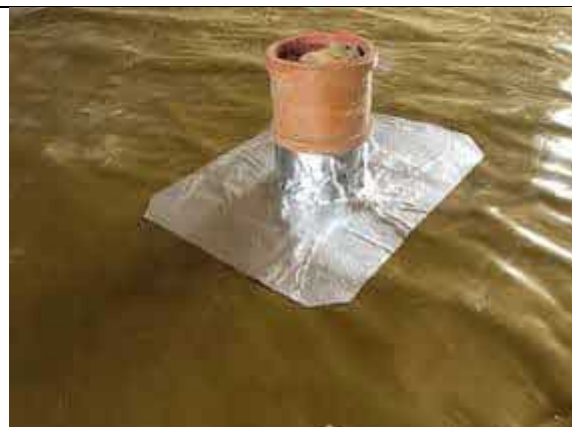
Plot 33 typical pipe penetration seal using SAGM.

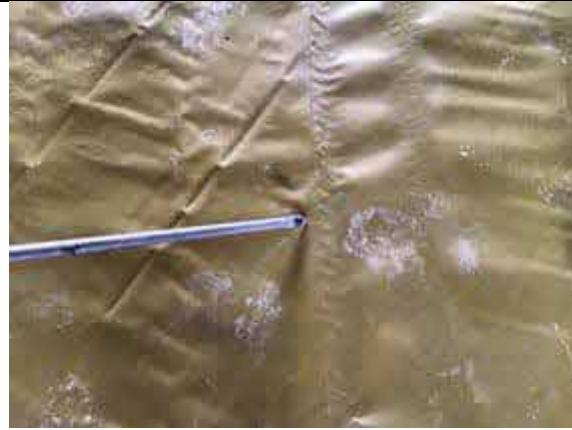
Plot 34 air lancing all welded membrane laps.

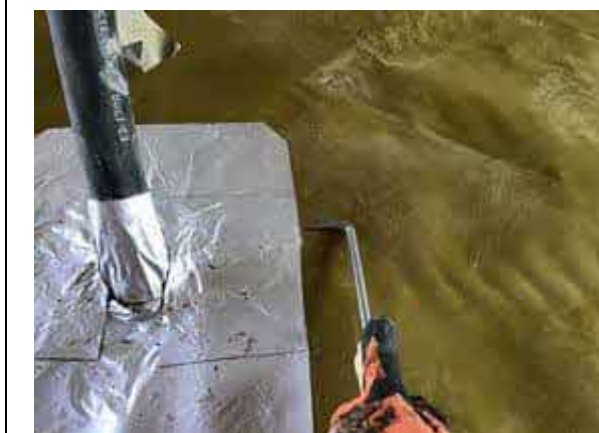
Plot 35 pick testing all SAGM detailing.

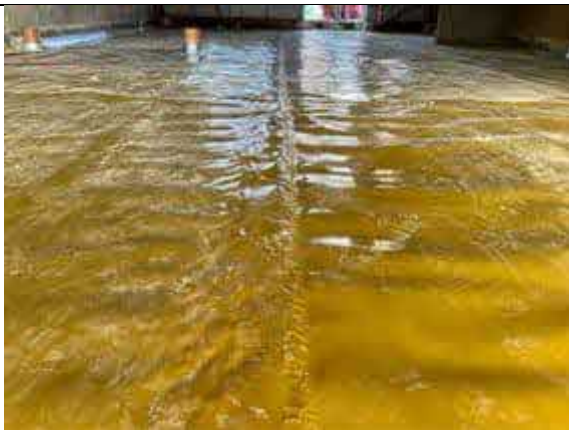
Plot 29 - Successfully hand welded membrane lap joint.

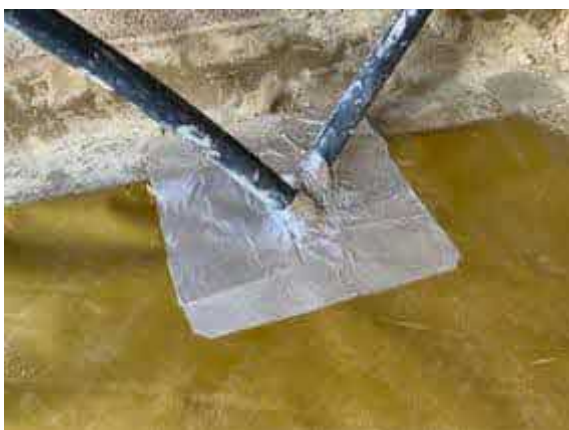
Plot 29 - Pipe penetration's sealed using SAGM.

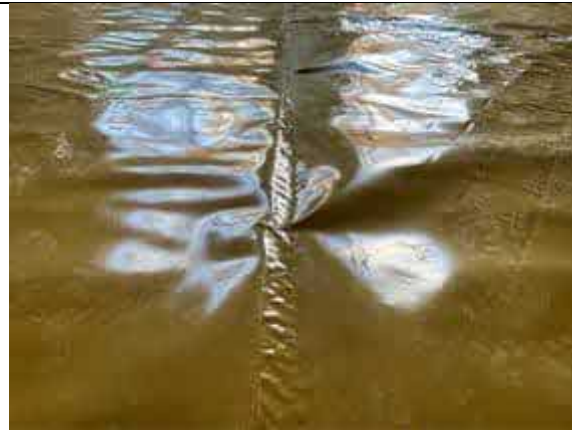
Plot 30 - Hand welded membrane lap joint.

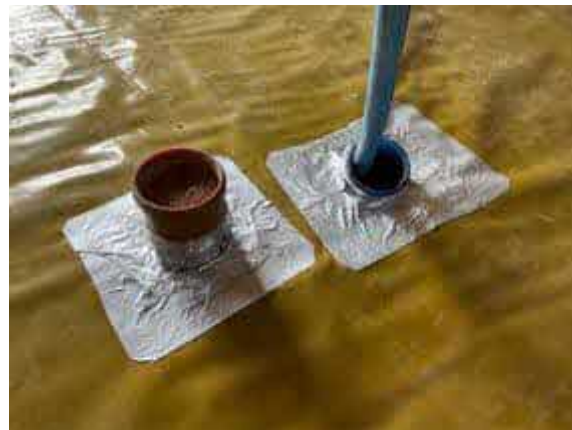
Plot 30 - Typical pipe penetration's sealed using SAGM.

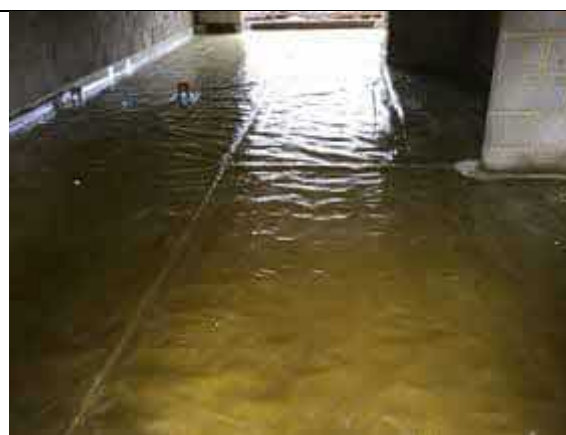
Overview of installed membrane to plot 28.

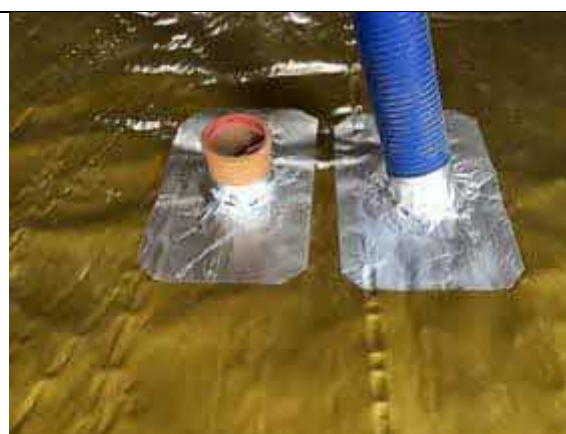
Plot 27 typical double pipe penetration seal using SAGM.

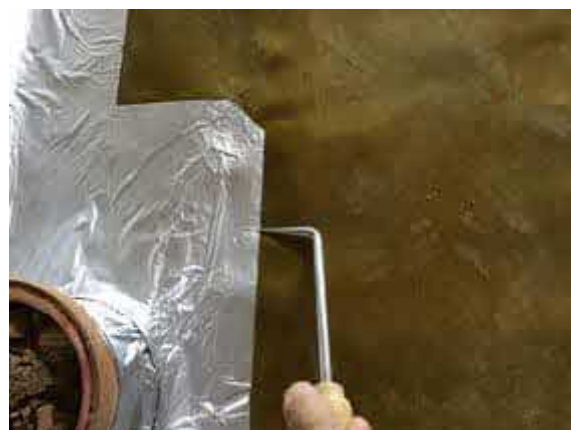
Plot 28 pick testing all SAGM detailing.

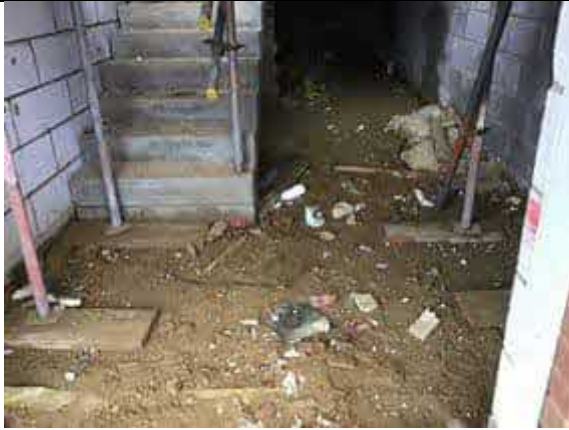
Incomplete stair lobby.

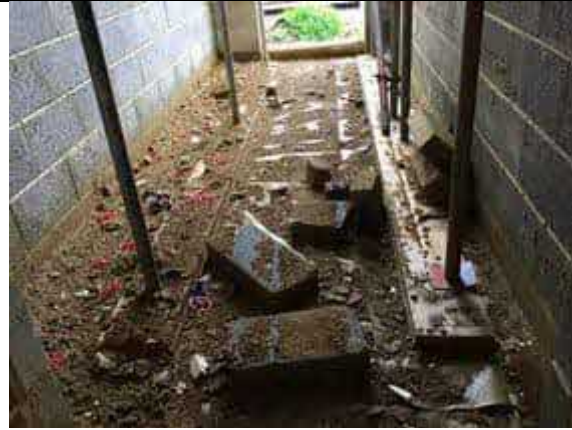
Incomplete cycle store.

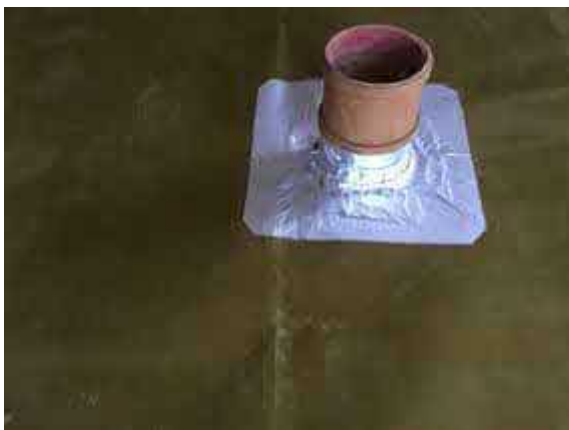
Typical pipe penetration seal using SAGM to plot 36.

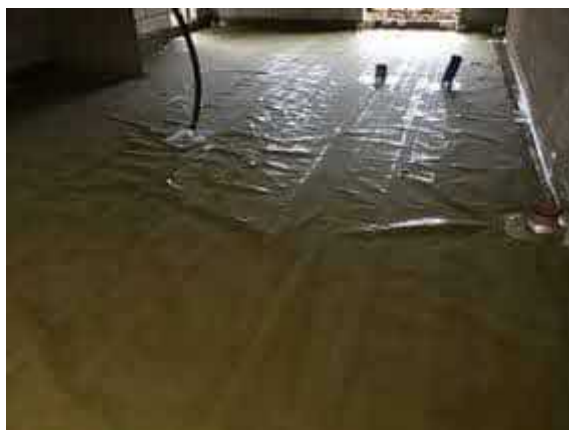
Overview of installed membrane to plot 39.

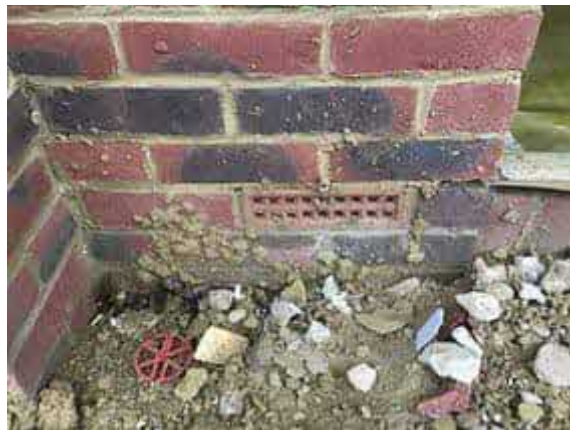
Air brick in place to plot 41.

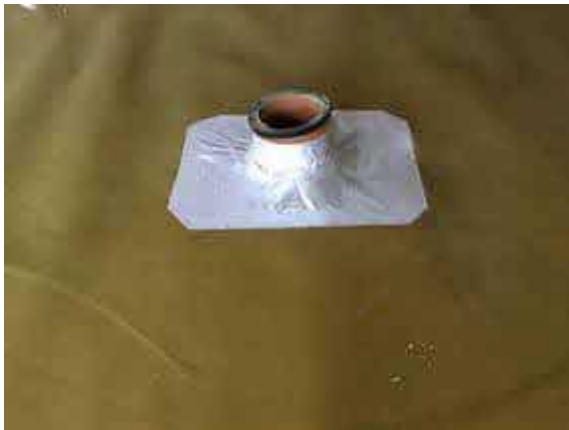
Typical pipe penetration seal to plot 41.

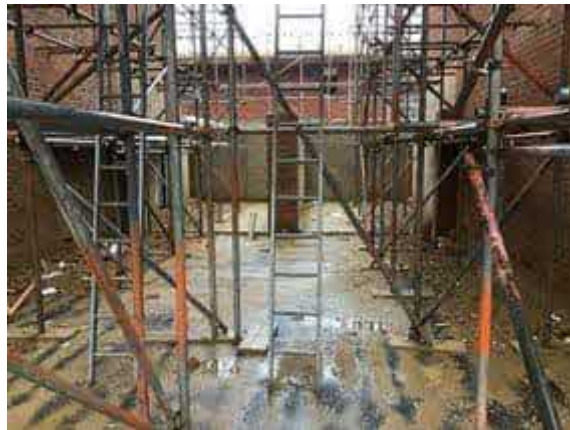
Scaffolding in place in all garages.

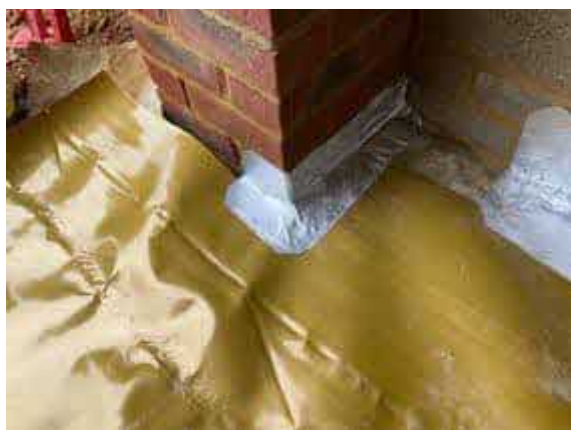
Plot 35 garage. Corner detailing sealed using SAGM.

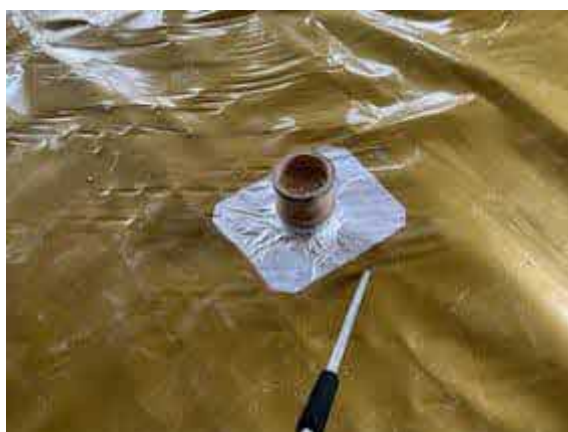
Plot 72. Air lance integrity test upon sealed pipe penetration.

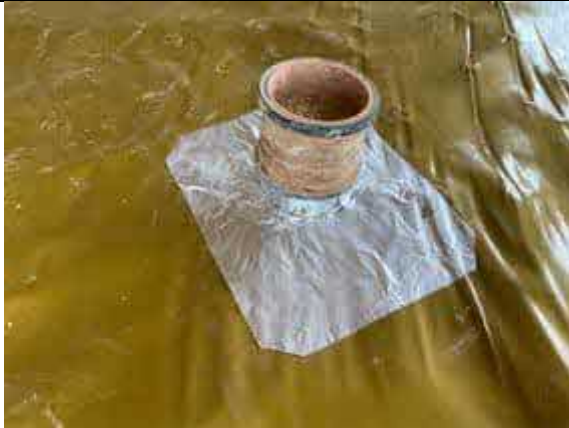
Plot 72. Typical pipe penetration sealed with SAGM.

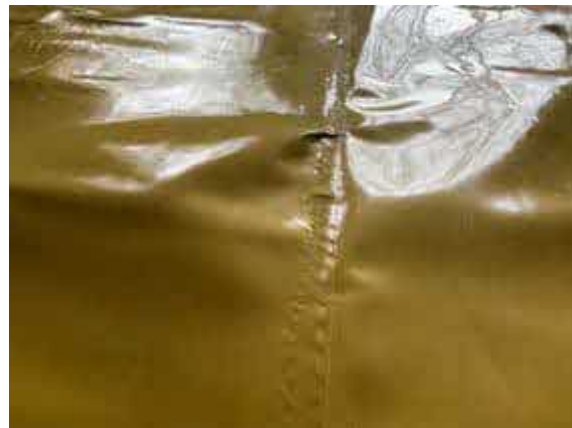
Plot 70. Overview of a hand welded membrane lap joint.

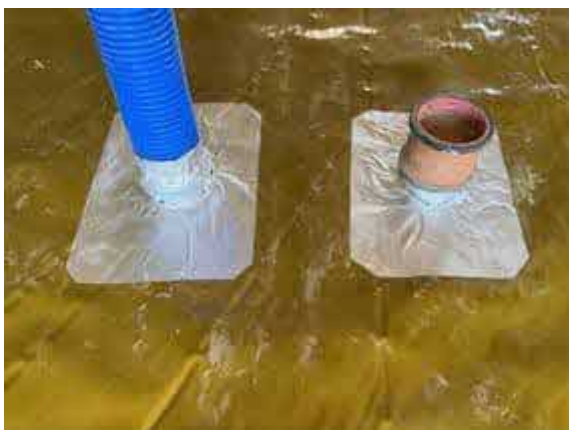
Plot 70. Typical pipe penetration's sealed using SAGM.

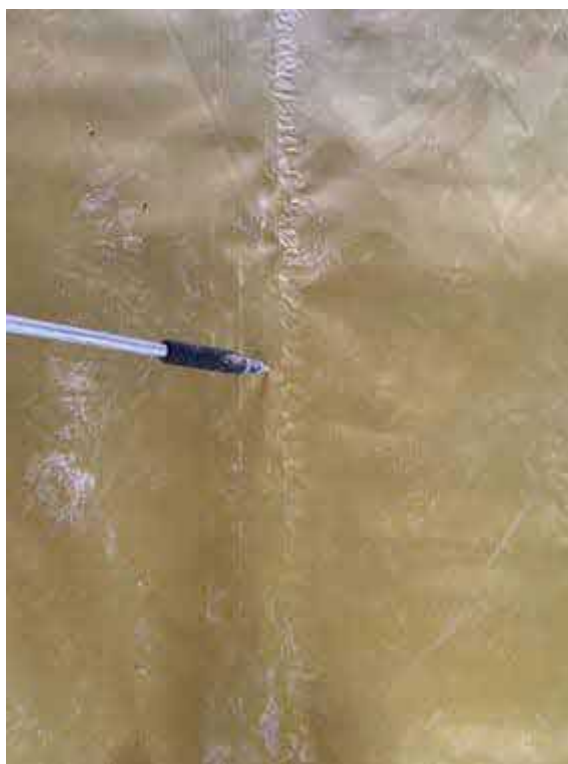
Plot 43 air lancing all hand welded membrane laps.

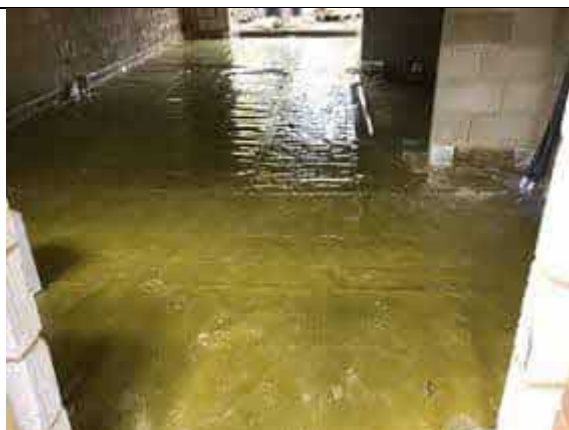
Overview of installed membrane to plot 48.

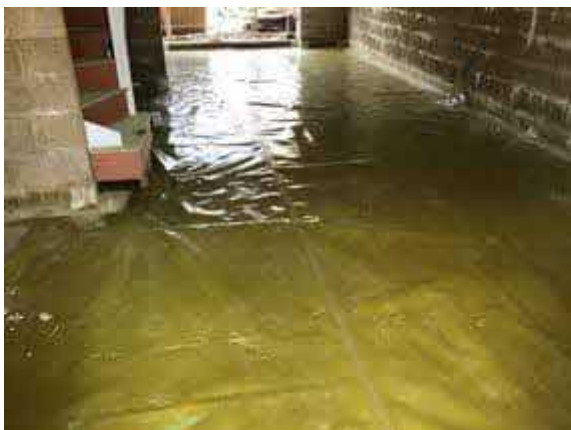
Overview of installed membrane to plot 49.

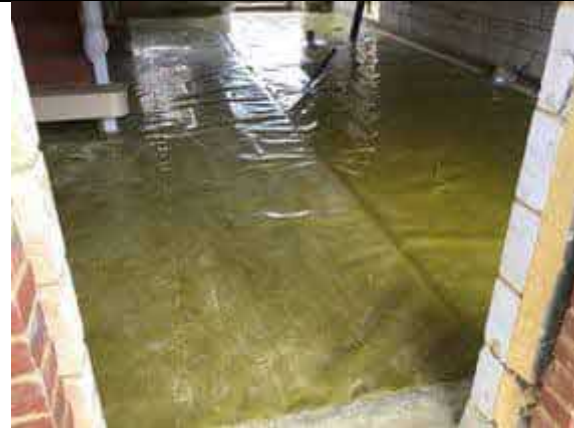
Overview of installed membrane to plot 50.

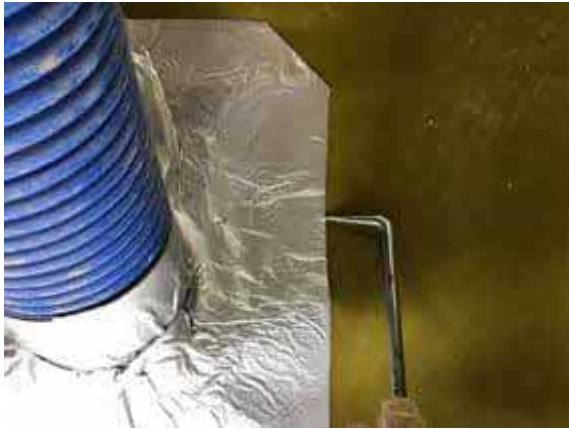
Pick testing all SAGM detailing in plot 50.

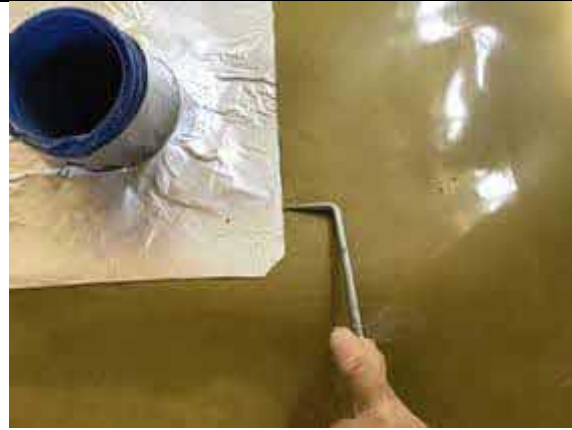
Pick testing all SAGM detailing to plot 67.

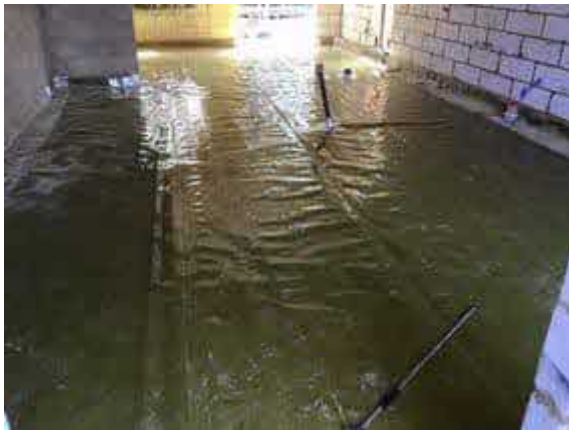
Overview of installed membrane to plot 67.

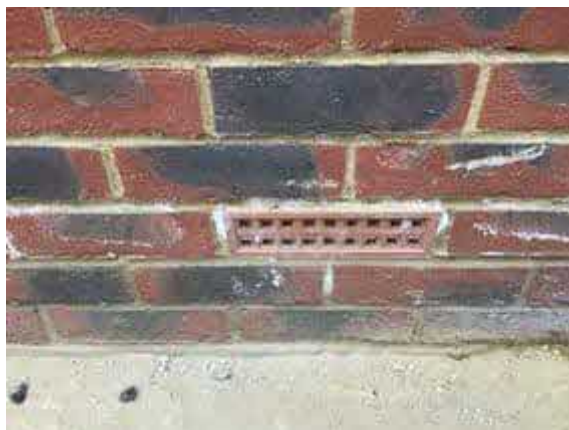
Air brick in place at the time of our inspection to plot 65.

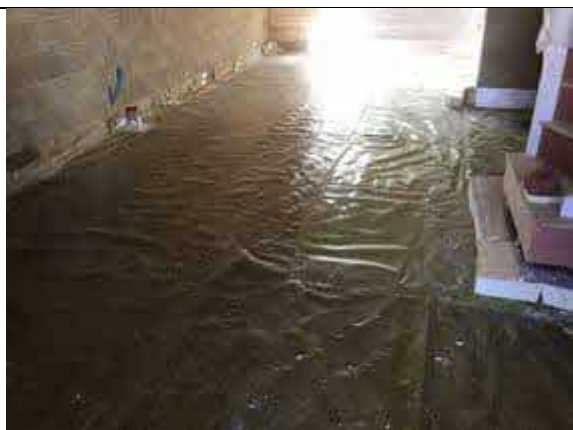
Overview of installed membrane to plot 65.

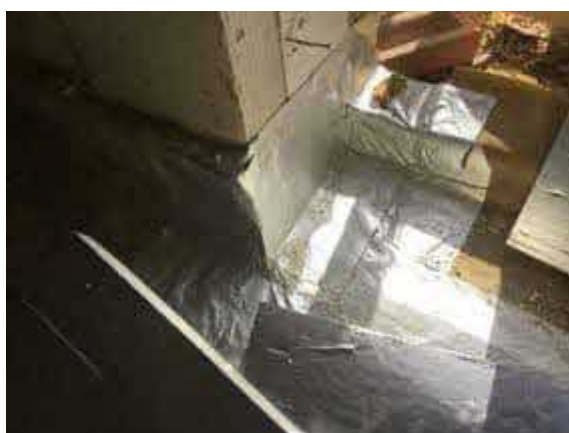
Re sealed door threshold detail using SAGM to plot 65.

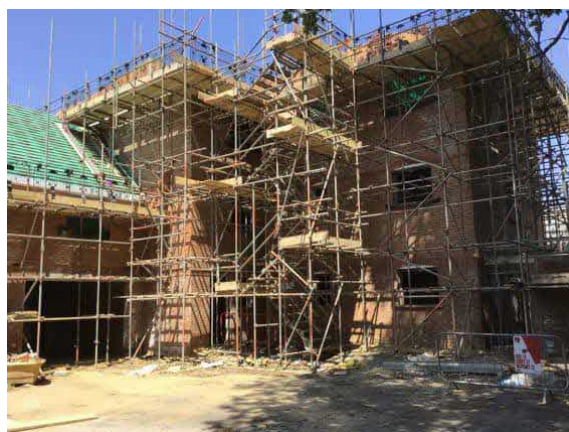
Overview of Apartment Block H. Plots 54-62.

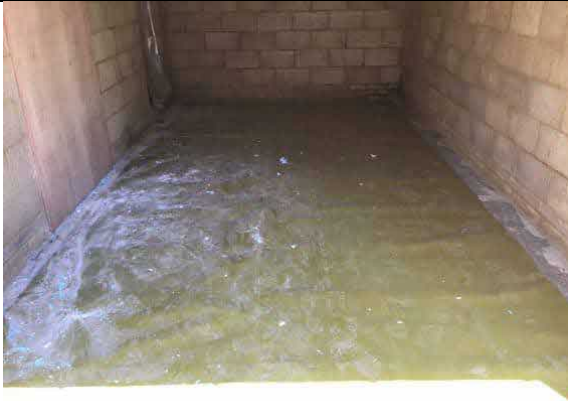
Overview of installed membrane to the garage, as an infill to plot 40.

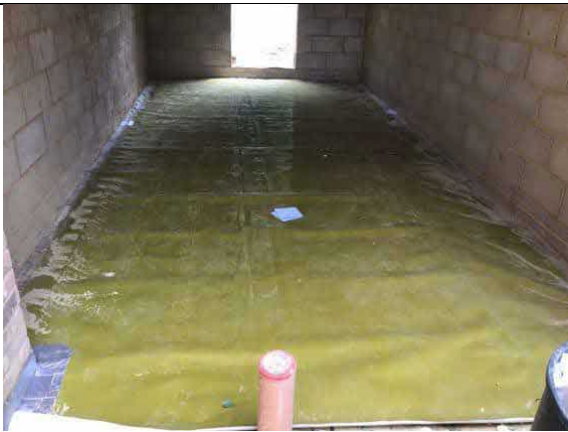
Overview of installed membrane to the garage, as an infill to plot 69.

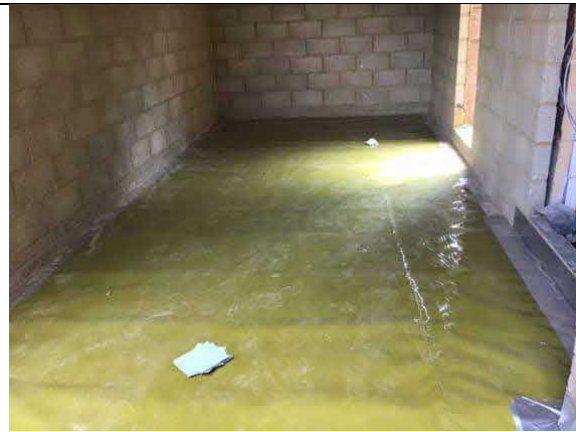
Overview of installed membrane to the garage, as an infill to plot 70.

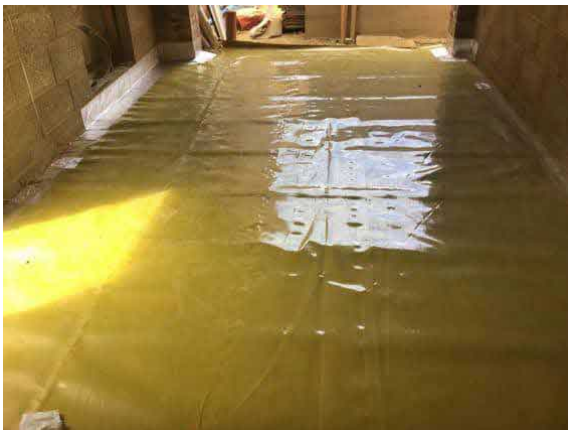
Overview of installed membrane to the garage, as an infill to plot 71.

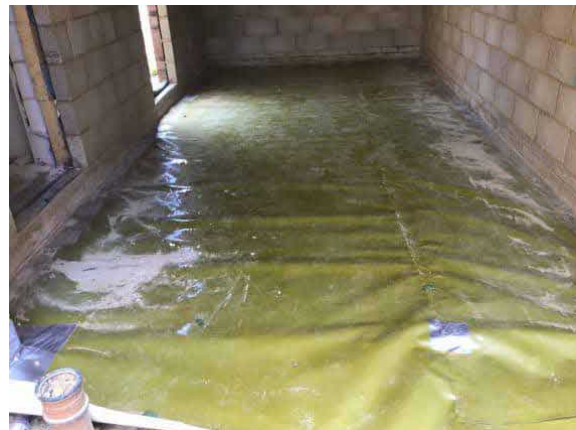
Overview of installed membrane to the garage, as an infill to plot 72.

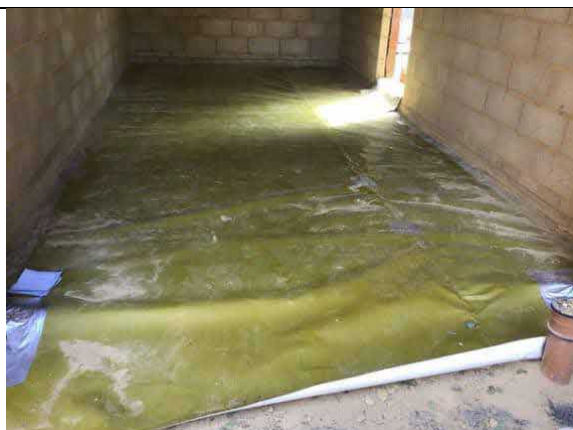
Overview of installed membrane to the garage, as an infill to plot 73.

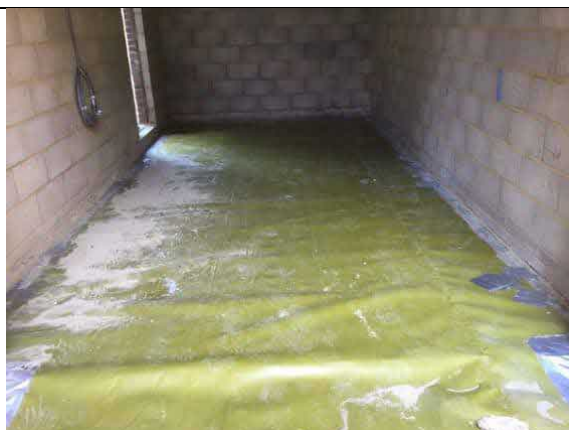
Overview of installed membrane to the garage, as an infill to plot 74.

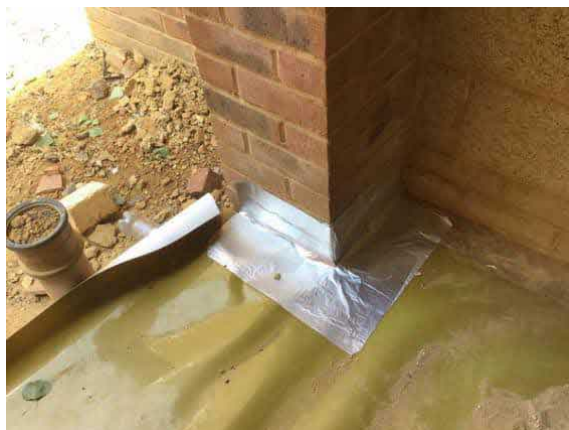
Sealed front of garage using SAGM.

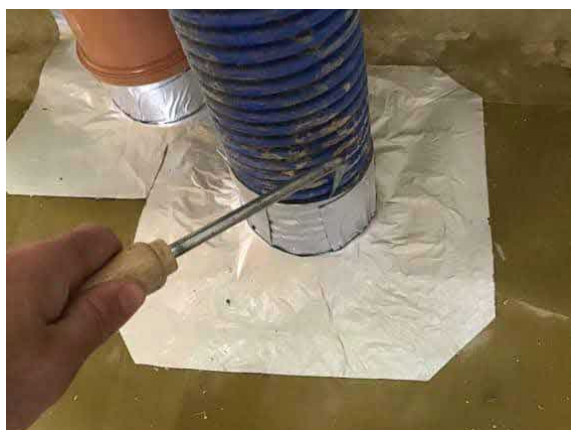
Pick testing all SAGM detailing in plot 52.

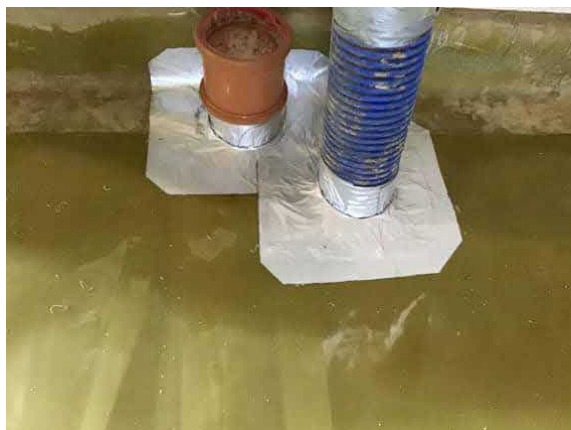
Sealed double pipe penetration using SAGM to plot 53.

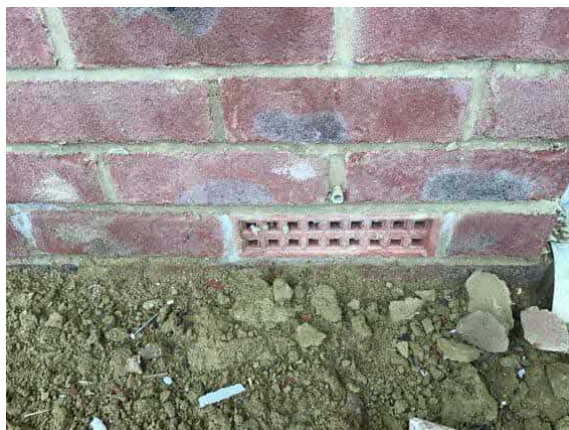
Air brick in place at the time of our inspection to plots 51-53.

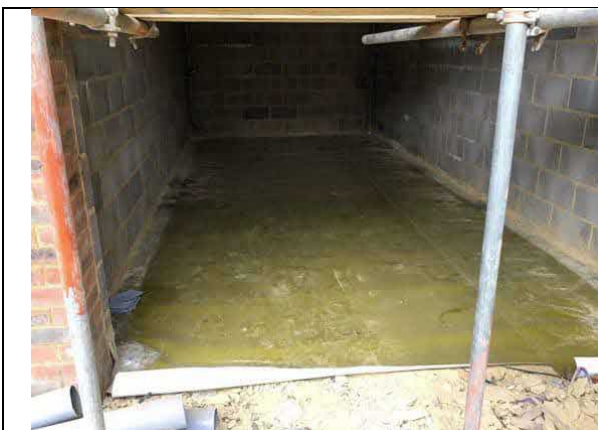
Overview of installed membrane in garage plot 63.

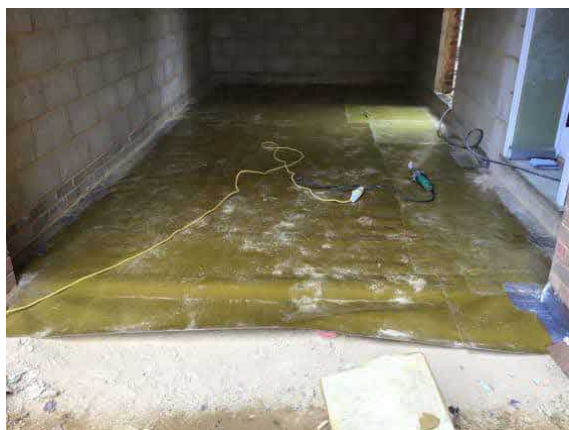
Overview of installed membrane in garage plot 68.
