Validation Letter

Our Ref: M41977-JNP-XX-XX-RP-G-0027-P01

Re: Former Sunninghill Gas Works – Validation of Capping Layer for Plots 64-67 inclusive (Block I)

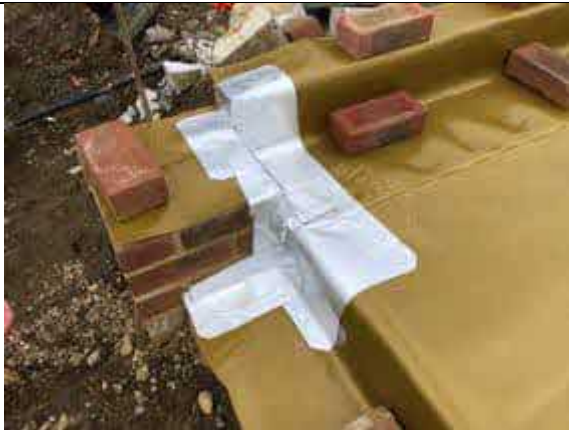
Plot 4 seal using SAGM to the front of the garage.

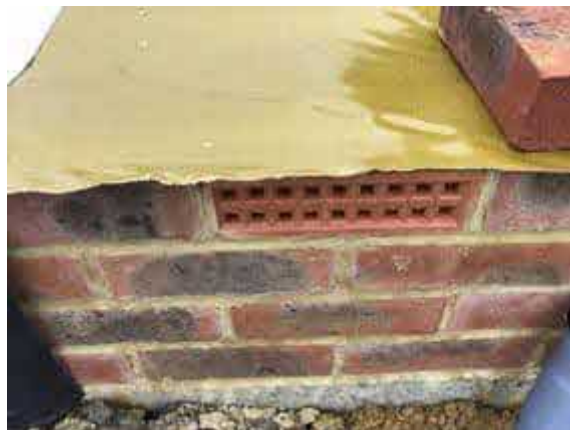
Plot 6 air brick in place.

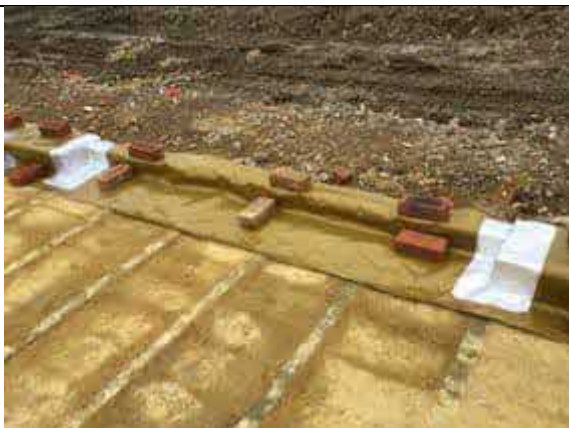
Plot 6 typical door threshold seal using SAGM.

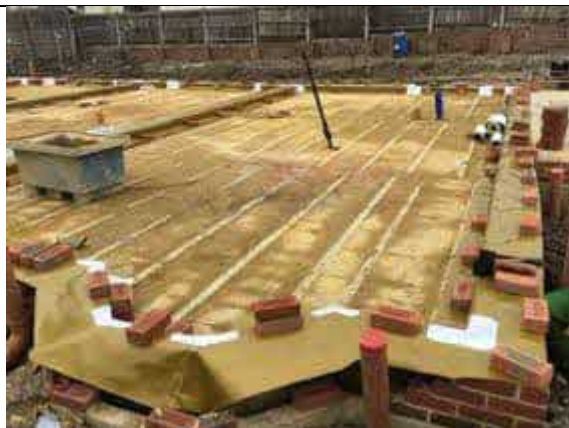
Plot 7 overview of installed membrane.

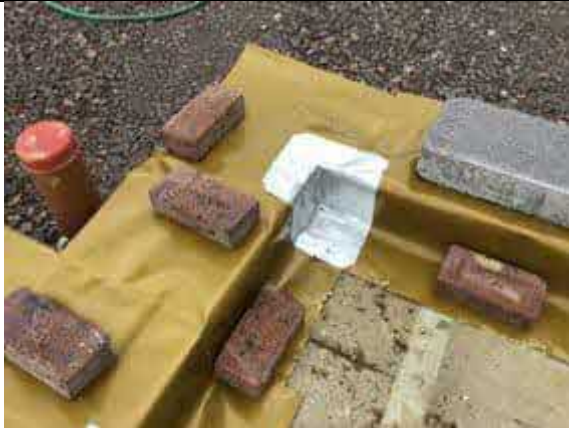
Plot 73 typical corner seal using SAGM.

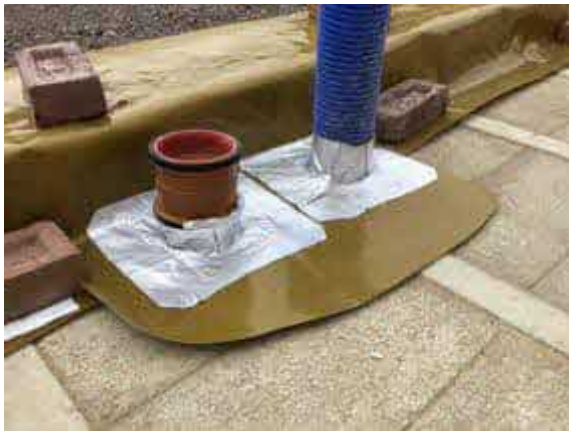
Plot 74 typical double pipe penetration seal using SAGM.

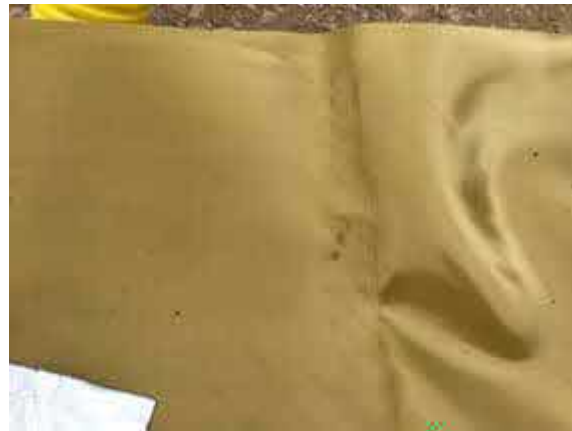
Plot 74 hand welded membrane laps over the cavity wall.

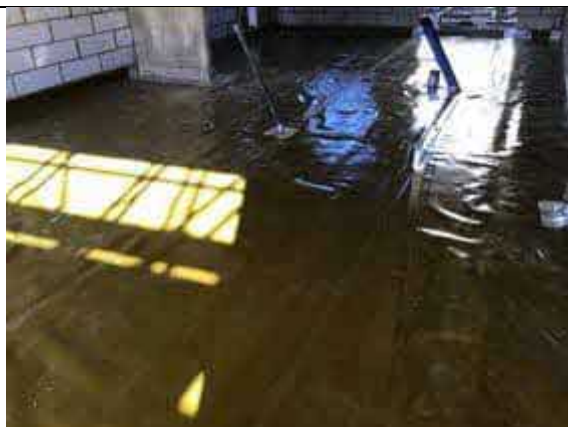
Plot 2 overview of installed membrane.

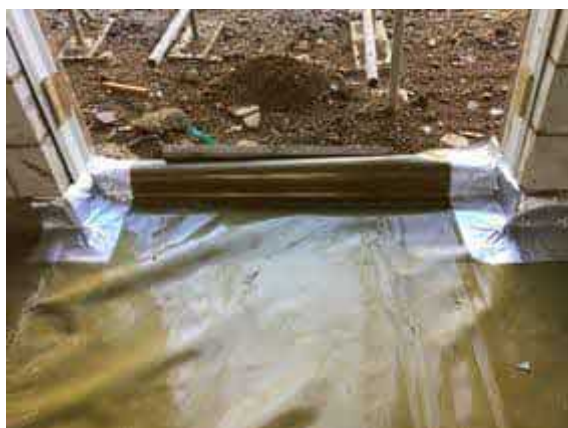
Plot 2 typical door threshold seal using SAGM.

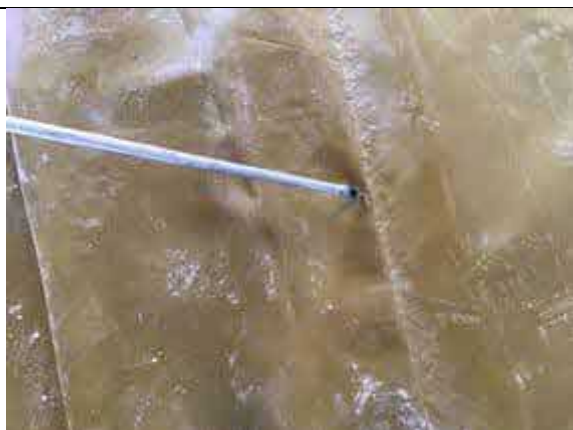
Plot 2 air lancing all weld laps and SAGM detailing.

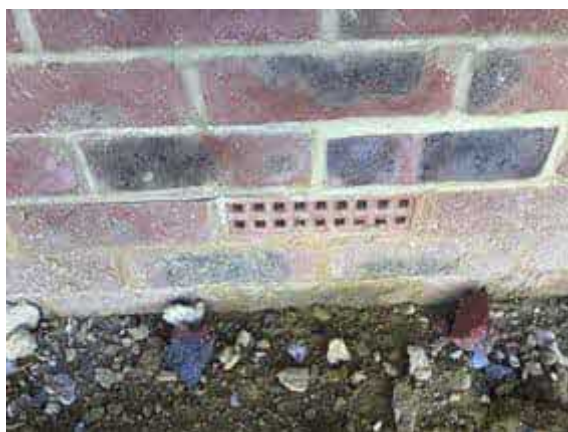
Air brick in place at the time of our inspection.

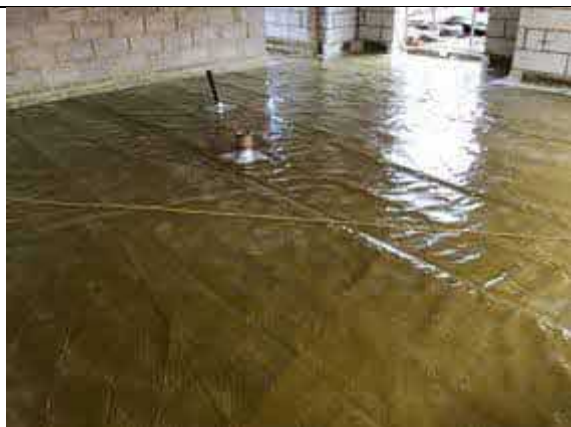
Plot 75 overview of installed membrane.

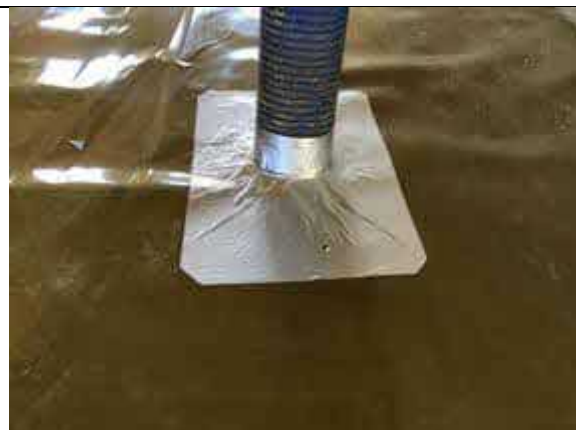
Plot 4 typical pipe penetration seal using SAGM.

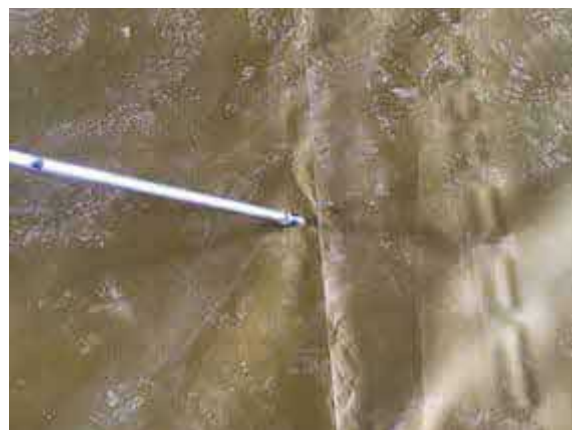
Plot 7 air lancing all welded membrane laps.

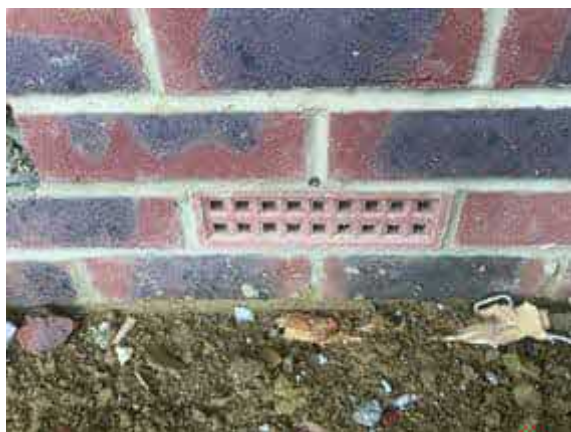
5no air bricks per plot were in place at the time of our inspection.

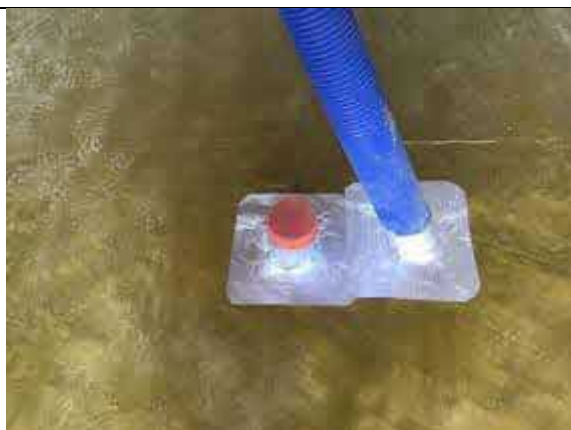
Plot 9 pipe penetrations sealed using SAGM

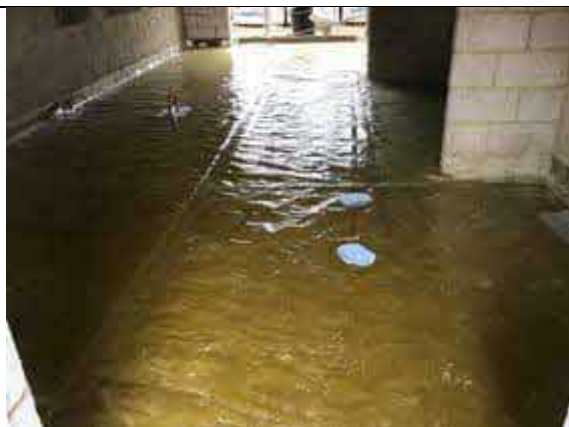
Plot 33 overview of installed Visqueen HC Blok Gas Barrier as an infill.

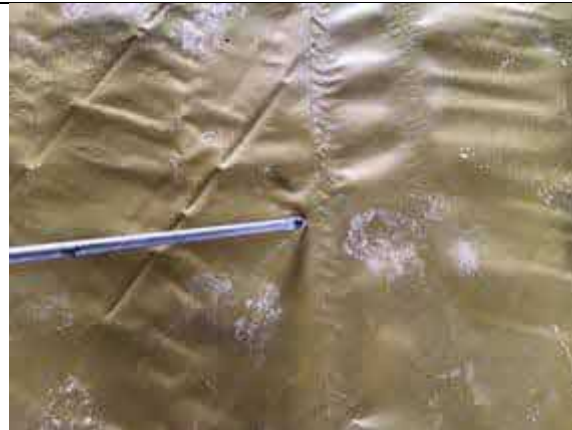
Plot 34 air lancing all welded membrane laps.

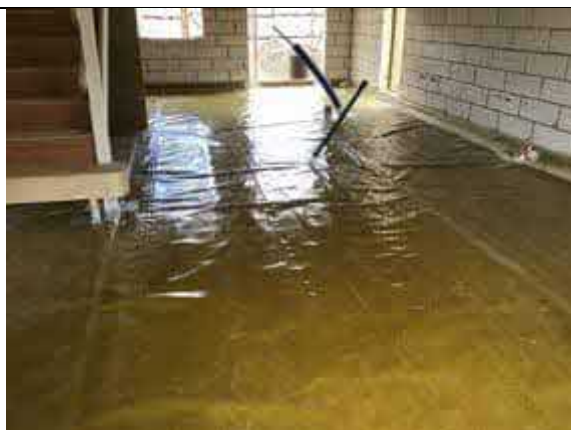
Plot 35 overview of installed Visqueen HC Blok Gas Barrier as an infill.

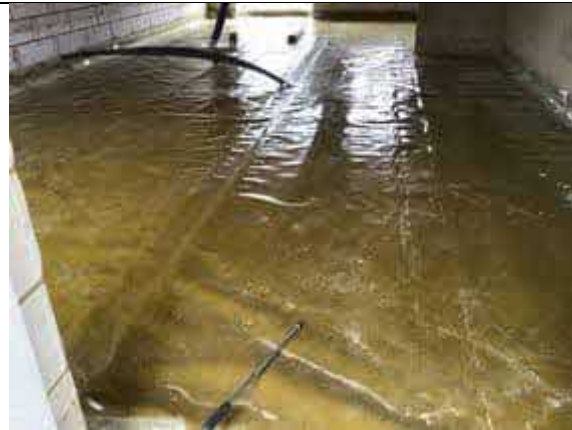
Plot 32 overview of installed Visqueen HC Blok Gas membrane.

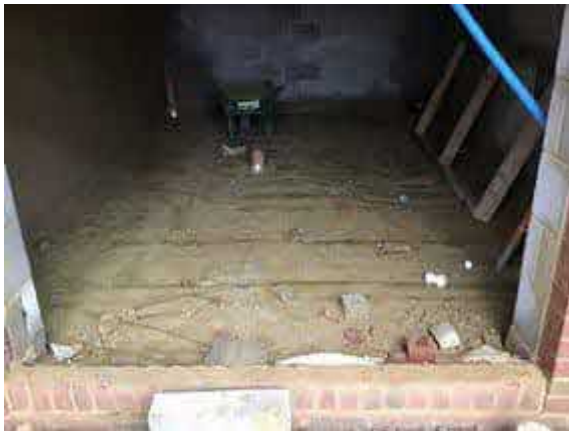
Incomplete bin store.

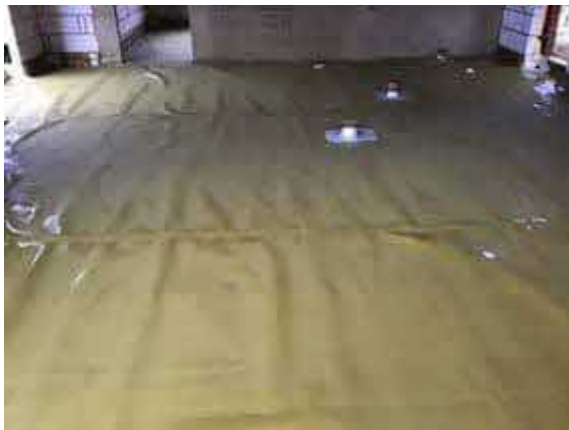
Overview of installed membrane to plot 41.

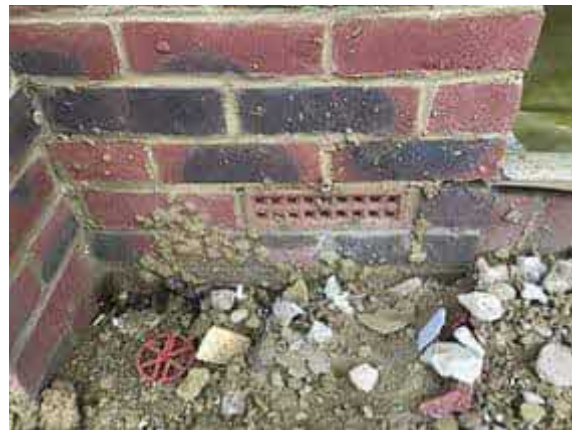
Air brick in place to plot 41.

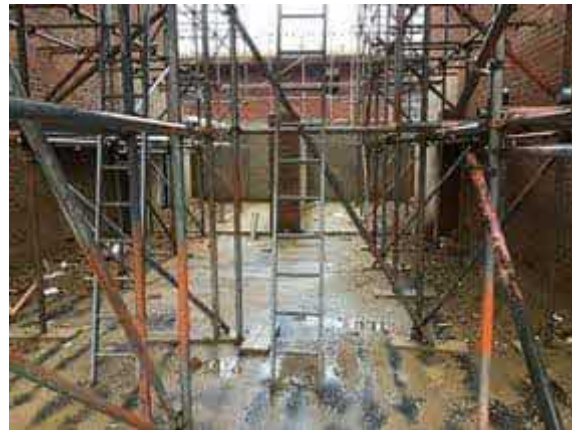
Scaffolding in place in all garages.

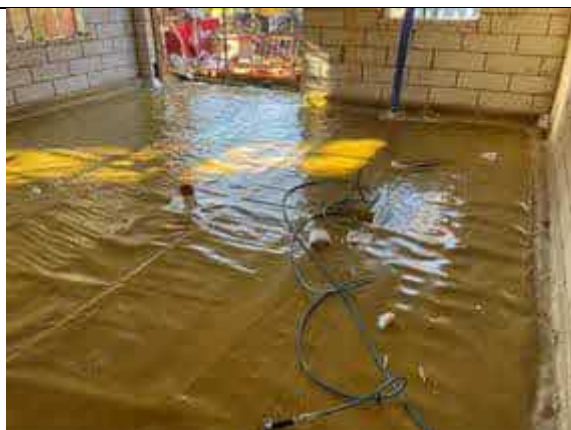
Plot 73. Visqueen HC Blok infill installation.

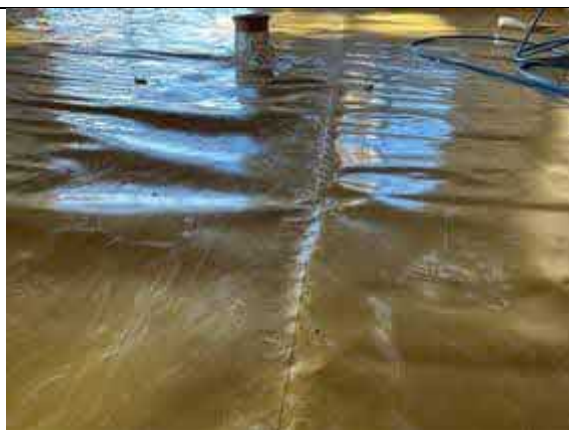
Plot 73. Hand welded membrane lap joint.

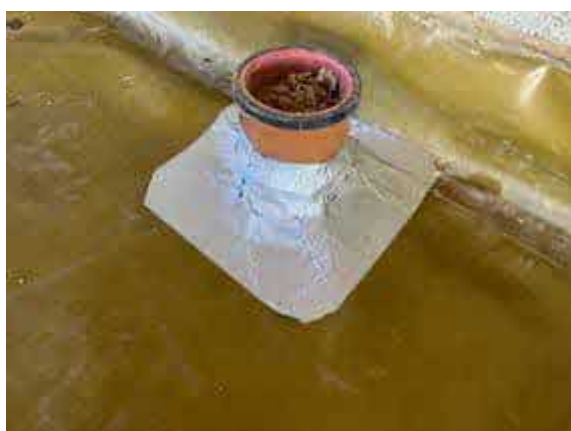
Plot 73. Typical pipe penetration sealed using SAGM.

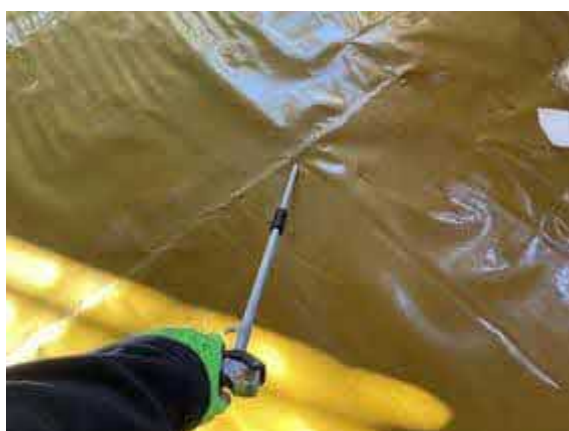
Plot 73. Air lance integrity test conducted upon all hand welded membrane lap joints.

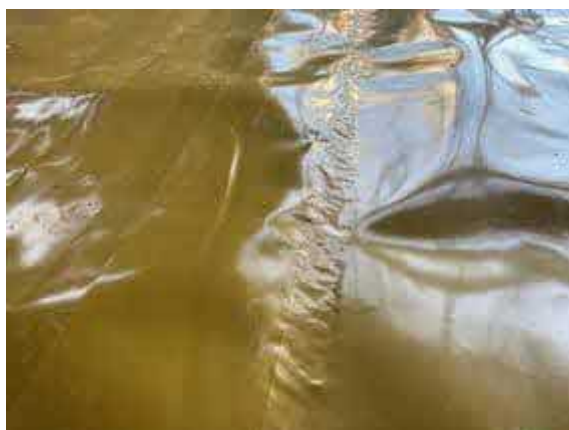
Plot 74. Hand welded membrane lap joint.

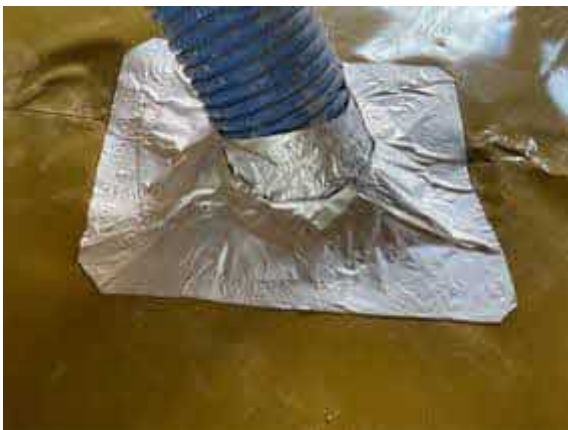
Plot 40. Typical pipe penetration sealed using SAGM.

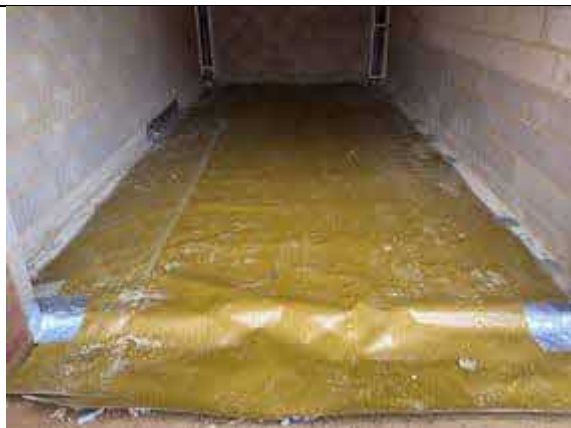
Overview of Visqueen HC Blok infill installation to Plot 30 FOG Unit Garage.

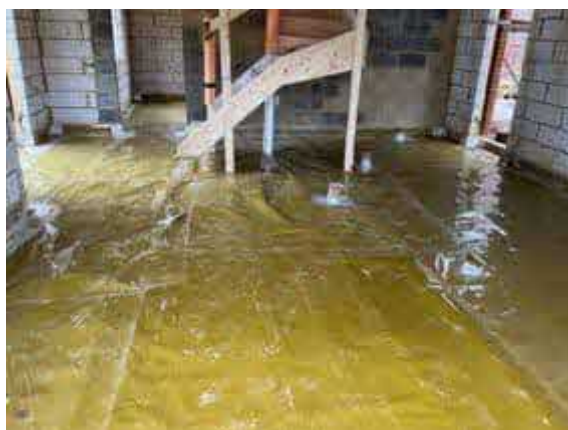
Overview of Visqueen HC Blok infill installation to Plot 72.

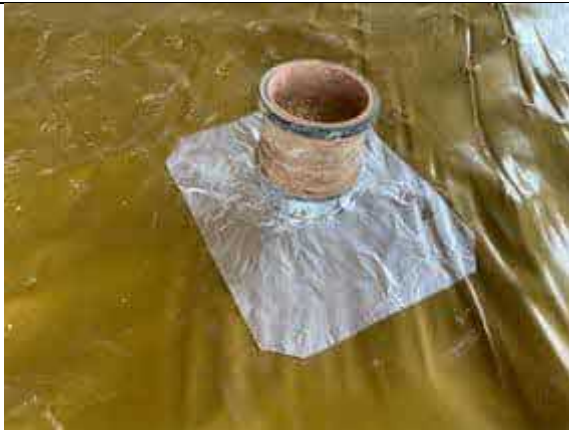
Plot 72. Typical pipe penetration sealed with SAGM.

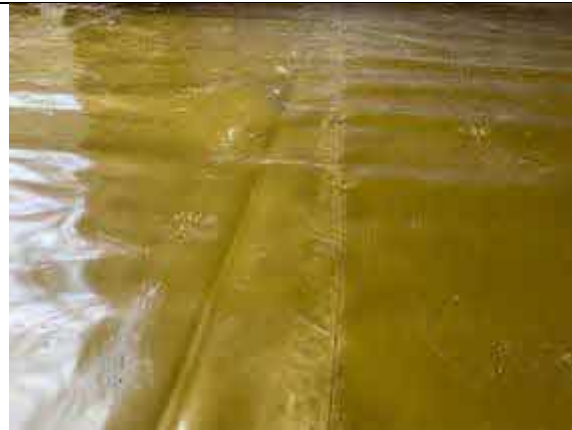
Plot 72. Overview of a hand welded membrane lap joint.

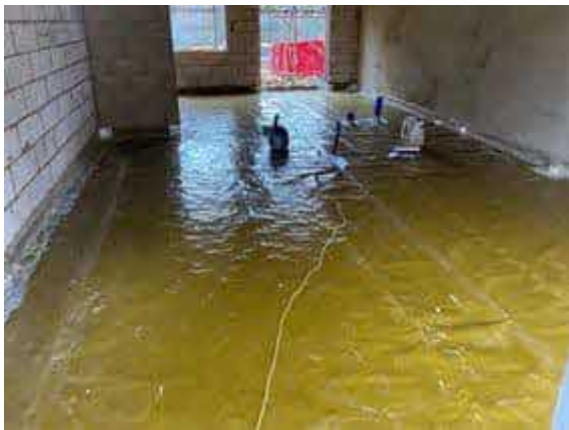
Overview of Visqueen HC Blok infill installation to Plot 70.

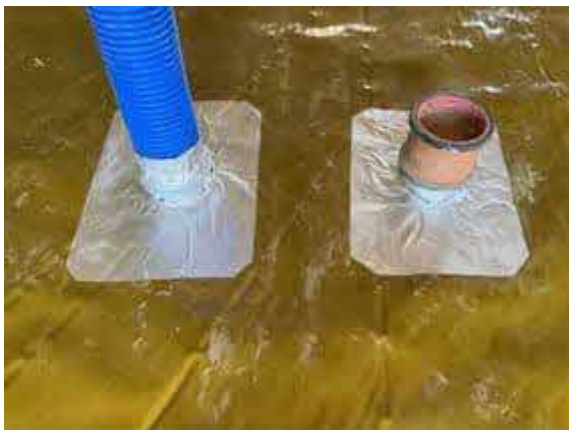
Plot 70. Typical pipe penetration's sealed using SAGM.

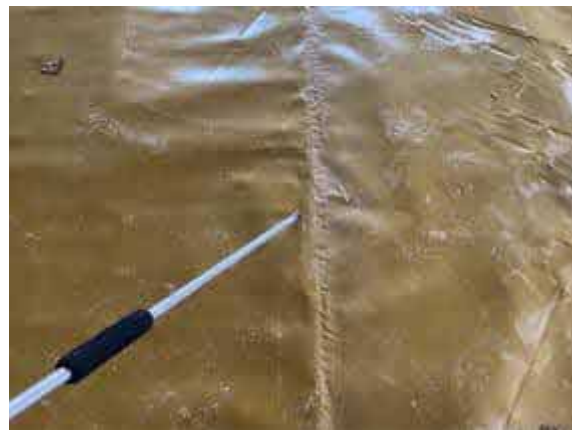
Plot 70. Air lance integrity testing along hand welded lap joint.

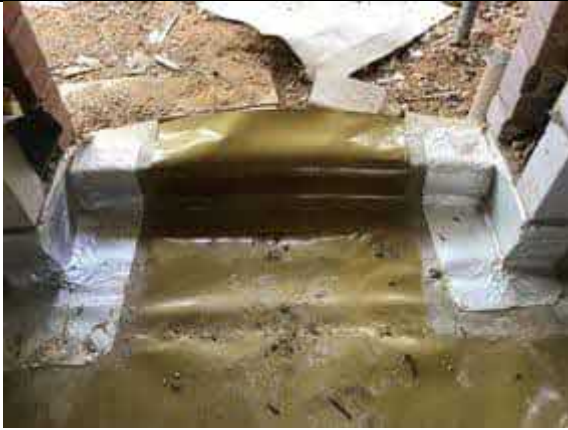
Sealed door threshold using SAGM.

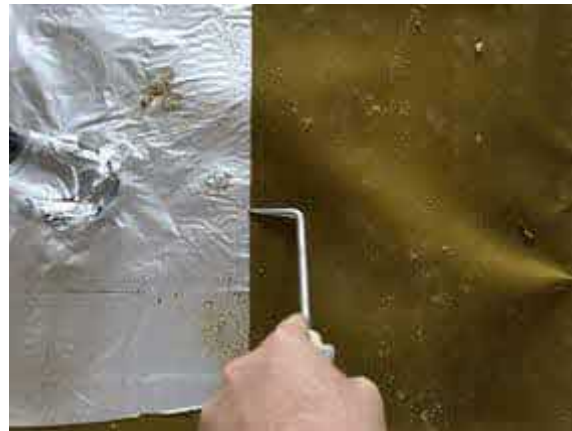
Pick testing all SAGM detailing.

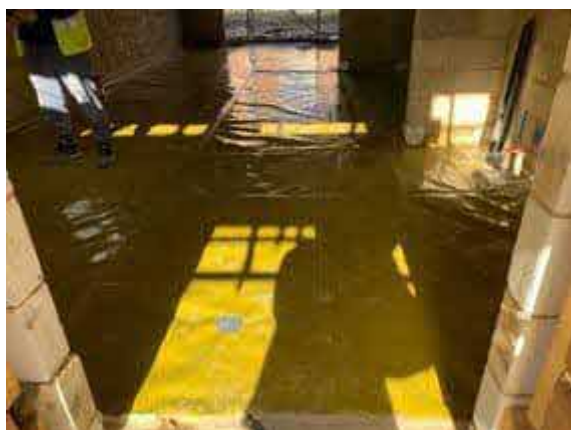
Plot 43 overview of installed membrane.

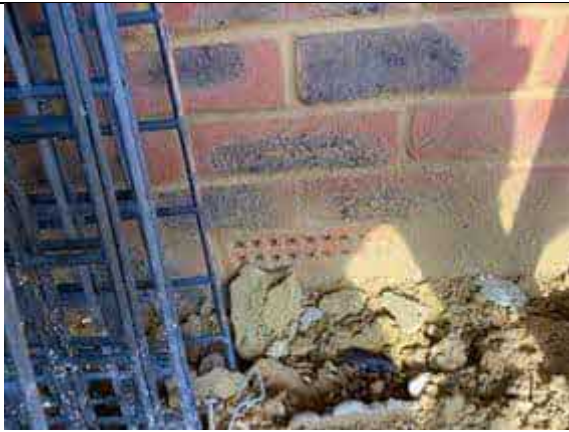
Plot 44 air brick in place at the time of our inspection.

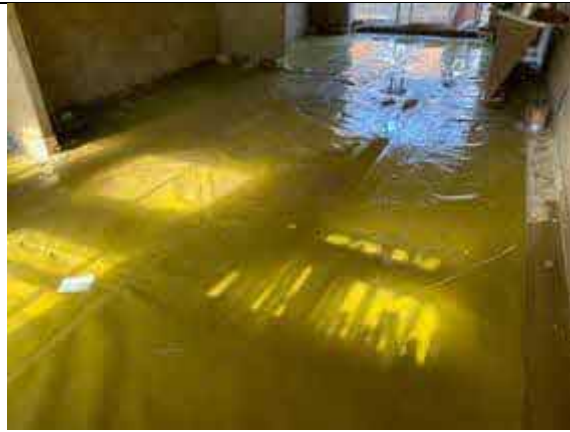
Plot 44 overview of installed membrane.

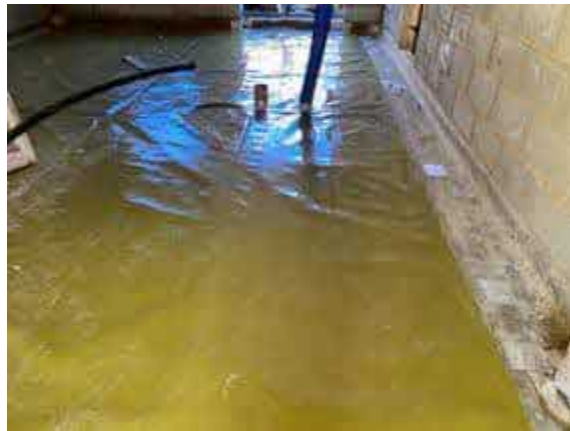
Plot 45 overview of installed membrane.

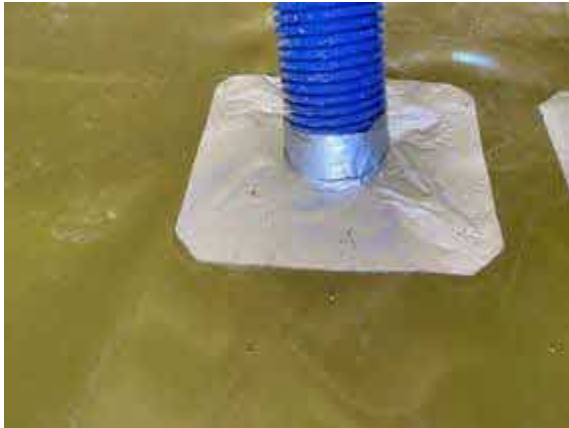
Plot 45 typical pipe penetration seal using SAGM.

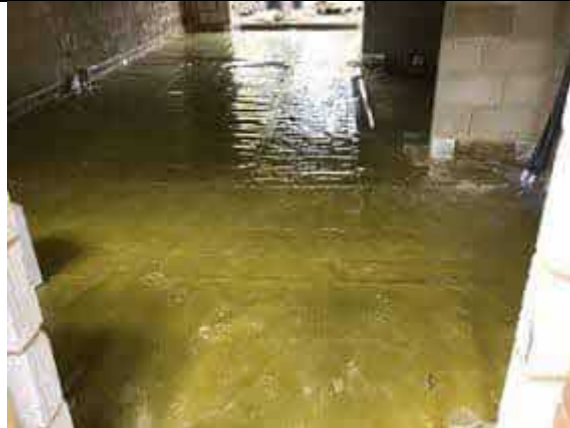
Overview of installed membrane to plot 48.

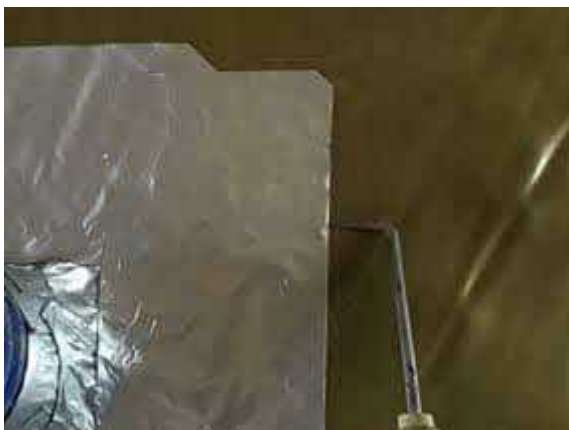
Pick testing all SAGM detailing to plot 64.

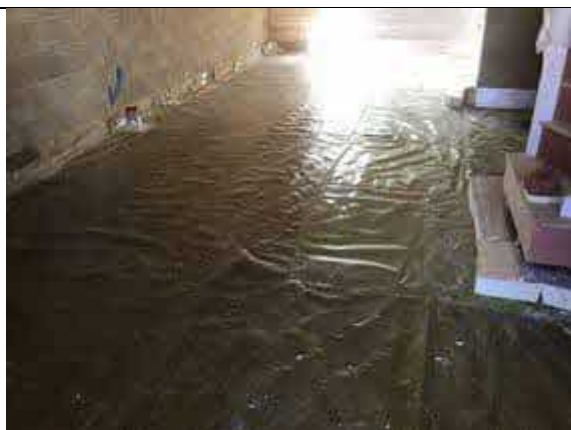
Overview of installed membrane to plot 65.

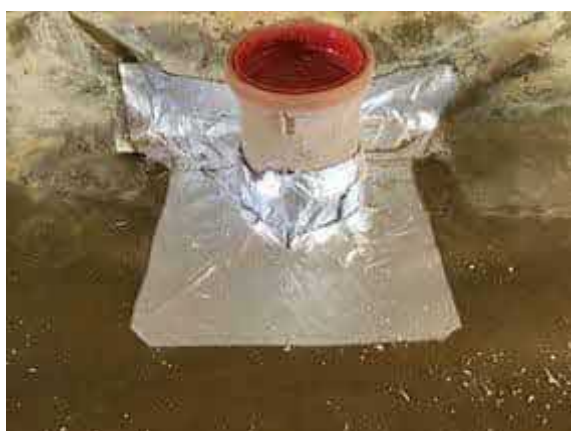
Typical pipe penetration seal using SAGM to plot 65.

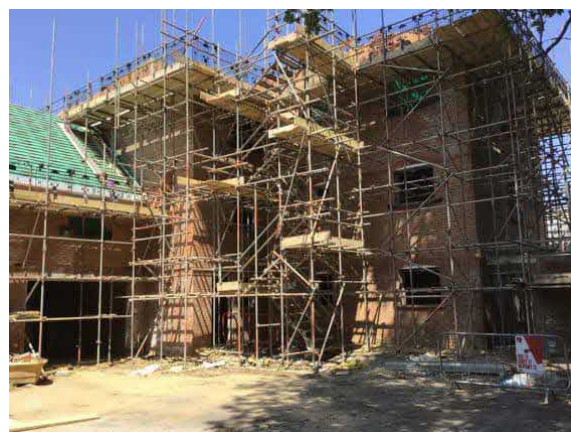
Overview of Apartment Block H. Plots 54-62.

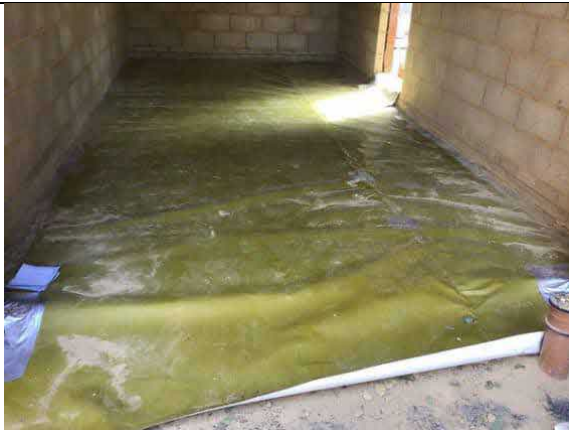
Overview of installed membrane to the garage, as an infill to plot 73.

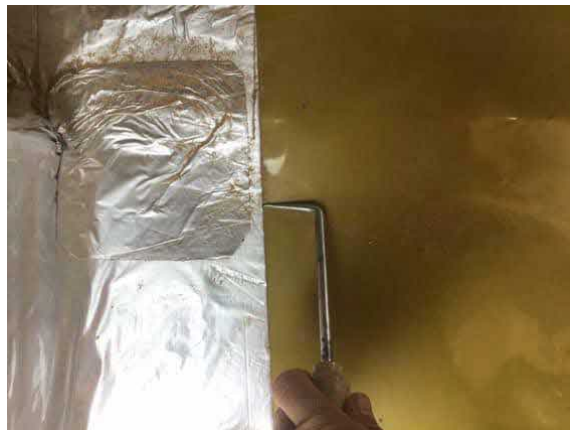
Pick testing all SAGM detailing.

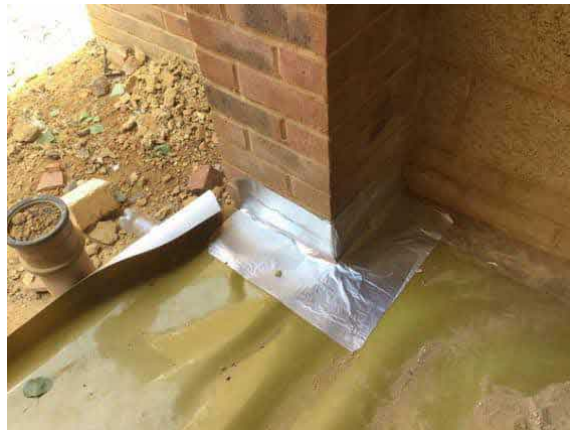
Sealed front of garage using SAGM.

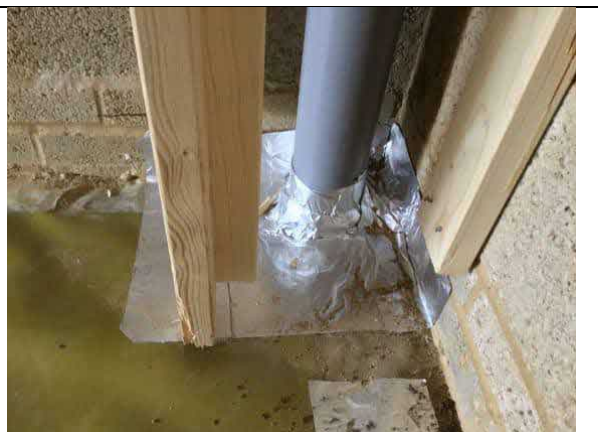
Sealed pipe penetration using SAGM to the rear of the garage plot 45.

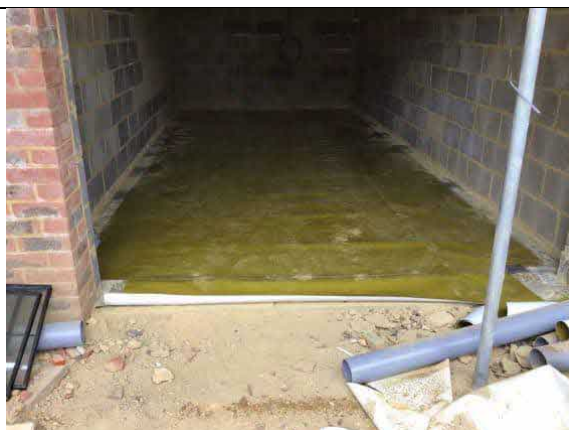
Overview of installed membrane in garage plot 64.

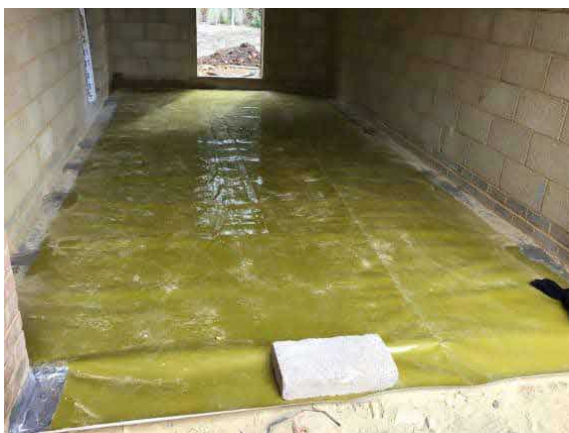
Overview of installed membrane in garage plot 67.

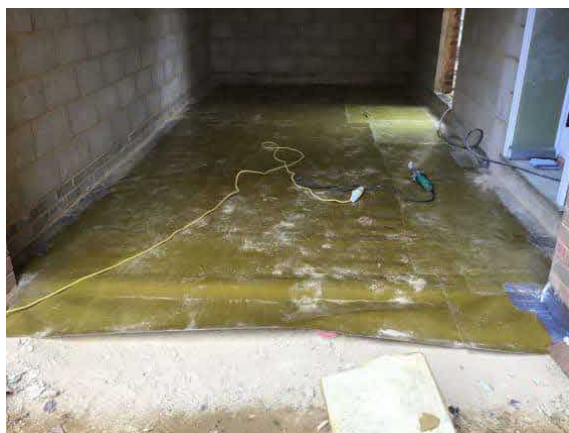
Overview of installed membrane in garage plot 68.

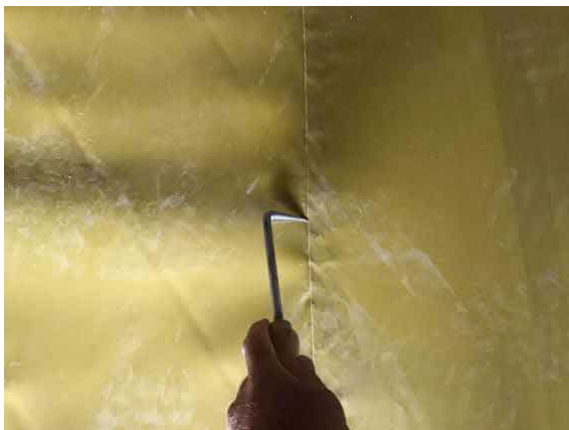
Pick testing all hand welded membrane laps.
