Validation Letter

Our Ref: M41977-JNP-XX-XX-RP-G-0024-P01

Re: Former Sunninghill Gas Works – Validation of Capping Layer for Plots 42- 50 inclusive (Block F)

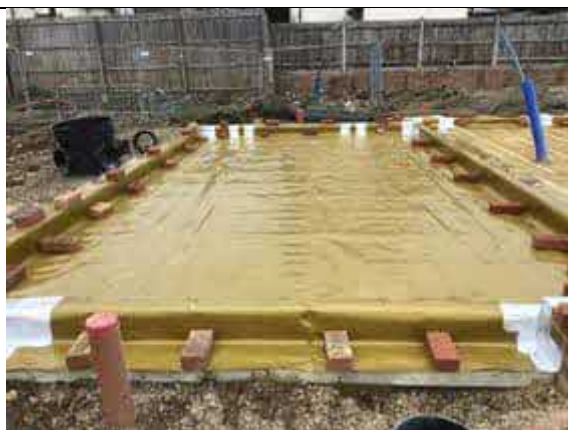
Plot 4 overview of installed membrane to the garage.

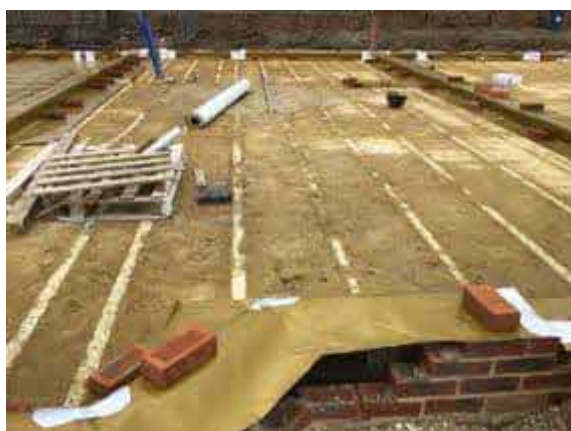
Plot 4 overview of installed membrane to the perimeters and party walls.

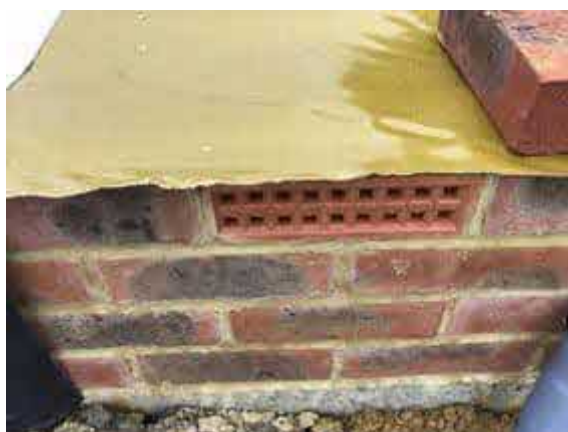
Plot 6 air brick in place.

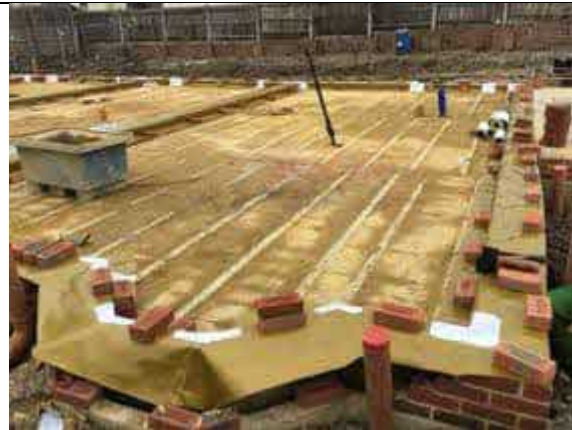
Plot 7 overview of installed membrane.

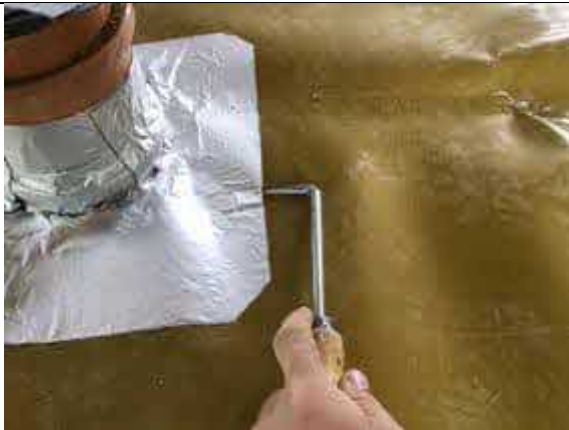
Pick testing all SAGM detailing.

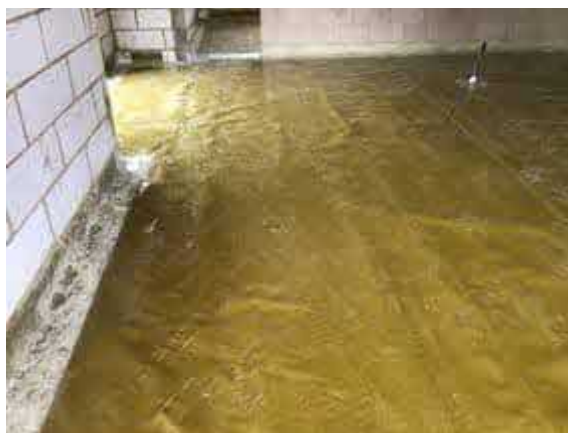
Plot 76 overview of installed membrane.

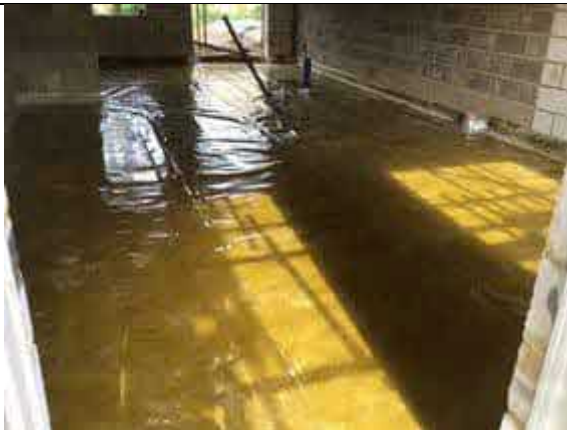
Plot 7 overview of installed membrane.

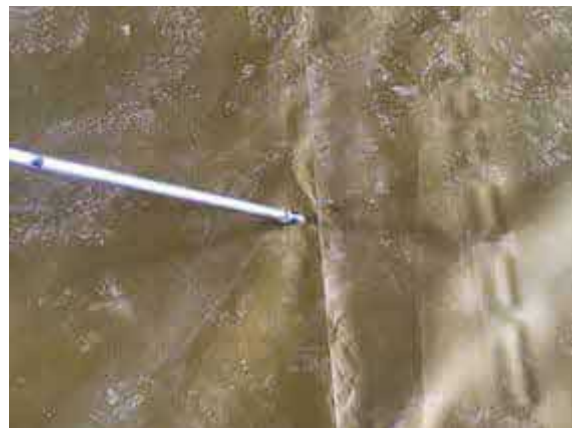
Plot 7 air lancing all welded membrane laps.

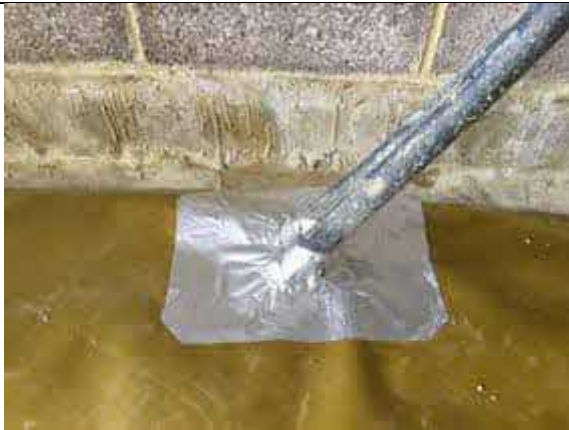
Pipe details within Plot 11 sealed with SAGM.

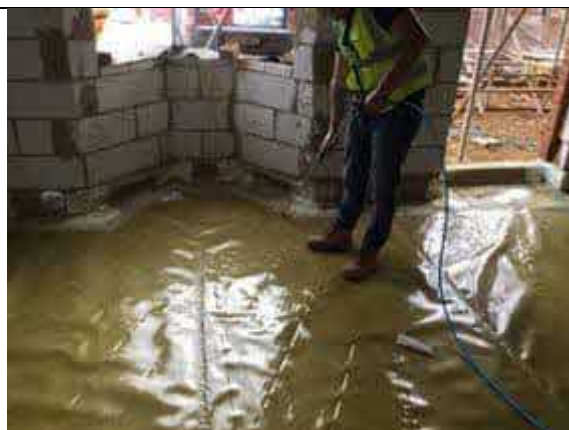
Air lance testing to Plot 10 lap joints.

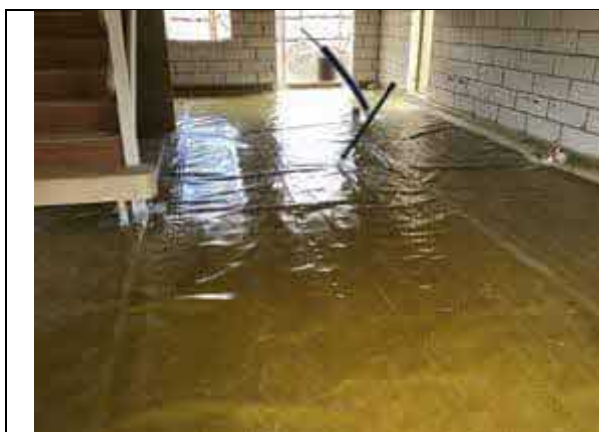
Plot 35 overview of installed Visqueen HC Blok Gas Barrier as an infill.

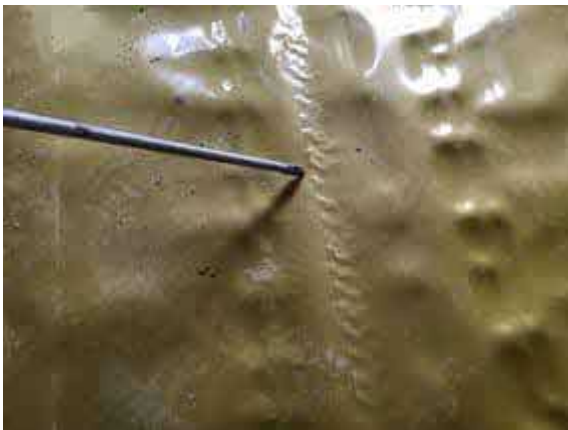
Plot 32 air lancing all welded membrane laps.

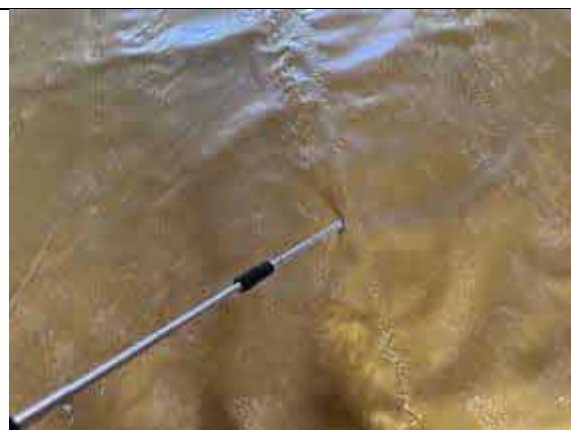
Plot 29 - Air lance integrity test upon a hand welded membrane lap joint.

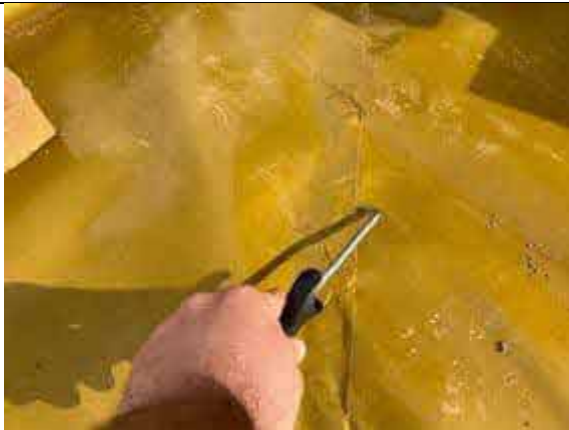
Plot 63 FOG Unit - Pick test upon a successfully hand welded lap joint.

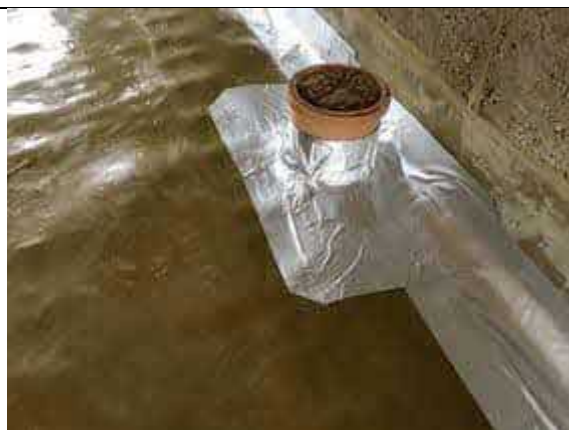
Plot 28 typical pipe penetration seal using SAGM.

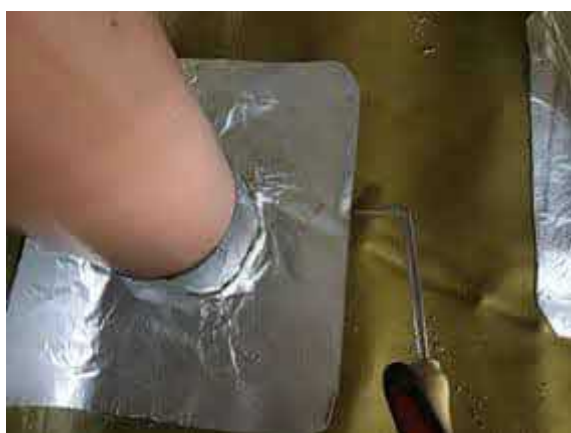
Pick testing all SAGM detailing.

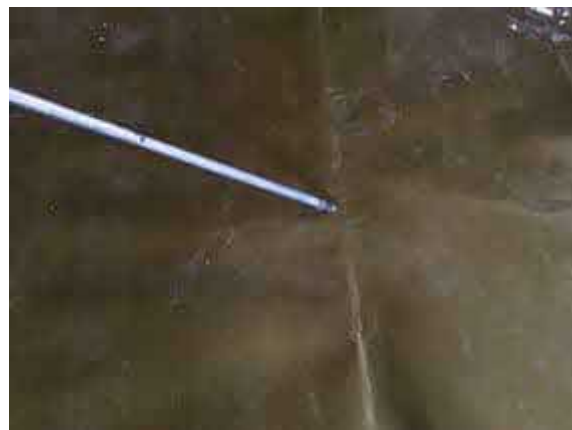
Air lancing all welded membrane laps to plot 37.

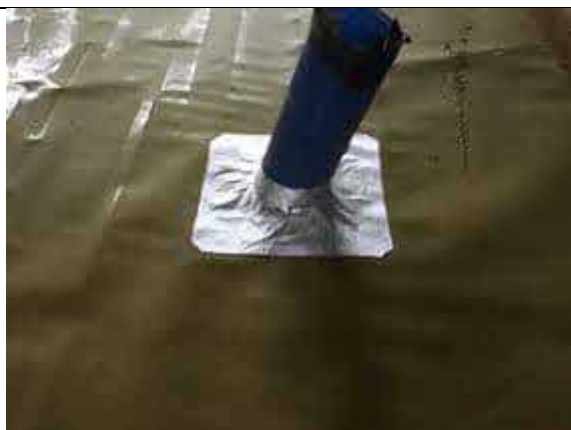
Typical pipe penetration seal using SAGM to plot 39.

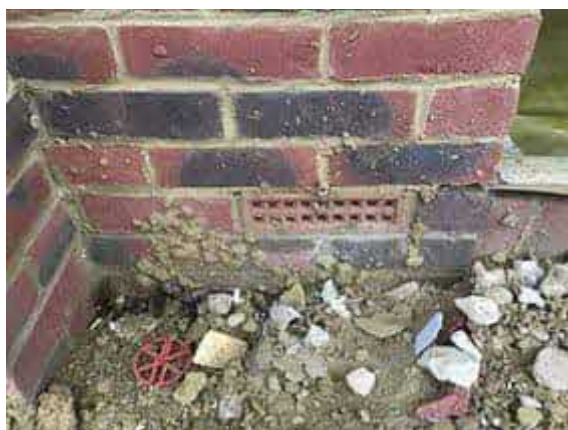
Air brick in place to plot 41.

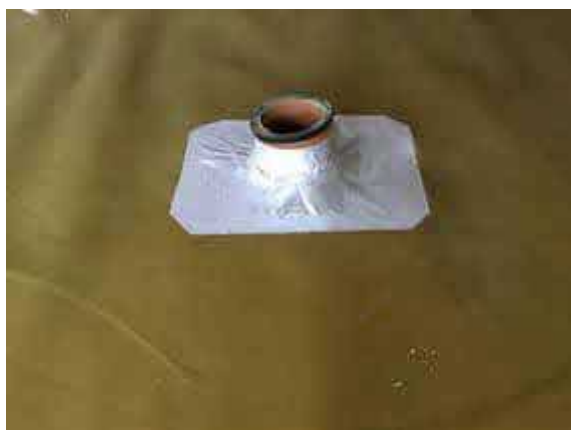
Typical pipe penetration seal to plot 41.

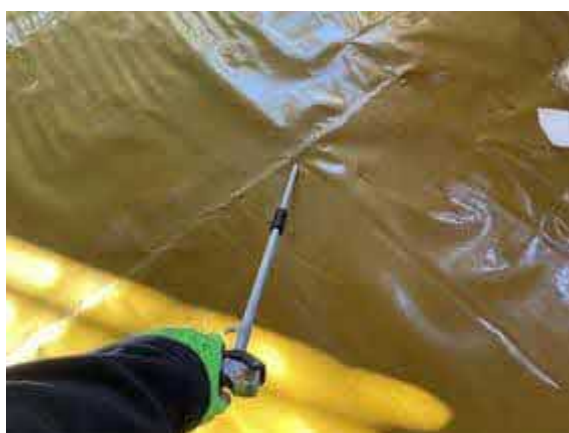
Plot 73. Air lance integrity test conducted upon all hand welded membrane lap joints.

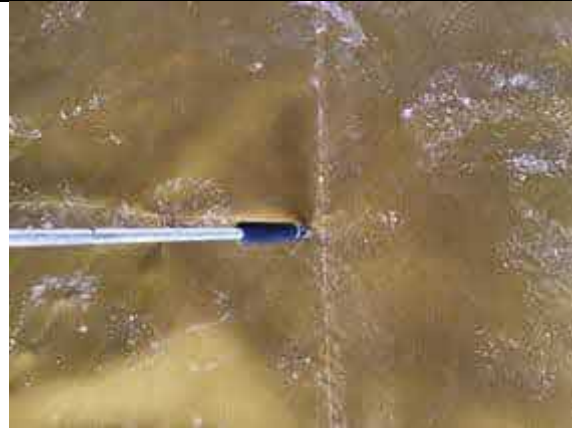
Air lancing all hand welded membrane laps.

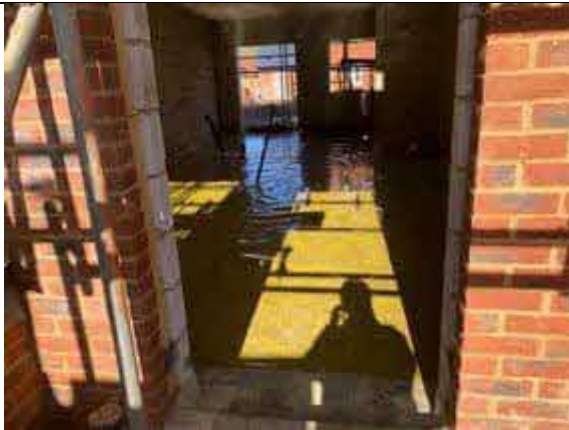
Plot 42 overview of installed membrane.

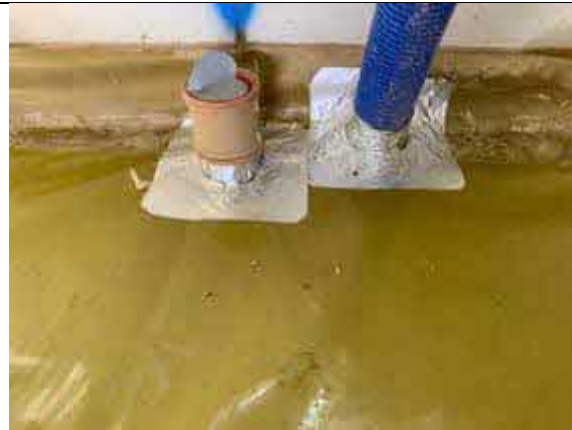
Plot 43 typical double pipe penetration seal using SAGM.

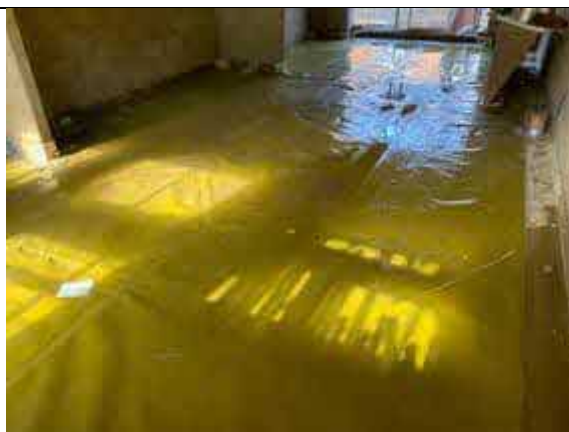
Plot 44 overview of installed membrane.

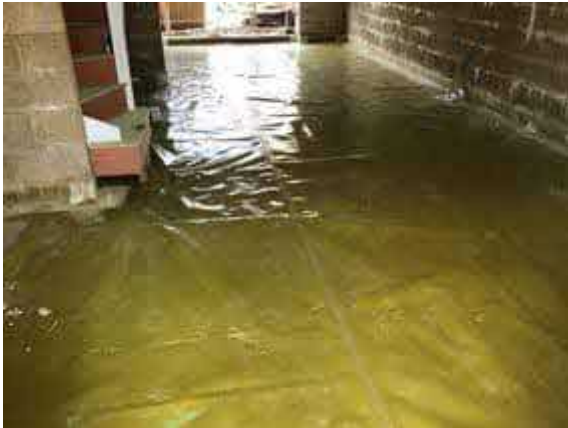
Overview of installed membrane to plot 49.

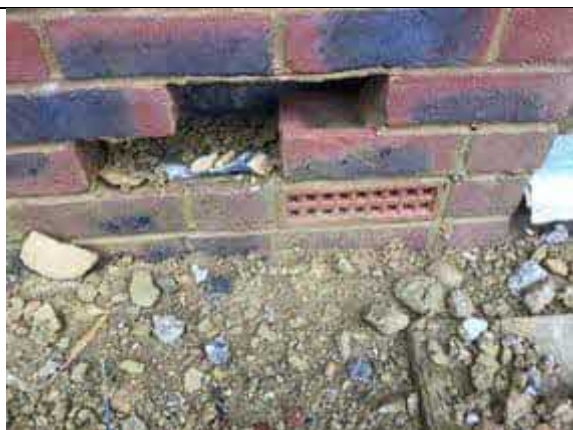
Air brick in place at the time of our inspection to plot 49.

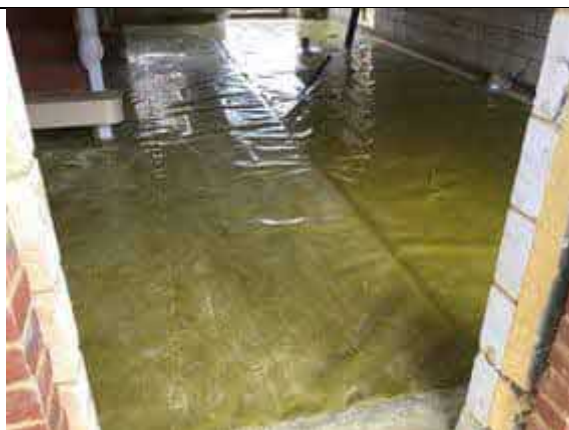
Overview of installed membrane to plot 50.

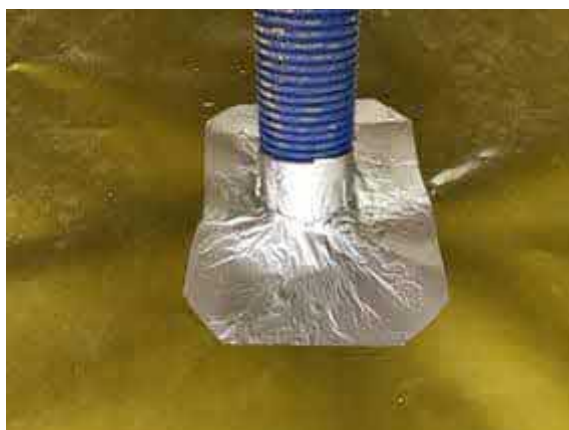
Typical pipe penetration seal using SAGM to plot 50.

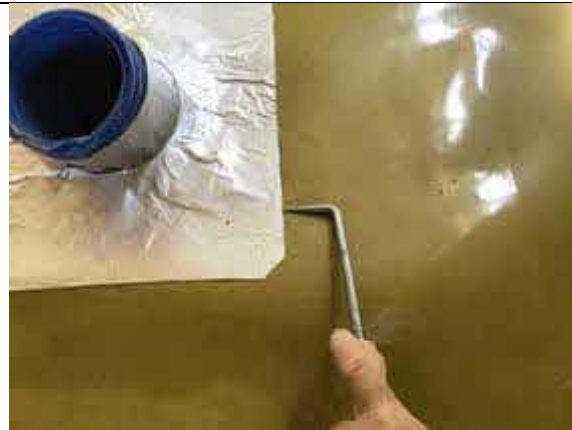
Pick testing all SAGM detailing to plot 67.

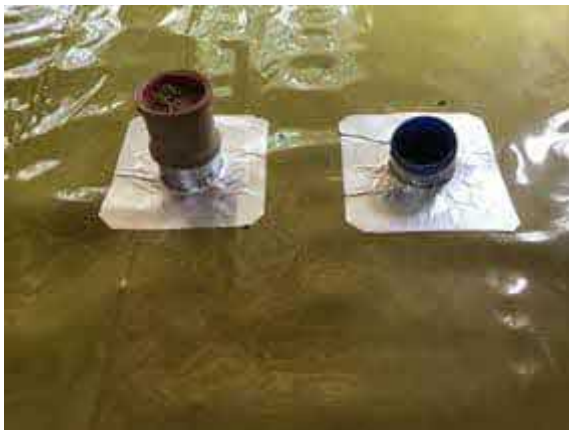
Sealed double pipe penetrations using SAGM to plot 67.

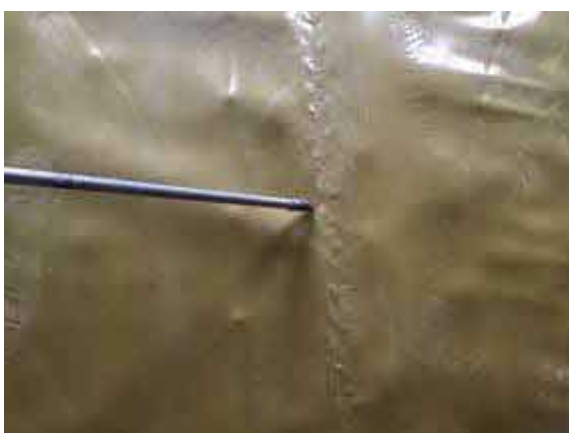
Air lancing all hand welded membrane laps to plot 64.

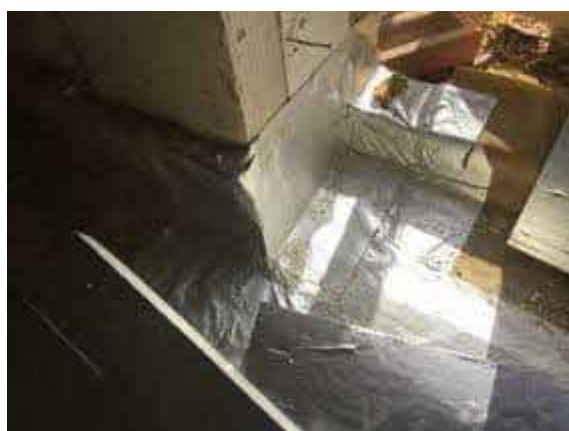
Re sealed door threshold detail using SAGM to plot 65.

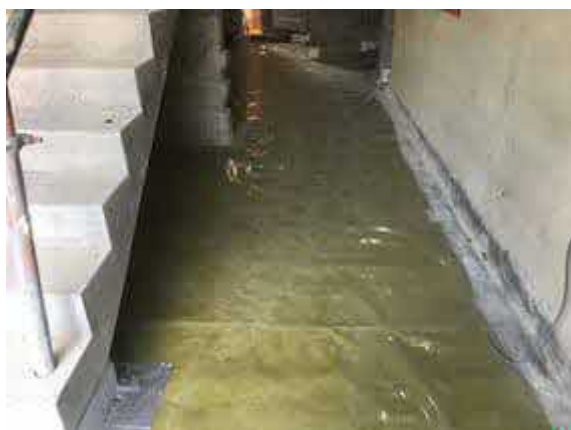
Over of installed membrane to apartment block c entrance lobby.

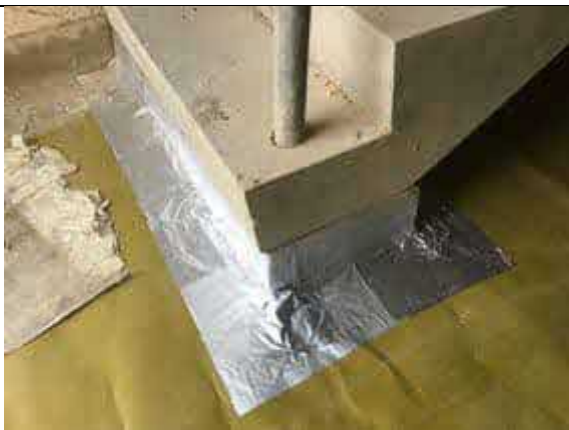
Retro fit detail using SAGM to the base of the concrete stairs in apartment block b.

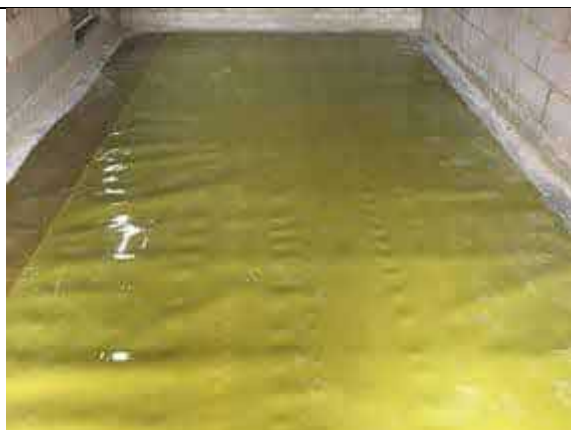
Overview of installed membrane to the garage area in plot 36.

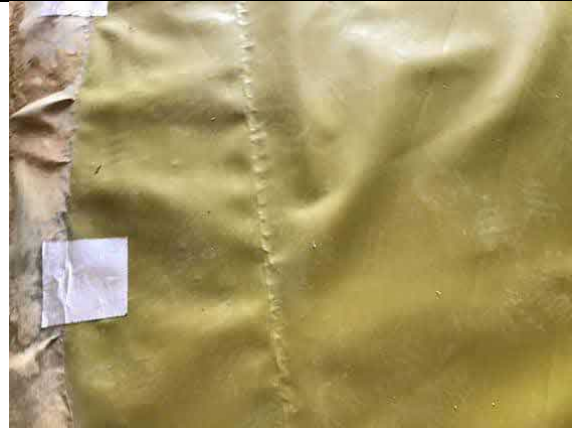
Hand welded membrane lap in garage plot 40.

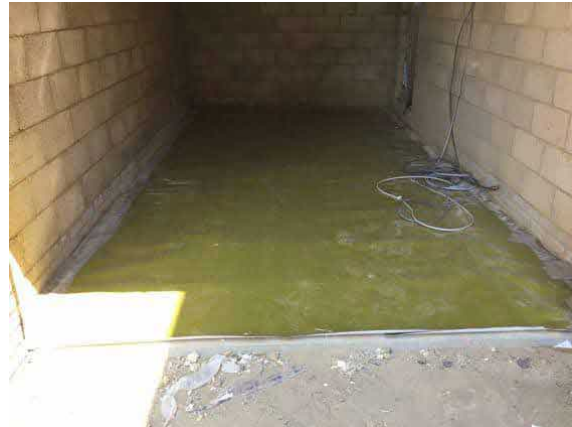
Overview of installed membrane to the garage in plot 41.

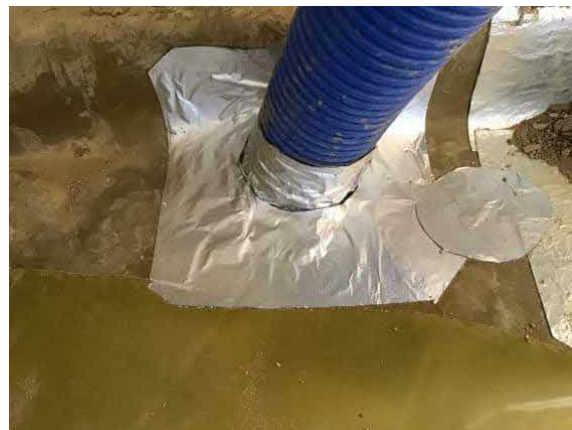
Typical pipe penetration seal using SAGM to plot 46.

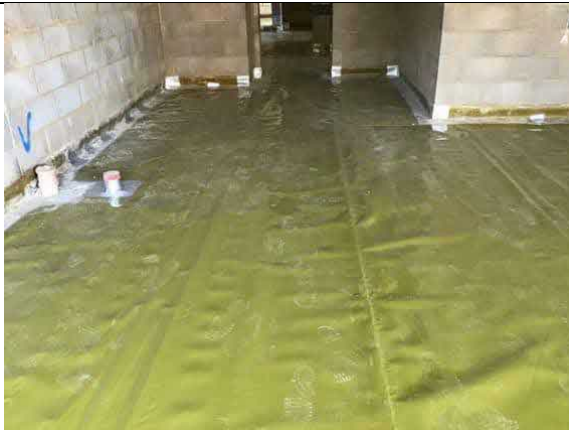
Overview of installed Visqueen HC Blok gas membrane, that has been installed as an infill to Apartment block H.

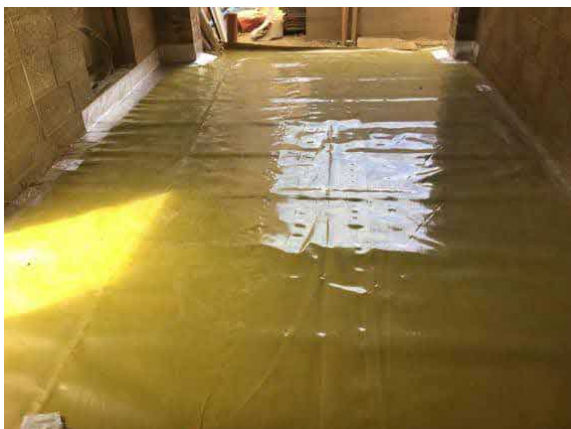
Overview of installed membrane to the garage, as an infill to plot 71.

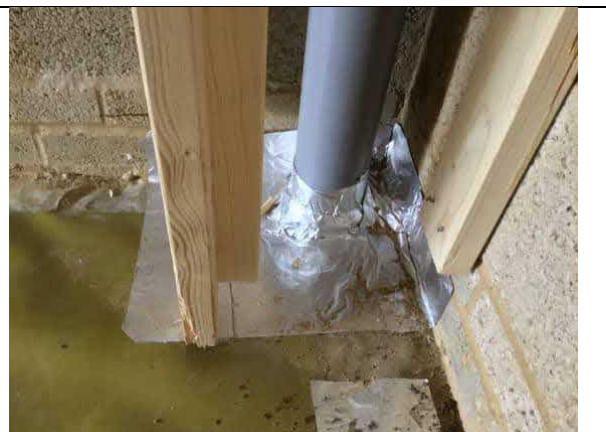
Sealed pipe penetration using SAGM to the rear of the garage plot 45.

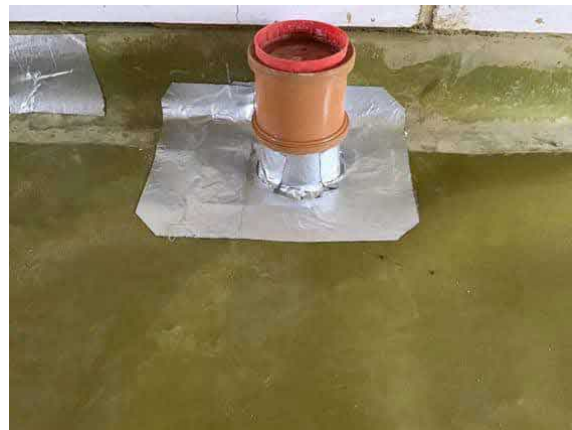
Typical pipe penetration seal using SAGM in plot 52.

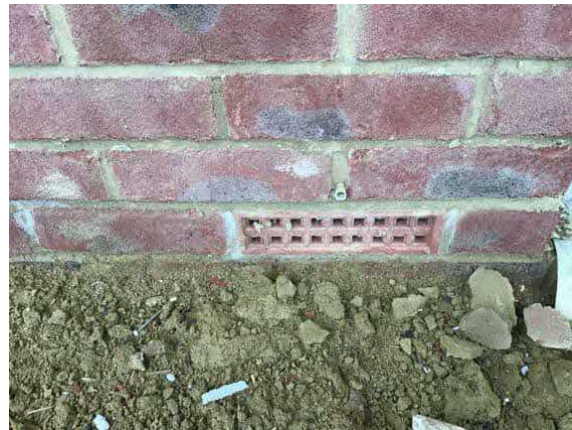
Air brick in place at the time of our inspection to plots 51-53.

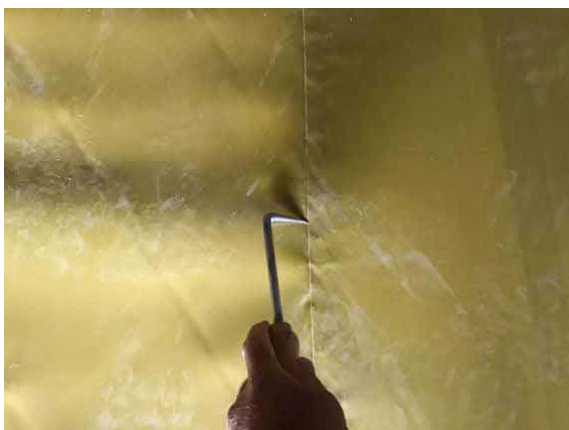
Typical hand welded membrane lap.
