Validation Letter

Our Ref: M41977-JNP-XX-XX-RP-G-0025-P01

Re: Former Sunninghill Gas Works – Validation of Capping Layer for Plots 51- 53 inclusive (Block G)

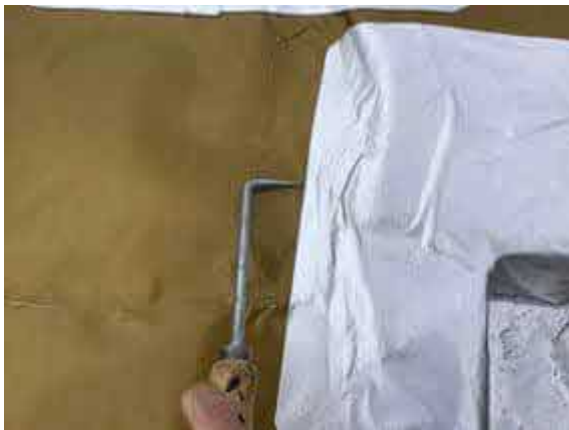
Plot 5 pick testing all SAGM detailing.

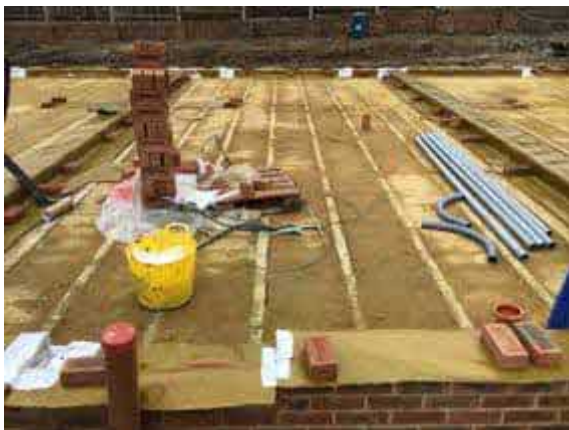
Plot 6 overview of installed membrane.

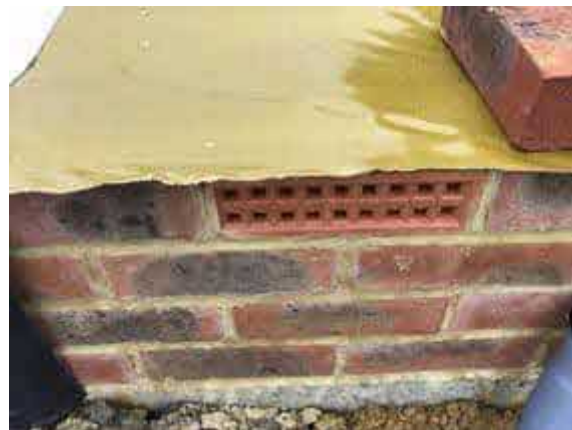
Plot 6 air brick in place.

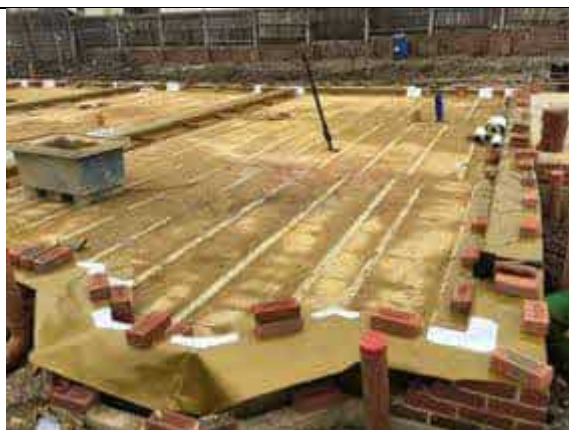
Plot 7 overview of installed membrane.

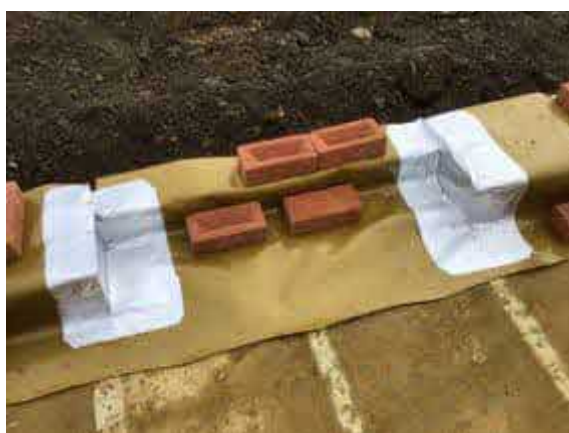
Plot 7 typical door seal using SAGM.

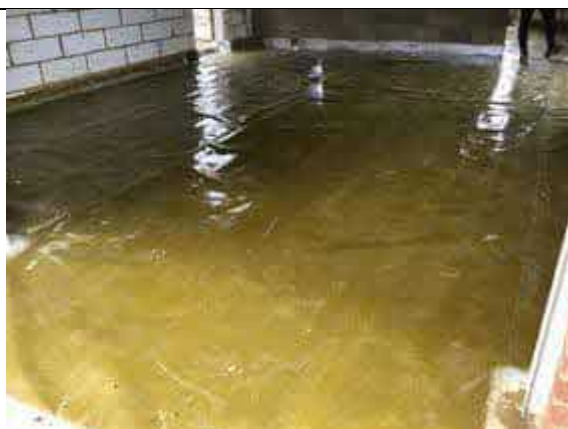
Overview of installed membrane.

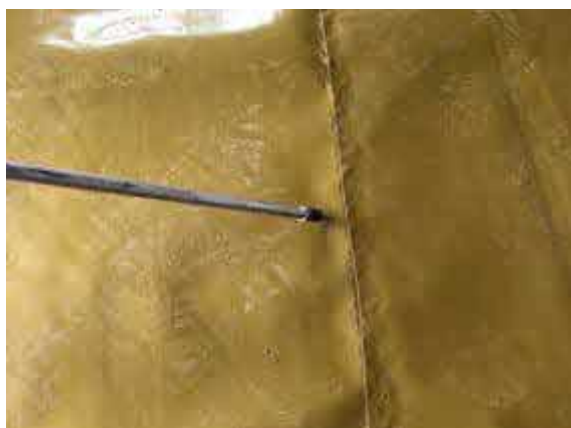
Air lancing all welded membrane laps.

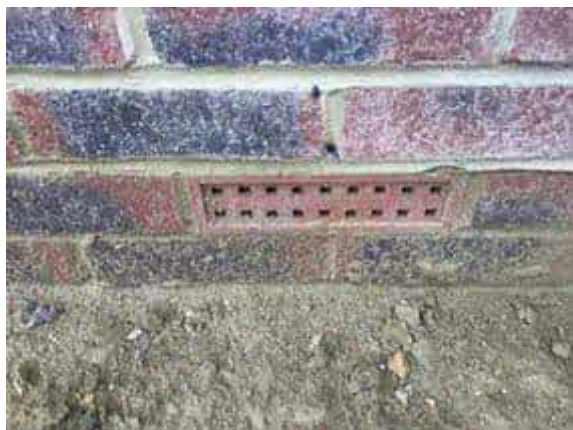
Air brick in place at the time of our inspection.

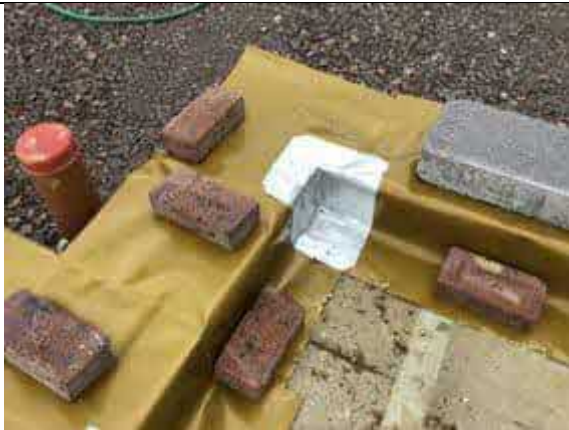
Plot 73 typical corner seal using SAGM.

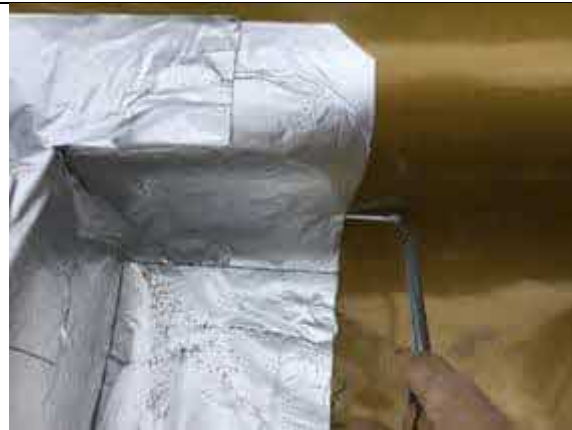
Plot 74 pick testing all SAGM detailing.

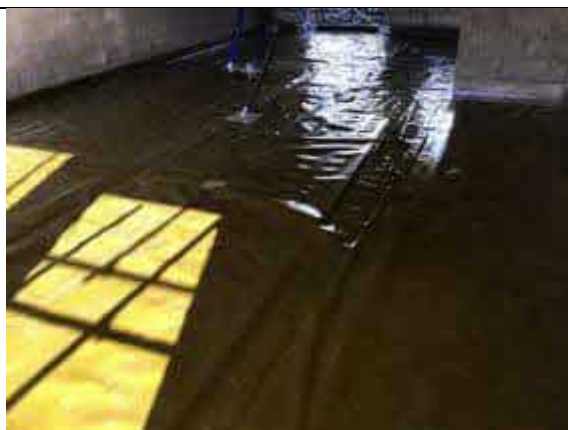
Plot 3 overview of installed membrane.

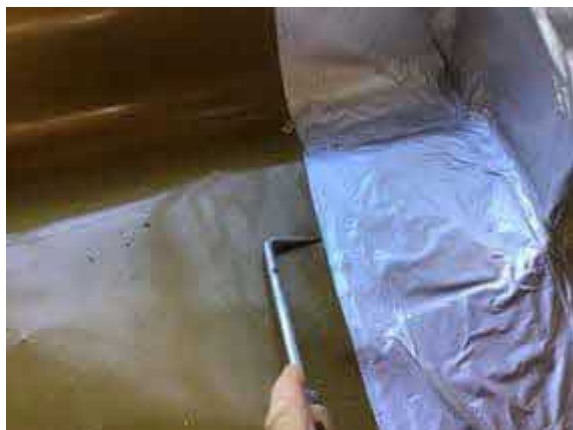
Plot 3 pick testing all SAGM detailing.

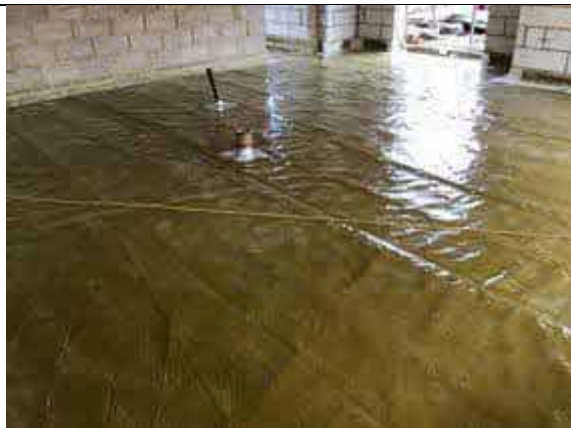
Plot 75 overview of installed membrane.

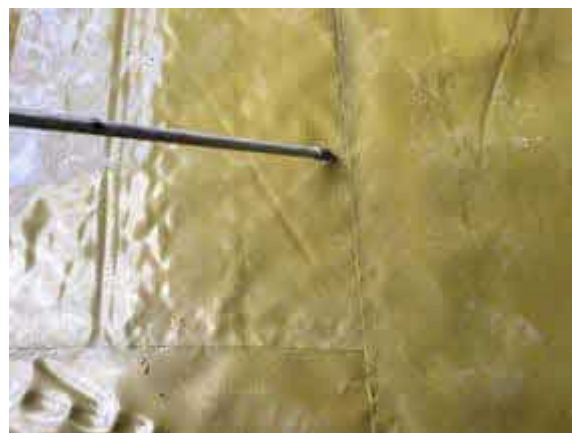
Plot 75 air lancing all weld laps and SAGM detailing.

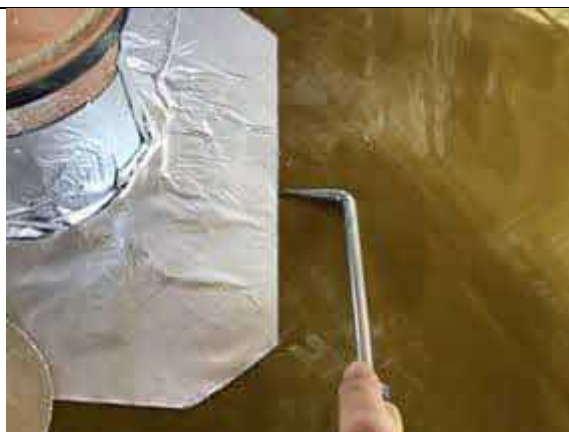
Plot 76 pick testing all SAGM detailing.

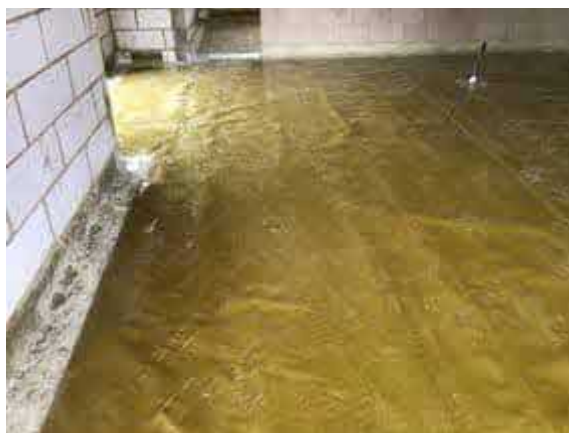
Plot 76 overview of installed membrane.

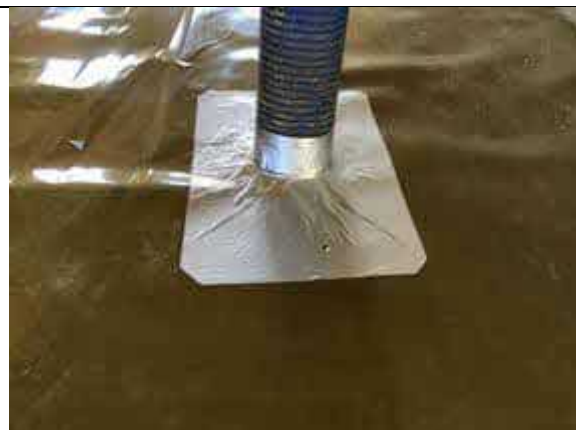
Plot 4 typical pipe penetration seal using SAGM.

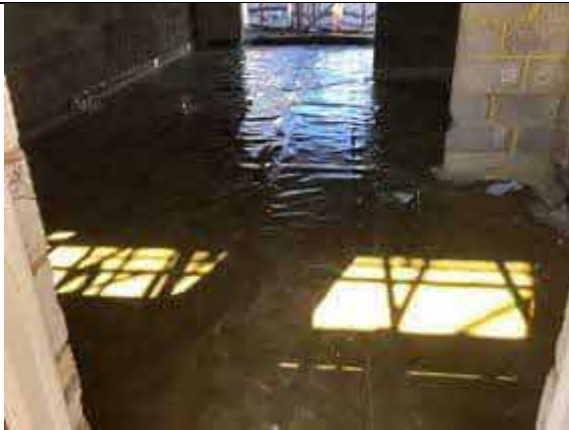
Plot 5 overview of installed membrane.

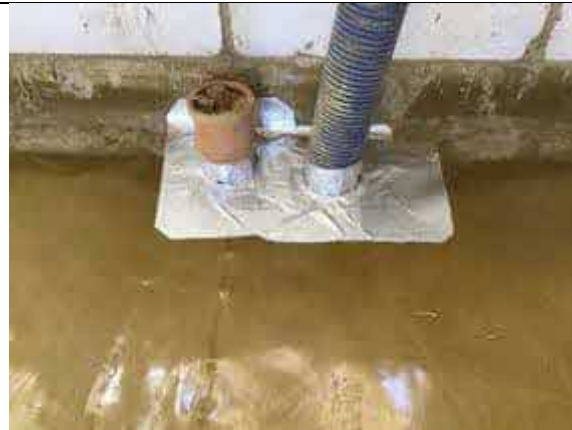
Plot 5 typical double pipe penetration seal using SAGM.

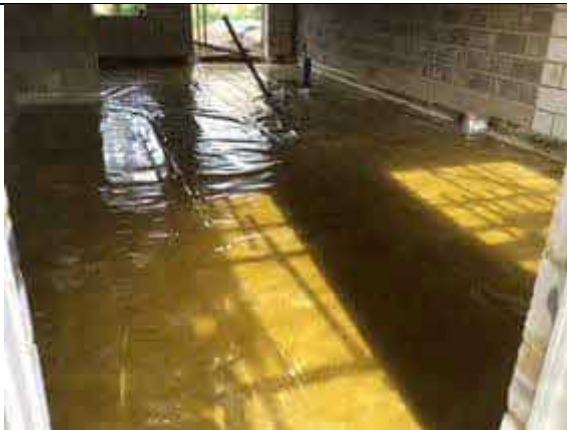
Plot 7 overview of installed membrane.

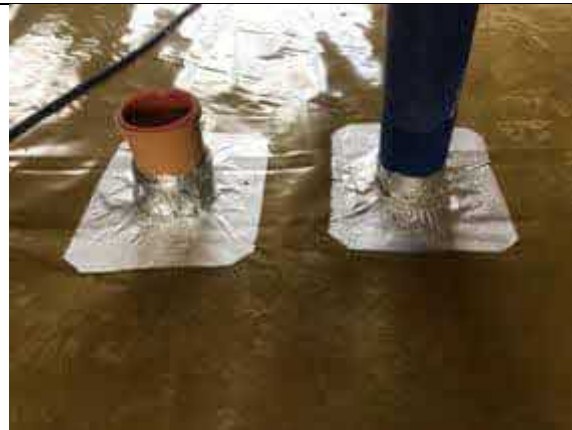
Plot 7 typical double pipe penetration seal using SAGM.

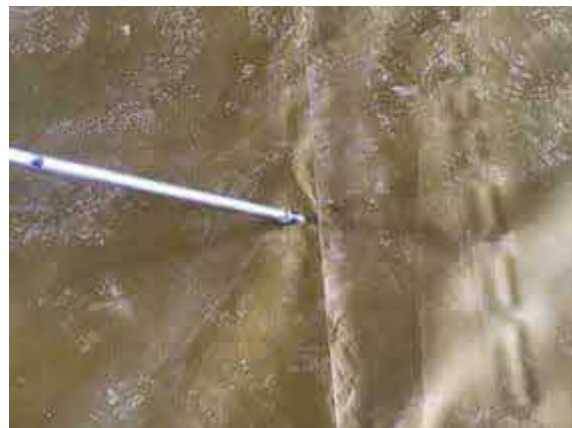
Plot 7 air lancing all welded membrane laps.

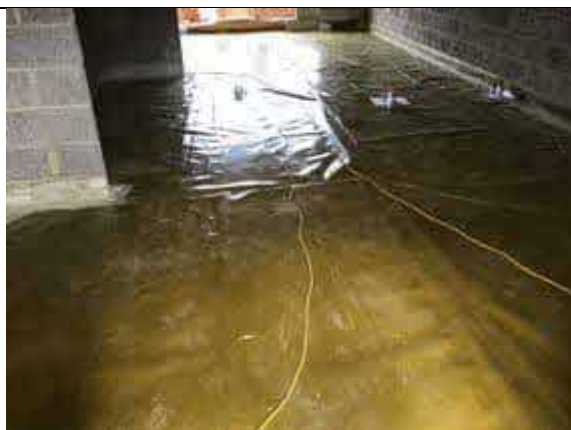
Plot 6 overview of installed membrane.

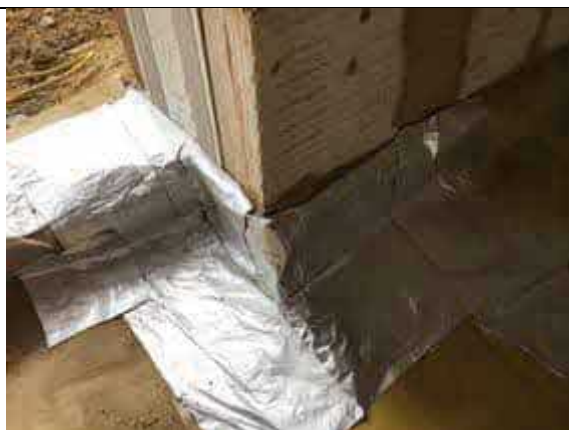
Plot 6 repaired door threshold detail using SAGM.

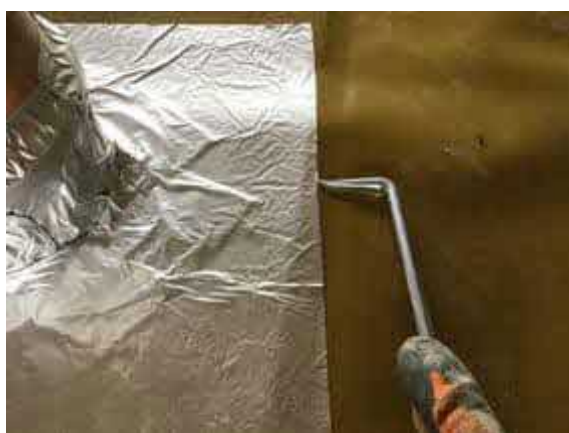
Plot 6 pick testing all SAGM detailing.

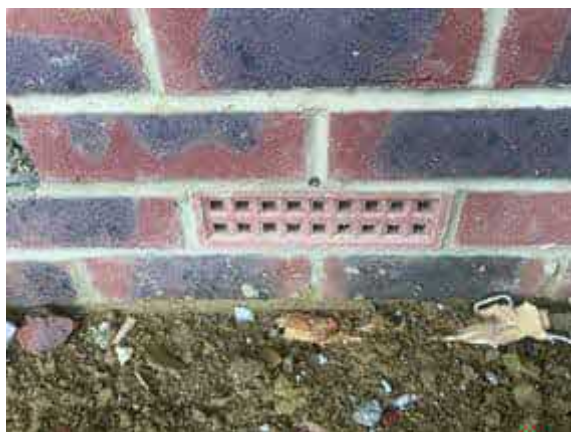
5no air bricks per plot were in place at the time of our inspection.

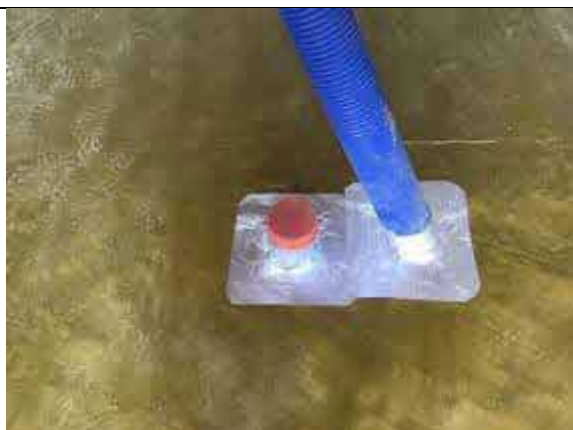
Plot 9 pipe penetrations sealed using SAGM

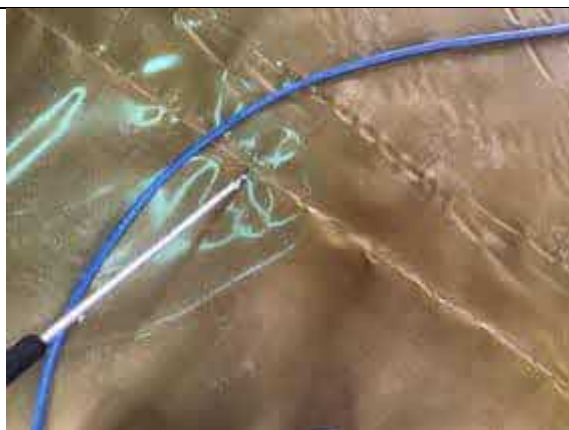
Plot 9 hand welded joint being air lanced

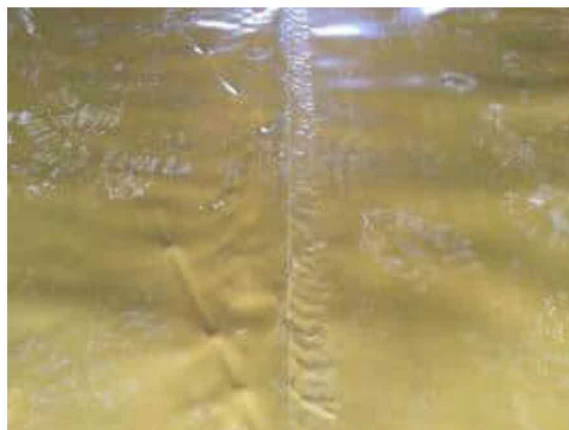
Overview looking down the hand welded lap joint.

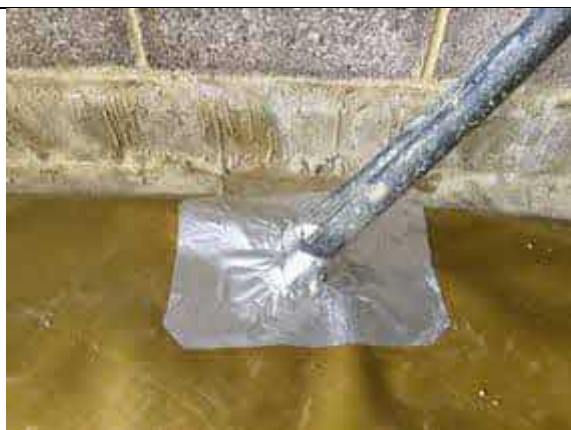
Pipe details within Plot 11 sealed with SAGM.

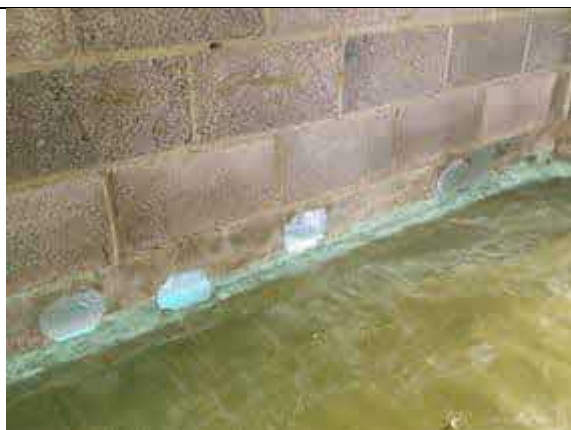
SAGM patches applied prior to inspection to the perimeter membrane within Plot 10.

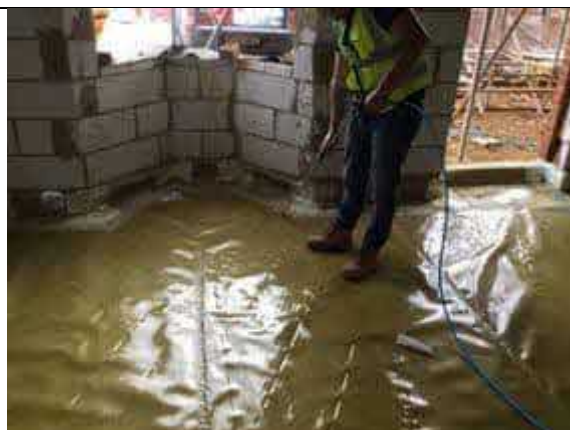
Air lance testing to Plot 10 lap joints.

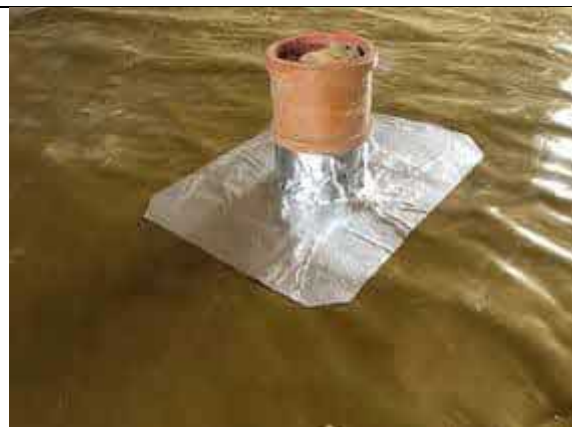
Plot 33 typical pipe penetration seal using SAGM.

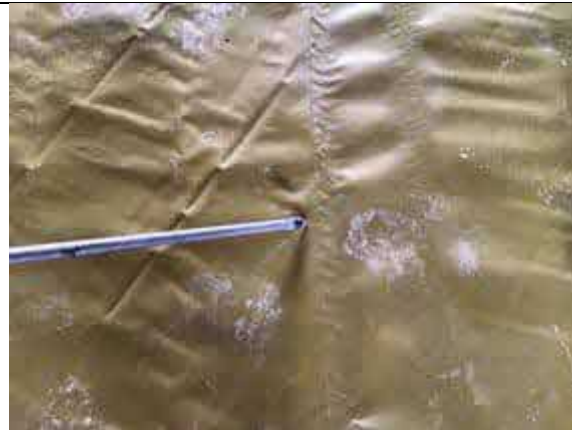
Plot 34 air lancing all welded membrane laps.

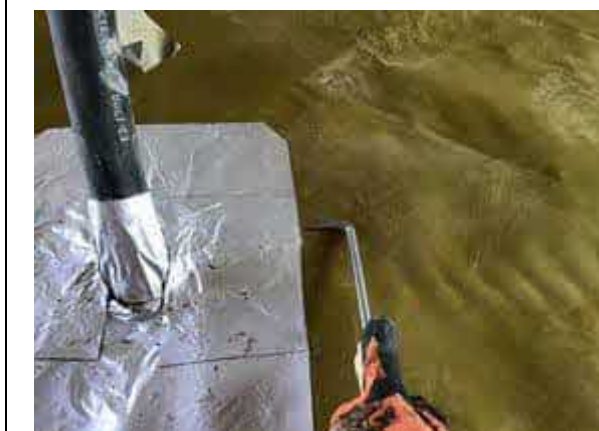
Plot 35 pick testing all SAGM detailing.

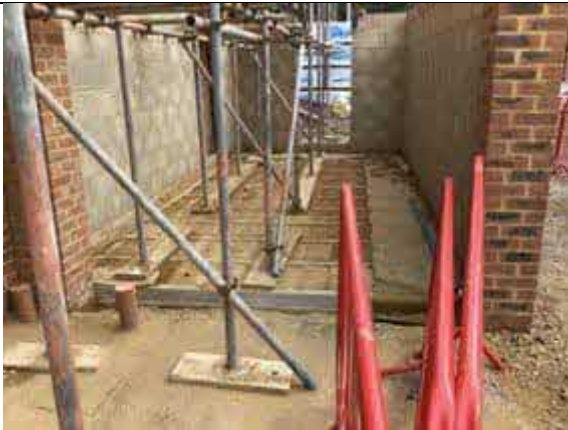
Plot 35 attached garage incomplete at the time of our inspection.

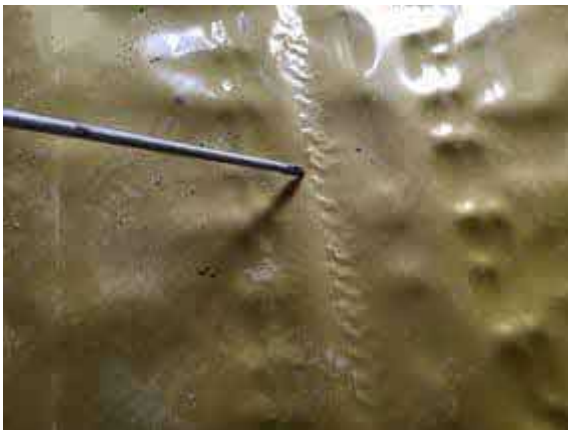
Plot 32 air lancing all welded membrane laps.

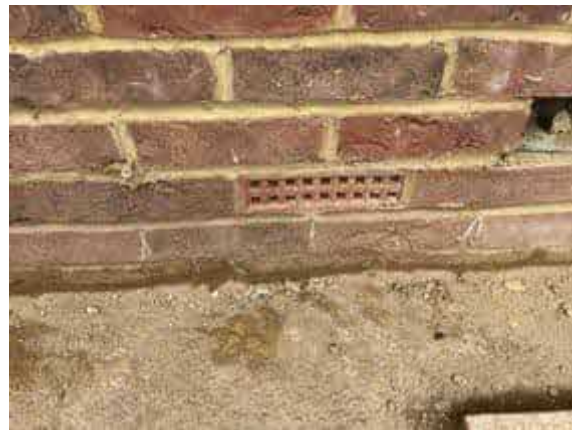
Plot 32 air brick in place at the time of our inspection.

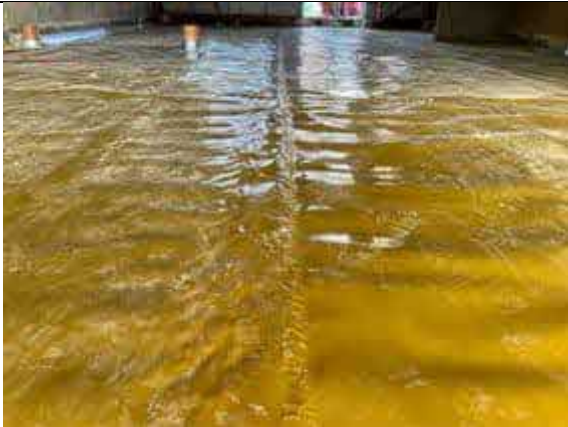
Plot 29 - Successfully hand welded membrane lap joint.

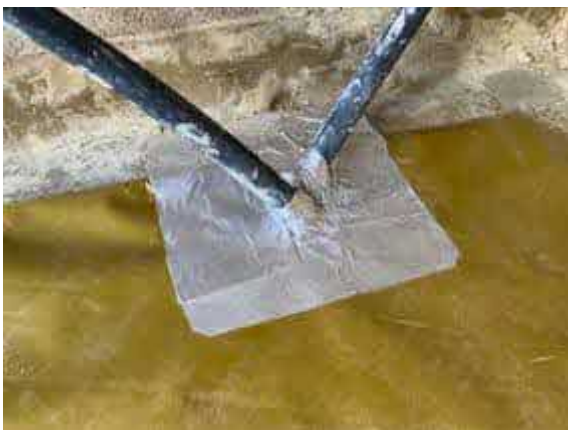
Plot 29 - Pipe penetration's sealed using SAGM.

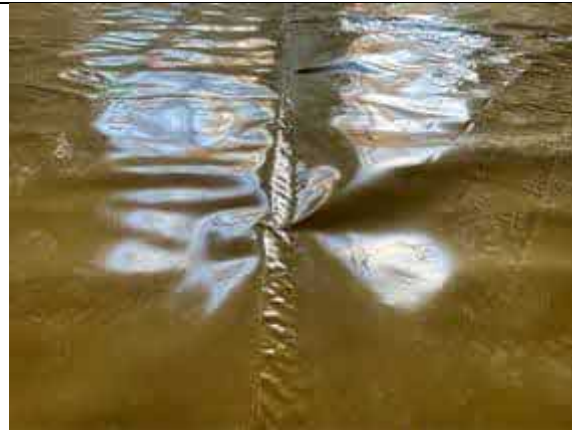
Plot 30 - Hand welded membrane lap joint.

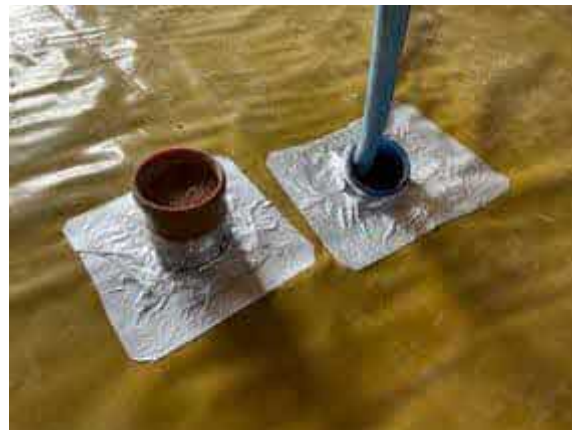
Plot 30 - Typical pipe penetration's sealed using SAGM.

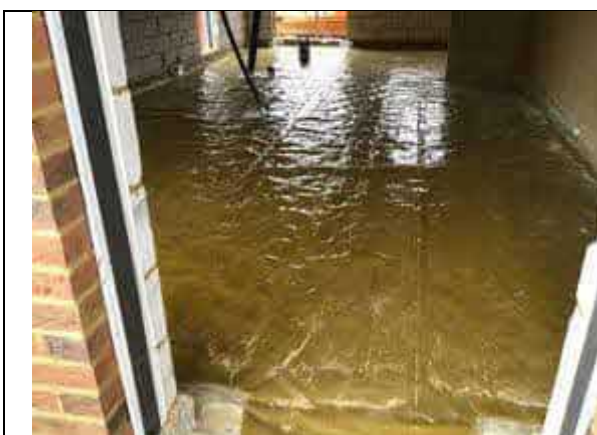
Overview of installed membrane to plot 27.

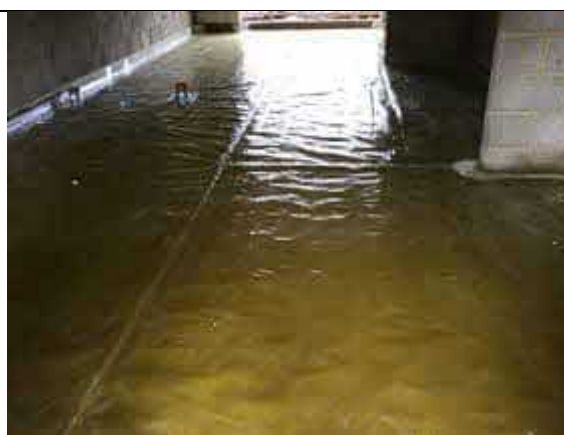
Overview of installed membrane to plot 28.

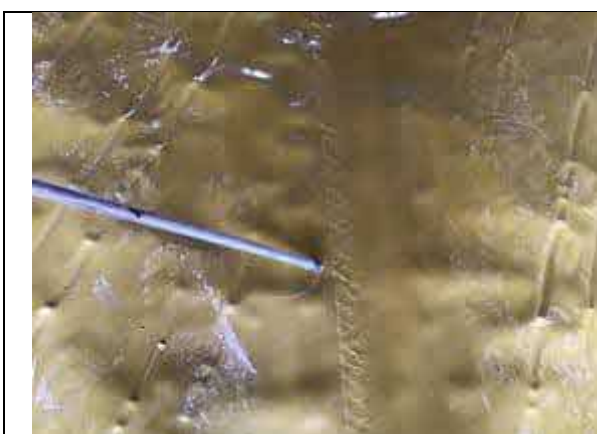
Plot 27 air lancing all weld laps.

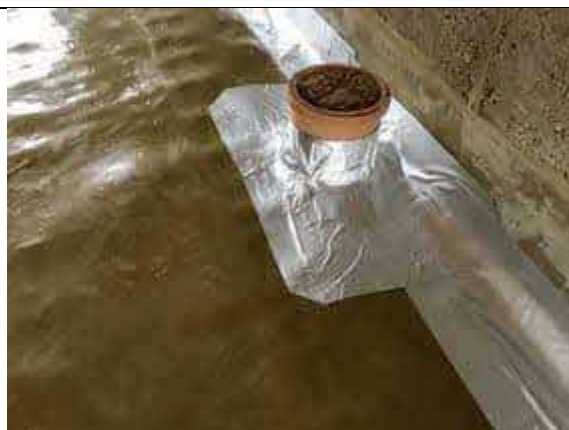
Plot 28 typical pipe penetration seal using SAGM.

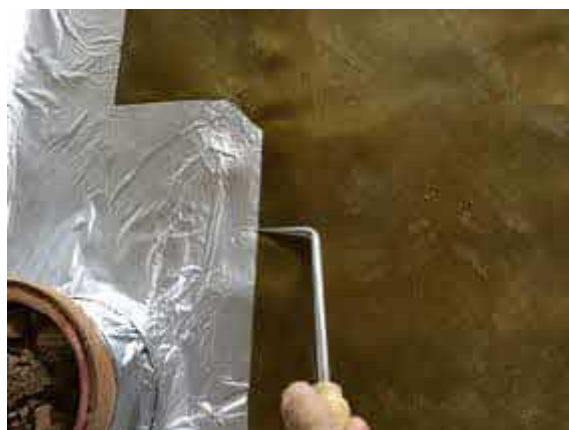
Plot 28 pick testing all SAGM detailing.

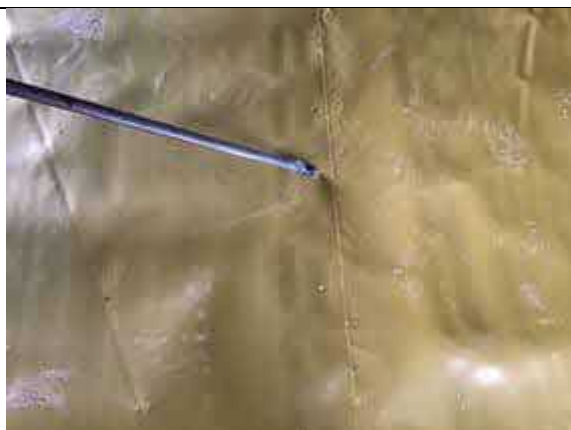
Air lancing all welded membrane laps.

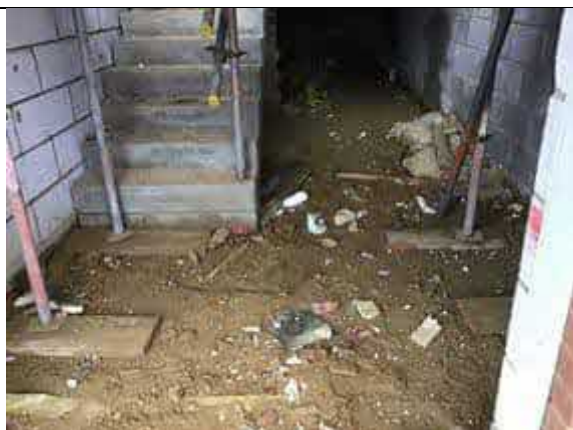
Incomplete stair lobby.

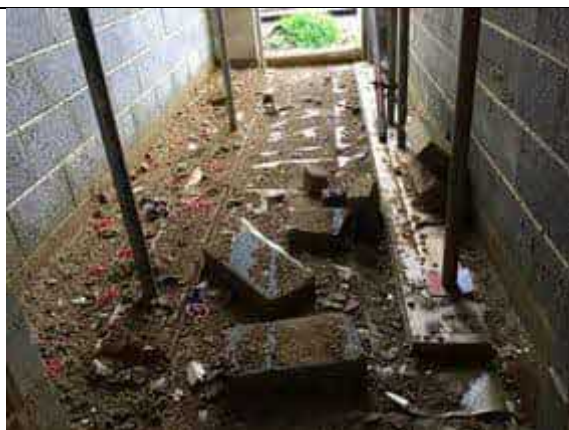
Incomplete cycle store.

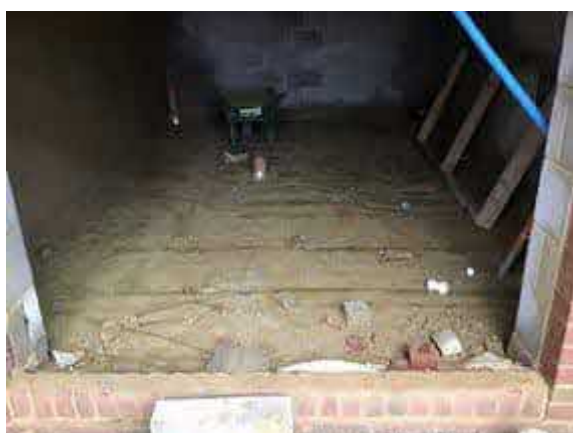
Incomplete bin store.

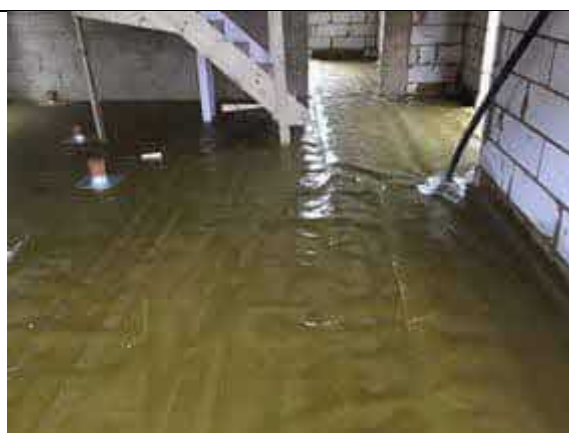
Overview of installed membrane to plot 36.

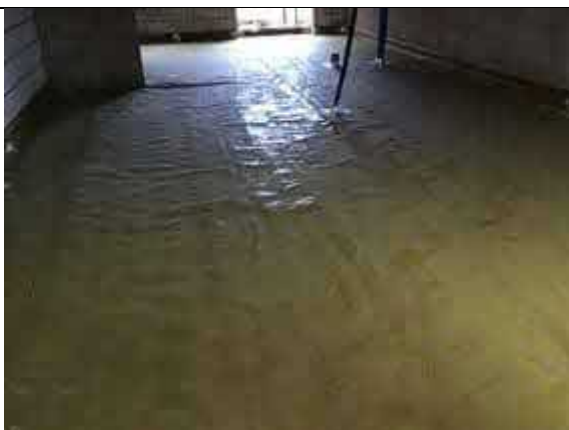
Overview of installed membrane to plot 37.

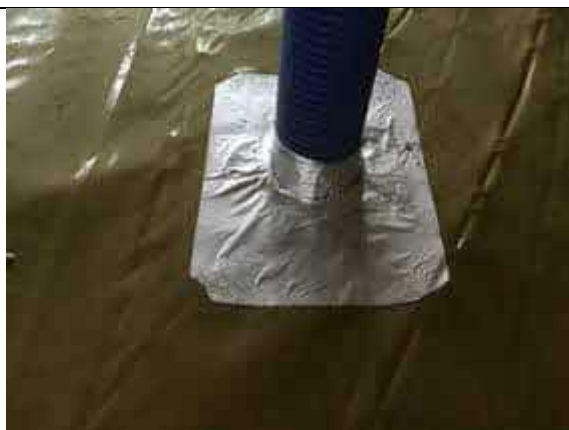
Typical pipe penetration seal using SAGM to plot 37.

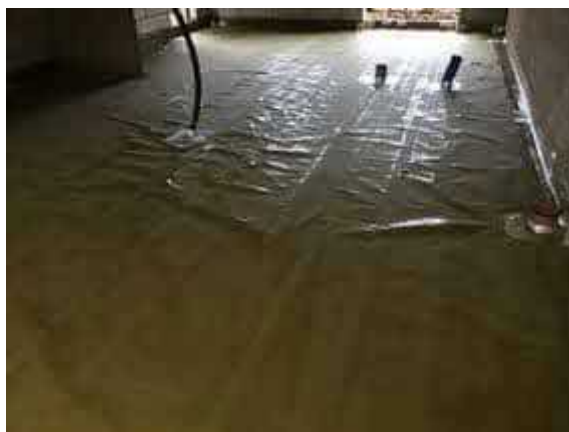
Typical pipe penetration seal using SAGM to plot 39.

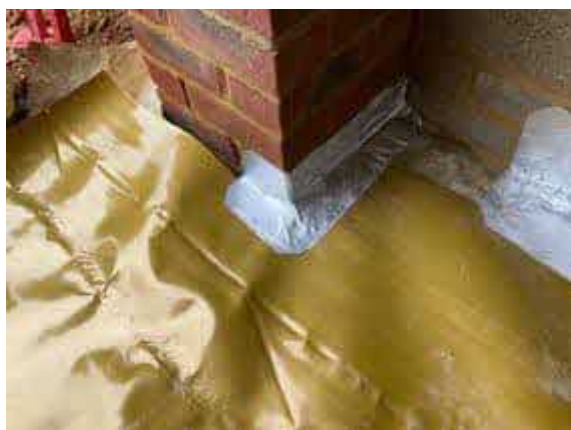
Overview of Visqueen HC Blok infill installation to Plot 72.

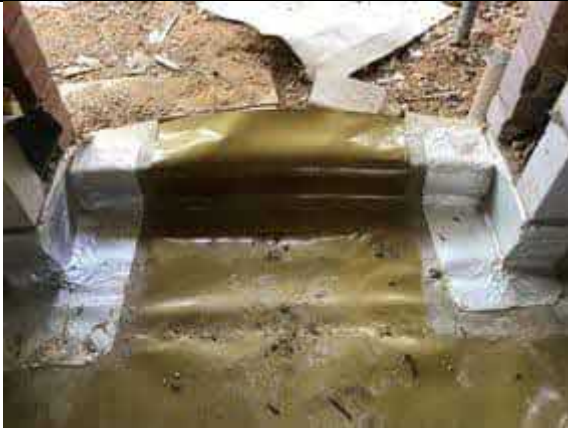
Sealed door threshold using SAGM.

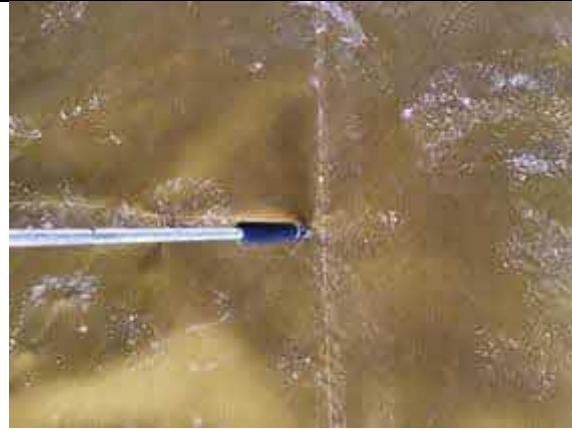
Air lancing all hand welded membrane laps.

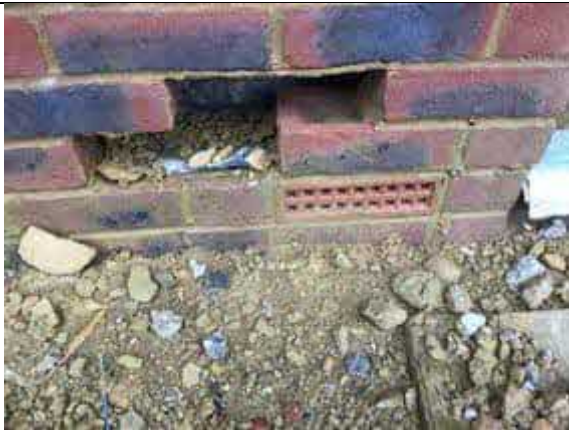
Air brick in place at the time of our inspection to plot 49.

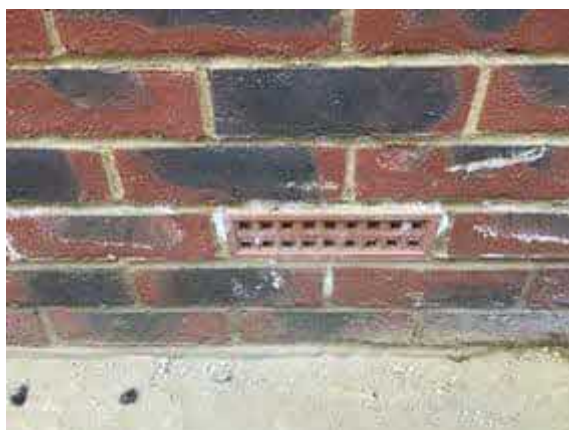
Air brick in place at the time of our inspection to plot 65.

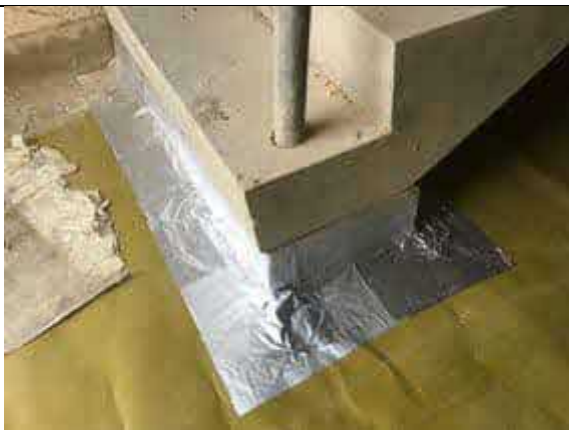
Retro fit detail using SAGM to the base of the concrete stairs in apartment block b.

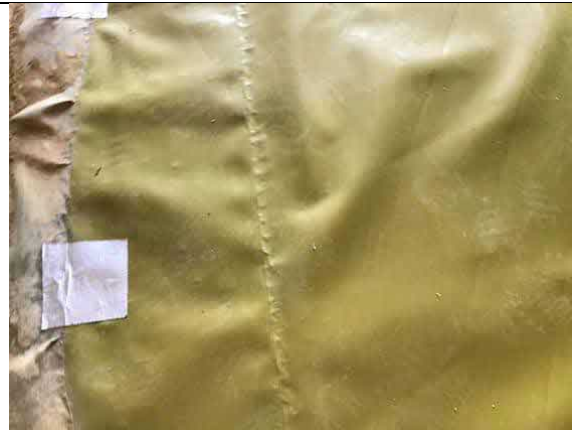
Hand welded membrane lap in garage plot 40.

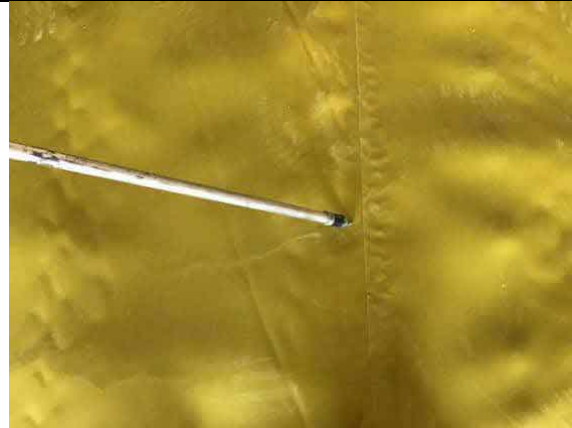
Air lancing all hand welded membrane laps in apartment block H.

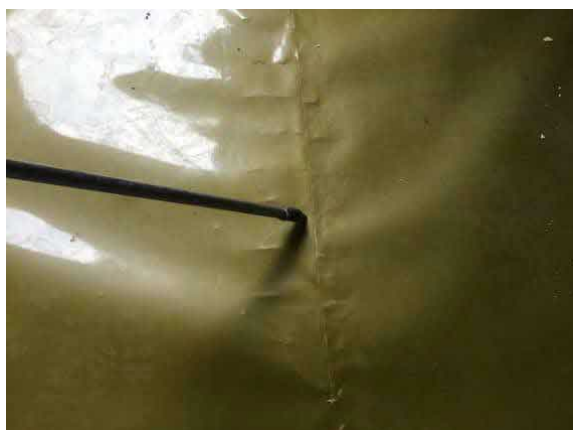
Air lancing all hand welded membrane laps.

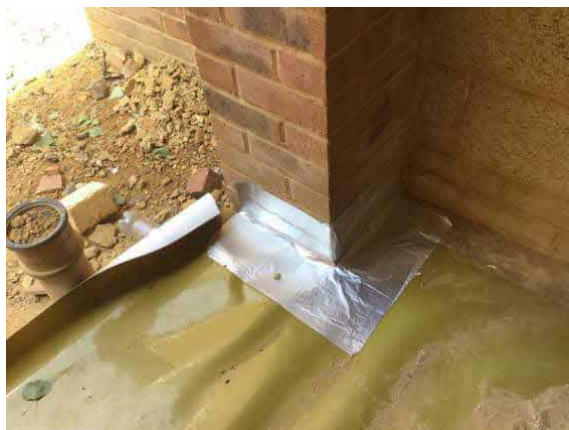
Sealed front of garage using SAGM.

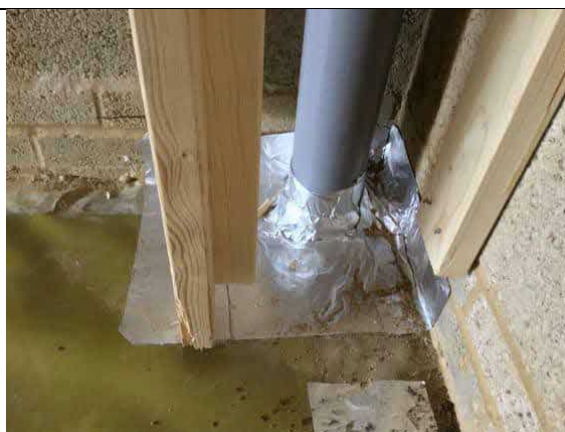
Sealed pipe penetration using SAGM to the rear of the garage plot 45.

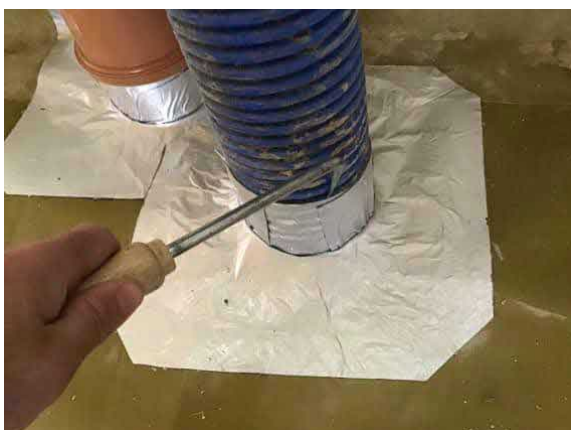
Pick testing all SAGM detailing in plot 52.

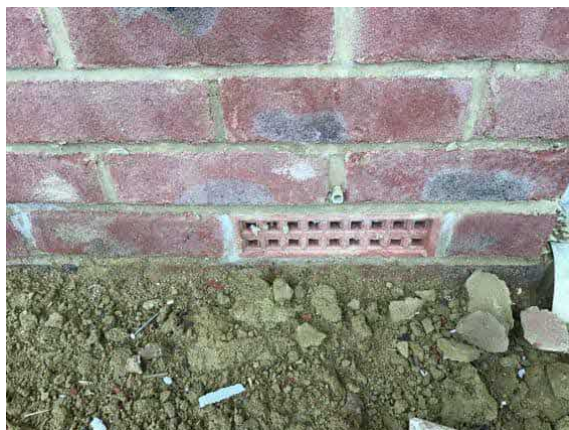
Air brick in place at the time of our inspection to plots 51-53.

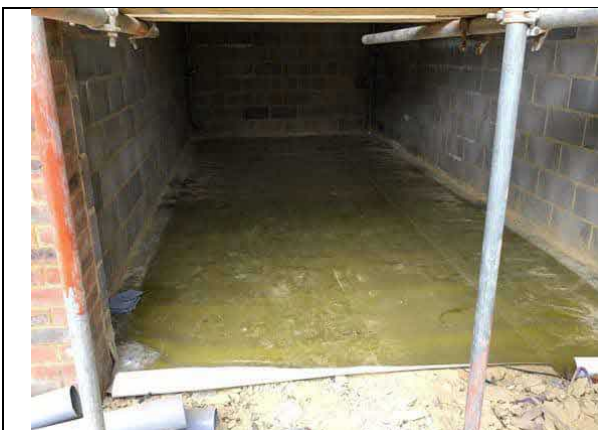
Overview of installed membrane in garage plot 63.

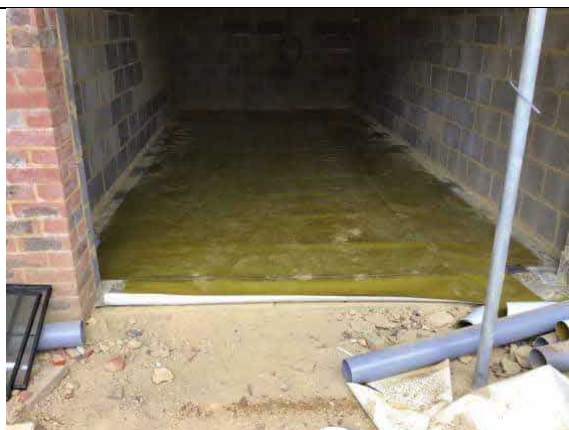
Overview of installed membrane in garage plot 64.

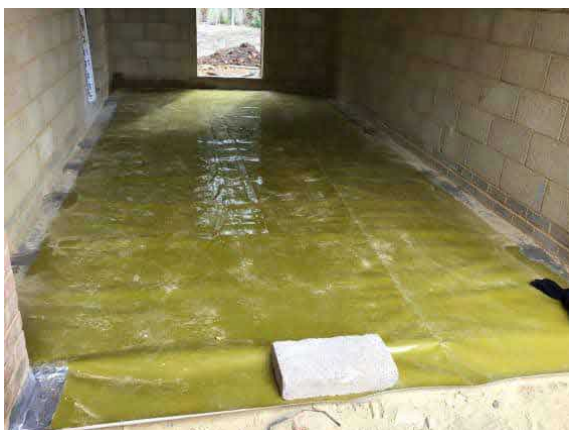
Overview of installed membrane in garage plot 67.
