Asbestos Inspection Report

DR Bejan roohi (home partners group limited)

Frenches Farm, Wigley Bush Lane, South Weald, Brentwood, Essex

Demolition Survey

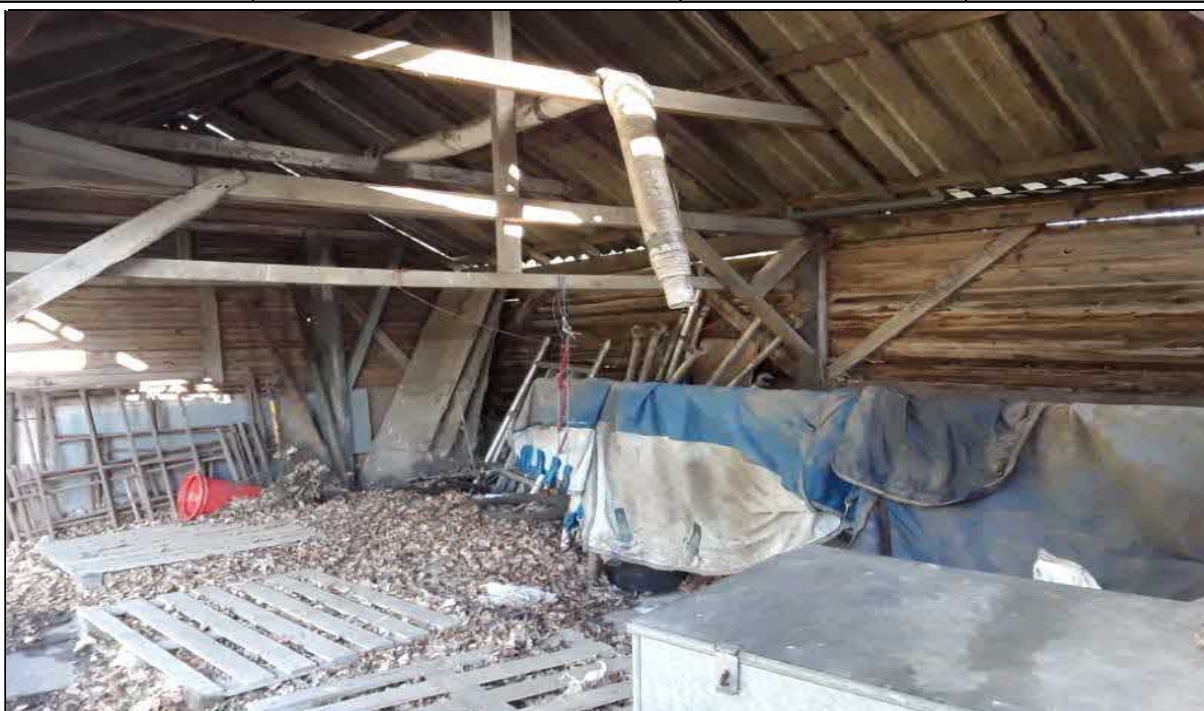
SAMPLE REFERENCE	Item No: 2	ASBESTOS	N/A
PRESUMPTION REFERENCE	N/A	RISK LEVEL	N/A

AREA	Internal	MATERIAL ASSESSMENT	
FLOOR	Ground Floor	PRODUCT TYPE	N/A
UNIQUE ROOM IDENTIFIER	Barn 1	DAMAGE	N/A
DESCRIPTION OF SAMPLE TAKEN OR PRESUMPTION	No suspect materials found	SURFACE TREATMENT	N/A
EXTENT	N/A	ASBESTOS TYPE	N/A
ACCESSIBILITY	N/A	MATERIAL ASSESSMENT SCORE	N/A
LEVEL OF IDENTIFICATION	N/A	POTENTIAL TO RELEASE FIBRES	N/A
RECOMMENDATIONS	COMMENTS

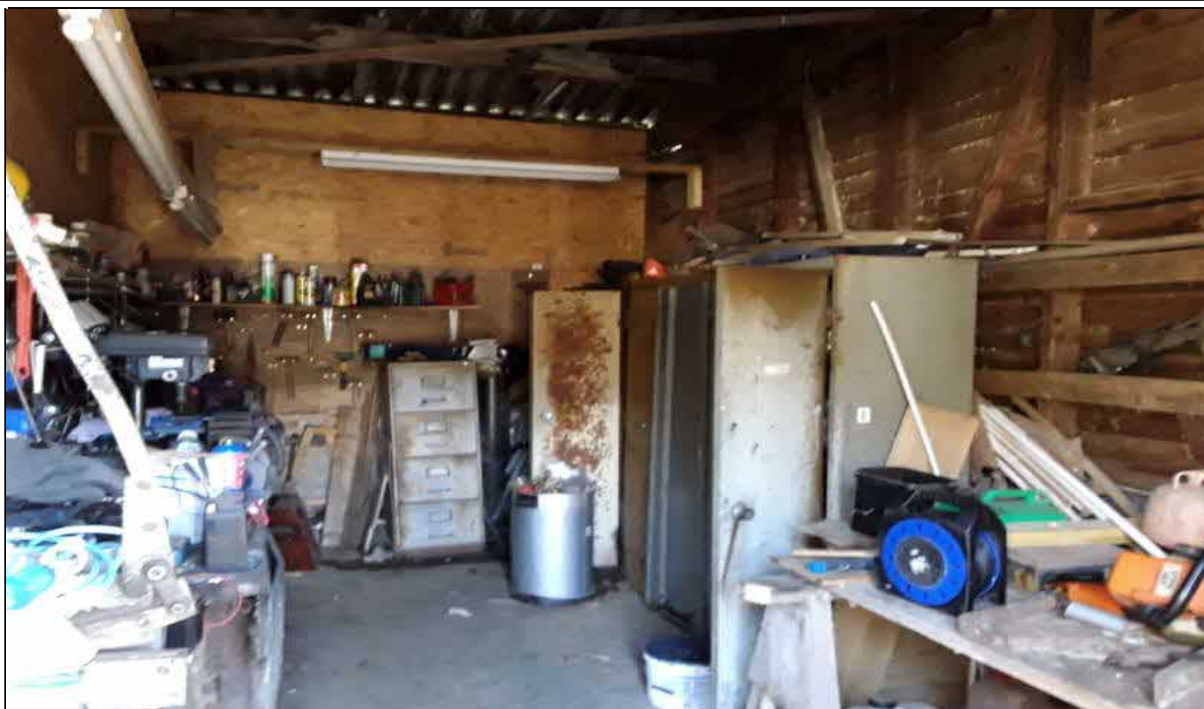
SAMPLE REFERENCE	Item No: 4	ASBESTOS	N/A
PRESUMPTION REFERENCE	N/A	RISK LEVEL	N/A

AREA	Internal	MATERIAL ASSESSMENT	
FLOOR	Ground Floor	PRODUCT TYPE	N/A
UNIQUE ROOM IDENTIFIER	Barn 2 room 1	DAMAGE	N/A
DESCRIPTION OF SAMPLE TAKEN OR PRESUMPTION	No suspect materials found	SURFACE TREATMENT	N/A
EXTENT	N/A	ASBESTOS TYPE	N/A
ACCESSIBILITY	N/A	MATERIAL ASSESSMENT SCORE	N/A
LEVEL OF IDENTIFICATION	N/A	POTENTIAL TO RELEASE FIBRES	N/A
RECOMMENDATIONS	COMMENTS

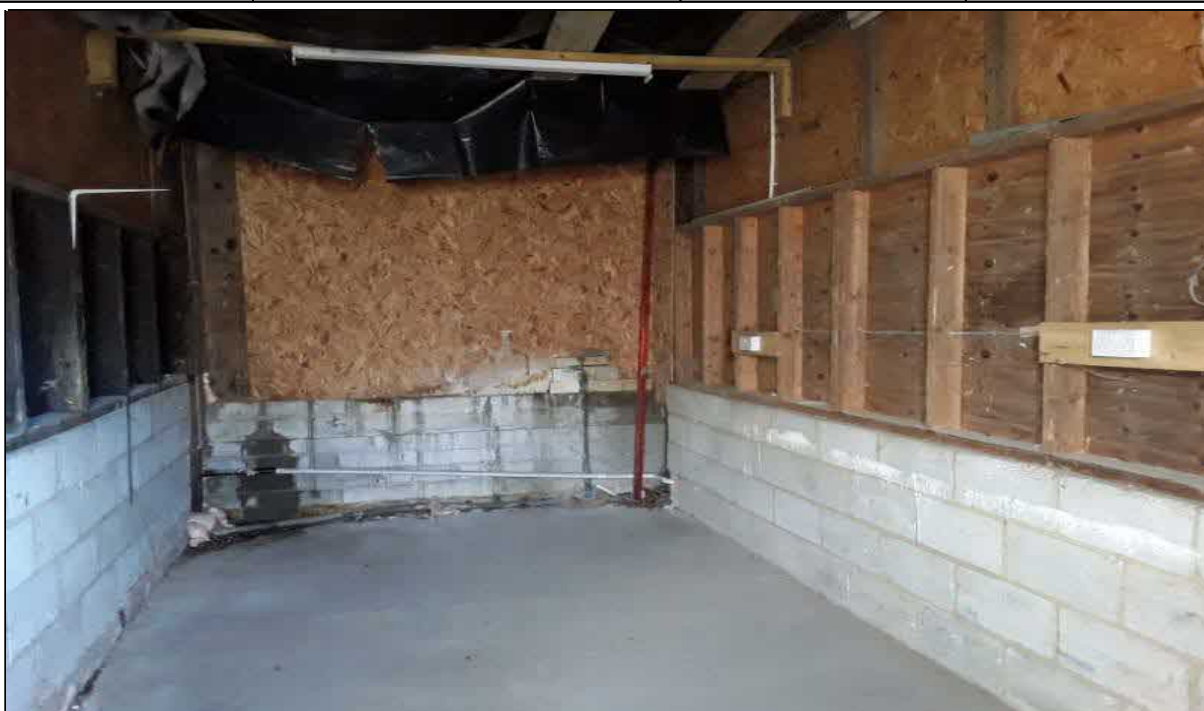
SAMPLE REFERENCE	Item No: 5	ASBESTOS	N/A
PRESUMPTION REFERENCE	N/A	RISK LEVEL	N/A

AREA	Internal	MATERIAL ASSESSMENT	
FLOOR	Ground Floor	PRODUCT TYPE	N/A
UNIQUE ROOM IDENTIFIER	Barn 2 room 2	DAMAGE	N/A
DESCRIPTION OF SAMPLE TAKEN OR PRESUMPTION	No suspect materials found	SURFACE TREATMENT	N/A
EXTENT	N/A	ASBESTOS TYPE	N/A
ACCESSIBILITY	N/A	MATERIAL ASSESSMENT SCORE	N/A
LEVEL OF IDENTIFICATION	N/A	POTENTIAL TO RELEASE FIBRES	N/A
RECOMMENDATIONS	COMMENTS

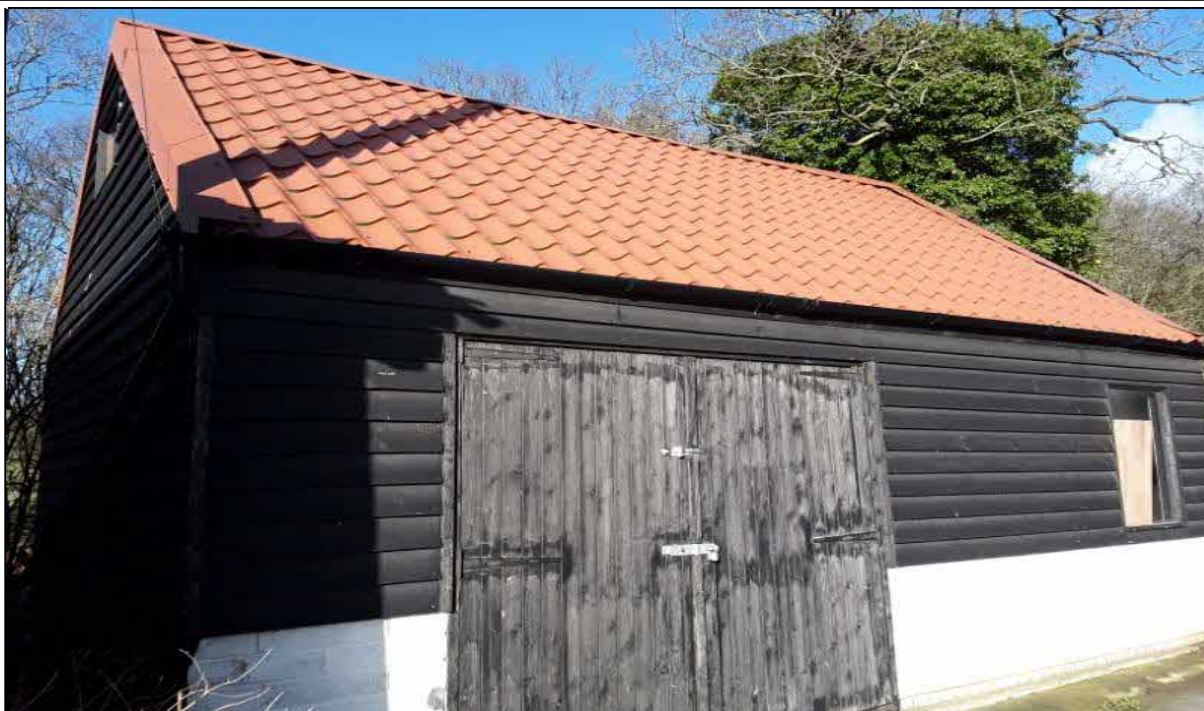
SAMPLE REFERENCE	Item No: 6	ASBESTOS	N/A
PRESUMPTION REFERENCE	N/A	RISK LEVEL	N/A

AREA	External	MATERIAL ASSESSMENT	
FLOOR	External	PRODUCT TYPE	N/A
UNIQUE ROOM IDENTIFIER	Barn 3	DAMAGE	N/A
DESCRIPTION OF SAMPLE TAKEN OR PRESUMPTION	No suspect materials found	SURFACE TREATMENT	N/A
EXTENT	N/A	ASBESTOS TYPE	N/A
ACCESSIBILITY	N/A	MATERIAL ASSESSMENT SCORE	N/A
LEVEL OF IDENTIFICATION	N/A	POTENTIAL TO RELEASE FIBRES	N/A
RECOMMENDATIONS	COMMENTS

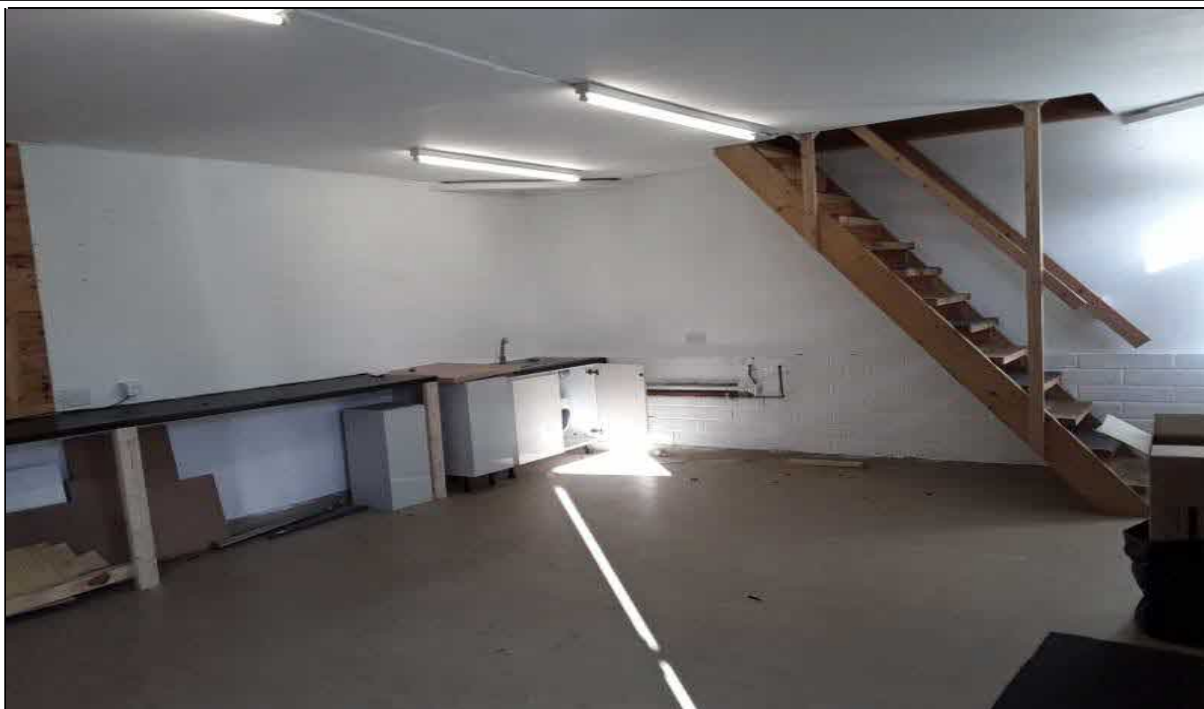
SAMPLE REFERENCE	Item No: 7	ASBESTOS	N/A
PRESUMPTION REFERENCE	N/A	RISK LEVEL	N/A

AREA	Internal	MATERIAL ASSESSMENT	
FLOOR	Ground Floor	PRODUCT TYPE	N/A
UNIQUE ROOM IDENTIFIER	Barn 3	DAMAGE	N/A
DESCRIPTION OF SAMPLE TAKEN OR PRESUMPTION	No suspect materials found	SURFACE TREATMENT	N/A
EXTENT	N/A	ASBESTOS TYPE	N/A
ACCESSIBILITY	N/A	MATERIAL ASSESSMENT SCORE	N/A
LEVEL OF IDENTIFICATION	N/A	POTENTIAL TO RELEASE FIBRES	N/A
RECOMMENDATIONS	COMMENTS

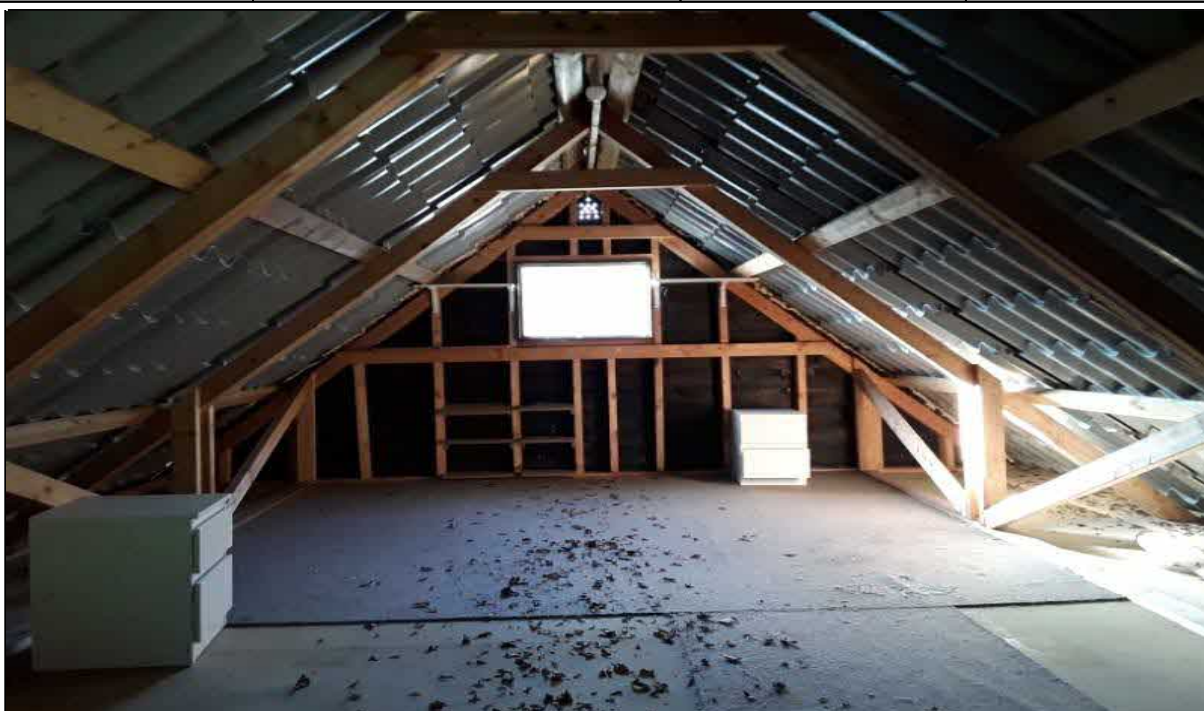
SAMPLE REFERENCE	Item No: 8	ASBESTOS	N/A
PRESUMPTION REFERENCE	N/A	RISK LEVEL	N/A

AREA	Internal	MATERIAL ASSESSMENT	
FLOOR	1st Floor	PRODUCT TYPE	N/A
UNIQUE ROOM IDENTIFIER	Barn 3	DAMAGE	N/A
DESCRIPTION OF SAMPLE TAKEN OR PRESUMPTION	No suspect materials found	SURFACE TREATMENT	N/A
EXTENT	N/A	ASBESTOS TYPE	N/A
ACCESSIBILITY	N/A	MATERIAL ASSESSMENT SCORE	N/A
LEVEL OF IDENTIFICATION	N/A	POTENTIAL TO RELEASE FIBRES	N/A
RECOMMENDATIONS		COMMENTS

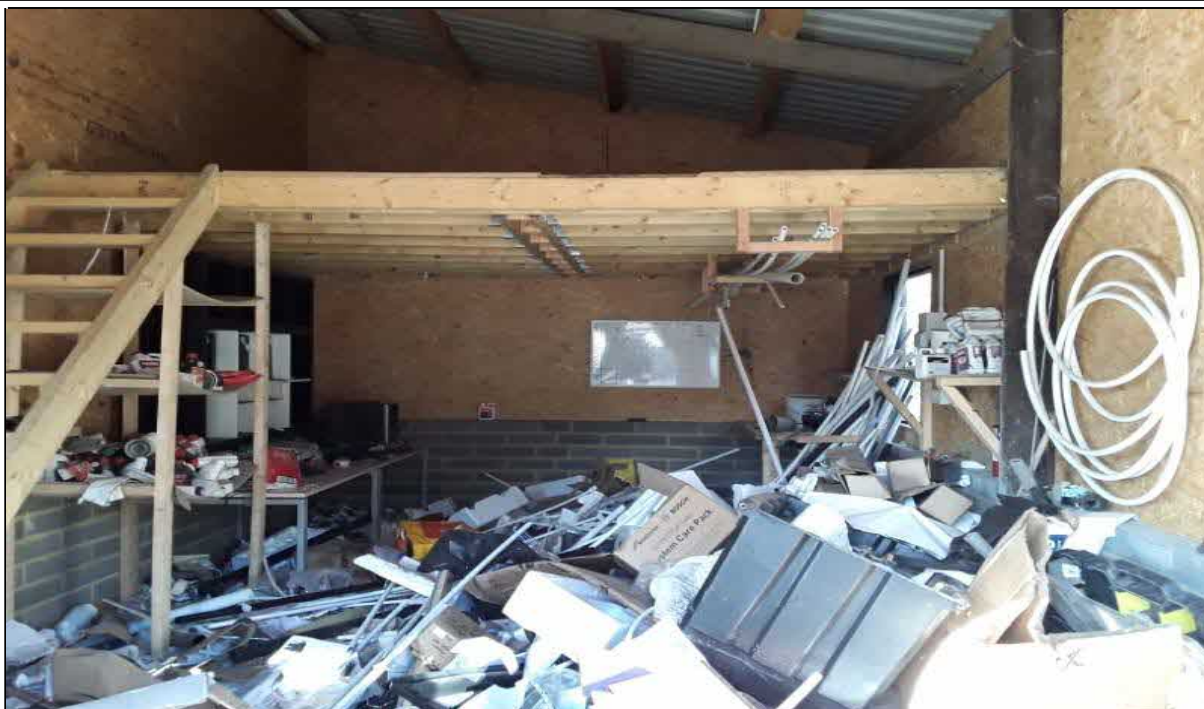
SAMPLE REFERENCE	Item No: 11	ASBESTOS	N/A
PRESUMPTION REFERENCE	N/A	RISK LEVEL	N/A

AREA	Internal	MATERIAL ASSESSMENT	
FLOOR	Ground Floor	PRODUCT TYPE	N/A
UNIQUE ROOM IDENTIFIER	Barn 4 room 1	DAMAGE	N/A
DESCRIPTION OF SAMPLE TAKEN OR PRESUMPTION	No suspect materials found	SURFACE TREATMENT	N/A
EXTENT	N/A	ASBESTOS TYPE	N/A
ACCESSIBILITY	N/A	MATERIAL ASSESSMENT SCORE	N/A
LEVEL OF IDENTIFICATION	N/A	POTENTIAL TO RELEASE FIBRES	N/A
RECOMMENDATIONS	COMMENTS

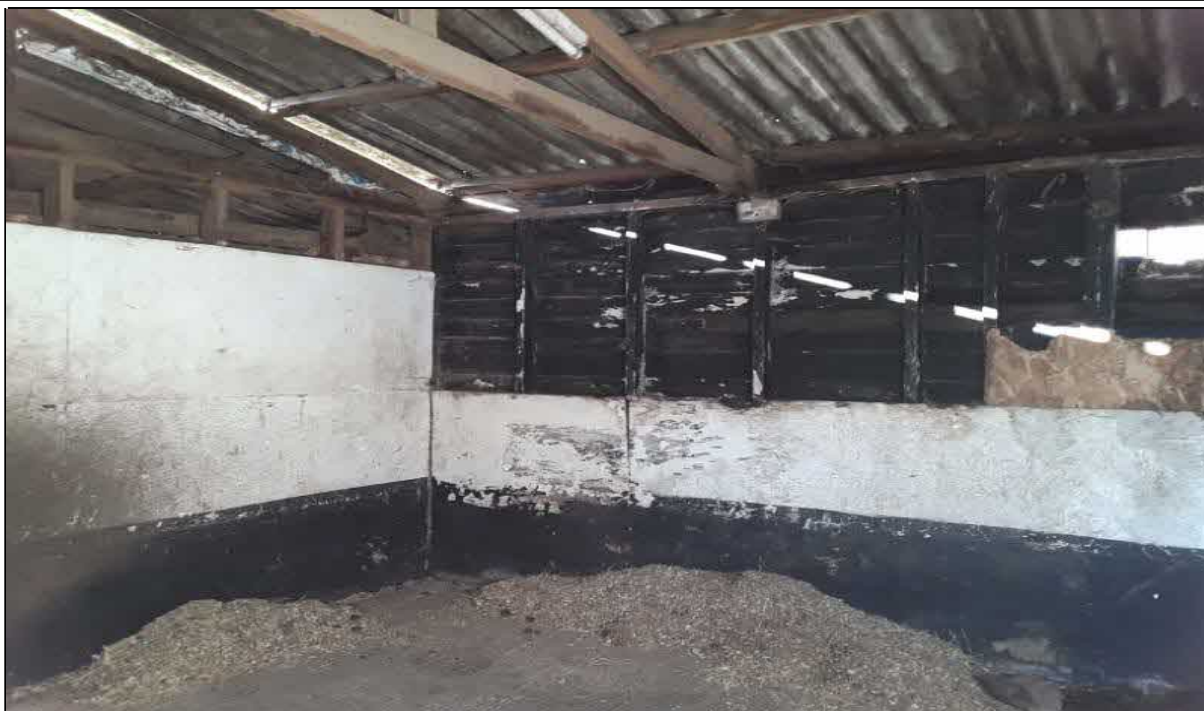
SAMPLE REFERENCE	Item No: 13	ASBESTOS	N/A
PRESUMPTION REFERENCE	N/A	RISK LEVEL	N/A

AREA	Internal	MATERIAL ASSESSMENT	
FLOOR	Ground Floor	PRODUCT TYPE	N/A
UNIQUE ROOM IDENTIFIER	Stables 1	DAMAGE	N/A
DESCRIPTION OF SAMPLE TAKEN OR PRESUMPTION	No suspect materials found	SURFACE TREATMENT	N/A
EXTENT	N/A	ASBESTOS TYPE	N/A
ACCESSIBILITY	N/A	MATERIAL ASSESSMENT SCORE	N/A
LEVEL OF IDENTIFICATION	N/A	POTENTIAL TO RELEASE FIBRES	N/A
RECOMMENDATIONS		COMMENTS

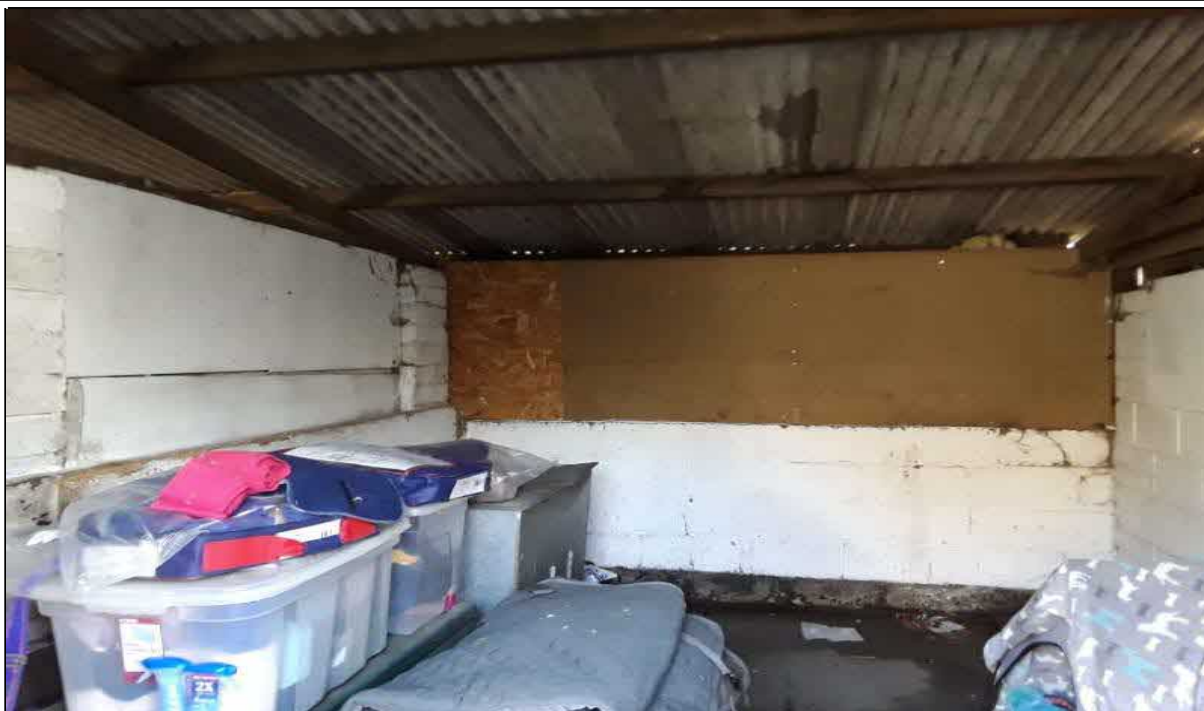
SAMPLE REFERENCE	Item No: 14	ASBESTOS	N/A
PRESUMPTION REFERENCE	N/A	RISK LEVEL	N/A

AREA	Internal	MATERIAL ASSESSMENT	
FLOOR	Ground Floor	PRODUCT TYPE	N/A
UNIQUE ROOM IDENTIFIER	Stables 2	DAMAGE	N/A
DESCRIPTION OF SAMPLE TAKEN OR PRESUMPTION	No suspect materials found	SURFACE TREATMENT	N/A
EXTENT	N/A	ASBESTOS TYPE	N/A
ACCESSIBILITY	N/A	MATERIAL ASSESSMENT SCORE	N/A
LEVEL OF IDENTIFICATION	N/A	POTENTIAL TO RELEASE FIBRES	N/A
RECOMMENDATIONS	COMMENTS

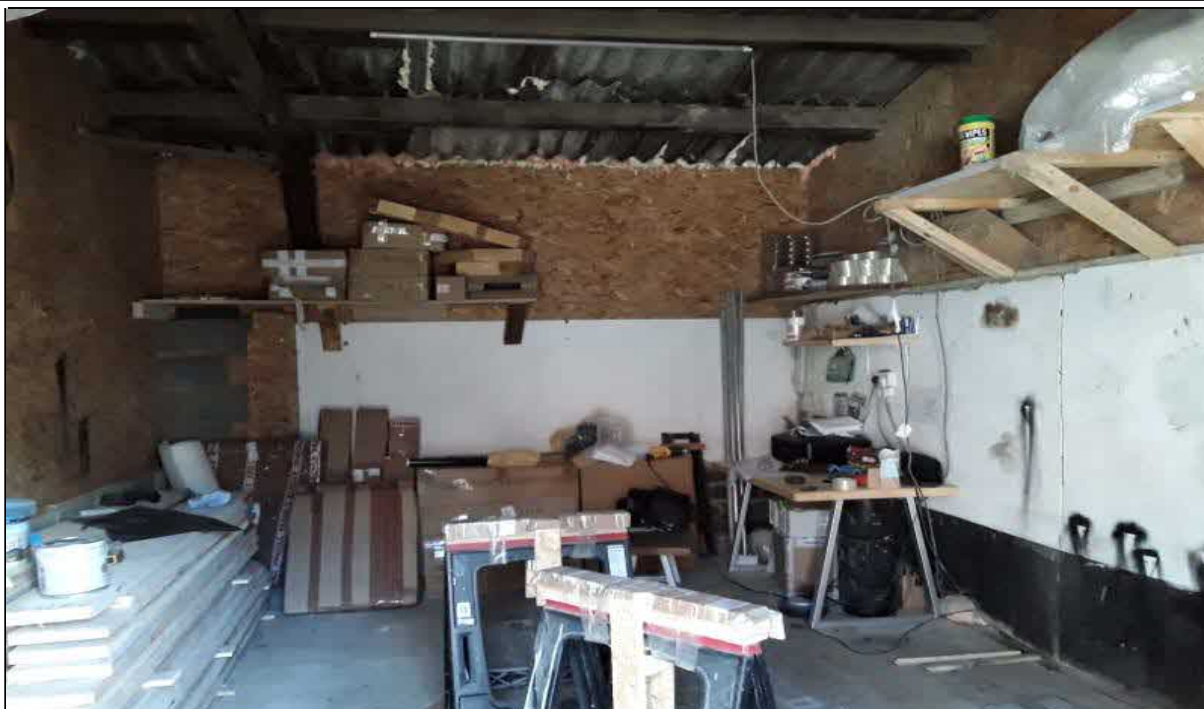
SAMPLE REFERENCE	Item No: 15	ASBESTOS	N/A
PRESUMPTION REFERENCE	N/A	RISK LEVEL	N/A

AREA	Internal	MATERIAL ASSESSMENT	
FLOOR	Ground Floor	PRODUCT TYPE	N/A
UNIQUE ROOM IDENTIFIER	Barn 2 room 4	DAMAGE	N/A
DESCRIPTION OF SAMPLE TAKEN OR PRESUMPTION	No suspect materials found	SURFACE TREATMENT	N/A
EXTENT	N/A	ASBESTOS TYPE	N/A
ACCESSIBILITY	N/A	MATERIAL ASSESSMENT SCORE	N/A
LEVEL OF IDENTIFICATION	N/A	POTENTIAL TO RELEASE FIBRES	N/A
RECOMMENDATIONS	COMMENTS

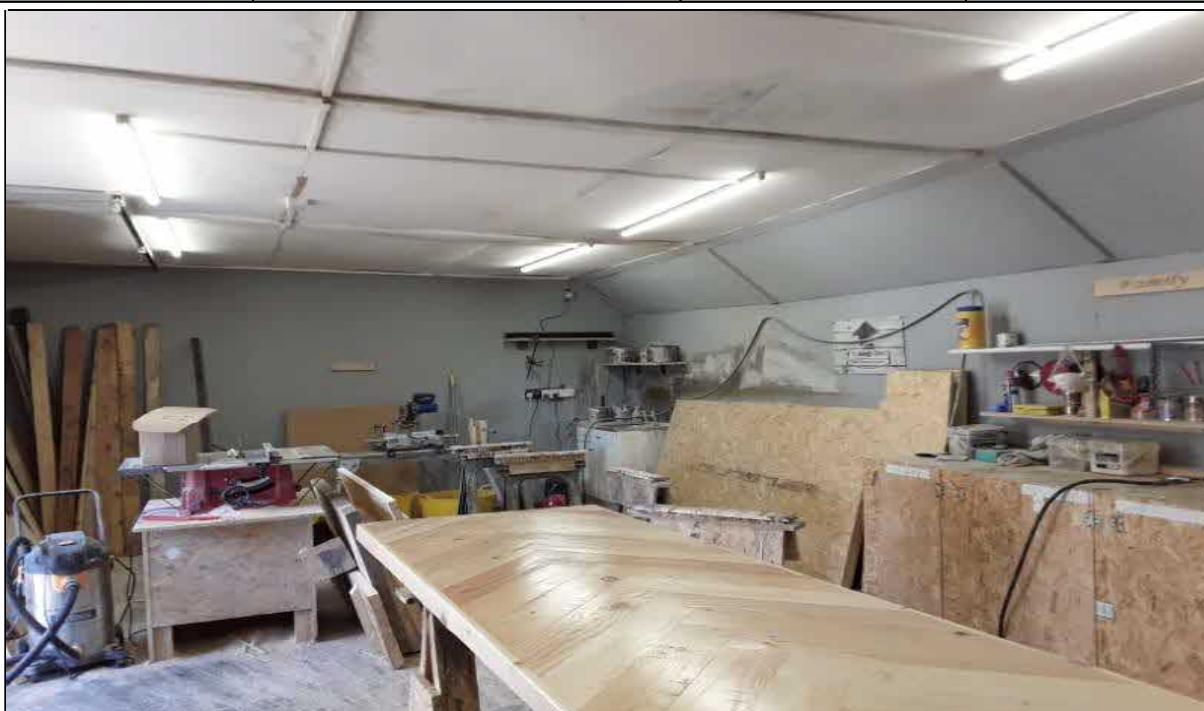
SAMPLE REFERENCE	Item No: 16	ASBESTOS	N/A
PRESUMPTION REFERENCE	N/A	RISK LEVEL	N/A

AREA	Internal	MATERIAL ASSESSMENT	
FLOOR	Ground Floor	PRODUCT TYPE	N/A
UNIQUE ROOM IDENTIFIER	Barn 2 room 3	DAMAGE	N/A
DESCRIPTION OF SAMPLE TAKEN OR PRESUMPTION	No suspect materials found	SURFACE TREATMENT	N/A
EXTENT	N/A	ASBESTOS TYPE	N/A
ACCESSIBILITY	N/A	MATERIAL ASSESSMENT SCORE	N/A
LEVEL OF IDENTIFICATION	N/A	POTENTIAL TO RELEASE FIBRES	N/A
RECOMMENDATIONS		COMMENTS

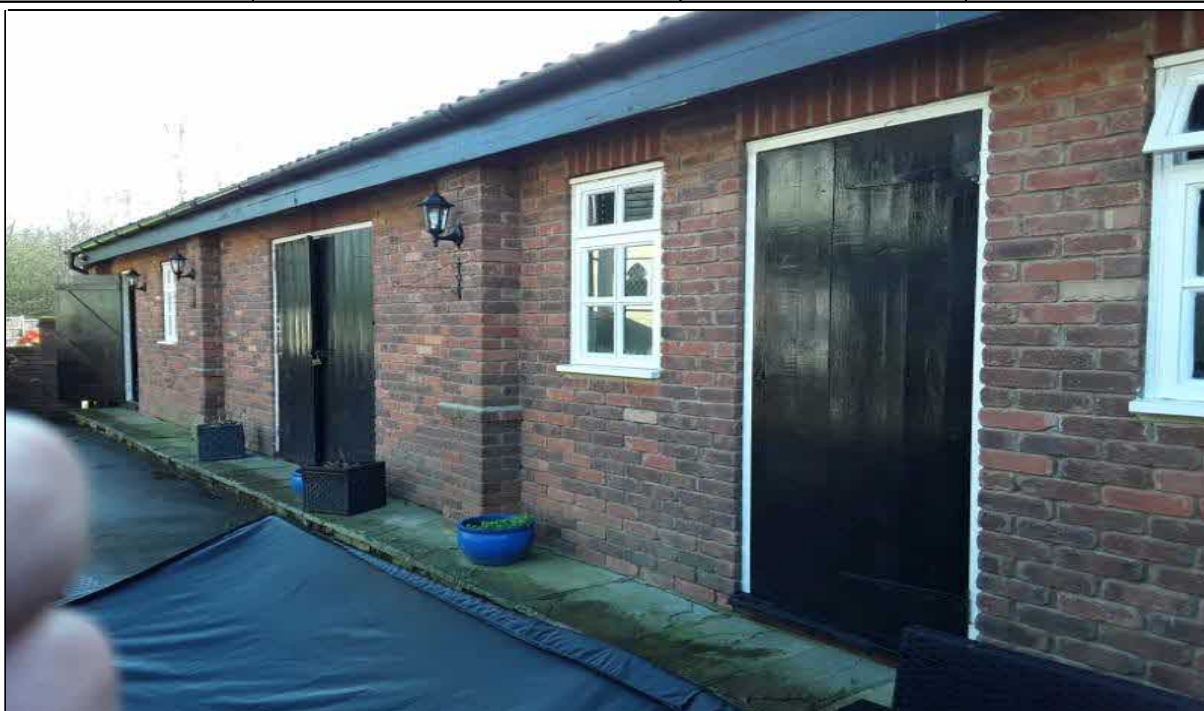
SAMPLE REFERENCE	Item No: 18	ASBESTOS	N/A
PRESUMPTION REFERENCE	N/A	RISK LEVEL	N/A

AREA	External	MATERIAL ASSESSMENT	
FLOOR	External	PRODUCT TYPE	N/A
UNIQUE ROOM IDENTIFIER	Offices	DAMAGE	N/A
DESCRIPTION OF SAMPLE TAKEN OR PRESUMPTION	No suspect materials found	SURFACE TREATMENT	N/A
EXTENT	N/A	ASBESTOS TYPE	N/A
ACCESSIBILITY	N/A	MATERIAL ASSESSMENT SCORE	N/A
LEVEL OF IDENTIFICATION	N/A	POTENTIAL TO RELEASE FIBRES	N/A
RECOMMENDATIONS	COMMENTS

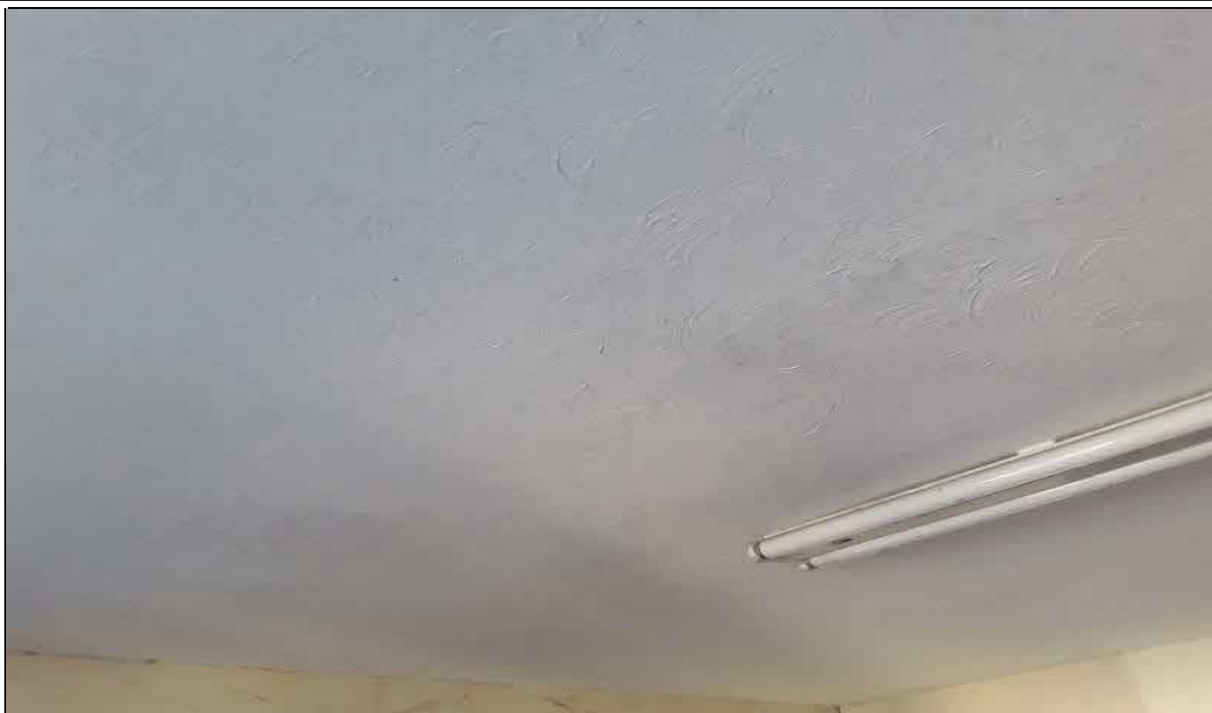
SAMPLE REFERENCE	CH000723	ASBESTOS	NO
PRESUMPTION REFERENCE	N/A	RISK LEVEL	N/A

AREA	Internal	MATERIAL ASSESSMENT	
FLOOR	Ground Floor	PRODUCT TYPE	0 - NADIS
UNIQUE ROOM IDENTIFIER	Offices room 1	DAMAGE	0 - NADIS
DESCRIPTION OF SAMPLE TAKEN OR PRESUMPTION	Textured coat Ceiling	SURFACE TREATMENT	0 - NADIS
EXTENT	16 Sq. m	ASBESTOS TYPE	0 - NADIS
ACCESSIBILITY	Low	MATERIAL ASSESSMENT SCORE	0
LEVEL OF IDENTIFICATION	Sampled	POTENTIAL TO RELEASE FIBRES	N/A
RECOMMENDATIONS No Further Action Required		COMMENTS No Asbestos Detected in Sample

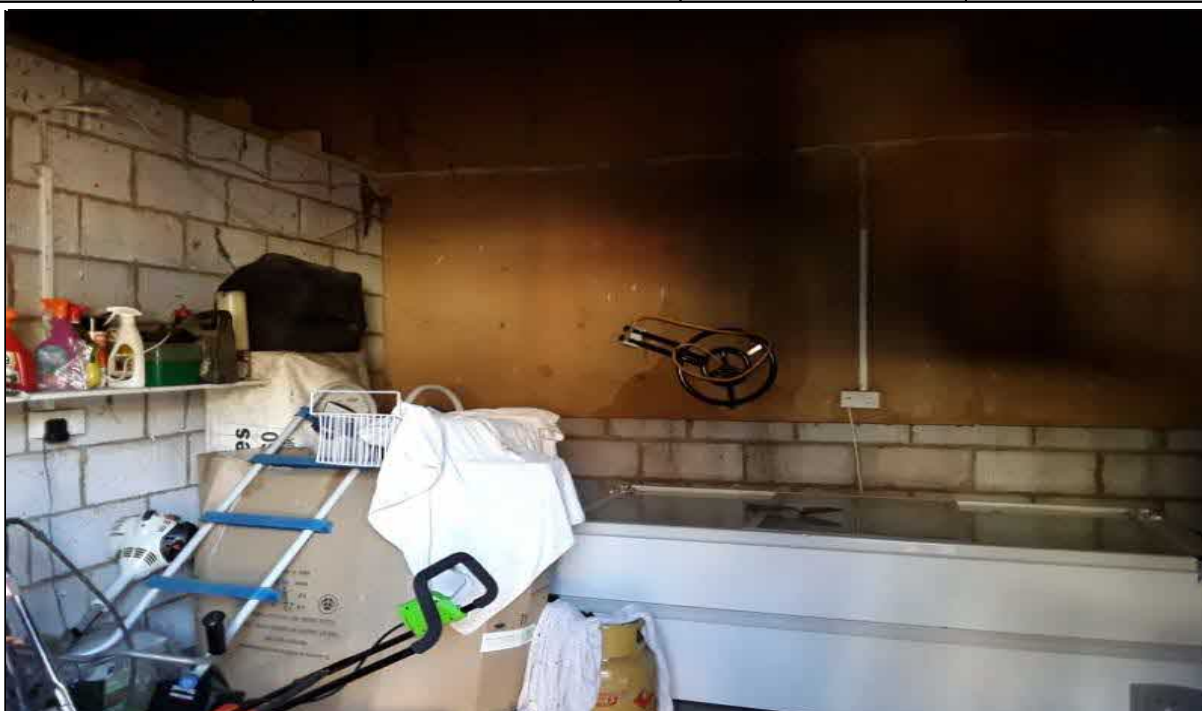
SAMPLE REFERENCE	Item No: 20	ASBESTOS	N/A
PRESUMPTION REFERENCE	N/A	RISK LEVEL	N/A

AREA	Internal	MATERIAL ASSESSMENT	
FLOOR	Ground Floor	PRODUCT TYPE	N/A
UNIQUE ROOM IDENTIFIER	Office room 2	DAMAGE	N/A
DESCRIPTION OF SAMPLE TAKEN OR PRESUMPTION	No suspect materials found	SURFACE TREATMENT	N/A
EXTENT	N/A	ASBESTOS TYPE	N/A
ACCESSIBILITY	N/A	MATERIAL ASSESSMENT SCORE	N/A
LEVEL OF IDENTIFICATION	N/A	POTENTIAL TO RELEASE FIBRES	N/A
RECOMMENDATIONS	COMMENTS

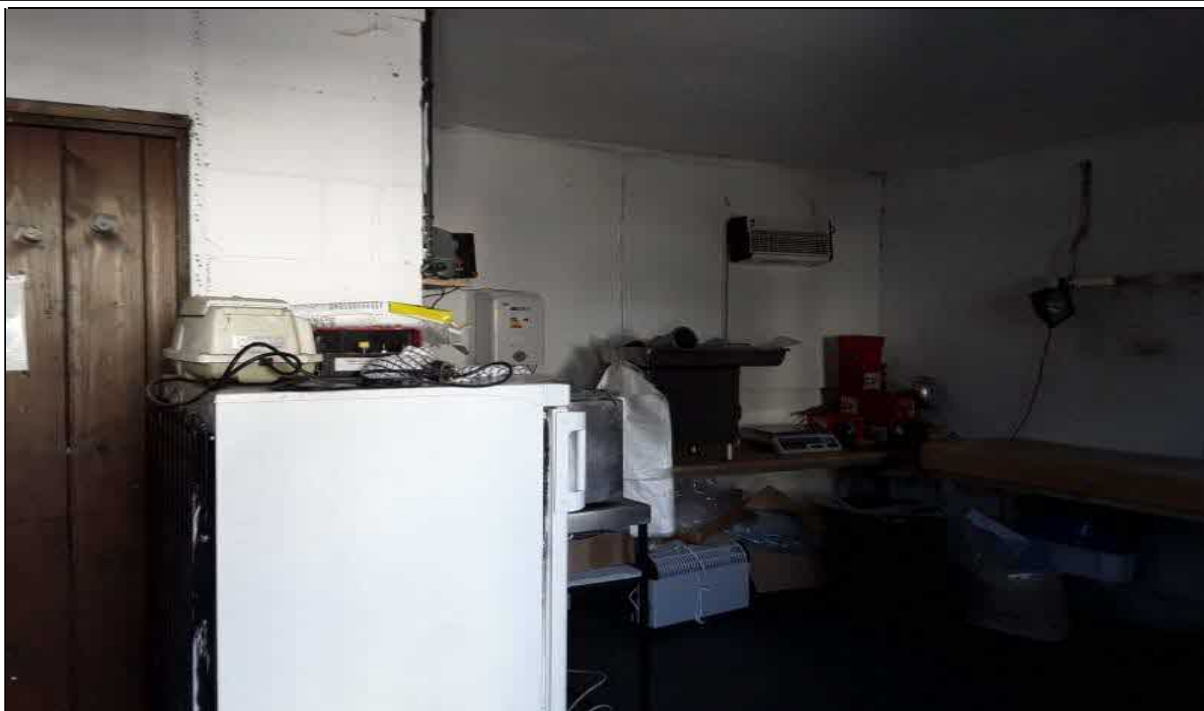
SAMPLE REFERENCE	Item No: 21	ASBESTOS	N/A
PRESUMPTION REFERENCE	N/A	RISK LEVEL	N/A

AREA	Internal	MATERIAL ASSESSMENT	
FLOOR	Ground Floor	PRODUCT TYPE	N/A
UNIQUE ROOM IDENTIFIER	Office room 3	DAMAGE	N/A
DESCRIPTION OF SAMPLE TAKEN OR PRESUMPTION	No suspect materials found	SURFACE TREATMENT	N/A
EXTENT	N/A	ASBESTOS TYPE	N/A
ACCESSIBILITY	N/A	MATERIAL ASSESSMENT SCORE	N/A
LEVEL OF IDENTIFICATION	N/A	POTENTIAL TO RELEASE FIBRES	N/A
RECOMMENDATIONS	COMMENTS

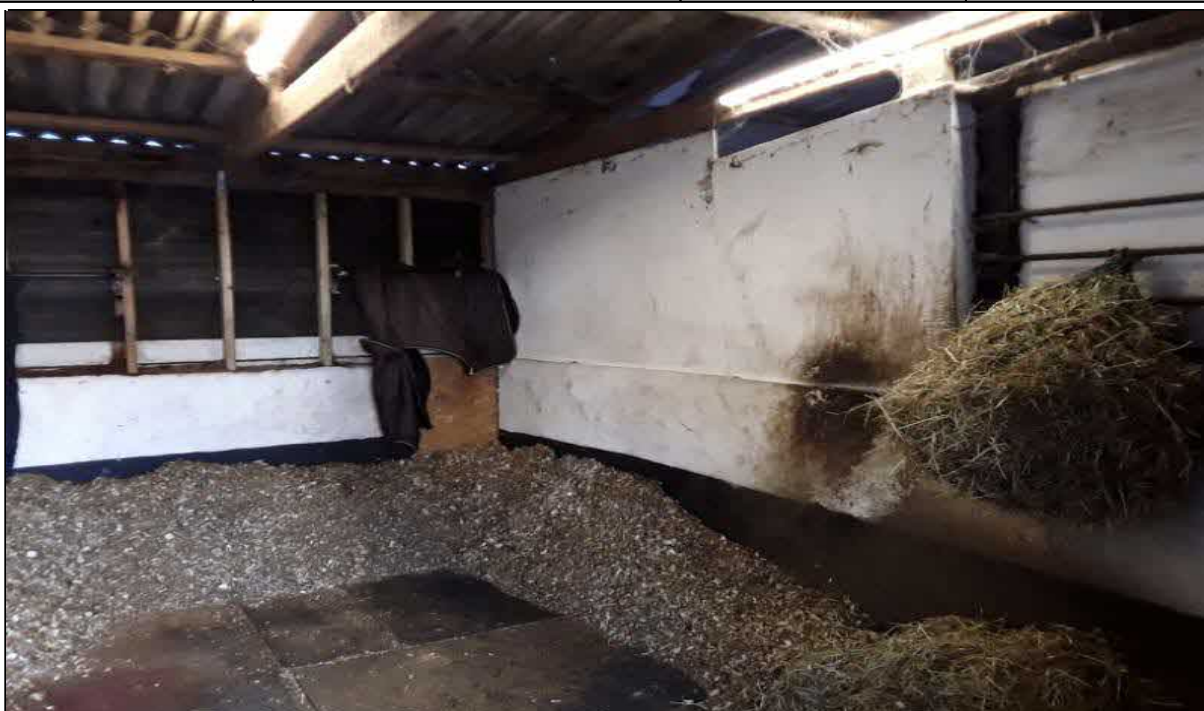
SAMPLE REFERENCE	Item No: 23	ASBESTOS	N/A
PRESUMPTION REFERENCE	N/A	RISK LEVEL	N/A

AREA	Internal	MATERIAL ASSESSMENT	
FLOOR	Ground Floor	PRODUCT TYPE	N/A
UNIQUE ROOM IDENTIFIER	Stables 3	DAMAGE	N/A
DESCRIPTION OF SAMPLE TAKEN OR PRESUMPTION	No suspect materials found	SURFACE TREATMENT	N/A
EXTENT	N/A	ASBESTOS TYPE	N/A
ACCESSIBILITY	N/A	MATERIAL ASSESSMENT SCORE	N/A
LEVEL OF IDENTIFICATION	N/A	POTENTIAL TO RELEASE FIBRES	N/A
RECOMMENDATIONS	COMMENTS

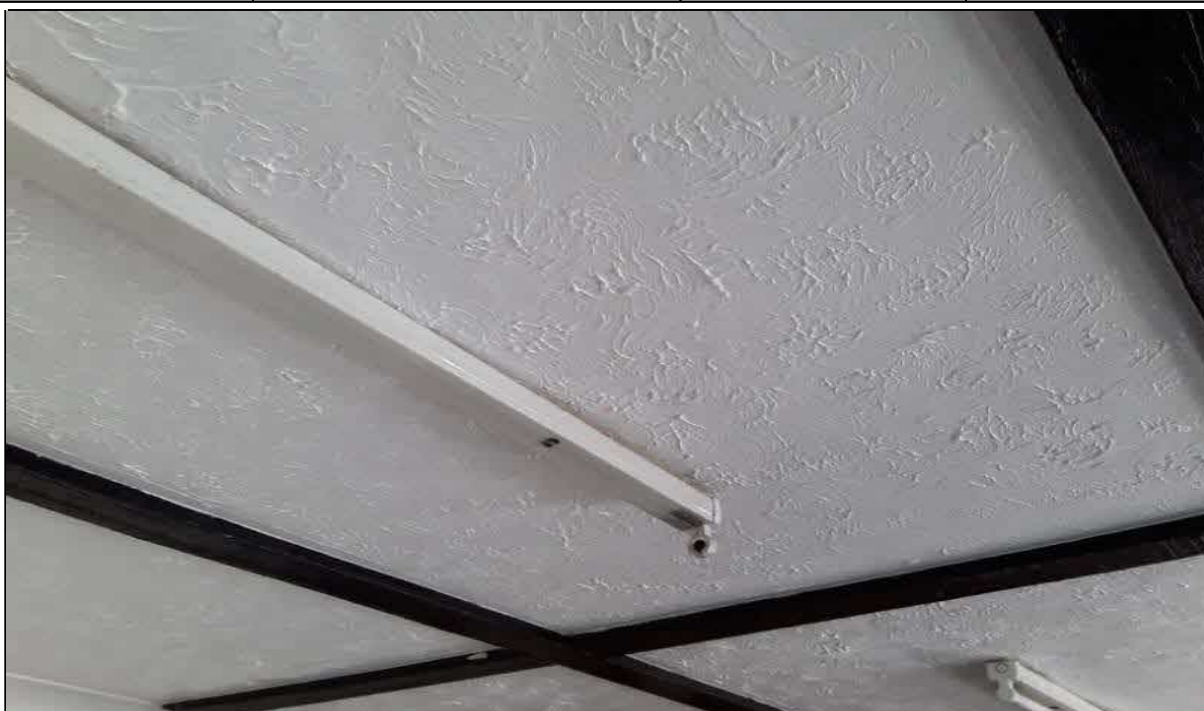
SAMPLE REFERENCE	CH000725	ASBESTOS	NO
PRESUMPTION REFERENCE	N/A	RISK LEVEL	N/A

AREA	Internal	MATERIAL ASSESSMENT	
FLOOR	Ground Floor	PRODUCT TYPE	0 - NADIS
UNIQUE ROOM IDENTIFIER	Barn 5	DAMAGE	0 - NADIS
DESCRIPTION OF SAMPLE TAKEN OR PRESUMPTION	Textured coat Ceiling	SURFACE TREATMENT	0 - NADIS
EXTENT	100 Sq. m	ASBESTOS TYPE	0 - NADIS
ACCESSIBILITY	Low	MATERIAL ASSESSMENT SCORE	0
LEVEL OF IDENTIFICATION	Sampled	POTENTIAL TO RELEASE FIBRES	N/A
RECOMMENDATIONS No Further Action Required		COMMENTS No Asbestos Detected in Sample

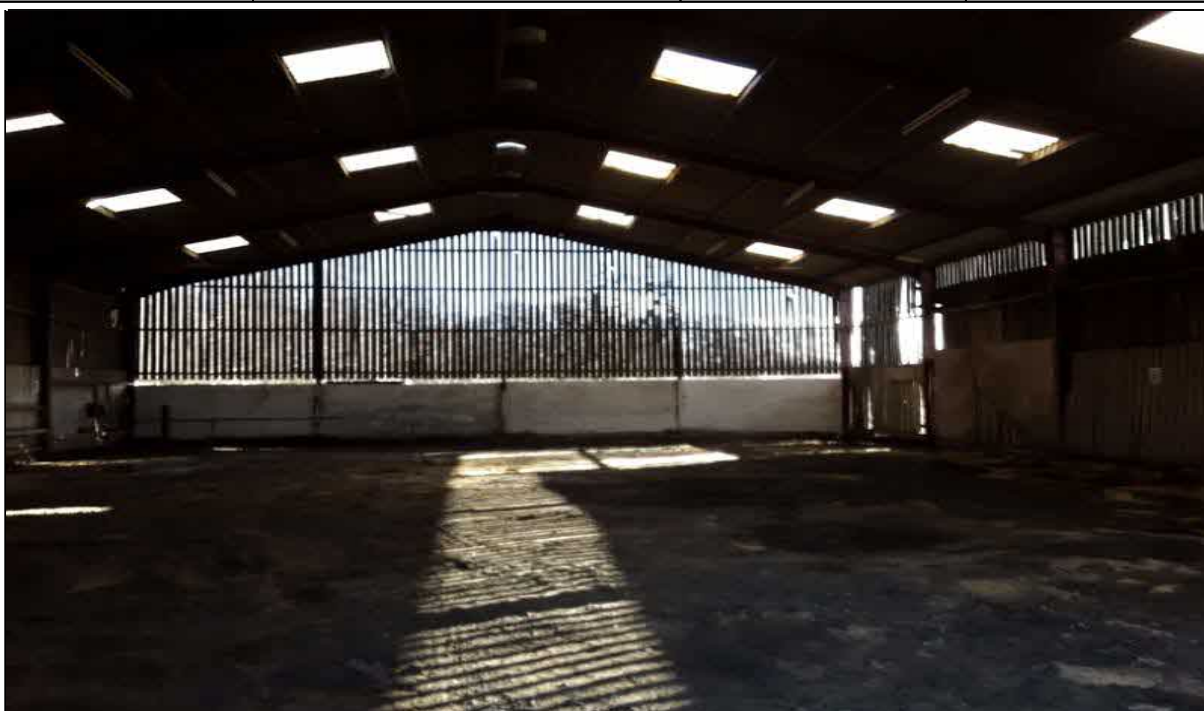
SAMPLE REFERENCE	Item No: 27	ASBESTOS	N/A
PRESUMPTION REFERENCE	N/A	RISK LEVEL	N/A

AREA	Internal	MATERIAL ASSESSMENT	
FLOOR	Ground Floor	PRODUCT TYPE	N/A
UNIQUE ROOM IDENTIFIER	Barn 6	DAMAGE	N/A
DESCRIPTION OF SAMPLE TAKEN OR PRESUMPTION	No suspect materials found	SURFACE TREATMENT	N/A
EXTENT	N/A	ASBESTOS TYPE	N/A
ACCESSIBILITY	N/A	MATERIAL ASSESSMENT SCORE	N/A
LEVEL OF IDENTIFICATION	N/A	POTENTIAL TO RELEASE FIBRES	N/A
RECOMMENDATIONS		COMMENTS

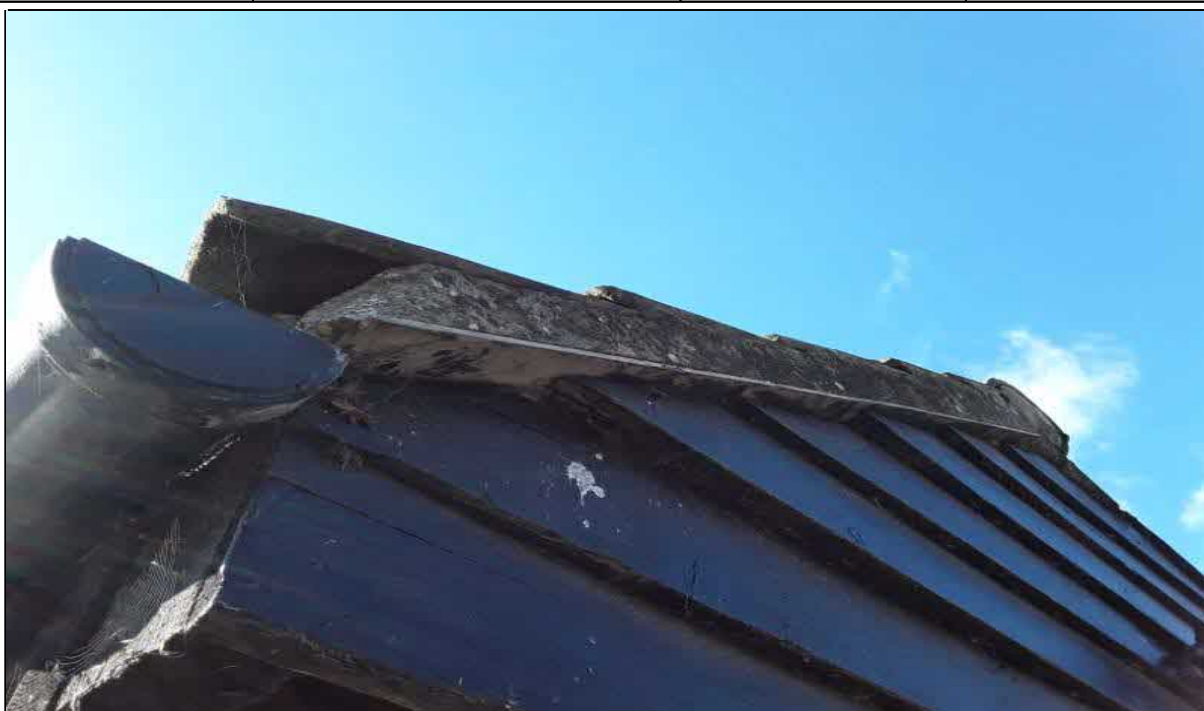
AREA	External	MATERIAL ASSESSMENT	
FLOOR	External	PRODUCT TYPE	0 - NADIS
UNIQUE ROOM IDENTIFIER	Stables 1	DAMAGE	0 - NADIS
DESCRIPTION OF SAMPLE TAKEN OR PRESUMPTION	Boarding Under cloak	SURFACE TREATMENT	0 - NADIS
EXTENT	4 linear metres	ASBESTOS TYPE	0 - NADIS
ACCESSIBILITY	Low	MATERIAL ASSESSMENT SCORE	0
LEVEL OF IDENTIFICATION	Sampled	POTENTIAL TO RELEASE FIBRES	N/A
RECOMMENDATIONS No Further Action Required		COMMENTS No Asbestos Detected in Sample

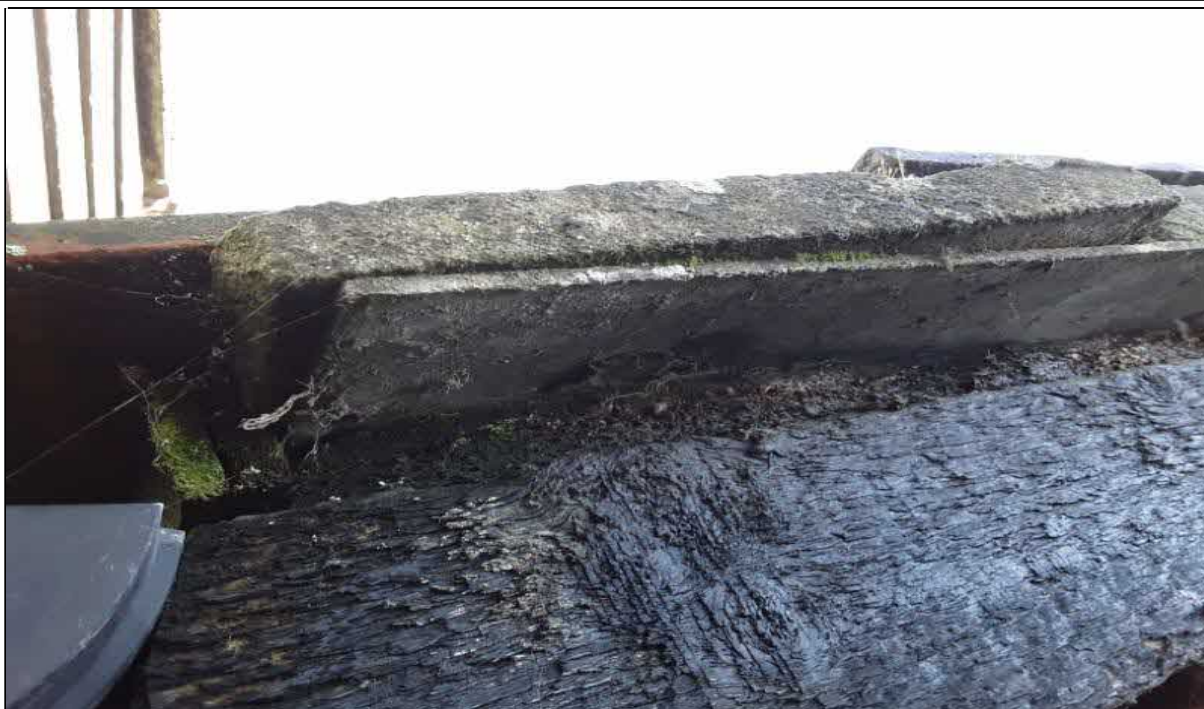
AREA	External	MATERIAL ASSESSMENT	
FLOOR	External	PRODUCT TYPE	0 - NADIS
UNIQUE ROOM IDENTIFIER	Stables 3	DAMAGE	0 - NADIS
DESCRIPTION OF SAMPLE TAKEN OR PRESUMPTION	Boarding Under cloak	SURFACE TREATMENT	0 - NADIS
EXTENT	6 linear metres	ASBESTOS TYPE	0 - NADIS
ACCESSIBILITY	Low	MATERIAL ASSESSMENT SCORE	0
LEVEL OF IDENTIFICATION	Strongly Presumed	POTENTIAL TO RELEASE FIBRES	N/A
RECOMMENDATIONS No Further Action Required		COMMENTS No Asbestos Detected in Sample

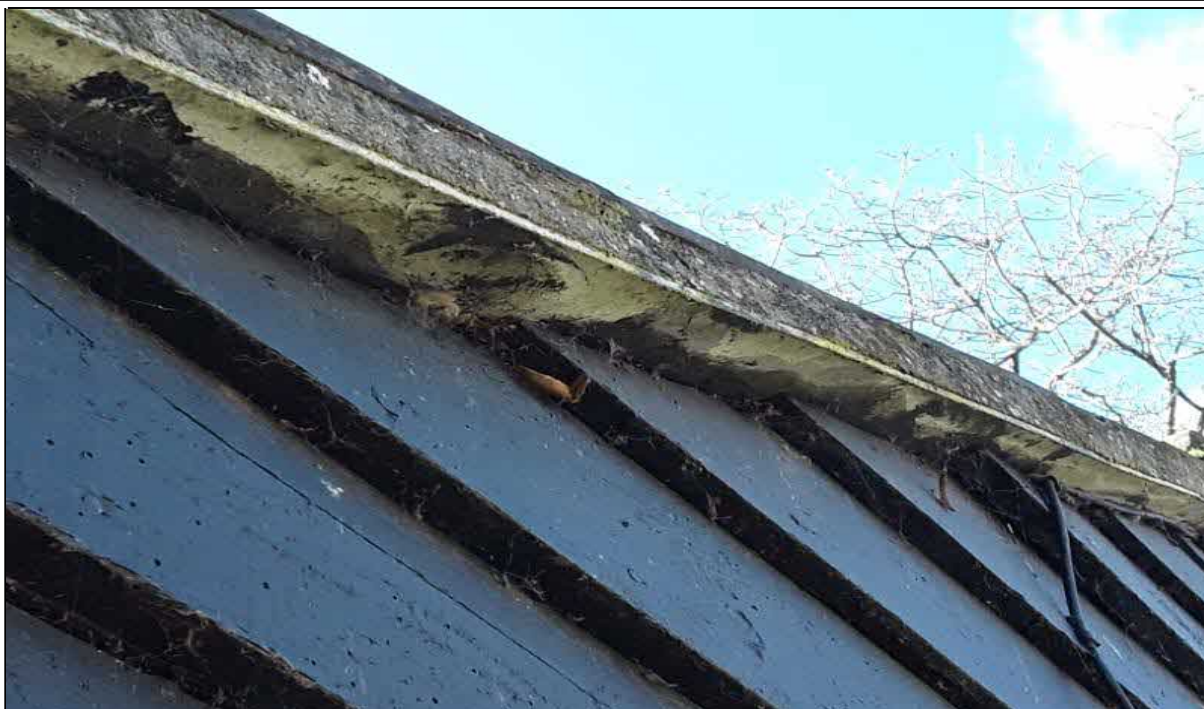
AREA	External	MATERIAL ASSESSMENT	
FLOOR	External	PRODUCT TYPE	0 - NADIS
UNIQUE ROOM IDENTIFIER	Barn 5	DAMAGE	0 - NADIS
DESCRIPTION OF SAMPLE TAKEN OR PRESUMPTION	Boarding Undercloak	SURFACE TREATMENT	0 - NADIS
EXTENT	5 linear metres	ASBESTOS TYPE	0 - NADIS
ACCESSIBILITY	Low	MATERIAL ASSESSMENT SCORE	0
LEVEL OF IDENTIFICATION	Strongly Presumed	POTENTIAL TO RELEASE FIBRES	N/A
RECOMMENDATIONS No Further Action Required		COMMENTS No Asbestos Detected in Sample

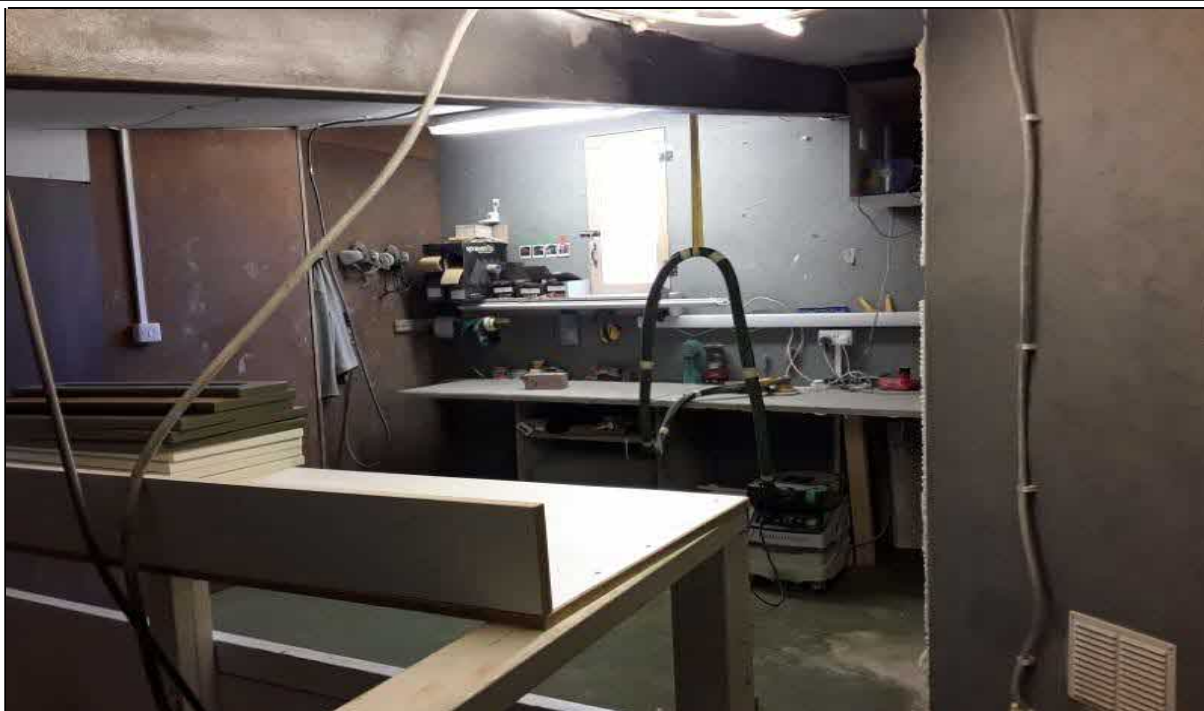
AREA	Internal	MATERIAL ASSESSMENT	
FLOOR	1st Floor	PRODUCT TYPE	N/A
UNIQUE ROOM IDENTIFIER	Barn 7	DAMAGE	N/A
DESCRIPTION OF SAMPLE TAKEN OR PRESUMPTION	No suspect materials found	SURFACE TREATMENT	N/A
EXTENT	N/A	ASBESTOS TYPE	N/A
ACCESSIBILITY	N/A	MATERIAL ASSESSMENT SCORE	N/A
LEVEL OF IDENTIFICATION	N/A	POTENTIAL TO RELEASE FIBRES	N/A
RECOMMENDATIONS	COMMENTS

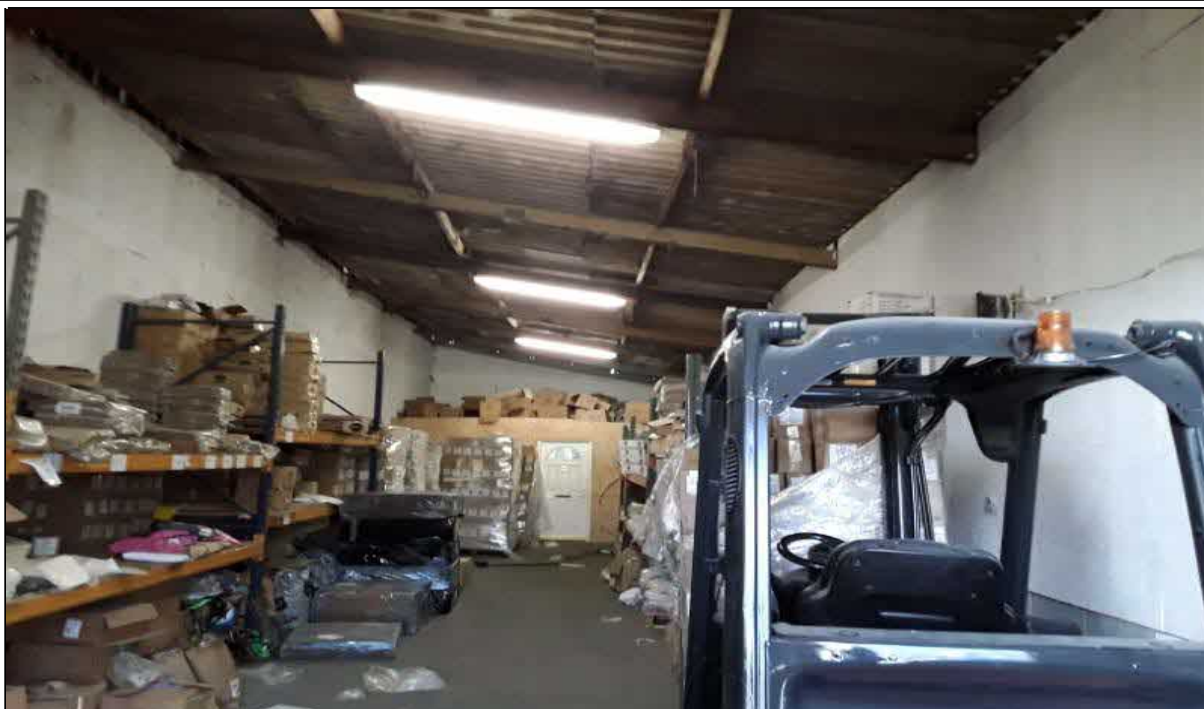
AREA	Internal	MATERIAL ASSESSMENT	
FLOOR	Ground Floor	PRODUCT TYPE	N/A
UNIQUE ROOM IDENTIFIER	Barn 8	DAMAGE	N/A
DESCRIPTION OF SAMPLE TAKEN OR PRESUMPTION	No suspect materials found	SURFACE TREATMENT	N/A
EXTENT	N/A	ASBESTOS TYPE	N/A
ACCESSIBILITY	N/A	MATERIAL ASSESSMENT SCORE	N/A
LEVEL OF IDENTIFICATION	N/A	POTENTIAL TO RELEASE FIBRES	N/A
RECOMMENDATIONS	COMMENTS
