Asbestos Inspection Report

DR Bejan roohi (home partners group limited)

Frenches Farm, Wigley Bush Lane, South Weald, Brentwood, Essex

Demolition Survey

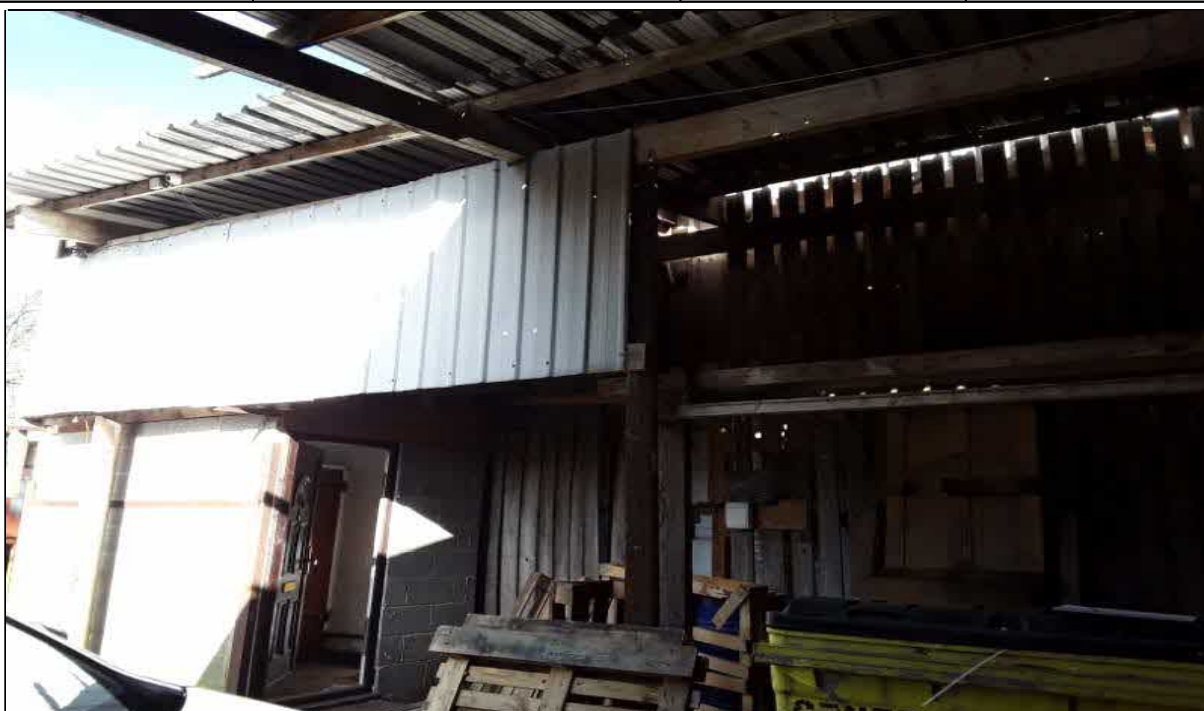
AREA	External	MATERIAL ASSESSMENT	
FLOOR	External	PRODUCT TYPE	N/A
UNIQUE ROOM IDENTIFIER	Lean 2	DAMAGE	N/A
DESCRIPTION OF SAMPLE TAKEN OR PRESUMPTION	No suspect materials found	SURFACE TREATMENT	N/A
EXTENT	N/A	ASBESTOS TYPE	N/A
ACCESSIBILITY	N/A	MATERIAL ASSESSMENT SCORE	N/A
LEVEL OF IDENTIFICATION	N/A	POTENTIAL TO RELEASE FIBRES	N/A
RECOMMENDATIONS	COMMENTS

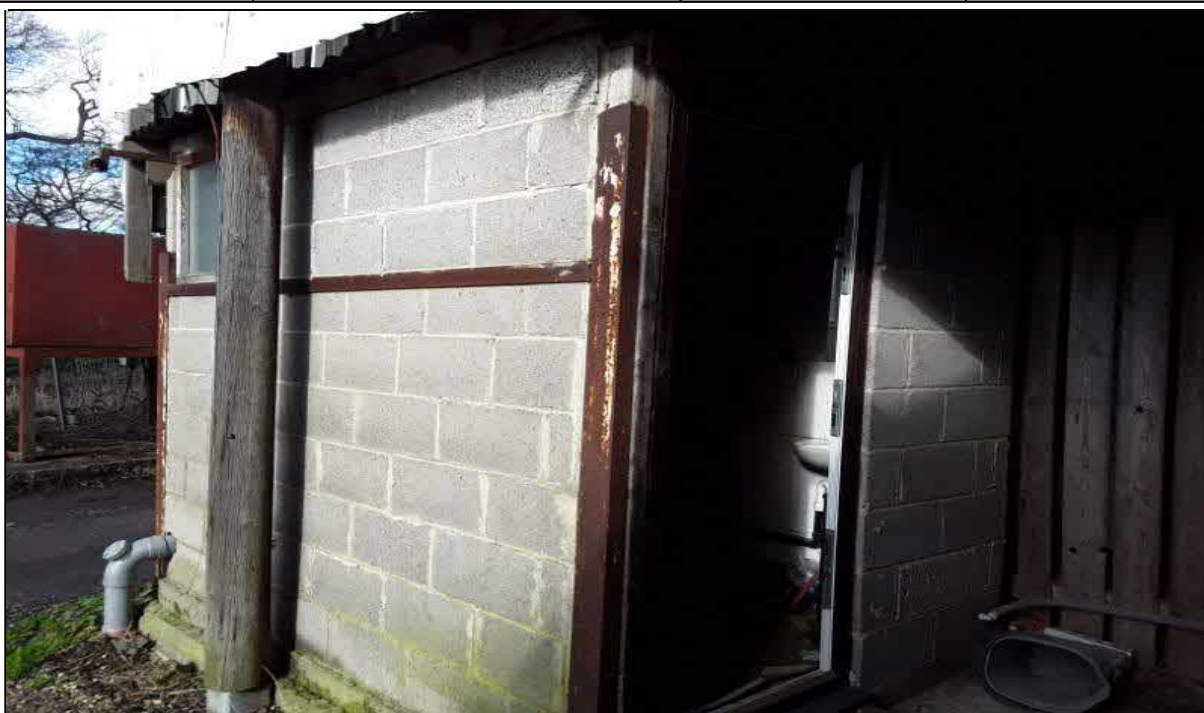
AREA	External	MATERIAL ASSESSMENT	
FLOOR	External	PRODUCT TYPE	N/A
UNIQUE ROOM IDENTIFIER	Toilets	DAMAGE	N/A
DESCRIPTION OF SAMPLE TAKEN OR PRESUMPTION	No suspect materials found	SURFACE TREATMENT	N/A
EXTENT	N/A	ASBESTOS TYPE	N/A
ACCESSIBILITY	N/A	MATERIAL ASSESSMENT SCORE	N/A
LEVEL OF IDENTIFICATION	N/A	POTENTIAL TO RELEASE FIBRES	N/A
RECOMMENDATIONS	COMMENTS

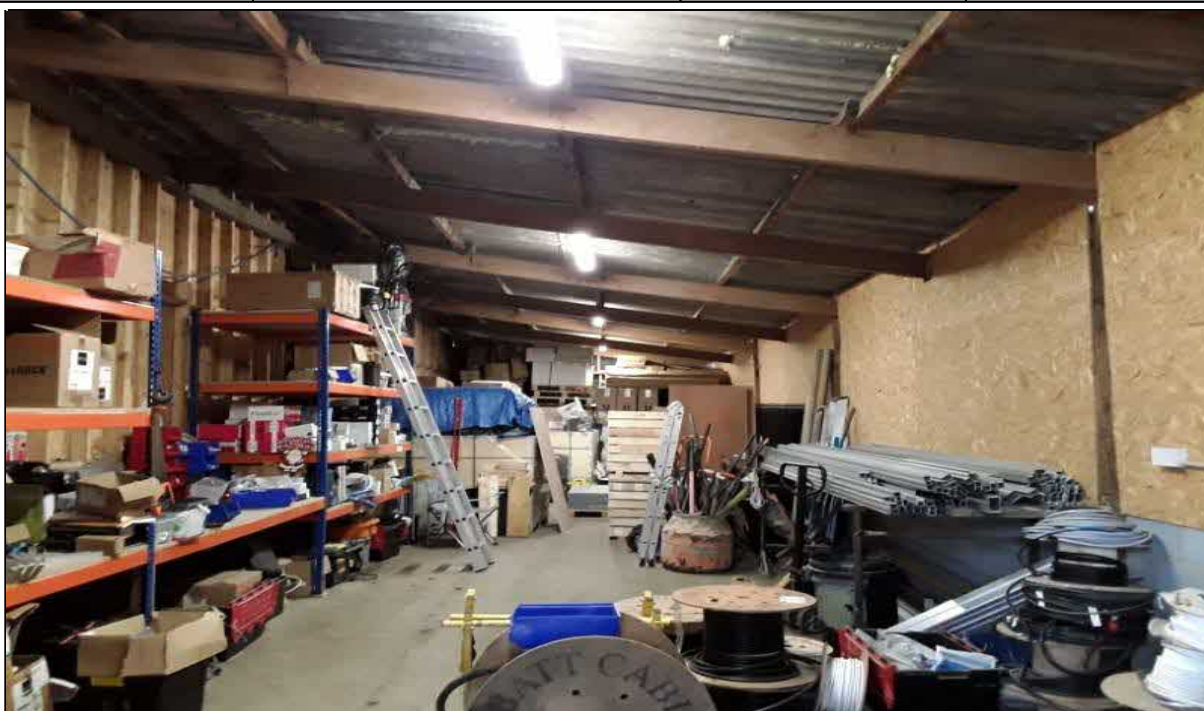
AREA	Internal	MATERIAL ASSESSMENT	
FLOOR	Ground Floor	PRODUCT TYPE	N/A
UNIQUE ROOM IDENTIFIER	Barn 9	DAMAGE	N/A
DESCRIPTION OF SAMPLE TAKEN OR PRESUMPTION	No suspect materials found	SURFACE TREATMENT	N/A
EXTENT	N/A	ASBESTOS TYPE	N/A
ACCESSIBILITY	N/A	MATERIAL ASSESSMENT SCORE	N/A
LEVEL OF IDENTIFICATION	N/A	POTENTIAL TO RELEASE FIBRES	N/A
RECOMMENDATIONS	COMMENTS

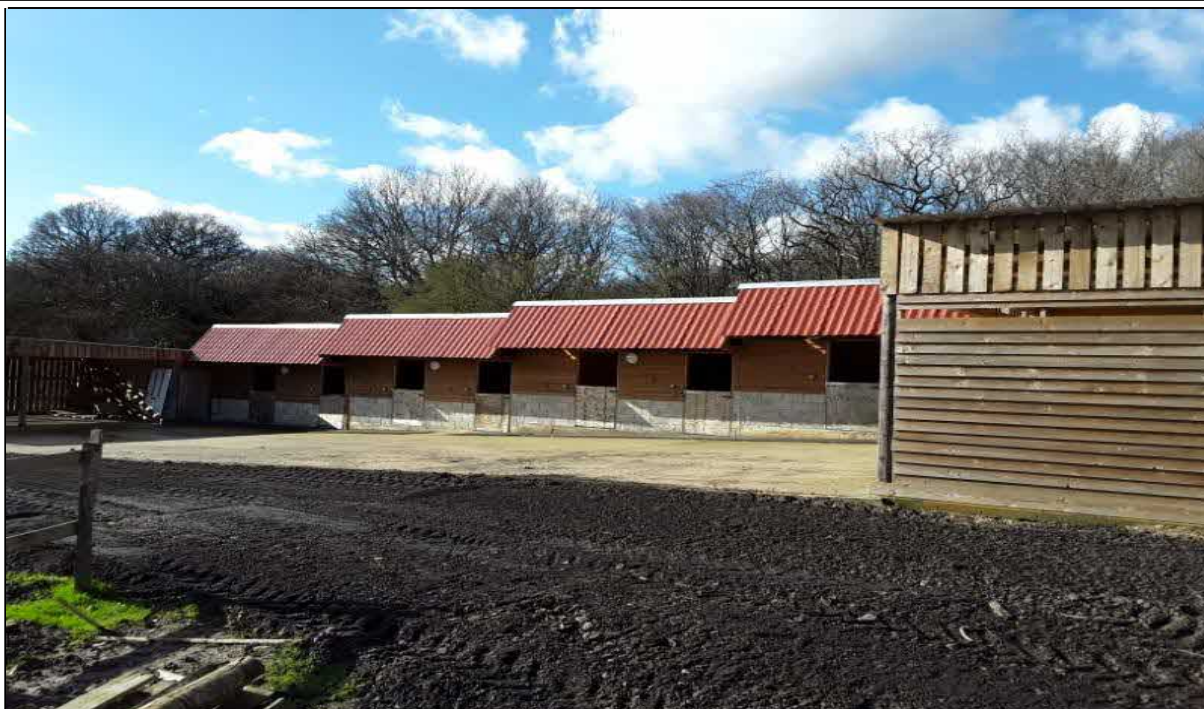
AREA	External	MATERIAL ASSESSMENT	
FLOOR	External	PRODUCT TYPE	N/A
UNIQUE ROOM IDENTIFIER	New stables	DAMAGE	N/A
DESCRIPTION OF SAMPLE TAKEN OR PRESUMPTION	No suspect materials found	SURFACE TREATMENT	N/A
EXTENT	N/A	ASBESTOS TYPE	N/A
ACCESSIBILITY	N/A	MATERIAL ASSESSMENT SCORE	N/A
LEVEL OF IDENTIFICATION	N/A	POTENTIAL TO RELEASE FIBRES	N/A
RECOMMENDATIONS		COMMENTS

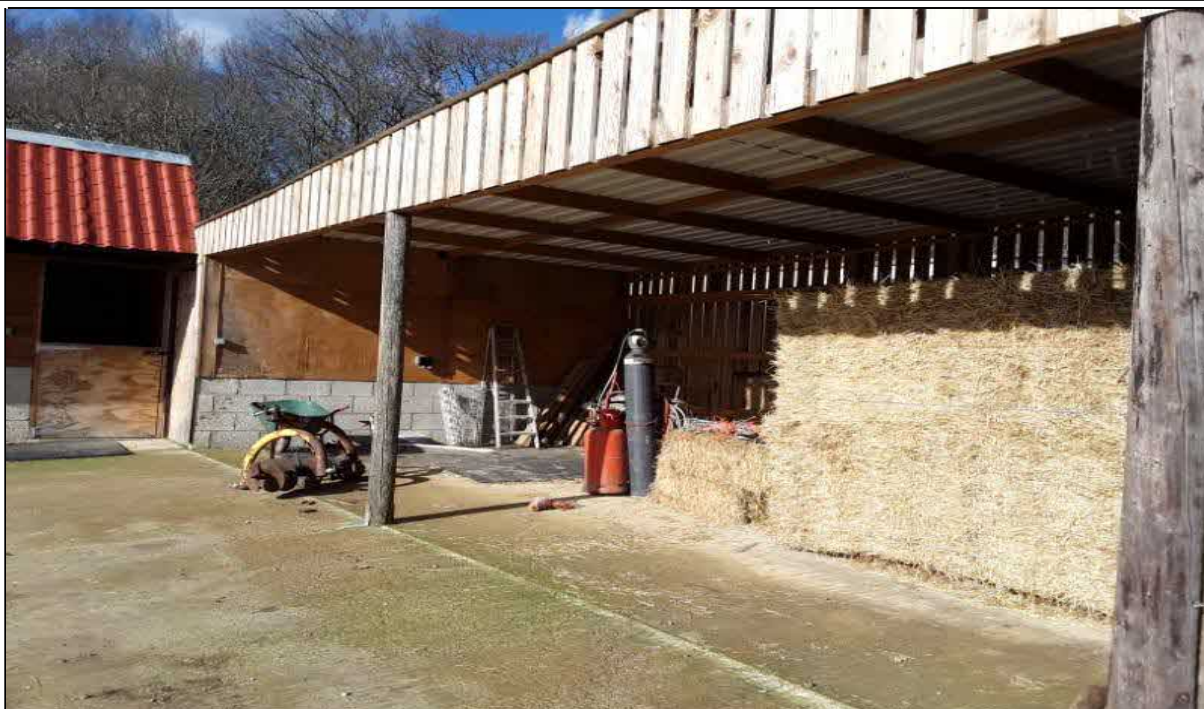
AREA	Internal	MATERIAL ASSESSMENT	
FLOOR	Ground Floor	PRODUCT TYPE	N/A
UNIQUE ROOM IDENTIFIER	New stables	DAMAGE	N/A
DESCRIPTION OF SAMPLE TAKEN OR PRESUMPTION	No suspect materials found	SURFACE TREATMENT	N/A
EXTENT	N/A	ASBESTOS TYPE	N/A
ACCESSIBILITY	N/A	MATERIAL ASSESSMENT SCORE	N/A
LEVEL OF IDENTIFICATION	N/A	POTENTIAL TO RELEASE FIBRES	N/A
RECOMMENDATIONS		COMMENTS

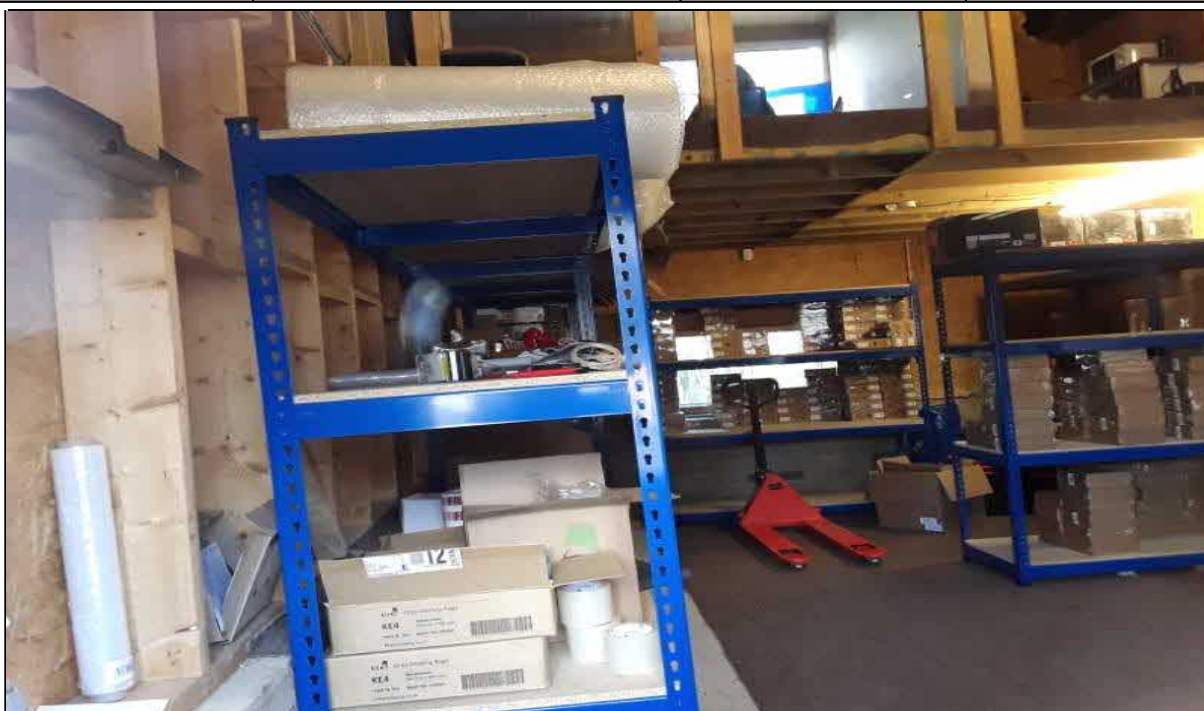
AREA	Internal	MATERIAL ASSESSMENT	
FLOOR	Ground Floor	PRODUCT TYPE	N/A
UNIQUE ROOM IDENTIFIER	Barn 4 room 2	DAMAGE	N/A
DESCRIPTION OF SAMPLE TAKEN OR PRESUMPTION	No suspect materials found	SURFACE TREATMENT	N/A
EXTENT	N/A	ASBESTOS TYPE	N/A
ACCESSIBILITY	N/A	MATERIAL ASSESSMENT SCORE	N/A
LEVEL OF IDENTIFICATION	N/A	POTENTIAL TO RELEASE FIBRES	N/A
RECOMMENDATIONS	COMMENTS
