**BAT PRELIMINARY ROOST
ASSESSMENT
CRIEFF RD LIDL
RAPLEYS LLP**

8/03/2022

Crieff Rd Lidl

P22071

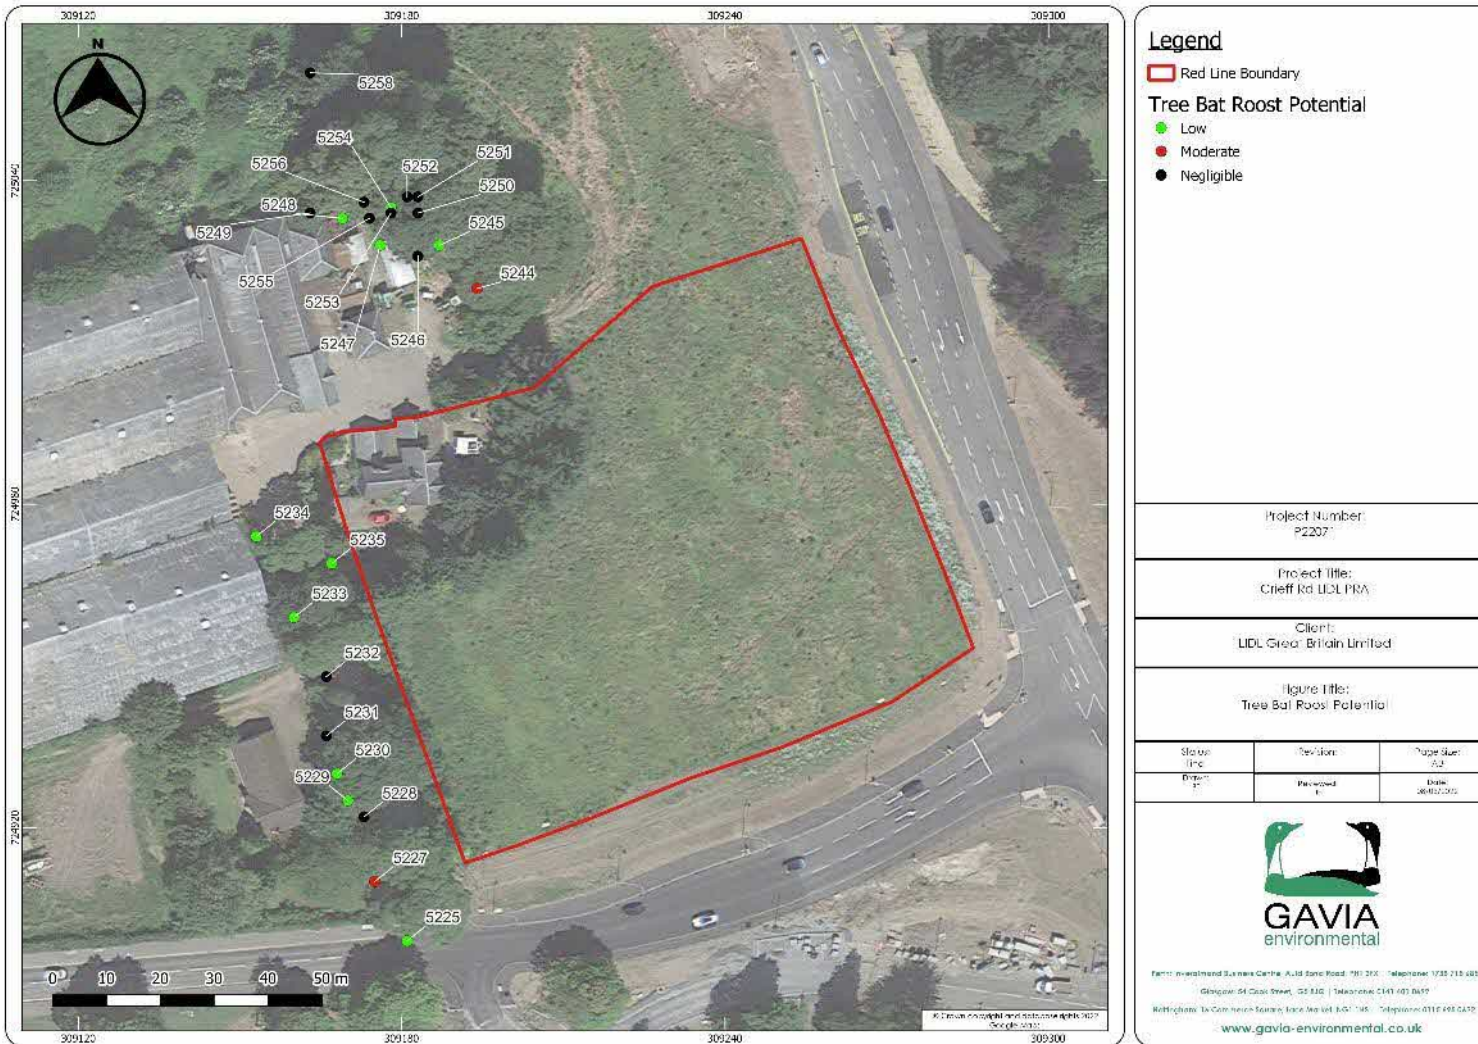
Appendix B: Trees with Potential Bat Roosting Features Map

The PRA found 12 trees with negligible roost potential, 11 trees with low roost potential and 2 trees with moderate roost potential. Table 3 provides descriptions of the features found. The coniferous trees bordering the road entering the Site were inspected but found to have no roost potential due to age, height and trunk thickness.
