Our Ref: B25239-JNP-XX-XX-RP-S-0001      Chkd: VW

Re: Bell Farm Avenue

The purpose of this report is to inspect and report on the existing structural arrangement, size of members and any visual defects. It also includes the findings from the CCTV survey and the Damp and Timber survey which can be found in the appendices.

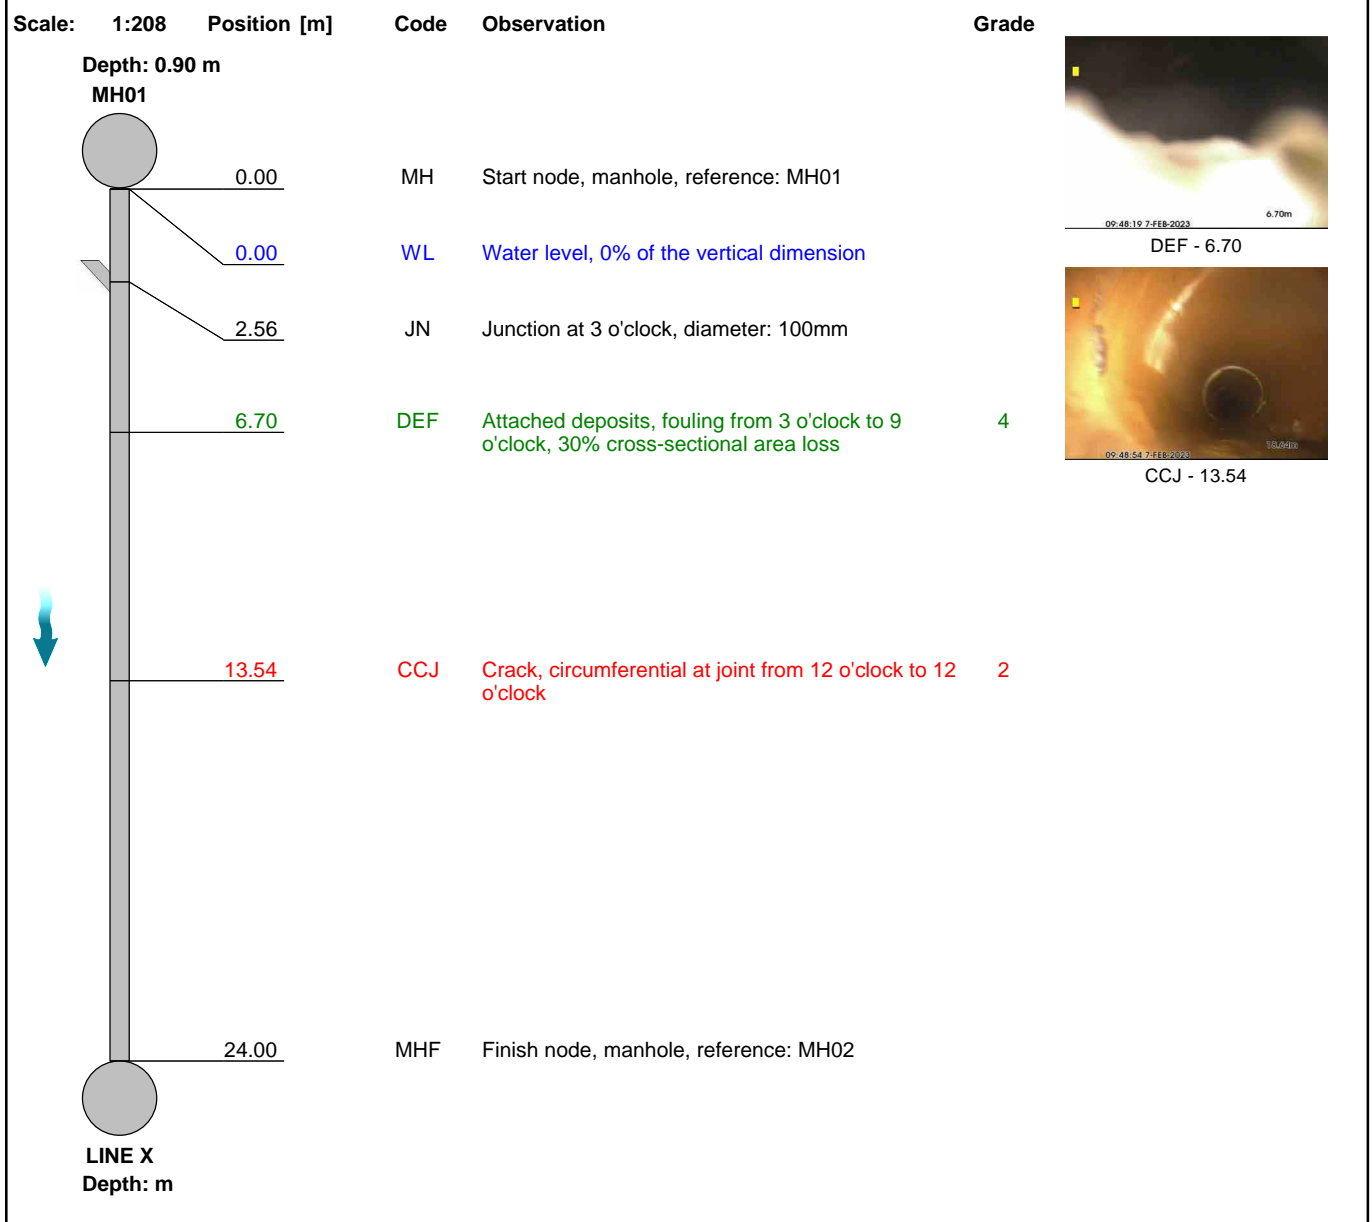
2, 00:00:58, 13.54 m  
Crack, circumferential at joint from 12 o'clock to 12 o'clock

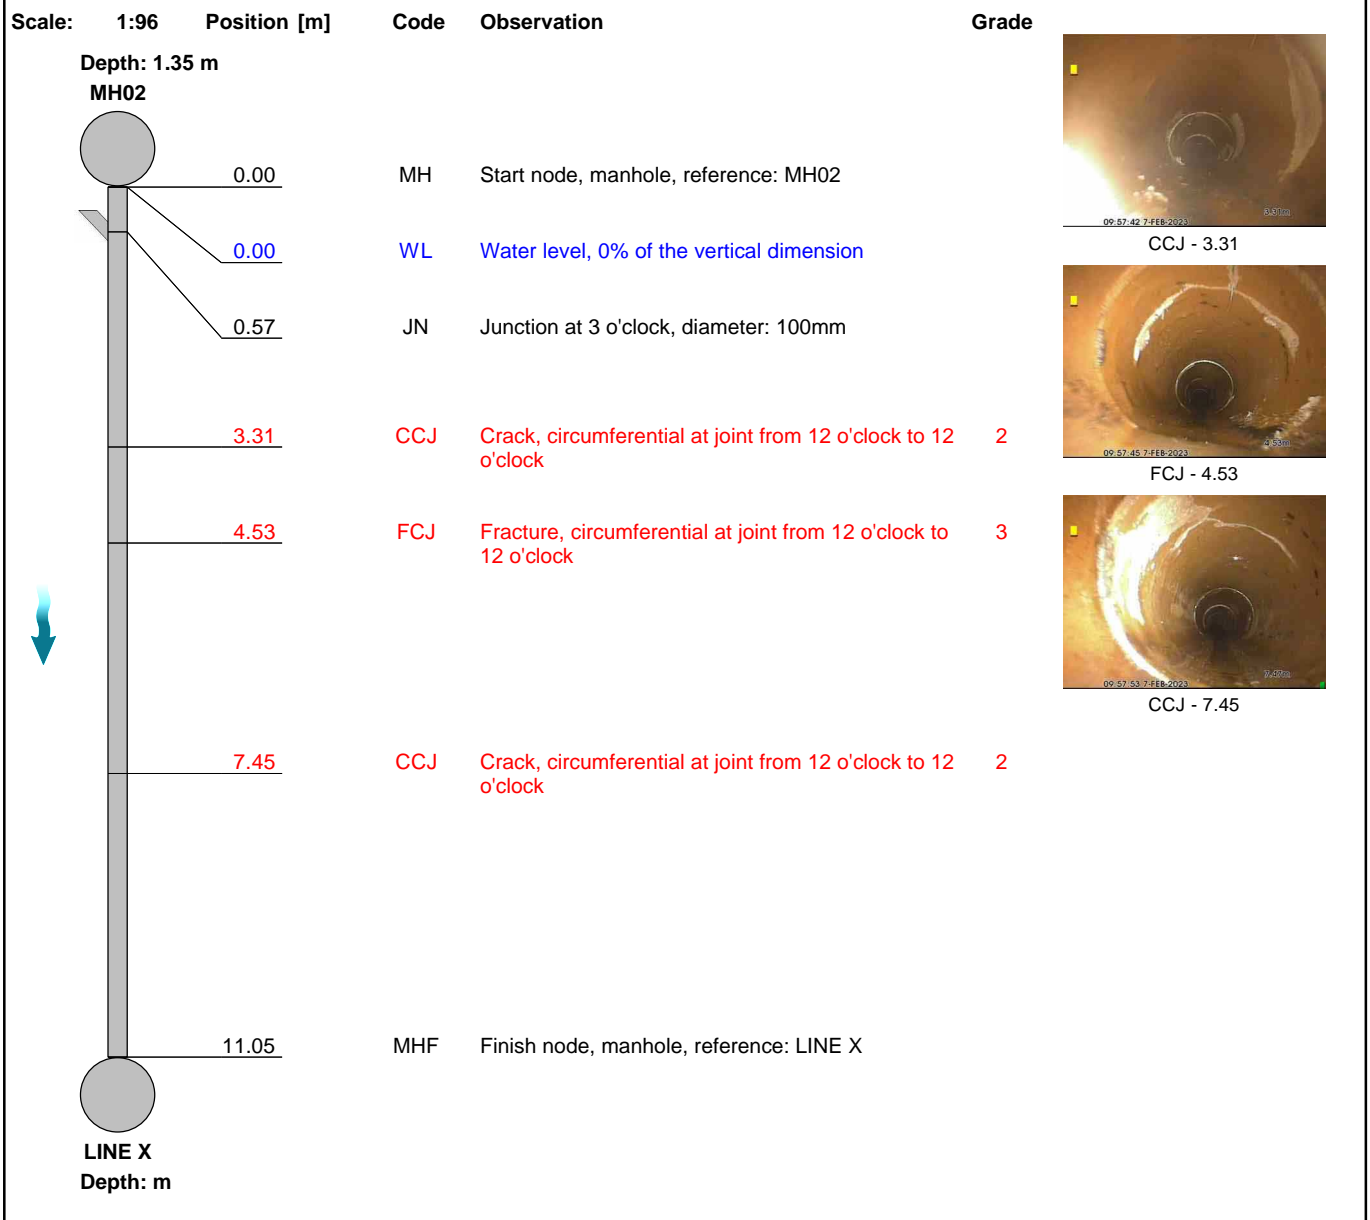
1, 00:00:15, 3.31 m  
Crack, circumferential at joint from 12 o'clock to 12 o'clock

2, 00:00:19, 4.53 m  
Fracture, circumferential at joint from 12 o'clock to 12 o'clock

3, 00:00:27, 7.45 m  
Crack, circumferential at joint from 12 o'clock to 12 o'clock

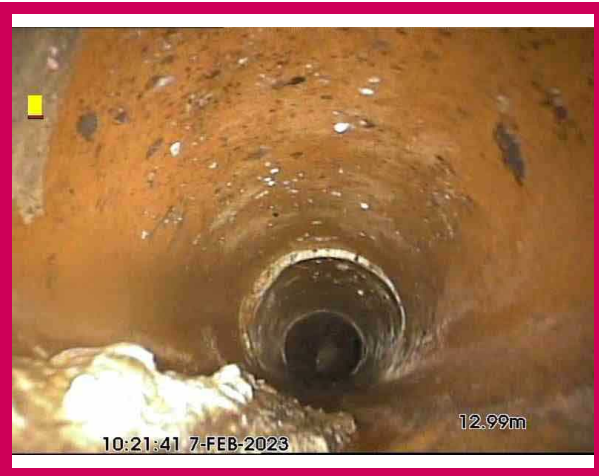
| Item No. | Inspection Direction | PLR | Insp. No. | Lanes Job Number |
|---|---|---|---|---|
| 7 | Downstream | MH04X | 7 | PJ00469270 |

1, 00:00:37, 13.00 m  
Attached deposits, fouling from 3 o'clock to 9 o'clock, 10%  
cross-sectional area loss

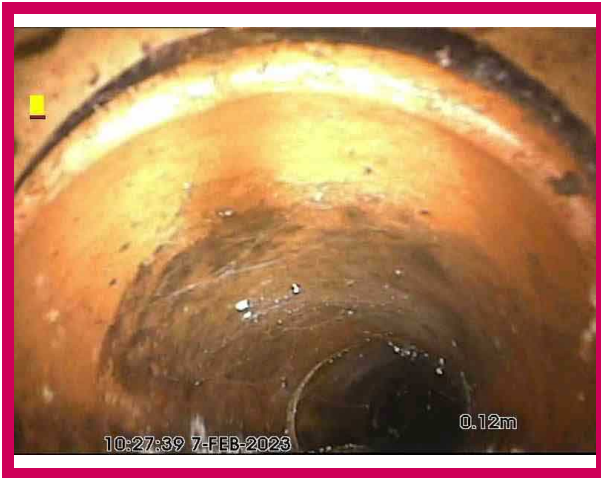
| Item No. | Inspection Direction | PLR | Insp. No. | Lanes Job Number |
|---|---|---|---|---|
| 9 | Upstream | LINE BX | 9 | PJ00469270 |

1, 00:00:05, 0.14 m  
Joint displaced, medium

Section 9. MH07- LINE B. Dia-150mm. Defect- JDM at 0.14m. Repair- 1x 600 CIPP Liner.

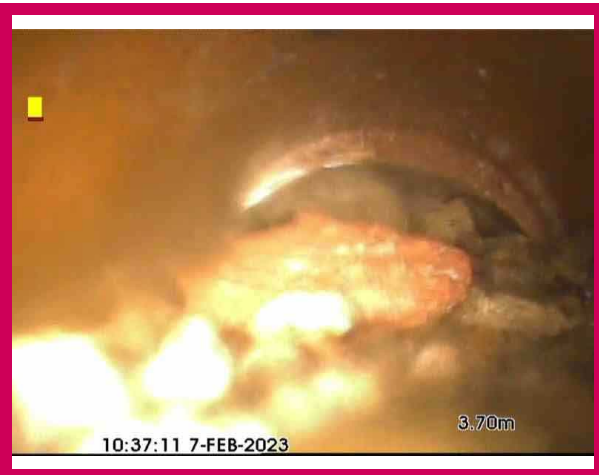
3, 00:00:21, 3.91 m  
 Settled deposits, hard or compacted, 100% cross-sectional area loss

Section 13. MH05- LINE C. Survey abandoned at 3.91m due to settled deposits. Repair- Clean & Resurvey.

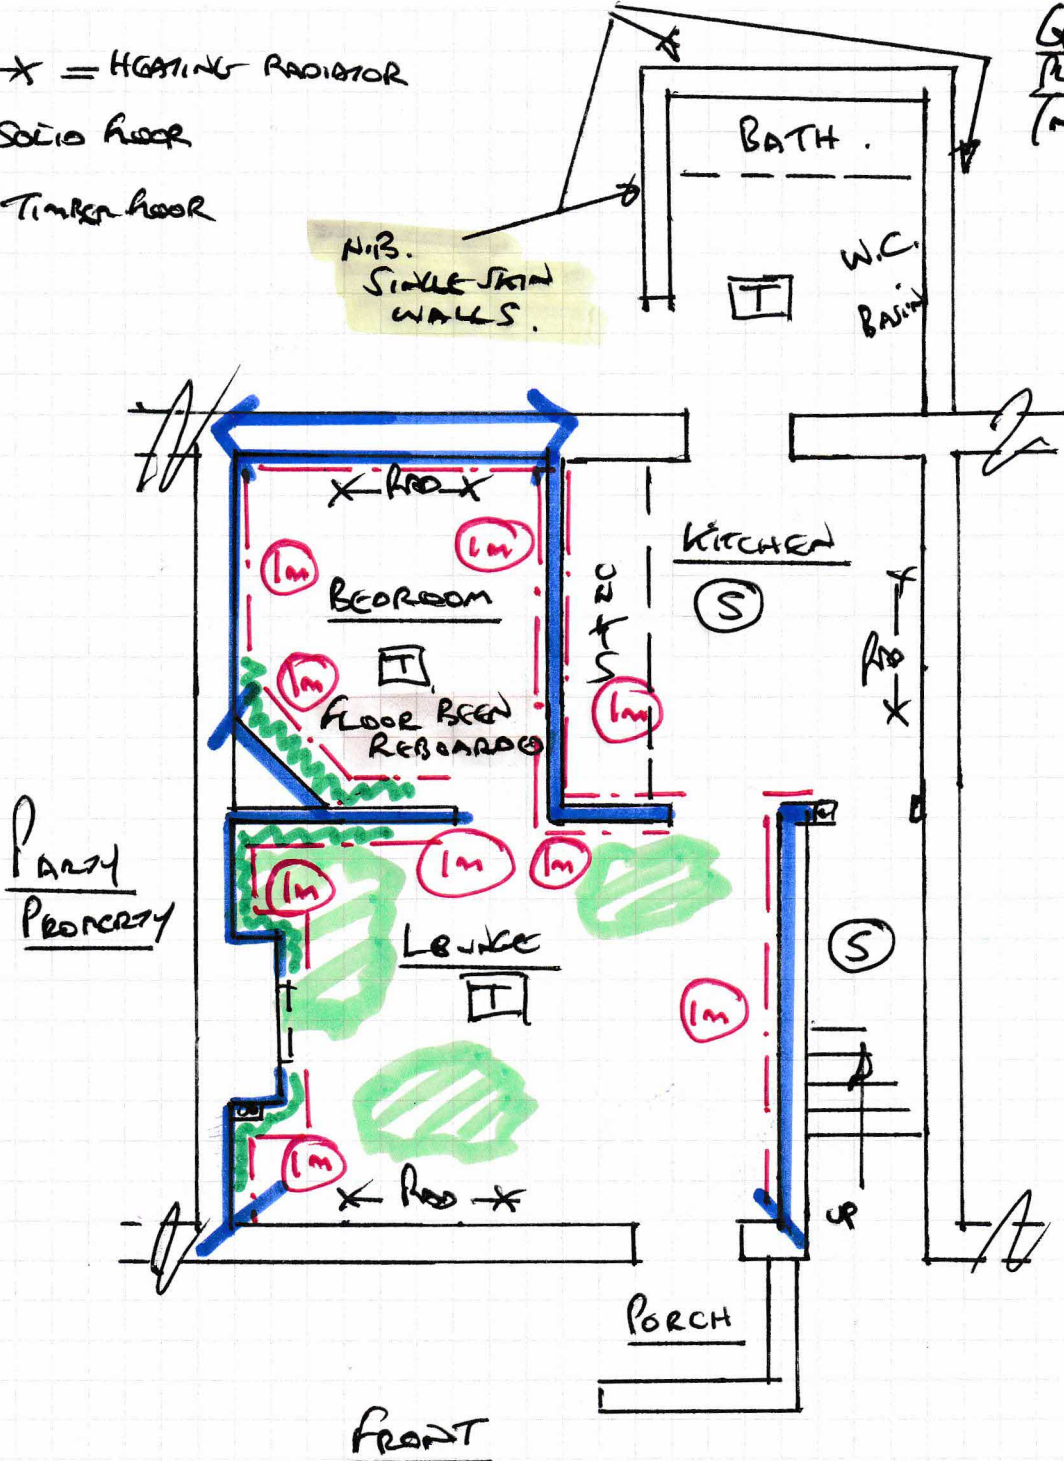
= FLOORBOARDS UNSOUND DUE TO INFESTATION.
