PROJECT
9 FORRES ST,
EDINBURGH

STATUS
LBC

DRAWING TITLE
EXISTING & PROPOSED W1&W2
DRAWINGS

DATE
FEB 24'
DWG. NO.
(31)100

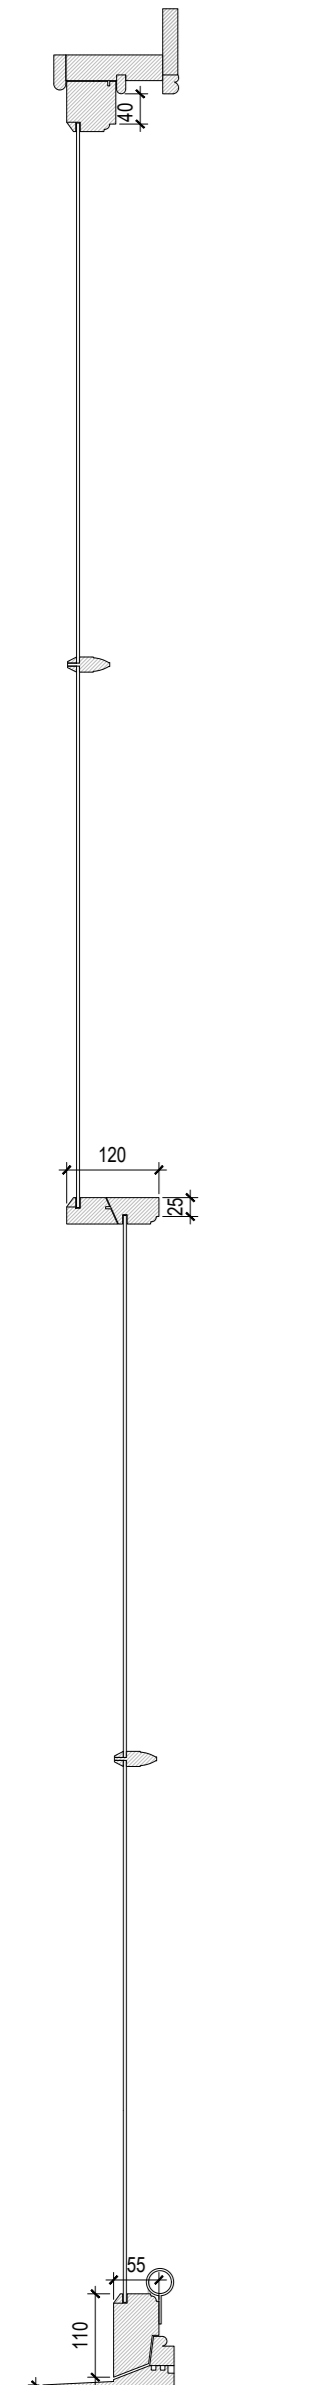
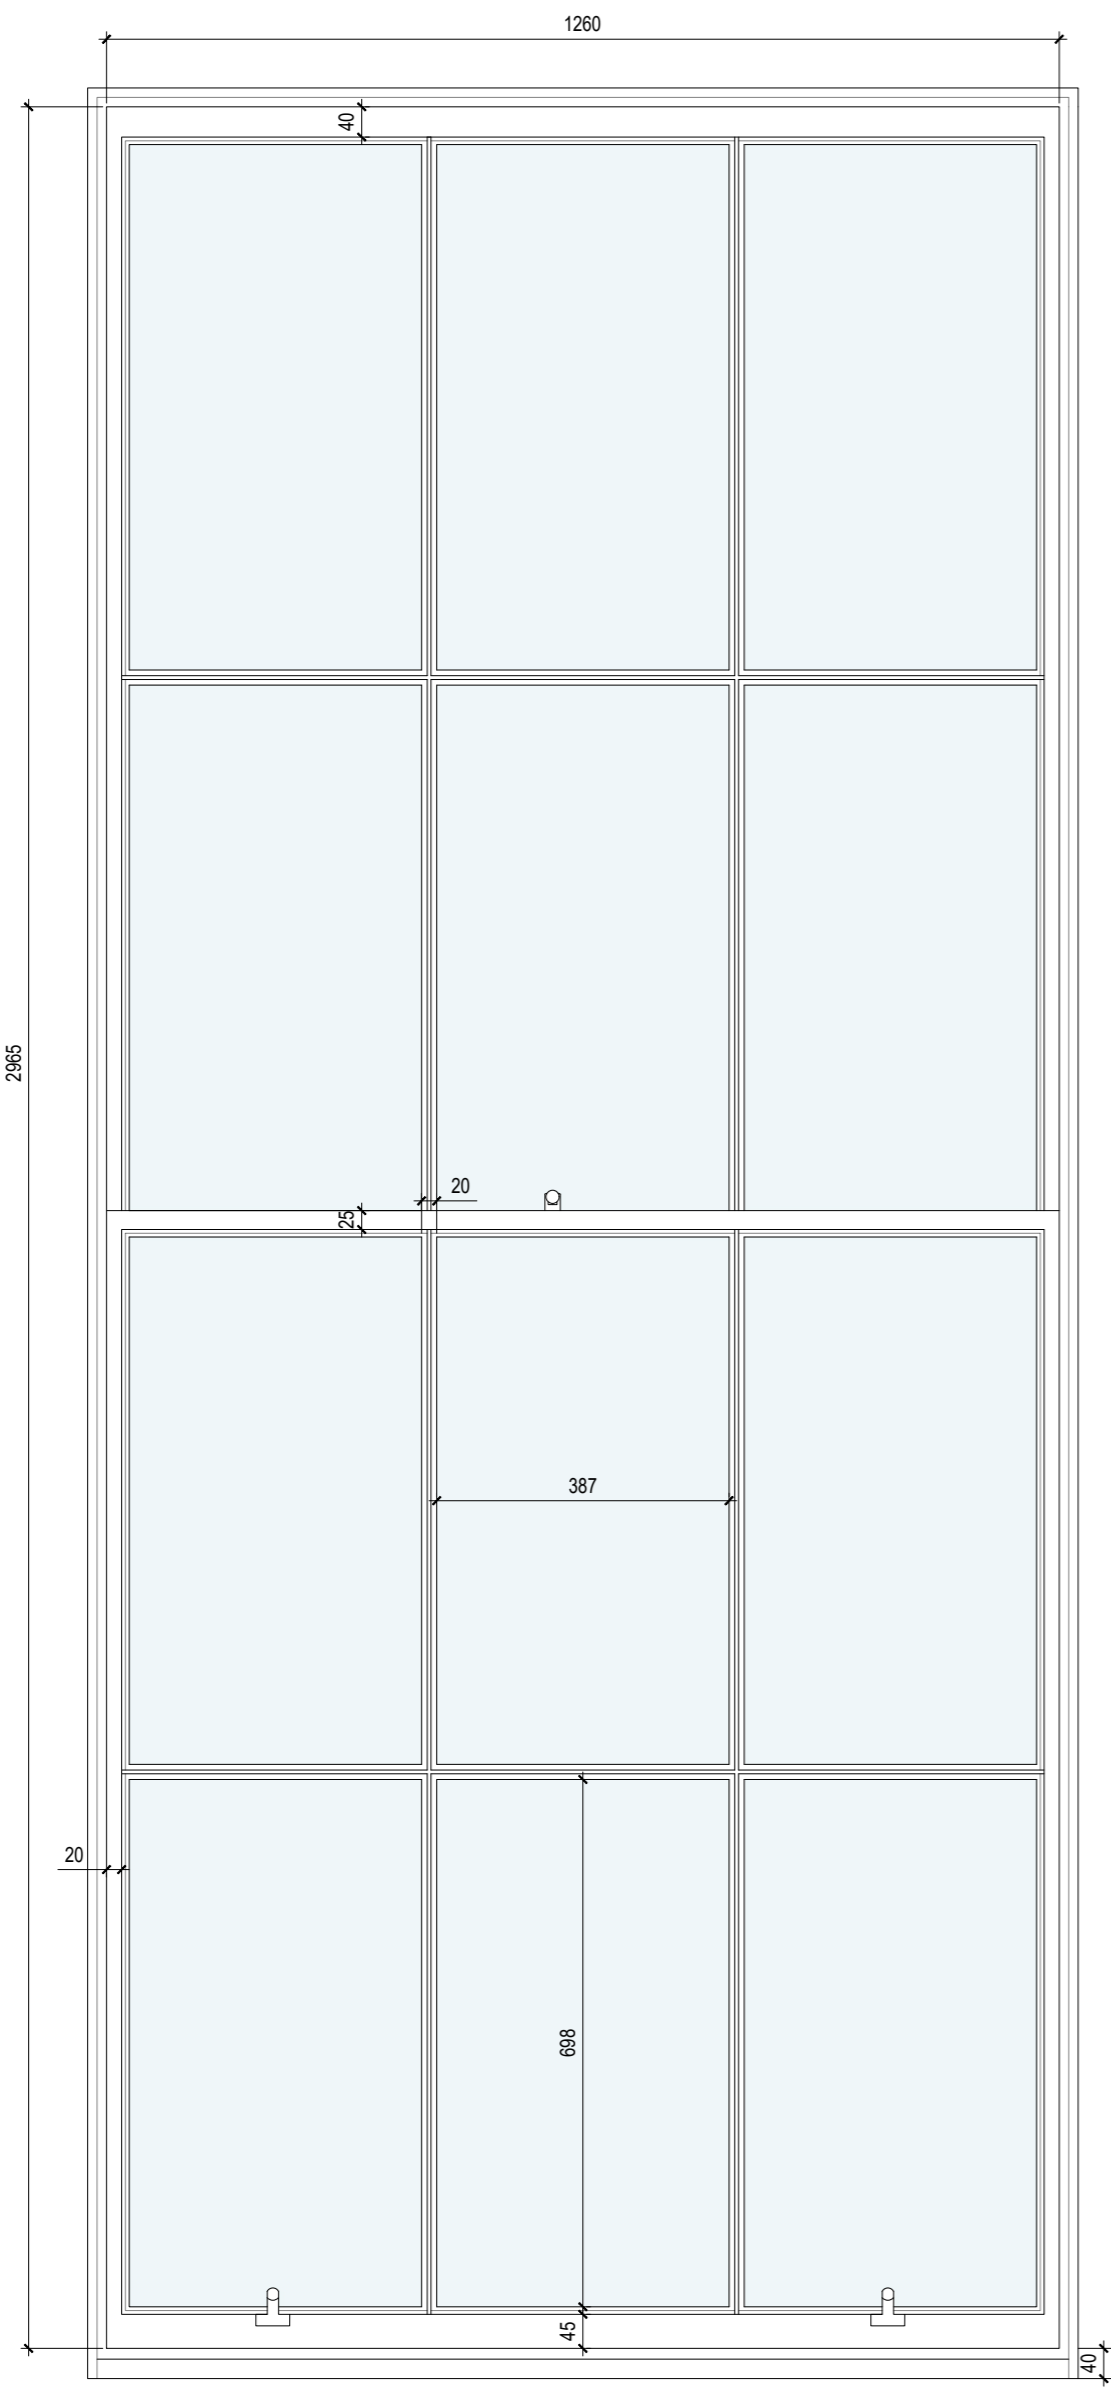
EXISTING WINDOW CONDITION NOTES:

W1& W2 both sashes are in working condition and can open, pulleys, ropes and weights would benefit from refurbishment to better ease of opening. No evidence of existing draught brushes installed to face of inner frame, there is a trickle vent to the underside of the outer sash mid transom. Windows would benefit from the install of draught brushes within the frame.

6 over 6 configuration, suggests window arrangements are as per the original design. Existing ironmongery in working condition but would benefit from refurbishment.

Both windows are identical in dimension and profile. Astragals appear to be original in profile and dimension.

Glazing Type: Single Glazing
GLASS MAKE UP: 6-7mm
