PROJECT
9 FORRES ST,
EDINBURGH
STATUS
LBC

DRAWING TITLE
EXISTING & PROPOSED W3
WINDOW DRAWINGS

DATE
FEB 24'
DWG. NO.
(31)101

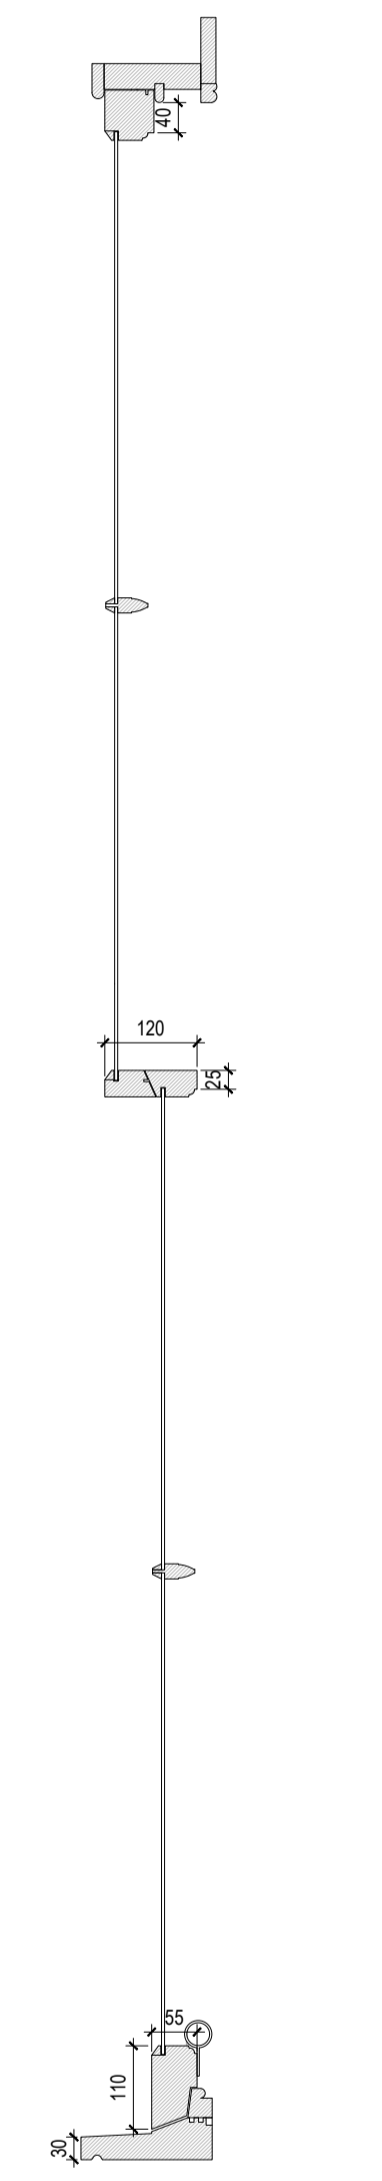
EXISTING THROUGH SECTION
scale 1:10

W3 both sashes are in working condition and can open, pulleys, ropes and weights would benefit from refurbishment to better ease of opening, as they are currently very stiff. Modern draught brushes have been applied to the face of the frame at the sides and mid transform recommended that the existing draught brushes are to be replaced with new draught brushes installed within the frame.

6 over 6 configuration, W3 has evidence of crown glazing, as shown, suggests window arrangements are as per the original design. Existing ironmongery in working condition but would benefit from refurbishment.

Astragals appear to be original in profile and dimension.

Glazing Type: Single Glazing
GLASS MAKE UP: 6-7mm
