Minmore Mill, Minmore House, Glenlivet, Ballindalloch, AB37 9DB  
CONDITION REPORT  
JULY 2022

The purpose of this report is to record the existing condition of the former Mil building on the site, with the intention of informing the buildings future use and restoration.

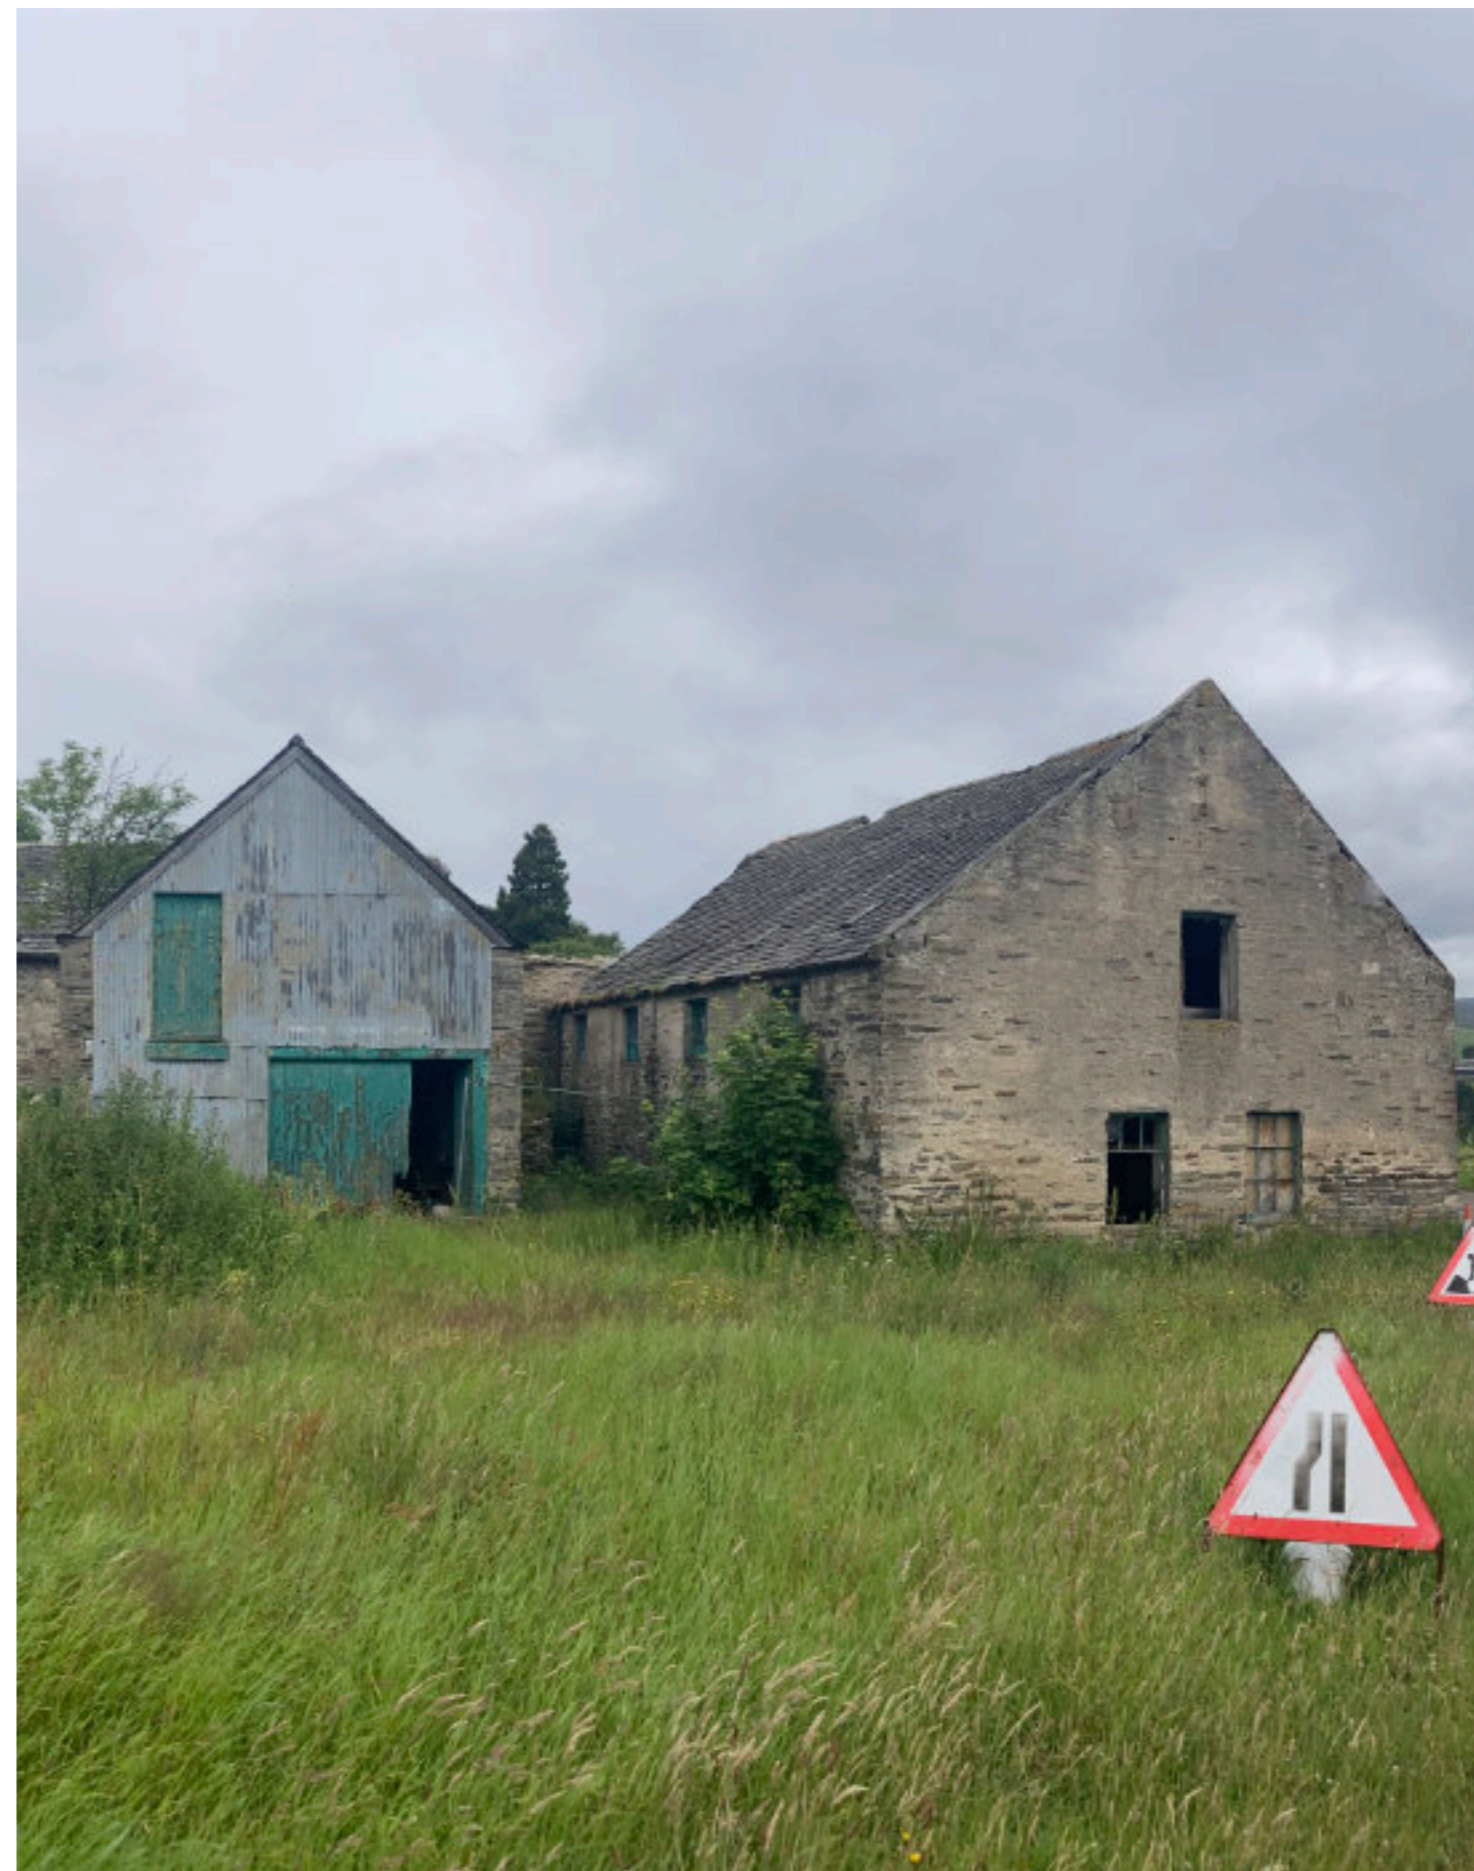
South gable of mill building

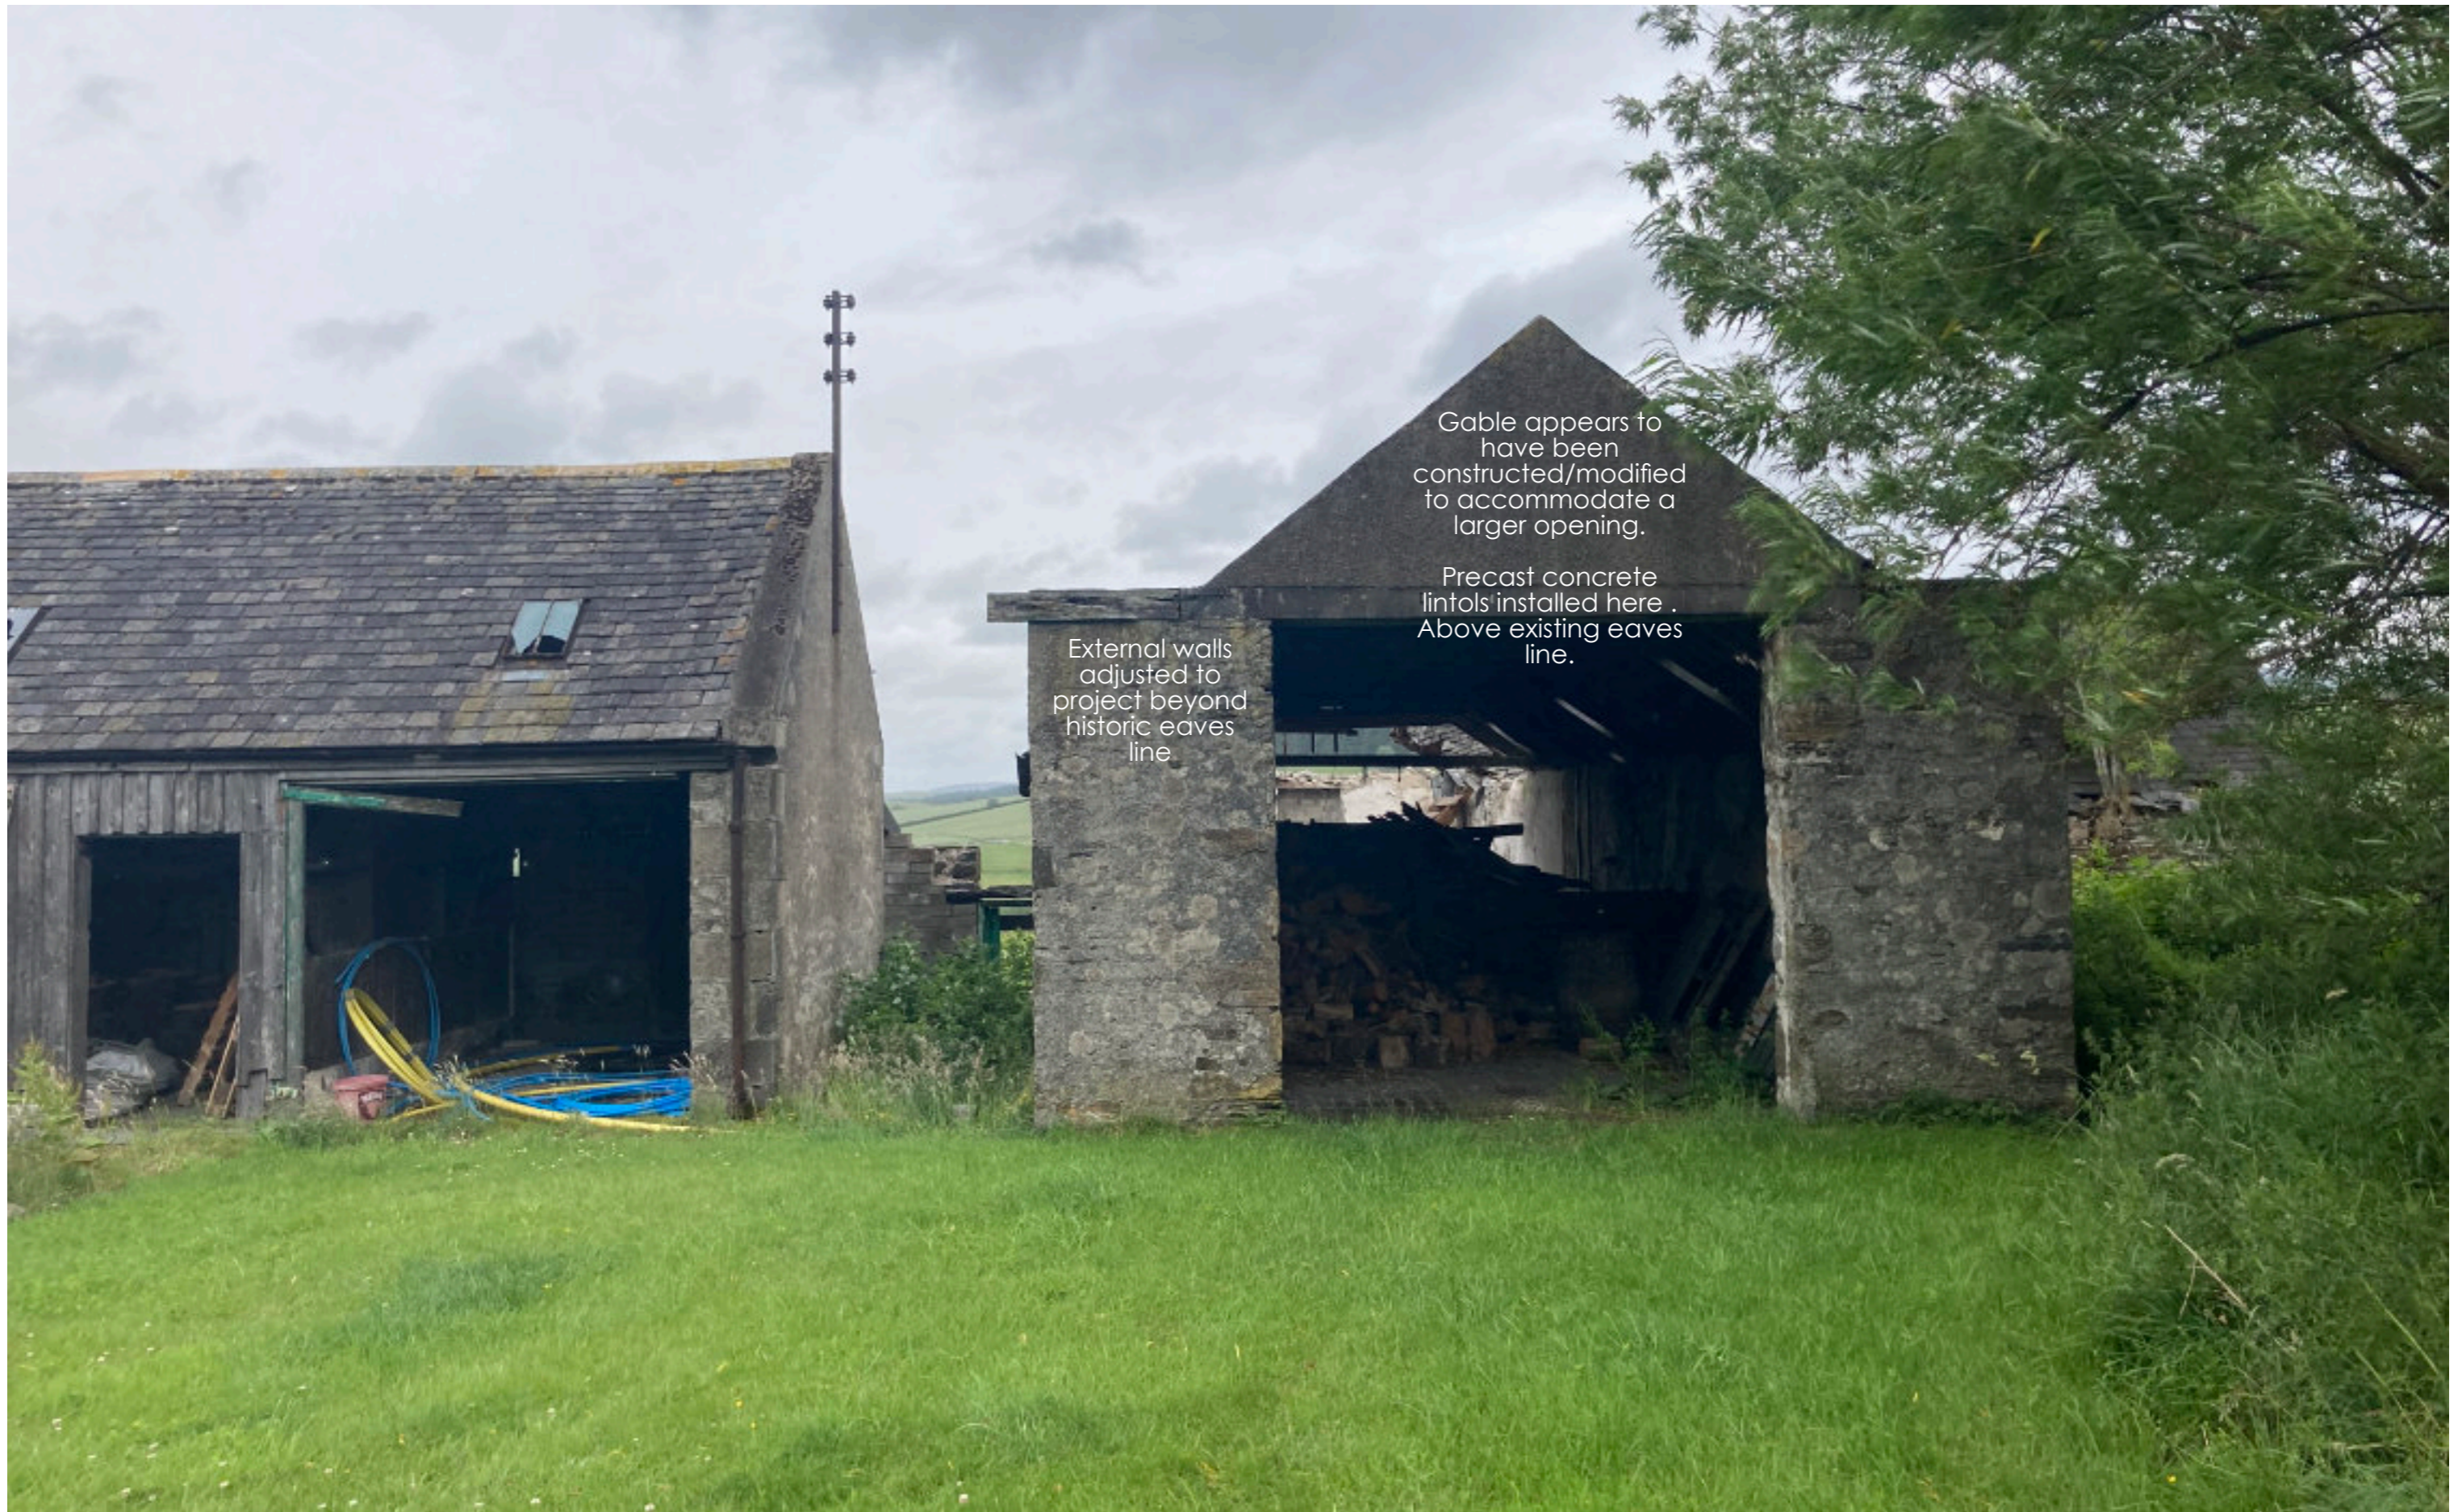
Existing West Elevation - Annotated

Ridge showing signs of movement / dropping

Gable to West elevation has suffered collapse, assumed at time roof has collapsed.

Remaining rainwater goods corroded / failing

Remaining timber lintols showing evidence of partial collapse/failure.

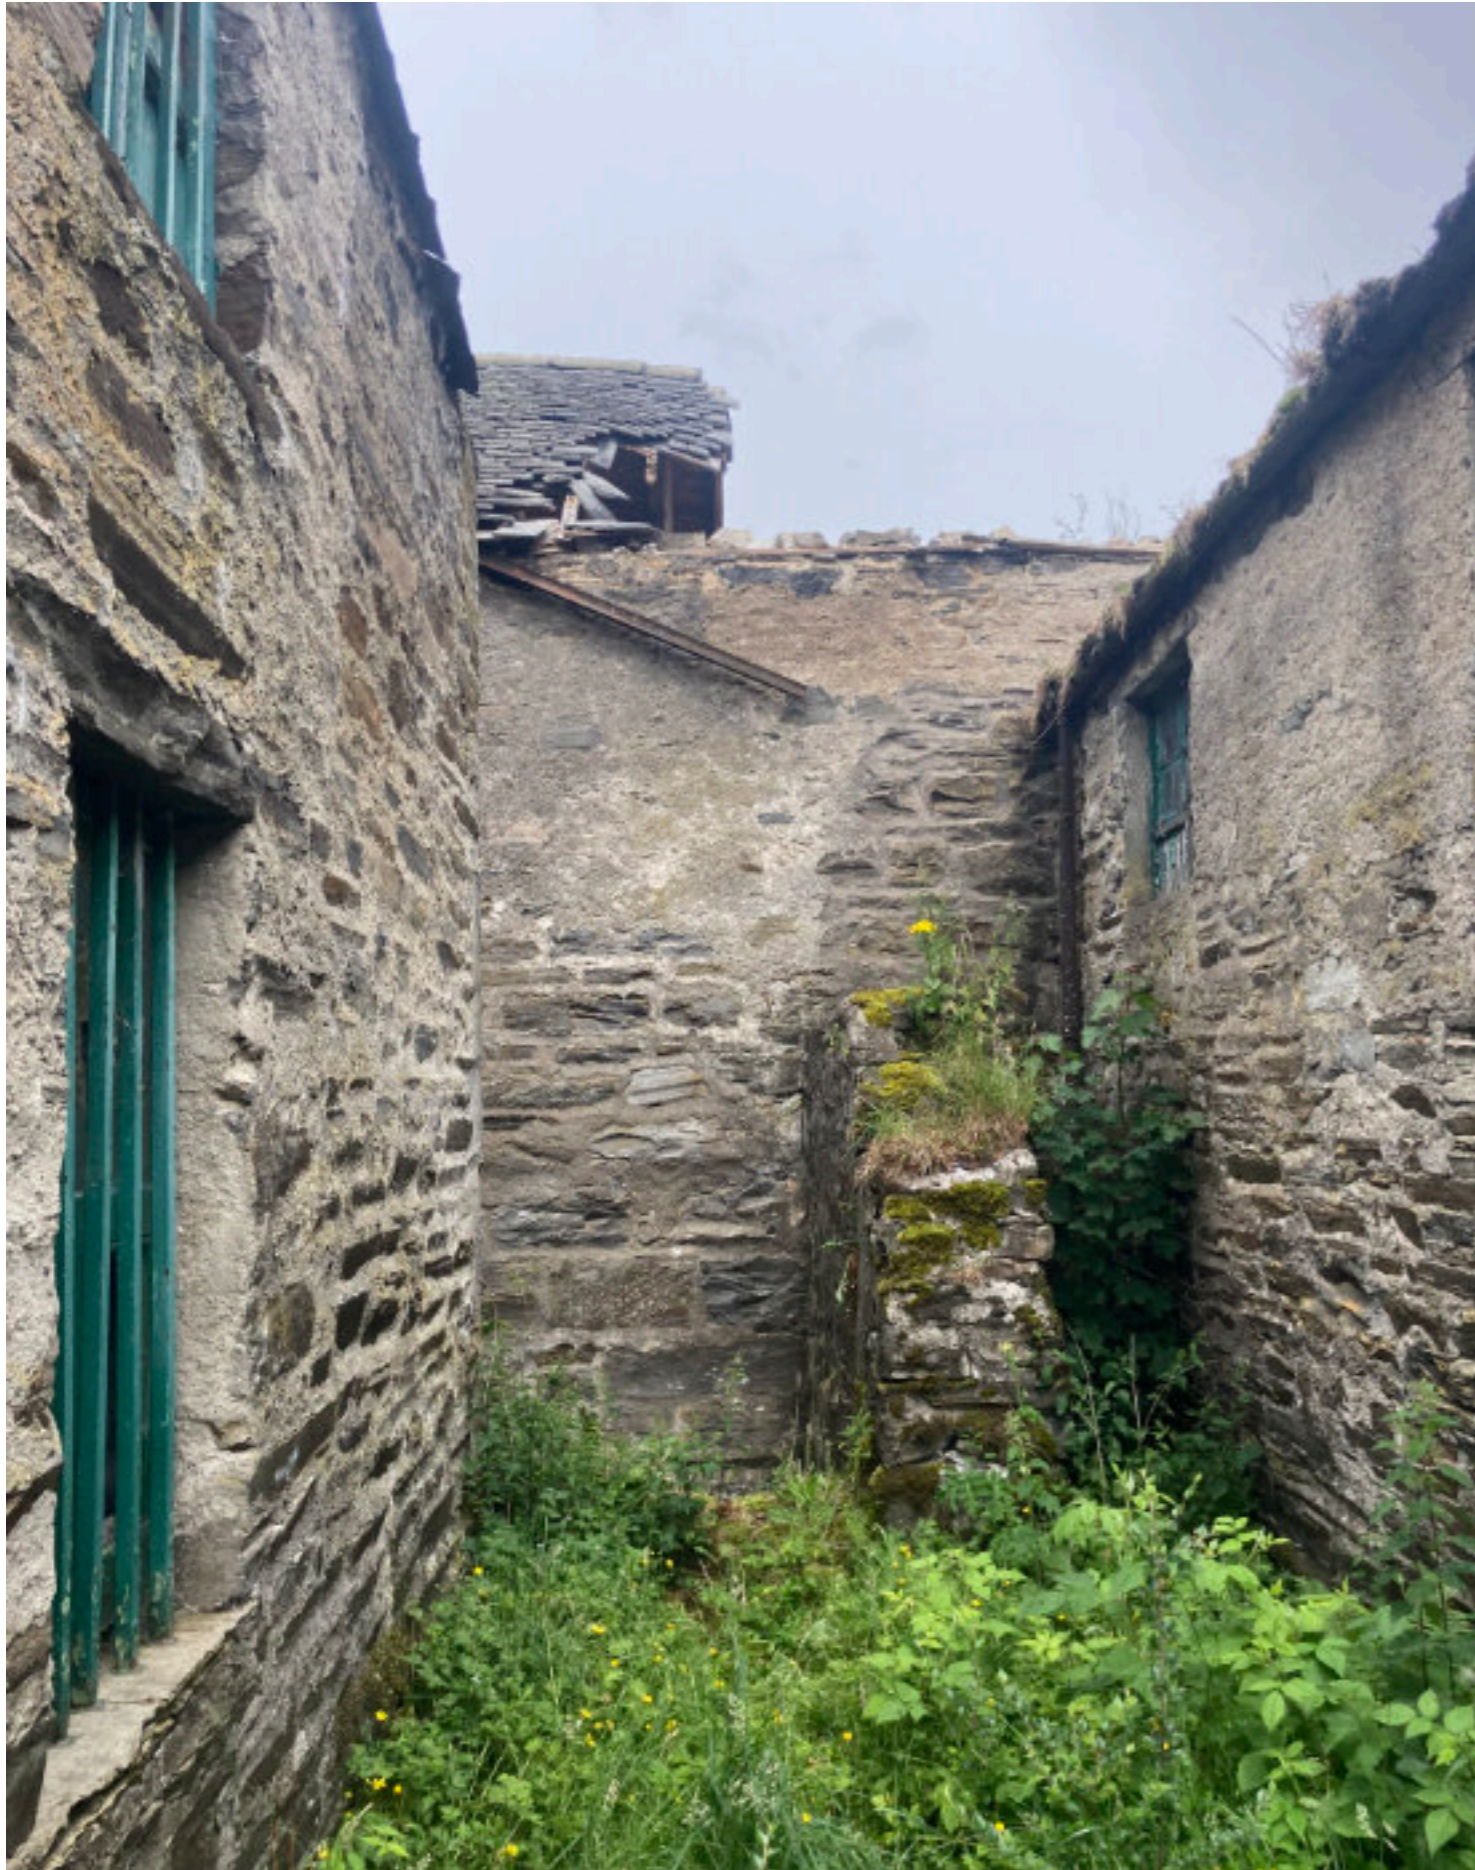
Area between mill and detached structure.

The freestanding structure to the South of the building has signs of significant cracking and movement, which would require this building to be at least partially demolished to ensure it remains safe.

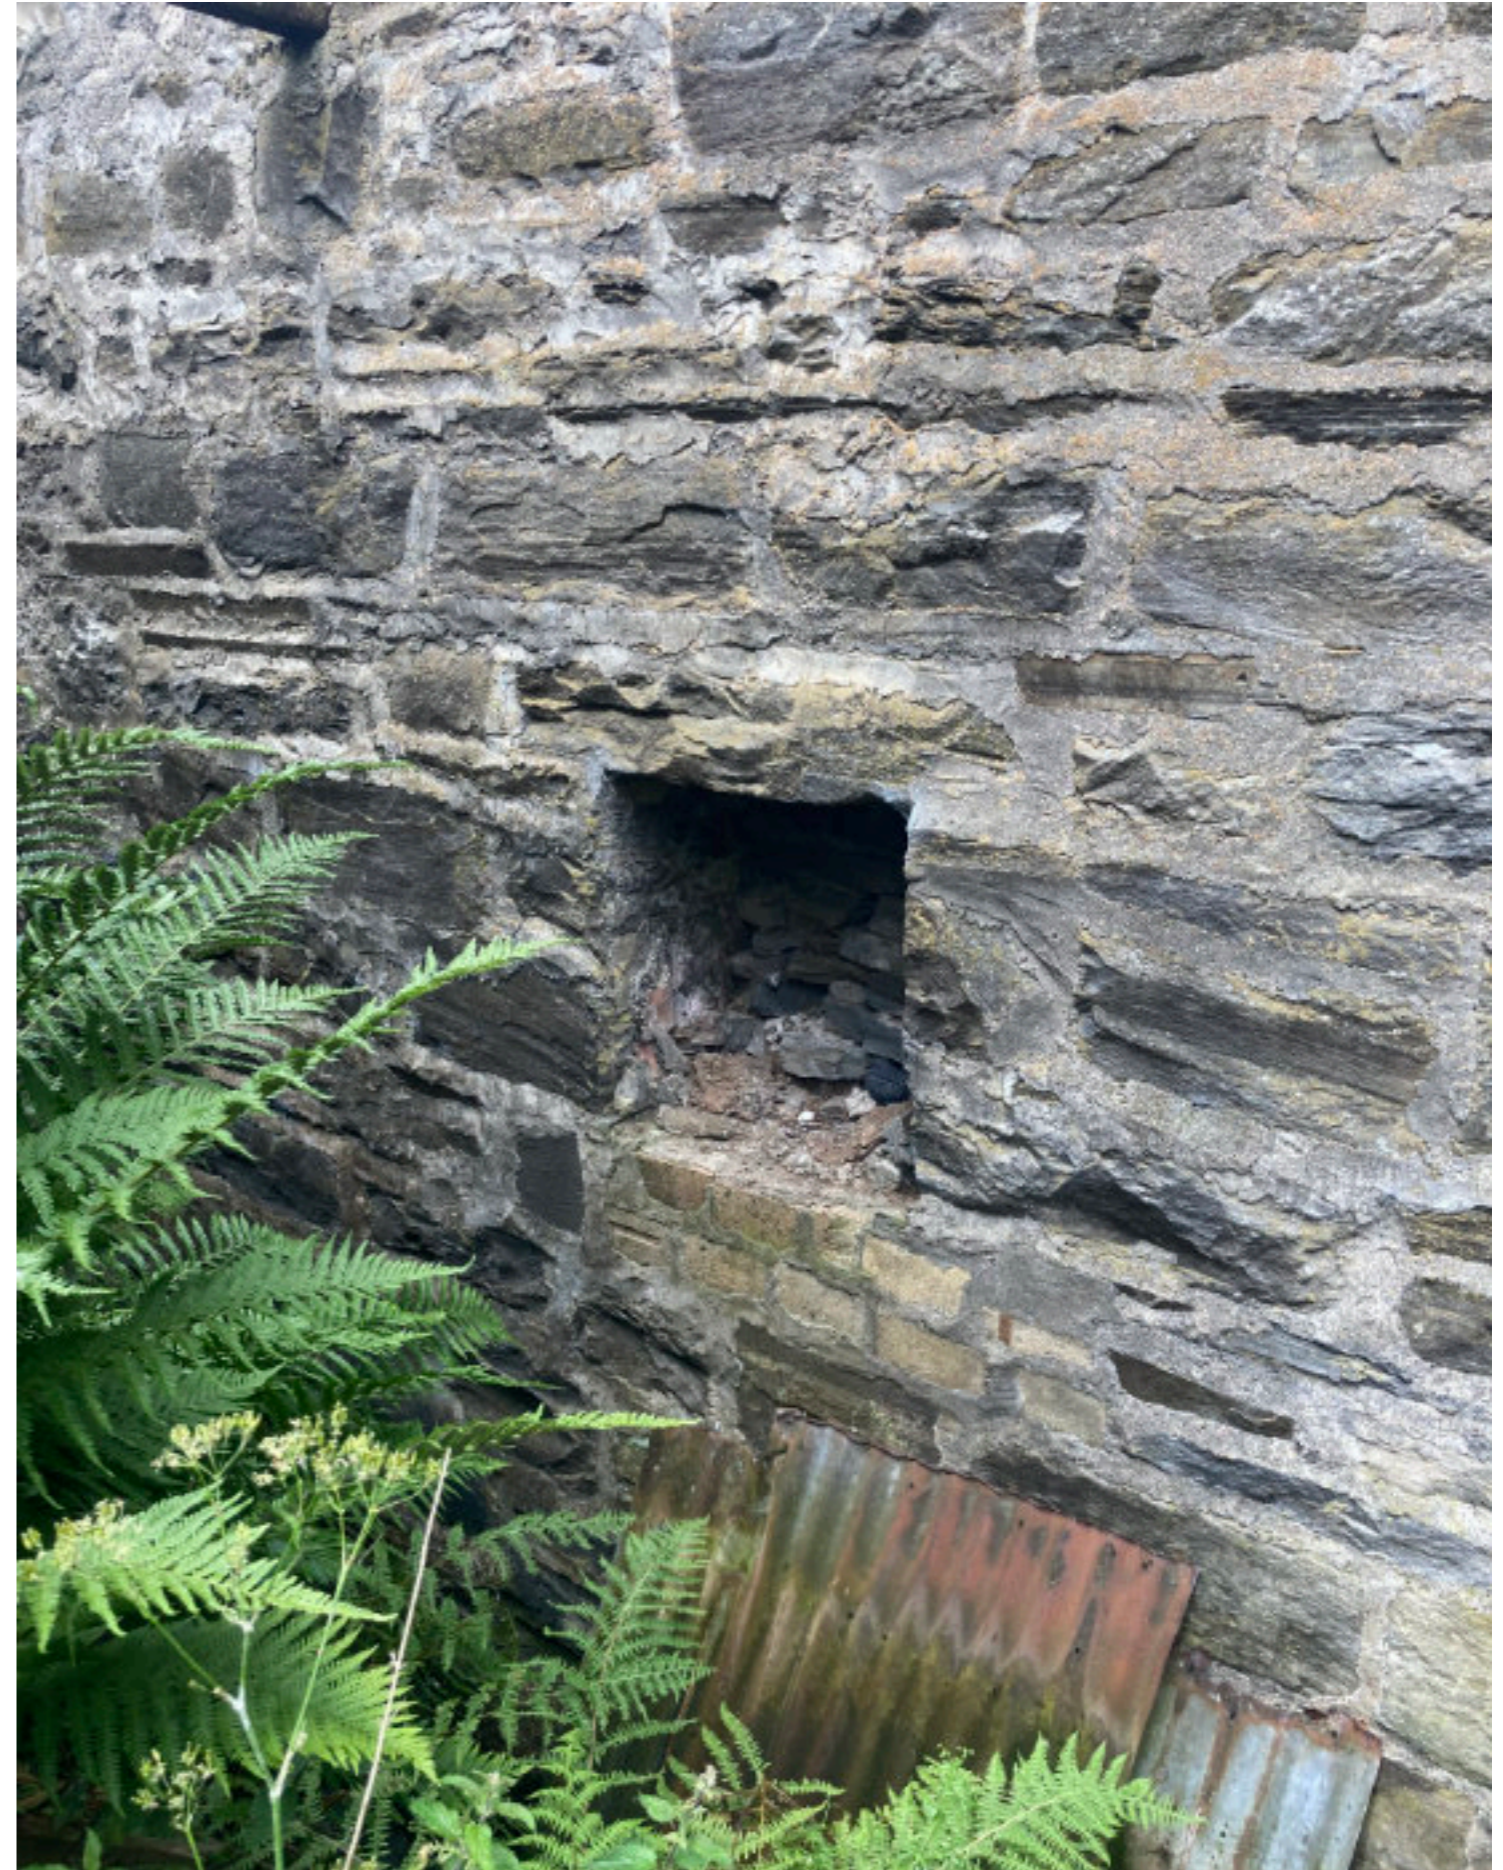
Historic mill wheel opening

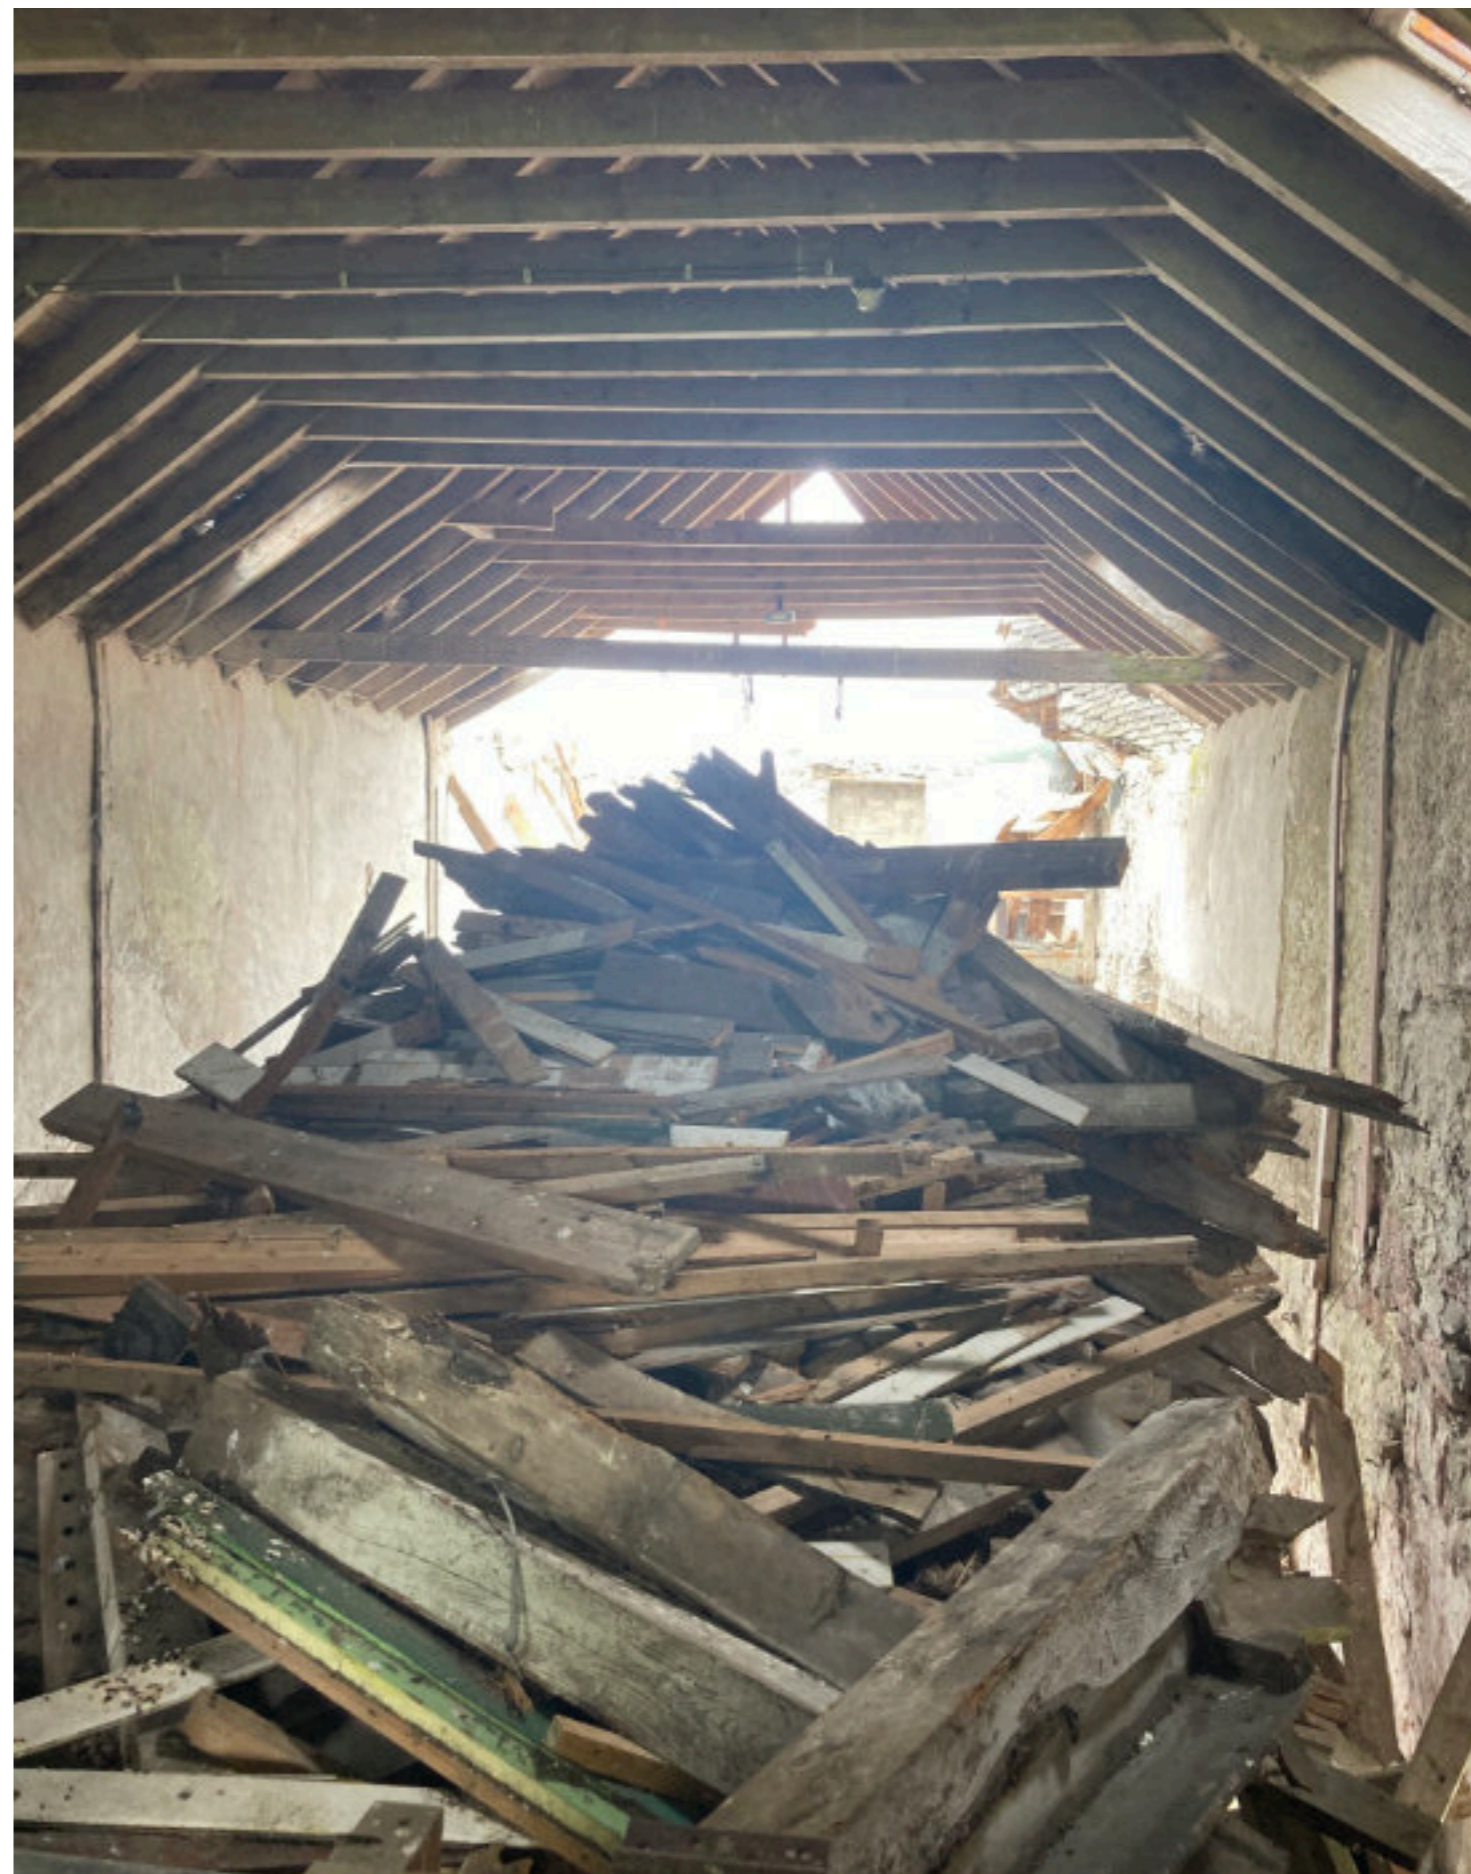
As a result of the collapsed roof and subsequent exposure to the elements for a prolonged period of time there appear to be no salvageable elements within the interior, with the majority of any remaining fixtures suffering significant decay.

Interior of mill from West access, upper level, looking East.

All internal timber from the building should be removed and disposed, as the extent of woodworm and rot is significant and widespread and there would be limited value in attempting to retain any of these timbers. This applies also to the existing doors and windows.

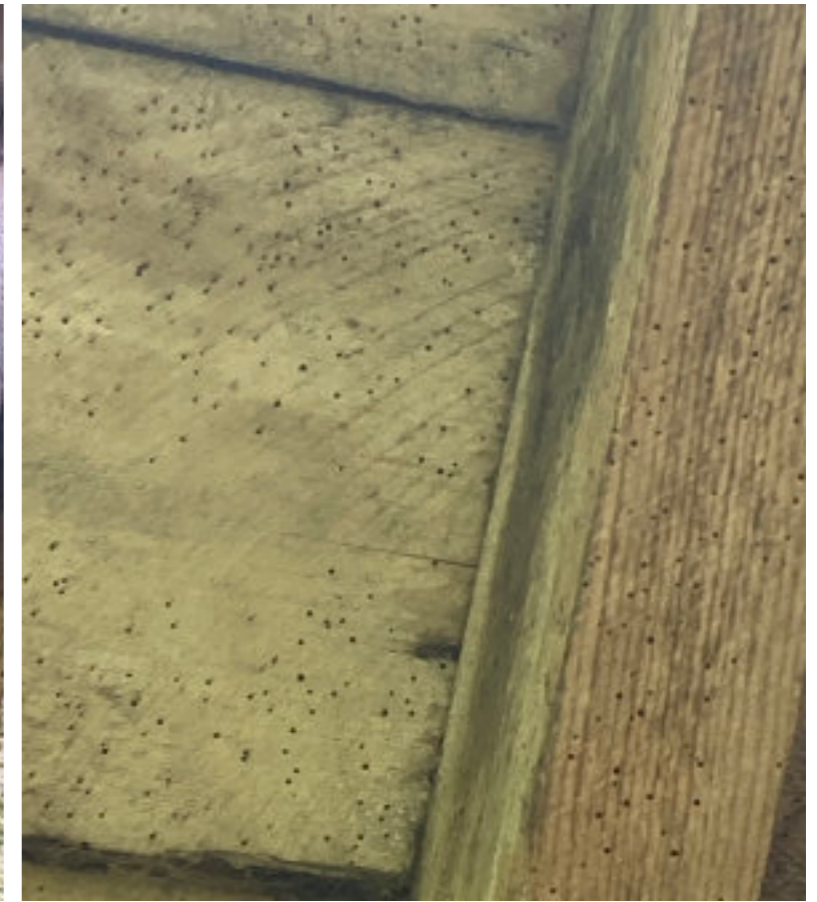
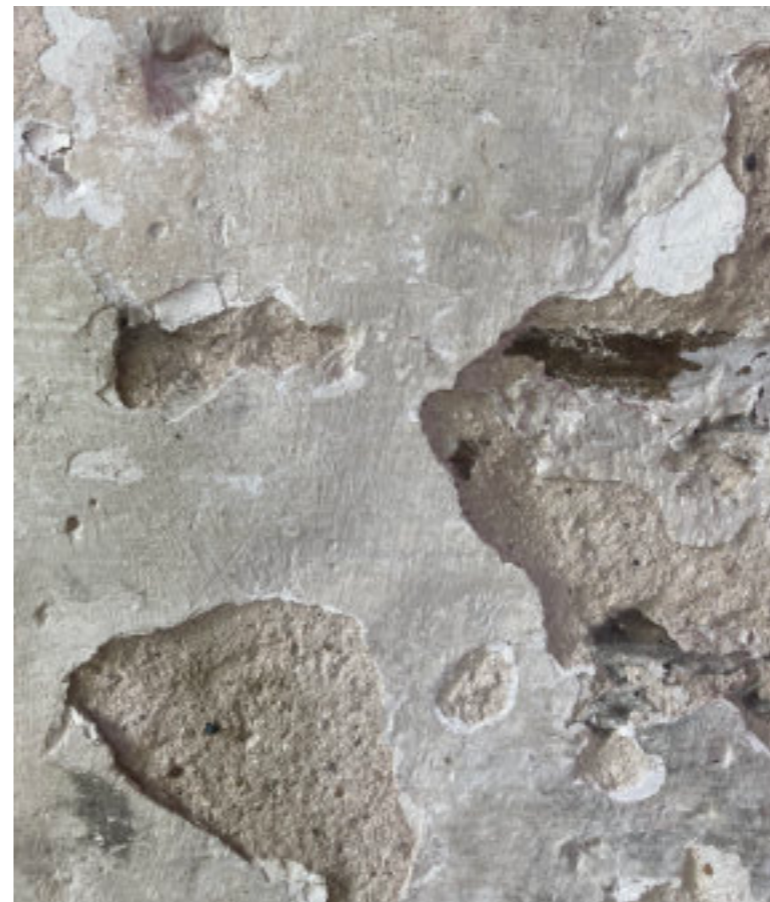
Internally the masonry walls generally appear to be in good condition, showing some evidence of having been lime washed or rendered historically. The walls to the existing 'L' shaped mill appear to be in relatively stable condition, with the exception of the collapsed gable to the West (assumed to have been pulled down by the roof).

Internal walls lime washed/rendered

Assuming these walls are suitable to be retained they should be picked of any loose mortar and render and prepared for repointing with a hydraulic lime-based mortar.

The walls are assumed to have no damp proofing and as such it is recommended that a tanking system is installed to the lower sections of the walls internally, as part of works to redevelop this building. In addition to this ground level externally should be reviewed to assess where possible to assess where it is possible to reduce these/remove damp ground from the building exterior. A 300mm well-draining gravel margin should be considered.
