# Arboricultural Report

Title: Arboricultural Impact Assessment, Arboricultural Method Statement and Tree Protection Plan, for the development of: 'Nostra Domus', Lyme Road, Uplyme DT7 3XA.

Date: 9 February 2024

Reference: APPA100124/1

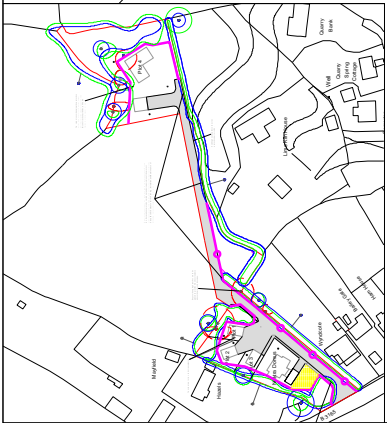
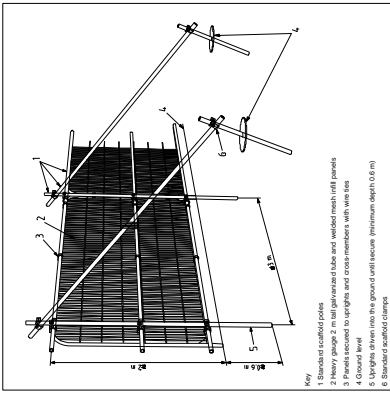
Site: 'Nostra Domus', Lyme Road, Uplyme DT7 3XA. 1:250 @ A2  
 Drawing Title: Tree Protection Plan (East elevation) February 2024

Tree crown is over hanging the protective barrier. However it is at 8 metres height which will provide adequate space below for construction activities, with a low likelihood of damage occurring.

Minor incursion of the access road into the root protection area of G1 and G4. Excavations are to be carried out under supervision of the project arboriculturist, and following the guidance set out in National Joint Utilities Group (NJUG) Guidance for the Planning, Installation and Maintenance of Utility Apparatus in Proximity to Trees - Issue 2.

Existing boundary fence to act as protective barrier to G4.
