DETAILS OF CRACK MONITORING

Level Monitoring Readings

Our reference: S87

Alleged subsidence at 11 Ketcher Green, Binfield, Bracknell, RG42 5TA

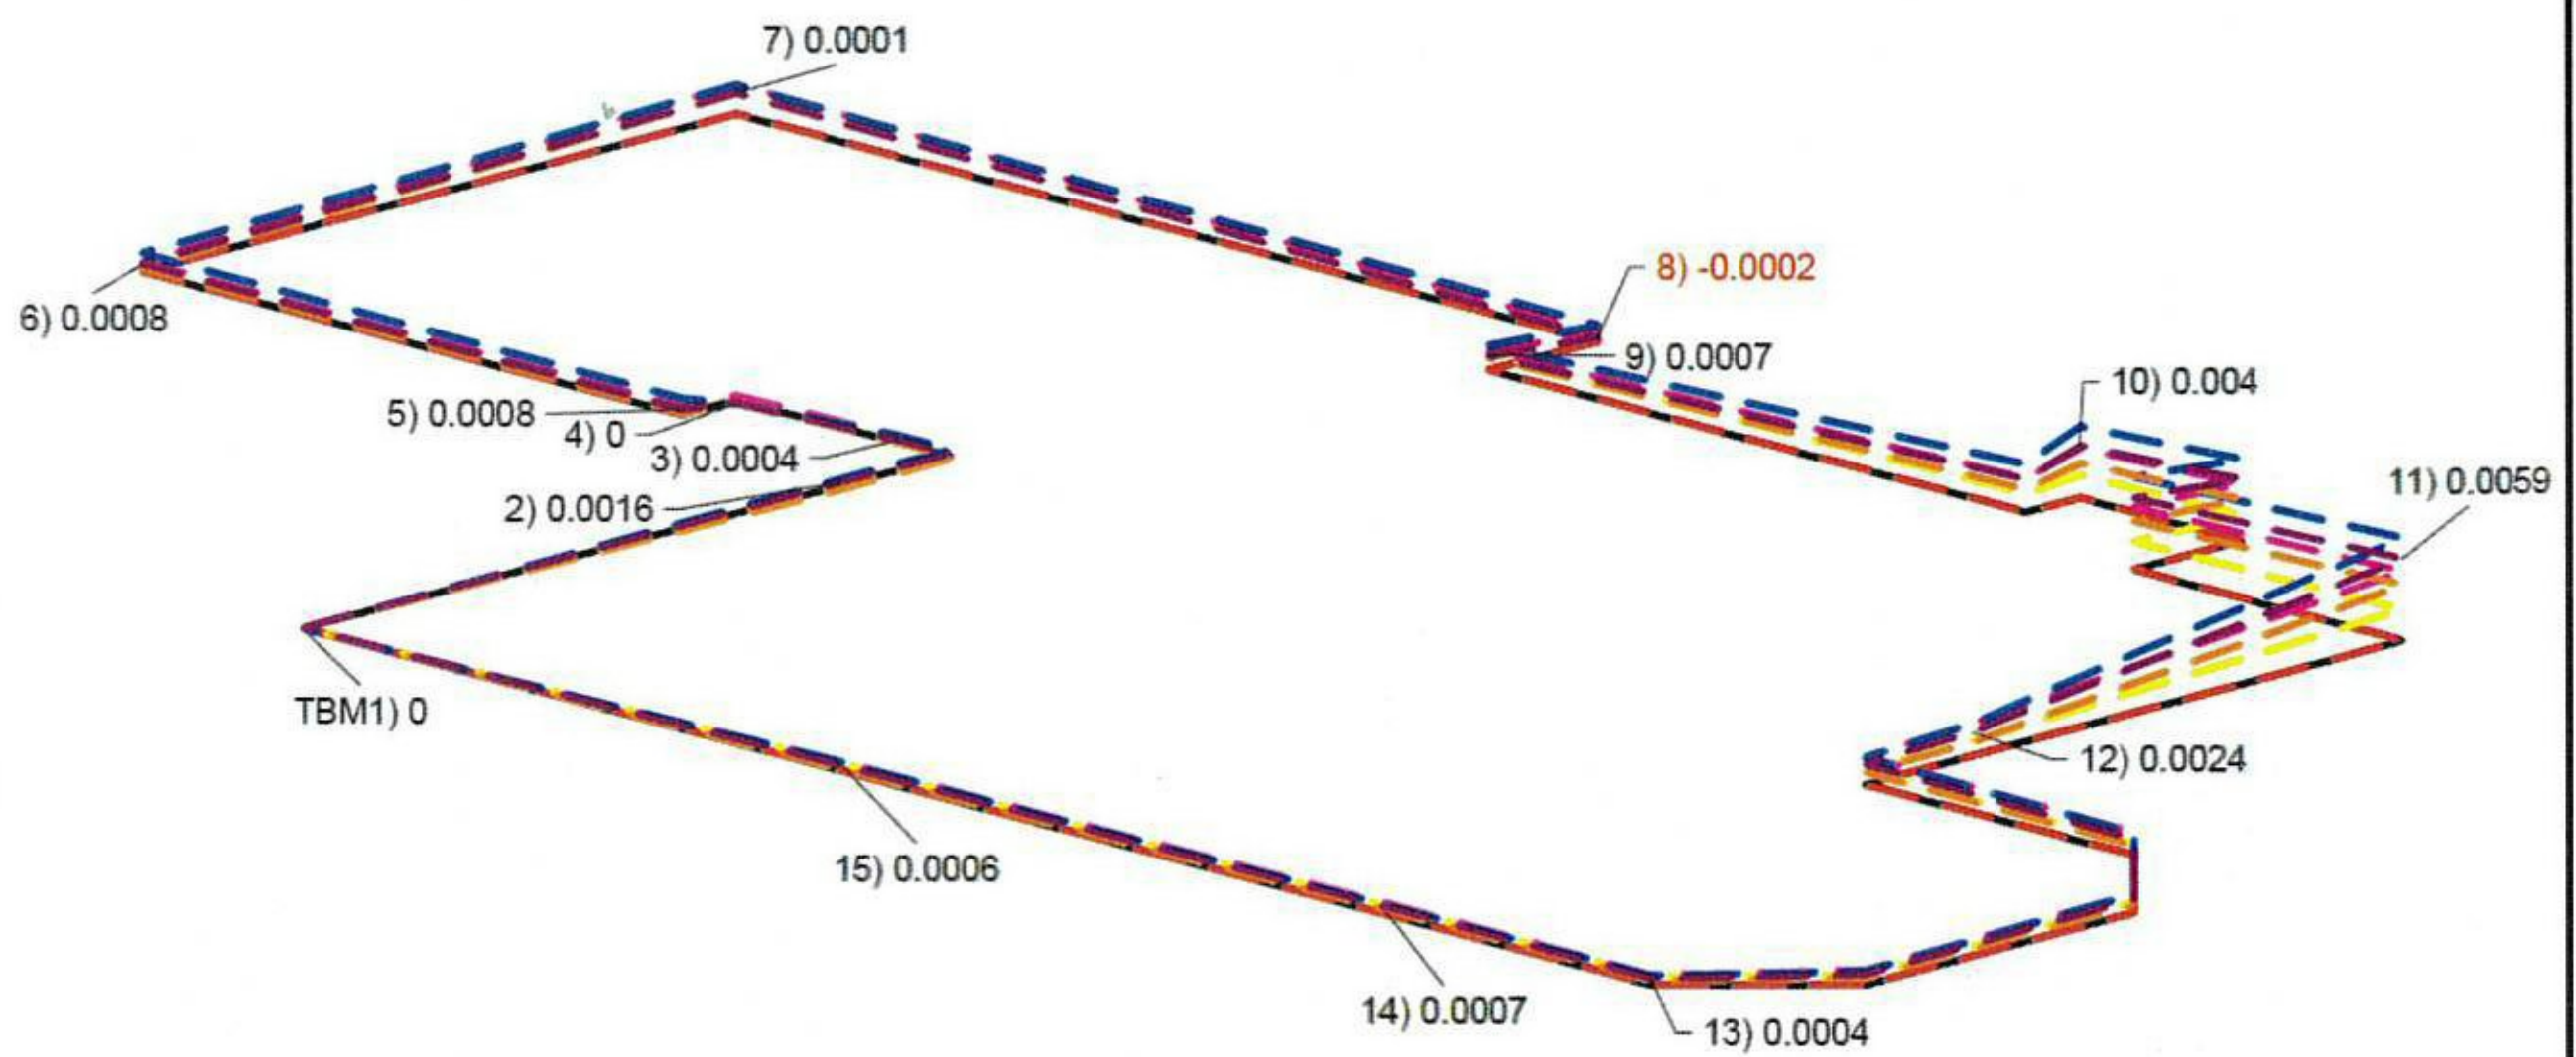
Movement Graphs

- 10. Level monitoring, which monitors the level of a building through time (usually on a single brick course), commenced on 13th September 2019 and the latest results available are for 5th January 2021 (Figure 5). The results demonstrate a seasonal pattern of foundation movement, with the building moving downwards in summer and upwards in winter. The maximum amplitude of movement is about 17mm at marker 11, at the rear left corner (Figure 6). This pattern of movement confirms that the building has been suffering from clay shrinkage subsidence damage, which has continued after the removal of T2, thus implicating T3 hawthorn, T4 Norway maple and T6 ash, which, in my opinion, should all be removed.
