## 1.0 About This Report

1 South Road,  
Kingsdown,  
Kent,  
CT14 8AQ.

Instructions were received from Jon More on the 16<sup>th</sup> November 2023 to undertake an invasive Building Survey and produce a report detailing findings to help inform the refurbishment of the property

The inspections were undertaken on the 12 & 19<sup>th</sup> December 2023 during cold and wet/damp weather conditions. The property was furnished but is generally unoccupied.

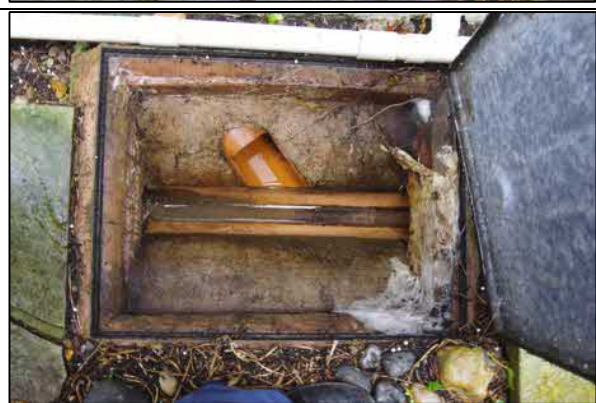
Inside the inspection chambers

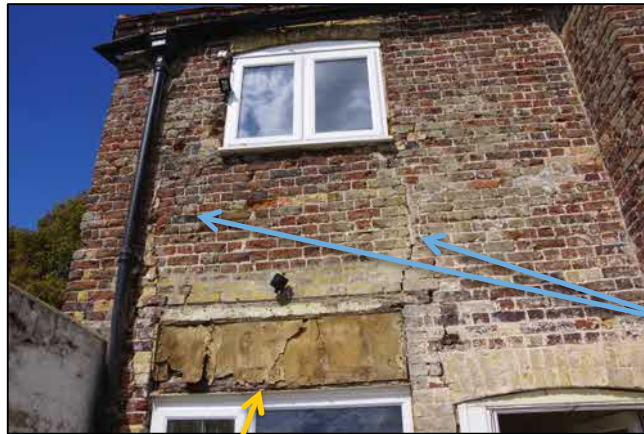
Example of cement removal and re-rendering ; Farmhouse

The full extent of the repairs only became evident after the cement was removed  
Vertical cracking between the structural openings

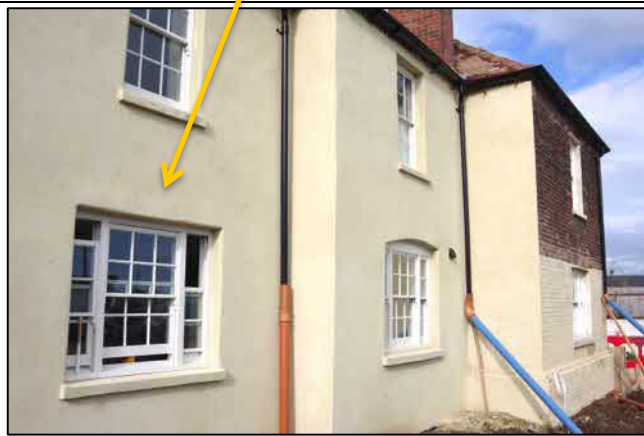
Arrowed yellow line is pointing at the during and after alterations and repairs

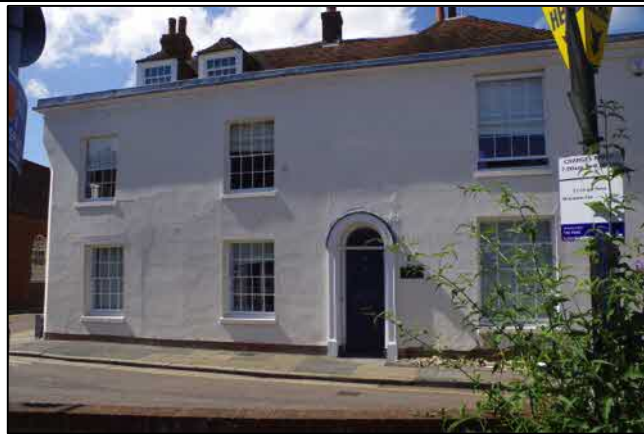
Example of localised repairs, including structural work; re-faced timber framed buildings

Before paint removal and localised structural repairs, including cracks between the structural openings

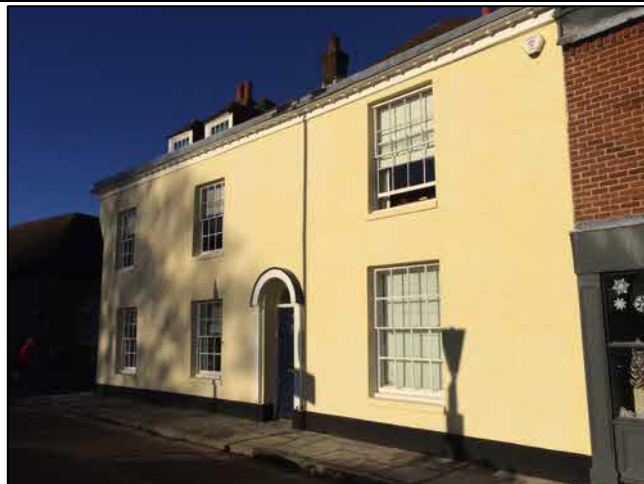
Final finish, after repairs

Note; the double refraction producing a glow in the early morning light
