BATTISFORD HALL

FARM BARNS

HERITAGE IMPACT ASSESSMENT

Date of inspection: 28th February 2017

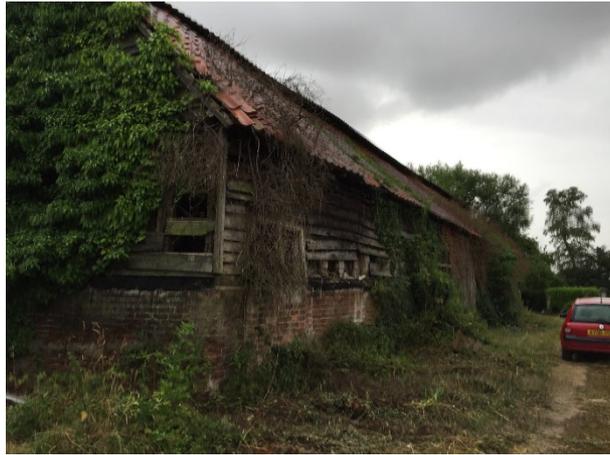
- 7.1 The two oldest buildings on the site are undoubtedly the so called "open Barn" building 7, and the northern end of building 10, currently used as a grain store. Photographs of the complex dated between 1975 and 1990 suggest that these were in recent times much better integrated with other buildings which have since disappeared or been demolished east of the barn.
- 7.2 Building 7 has a brick and flint plinth containing Tudor bricks typically 62mm x 225mm (2 1/4" x 9"),

giving a fairly safe suggestion that this is in-situ and pre 1600 or thereabouts in date. Datable bark adherence already alluded to in East Bay 3 may be able to date the construction with some accuracy. Two series of carpenter's marks, one earlier one to the main frame members and one eighteenth or nineteenth century one to side timbers in the west aisle suggest that the main timbers are intact, and that the aisle walls have been adapted at a later date. Given the historic record of a change of ownership in 1545, it is quite likely that this might have been constructed soon afterwards. The roof structure to the main barn has been replaced with a C20th lightweight softwood structure and asbestos cement sheet finish. The aisle roofs appear to be original with a 45degree pitch and covered on red pantiles with lath for torching on underside.

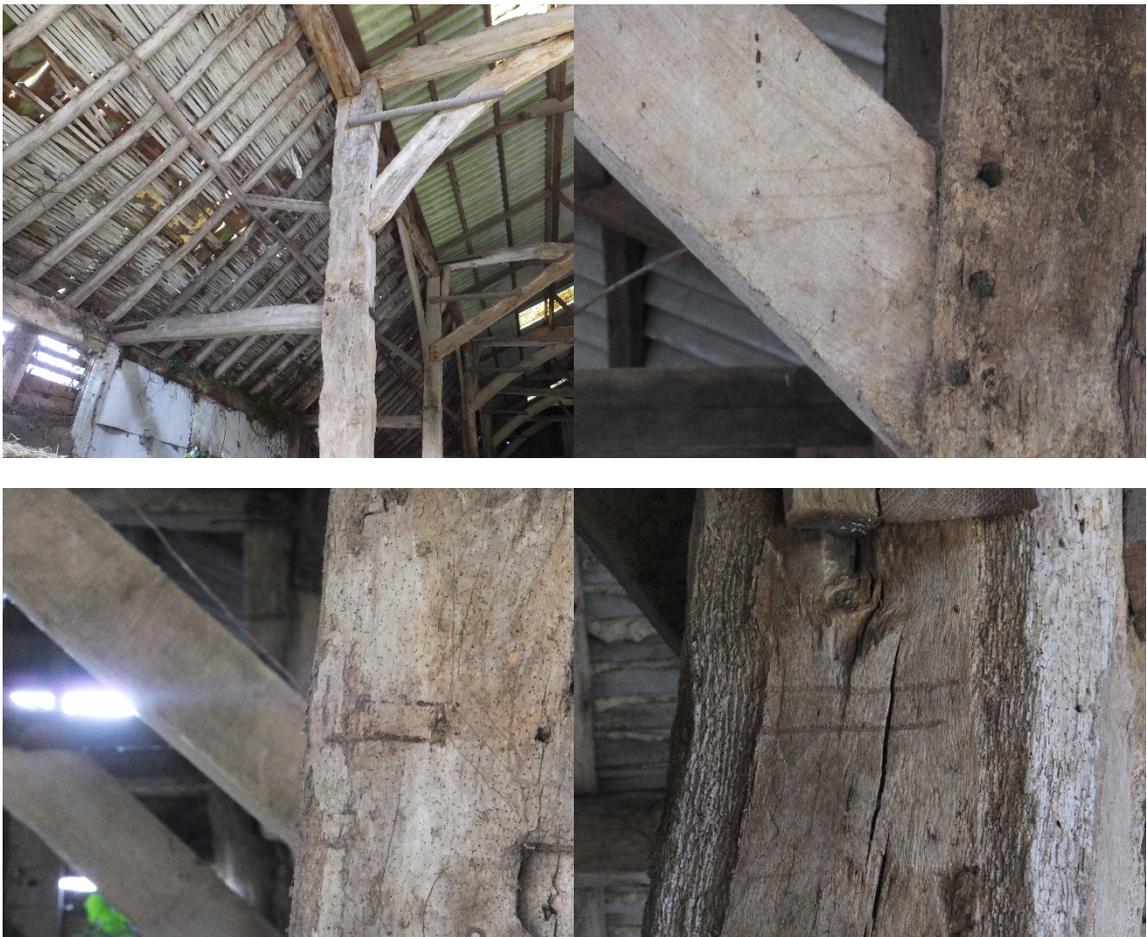
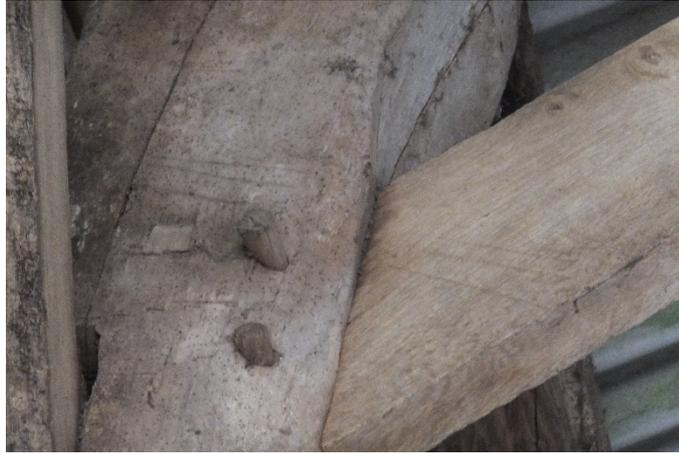
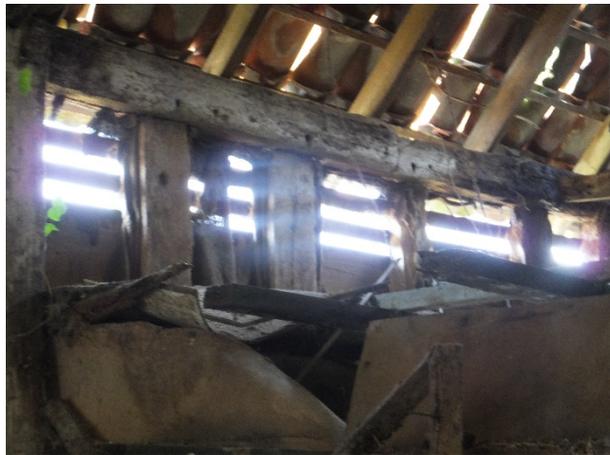
The wall frames have been heavily amended to the east wall, while the west side has retained its horizontal weather boarding. The upper part to this has however been amended to include slats for ventilation under the eaves (Appendices 3 & 4). Suggesting stabling for farm animals (see below)

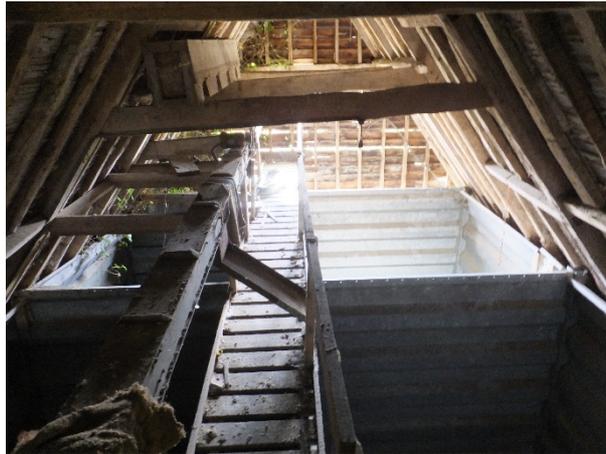
- 7.3 Building 10 is a short five bay barn with haunched posts and cross ties, with principle trusses in slightly tapering oak rafters clasped at the ridge, with three intermediate rafters per bay at approx. 18" centres, in approx. 5" round in scantlings, with upper ties between the lower main cross tie and ridge housed into the sides of the trusses. Lathes for torching mortar are in place on the topside, under the pantiled roof, with double purlins housed into the sides of the main truss timbers and curved lower braces between post and cross ties, all of which appear to be intact.

Corn storage bins prevented close inspection, but the storey height walls which support the posts and remaining timber framed construction are of flint rubble with red brick quoins with brick dimensions $2\frac{1}{2} \times 8\frac{1}{4}$ ", typical of early nineteenth century post standardisation. Diaper work in a diamond pattern created ventilation suggestion that this was erected as a storage barn.

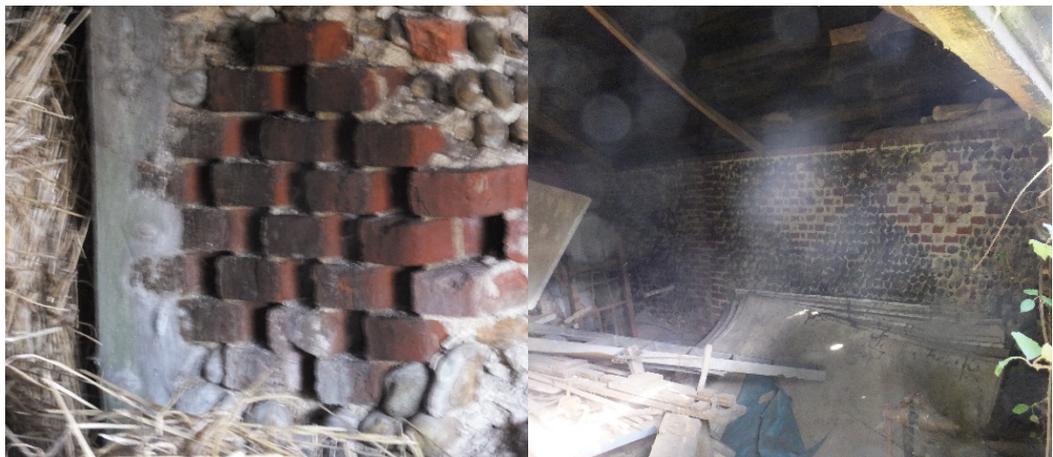
- 7.4 The northern end of barn 10 is earlier. This is a separate barn of five constructional bays (see appendix 5), all in oak, with trusses clasped at the ridge, supporting single purlins housed into the back of the truss timbers supporting common rafters, four per bay, also in oak, approx. $5\frac{1}{2} \times 4$ ", themselves supporting close softwood boarding with an asbestos roof finish over.

- 7.5 The posts where visible, each have two mortices for diagonal braces, although all of them are missing where access could be obtained to inspect, but none of the visible cross ties have mortices for braces. The wall framing is integral to the posts suggesting that these are of a single constructional date and in-situ. The roof structure is less certainly integral, but single purlins under each slope cover two bays each working inwards from each end, with the central bay common rafters supported by a short purlin each side, together with an additional introduced truss supported off the lintel beams over the cart entrances on each side. Although the roof structure appears to have been reworked, and additional trusses introduced in bays three and four numbering from the southern end, the main frame appears to be substantially intact and readable as an early structure, possibly early to mid C14th⁷⁸. Again, corn storage silos prevented close and detailed inspection. Further investigation of these is necessary once the silos have been removed.

10	Grain barn: older section: frame details	High	High	Re-inspect and record frame details once grain mechanism removed. Possibly high value building. may require further expert involvement to interpret once exposed.
	External envelope details	Medium	Medium	Urgent repairs needed to frame to retain integrity
	Southern most five bays: external envelope	Medium	Medium	Retain evidence of original usage in brick vents
13	<i>Clay lump apple store</i>	<i>Medium</i>	<i>High</i>	<i>Rebuild clay lump walls would be an idea, but building not in development area</i>

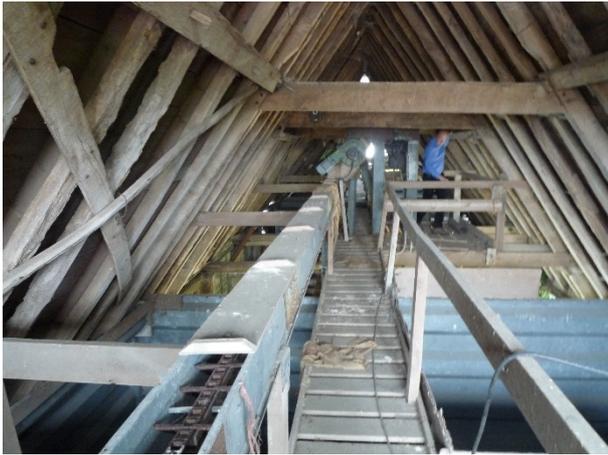
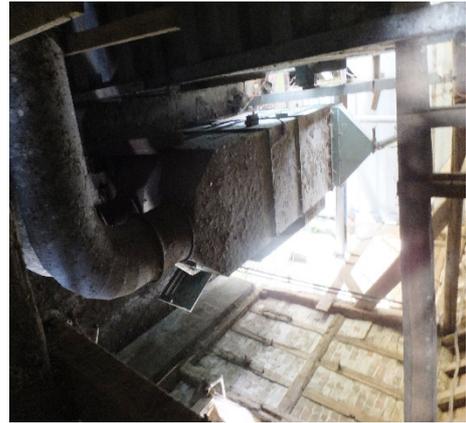
7.6 **Building 9:** which is tangential to Building 10 is much later in construction, possibly early C19th and has been altered and extended since to the south.

This formed part of a range of outshot buildings to the east side of building 10, the remainder of which have been subsequently demolished.

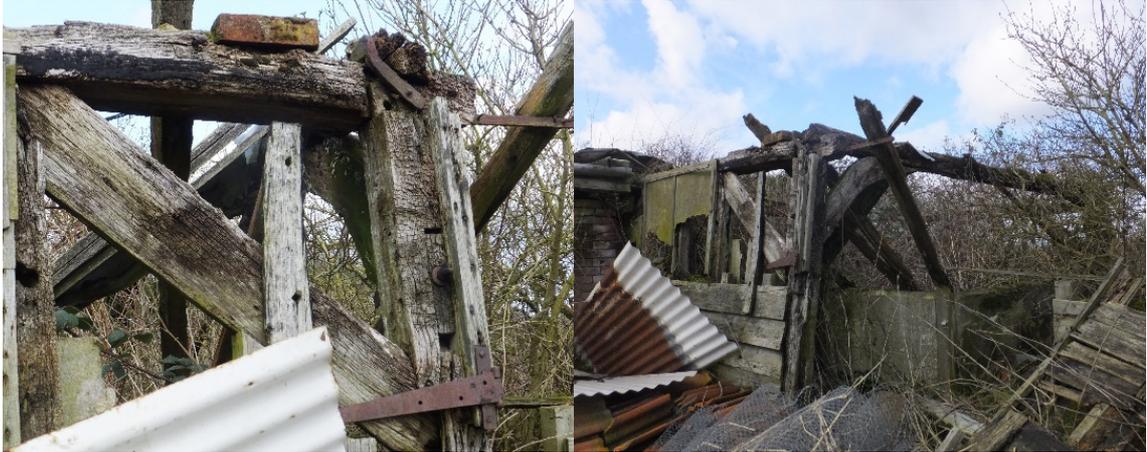
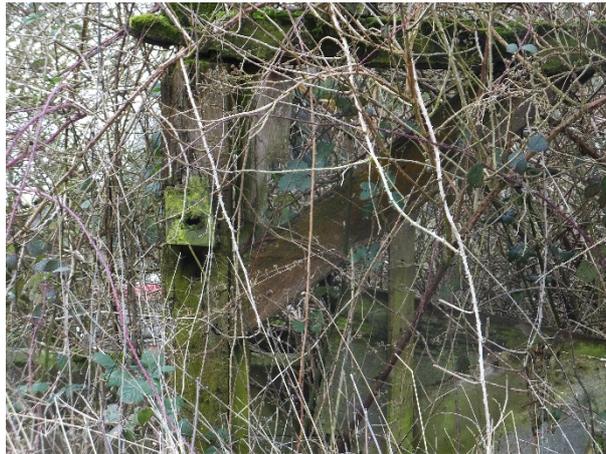
- 7.8 **Buildings 2 to 5:** form a group of narrow part timber framed buildings with outer walls in brick or clay lump construction. Clay lump is rarely seen in Suffolk buildings other than dovecotes and columbariums before 1830 and its peak of use in agricultural and domestic structures was probably 1840 to 1860, when arable farming was at its peak and fired bricks expensive due to taxation. This might be a reasonable date to give to this group of buildings, although the derelict building 5 retains elements of a circa C17th timber frame in its eastern gable, with an unusual corner truss detail where the tenon passes through the mortised corner post with a wedged end to retain it (see below and Appendix 6).

Building	Item	Value	Risk	Mitigation
2-5	General arrangement	Low	Medium	Retain sense of enclosure and courtyard.
4	Original layout: development from open fronted horse bye. Possible evidence of earlier development	Medium	Low	Record as found during alterations
5	Unusual timber details in derelict structure	Medium	Low	Derelict structure. Record, photographically
5	Open layerage: possible earlier floor beneath concrete	Low	Low	Record as found, salvage if possible
6	Mill: good structure in original condition	Medium	Medium	Retain as much structure as possible in conversion, remove later excrescences to enable better reading of original structure
7	Open barn: structure	Medium	Medium	Repair derelict parts to retain integrity
	Carpenters' marks	High	Medium	Ensure cleaning does not erase marks
	Datable timbers	High	Low	Retain dating evidence if at all possible
8	Piggery: building proportions	Low	Low	Retain sense of proportion in any new work
