Arboricultural Impact Assessment

Old Brickyard Farm, Great Horwood Road, Winslow

Bloor Homes South Midlands

JBA 21/303 AR01 Issue C

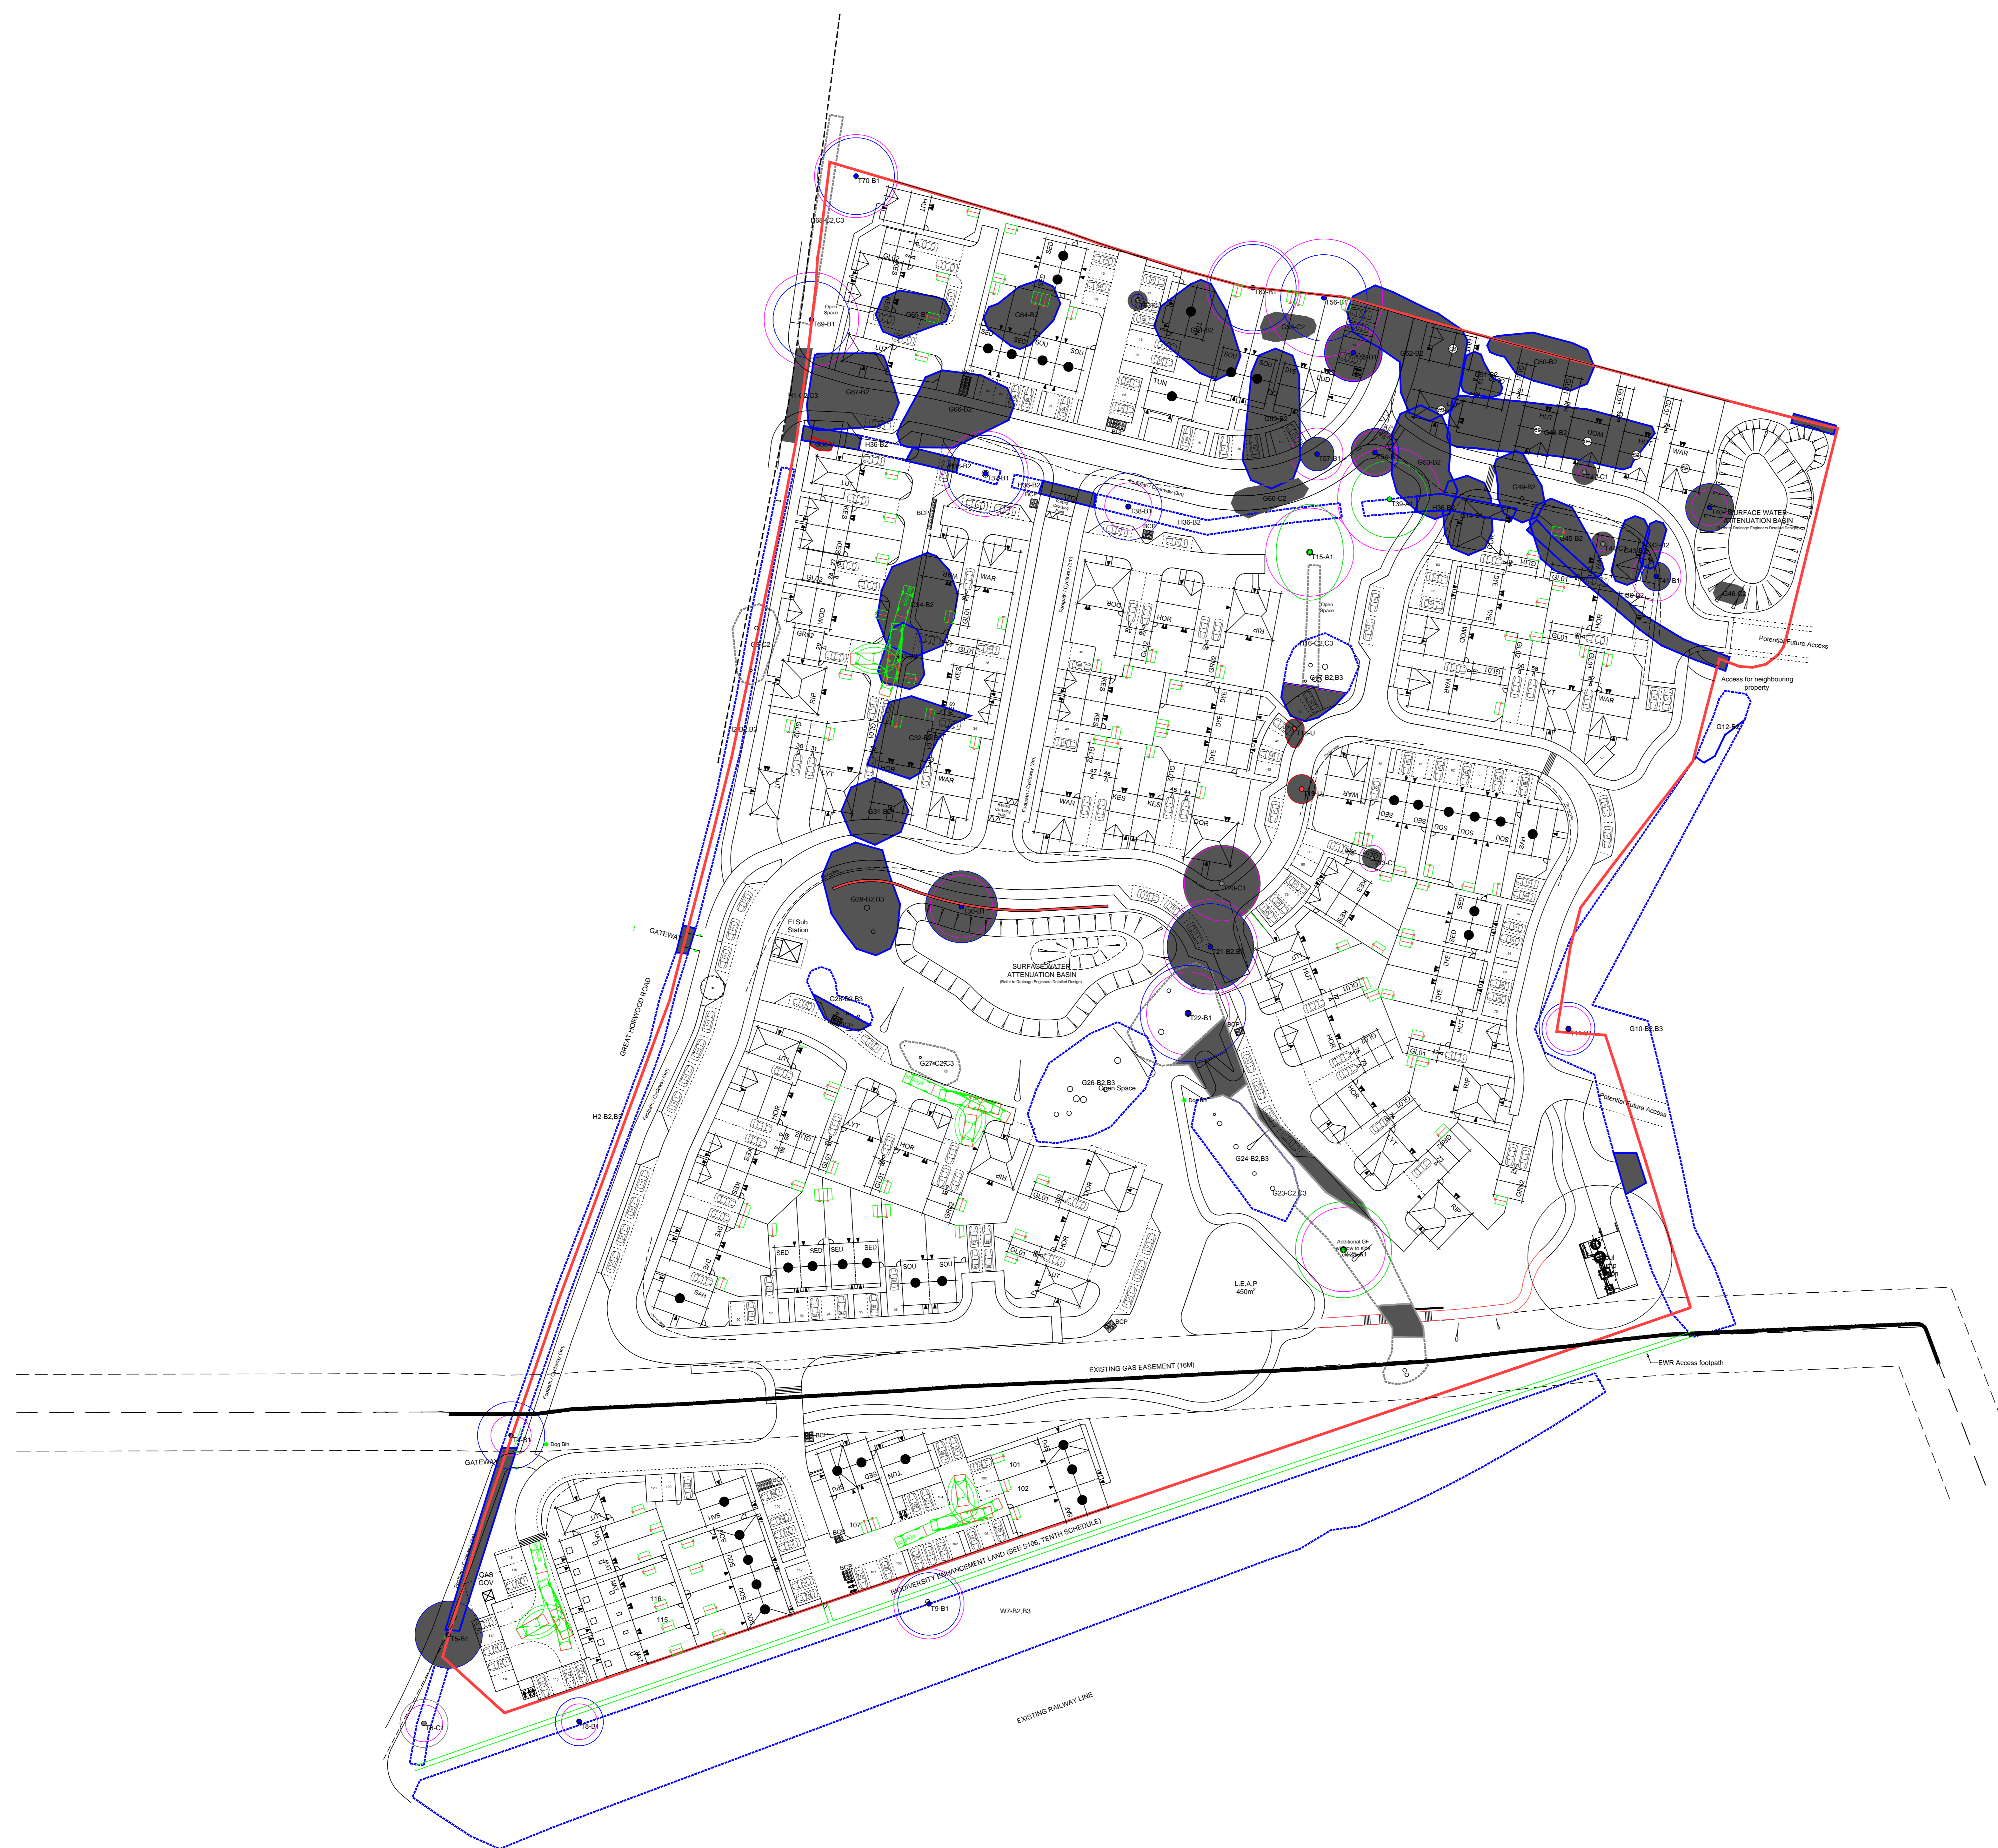
- 6.6 In order to implement the proposal, it will be necessary to remove a total of 44 trees, hedges or groups, as specified in the table below:
- Three tree features T18, T19 and G35 are recommended for removal irrespective of development. Due to a life expectancy of below 10 years.

- 6.10 Parking spaces and hard surfacing encroach into the precautionary root protection area (RPA) of T70, mature silver birch.
- 6.11 Parking spaces encroach into the RPA of T56, a mature white willow.
- 6.12 Due to the construction of hard surfacing running beneath the crown of the tree a cellular confinement system will be used to form a “tabletop” which will then be finished with permeable block pavers or other porous wear layer.
- 6.13 Edges will consist of staked railway sleepers to avoid any excavation for kerbs within the RPA.
- 6.14 A small area to the west of T62’s RPA will be excavated to install hard surfacing and construct building foundations. The risk of root damage in such a small area is considered to be negligible provided the excavation and construction is carried out under supervision.

- 6.25 Due to the significant loss of canopy cover throughout the site, it is recommended that the development proposals include a comprehensive landscape strategy which includes significant tree, shrub and hedgerow planting.
- 6.26 As part of the proposals a significant number of new trees will be planted at key locations throughout the development.
- 6.27 These new trees offer the opportunity to compensate for tree removals and enhance the retained tree population, ensuring the continuation of visual and green amenity for future generations.
