Whitfield Court, Littlewick Road,
Knaphill, Woking. GU21 2JU
Heritage Statement

Woking Borough Council
April 2022

Heritage Statement

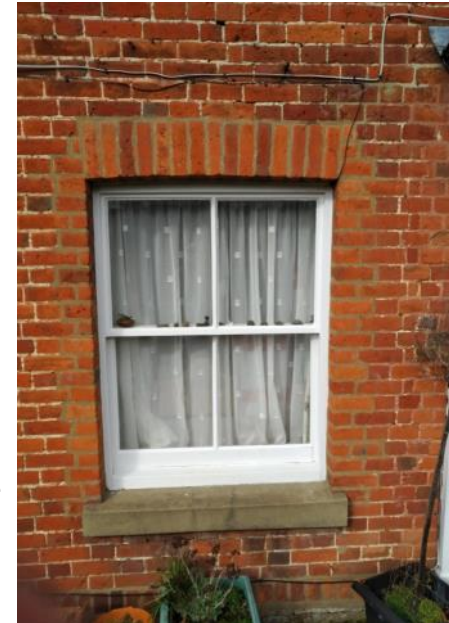
Figure 5.24: Showing the later window to the west of the current main entrance. Note the reformed window opening.

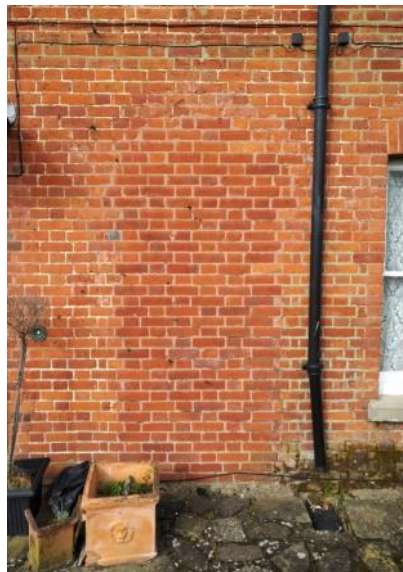
Figure 5.25: Showing the former location of the former central entrance, since infilled. Note the brickwork is a slightly darker hue.

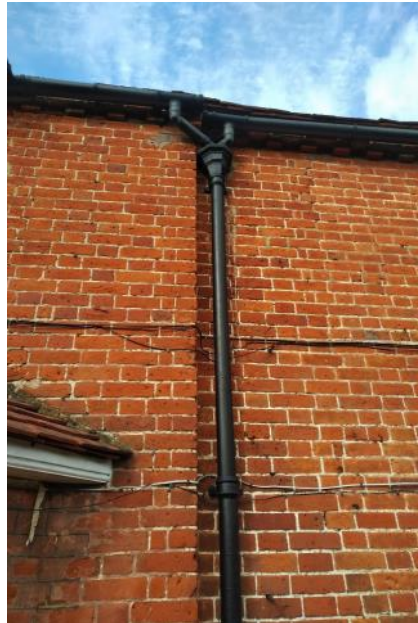
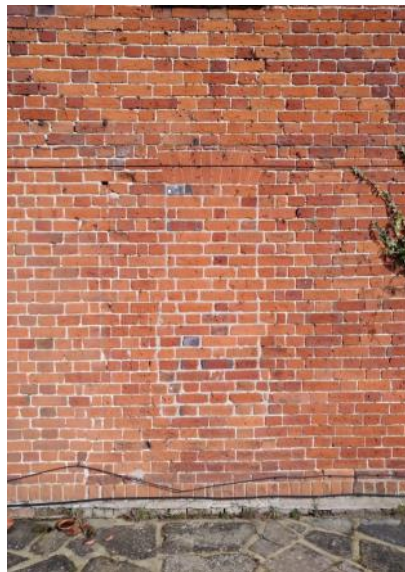
Figure 5.27: Showing how the front elevation is slightly steeped forward to its western and eastern ends. Also note the uPVC guttering and the cables attached to the brickwork.

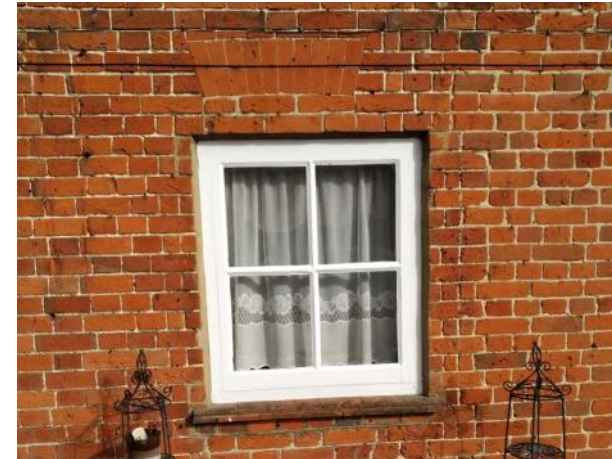
Figure 5.32: Showing the northern ground floor window to the Front Range's western elevation. Note how the window is wider than the head.

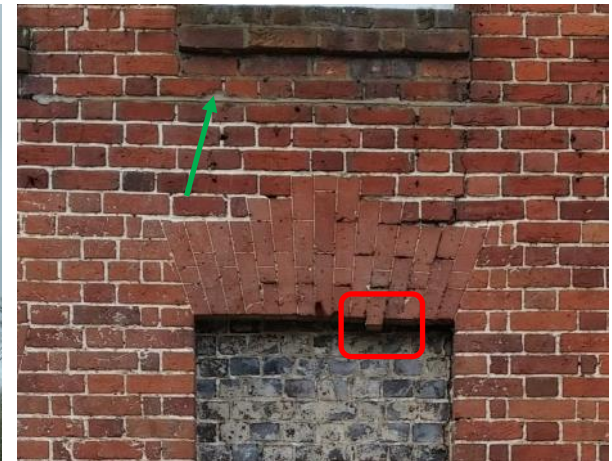
The brickwork on the eastern elevation retains evidence of being rendered at some point. This is potentially the

Figure 5.38: Showing the head to the central first floor window to the Front Range's eastern elevation. Note the collapsing brickwork (marked red) and the junction of the previous conservatory (marked green).

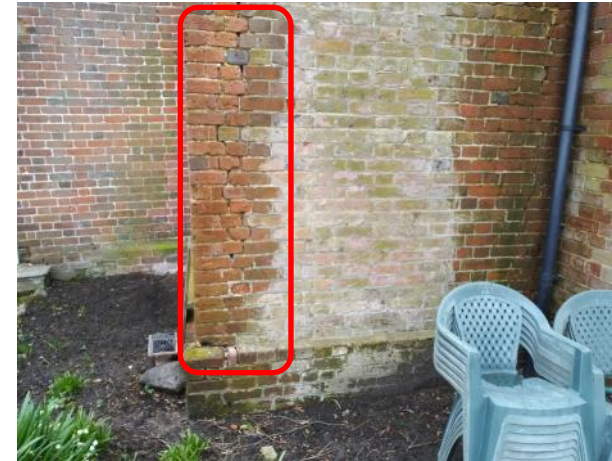
To the western side of the stair core one of the brick dentils is damaged and has partially fallen off. A section of brickwork to the western elevation of this stair core diminishes from a full brick height to nothing along the course of bricks, potentially indicating a structural compensation as a later repair due to structural movement.

A downpipe is missing to the western elevation of the Georgian stair core. This is leading to the elevation brickwork becoming saturated. Above is low-grade uPVC guttering that detracts from significance.

The brickwork to the western side of the rear elevation appears to have structural movement. There are also some bricks missing and several cracks in the brick plinth.

Figure 5.44: The brickwork to the western side of the Georgian stair core appears to have structural movement.

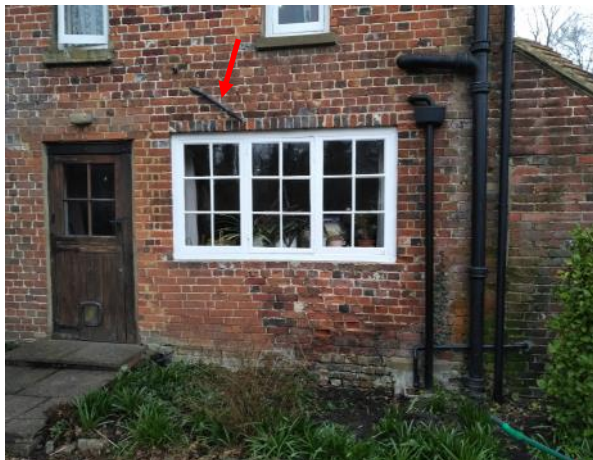
Figure 5.56: Showing the window to the eastern side of the Rear Range. Note the incongruous pipe (marked in red).

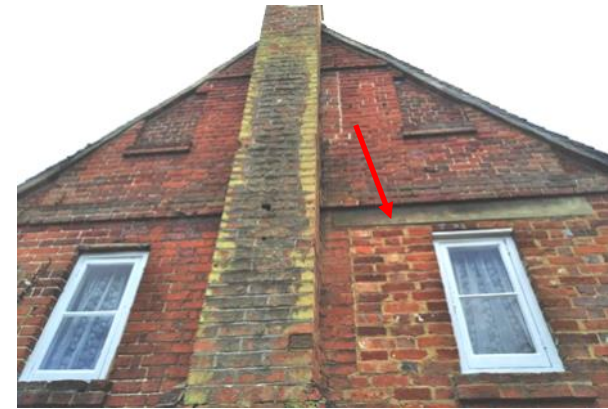
Figure 5.63: Showing the first floor of the Rear Range's northern elevation. Marked in red is the concrete lintel from a former window.

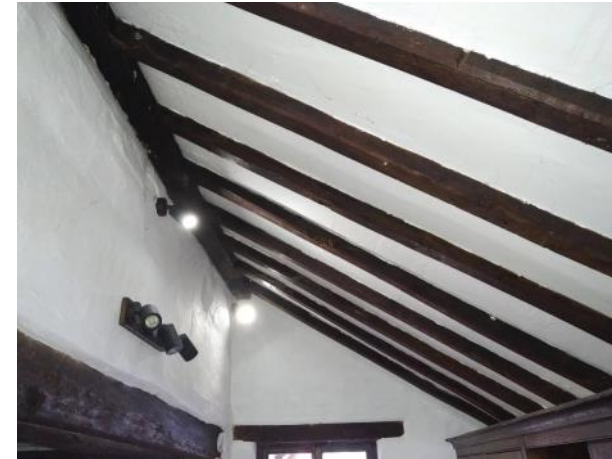
Figure 5.77: Showing the monopitched roof above the Kitchen.

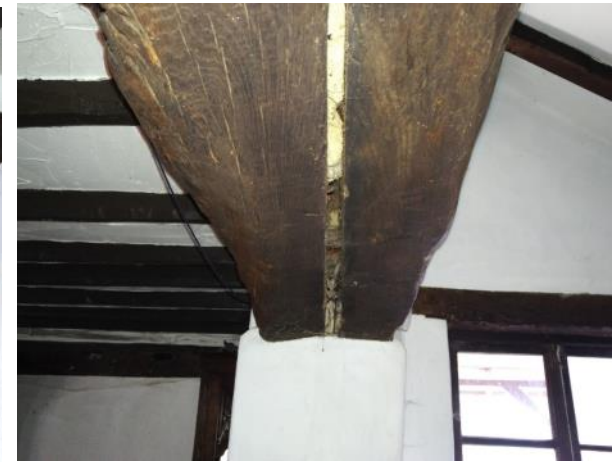
Figure 5.79: Showing the double beam on the opening between the Kitchen and the Breakfast Room. Note the low-grade infill between the beams.

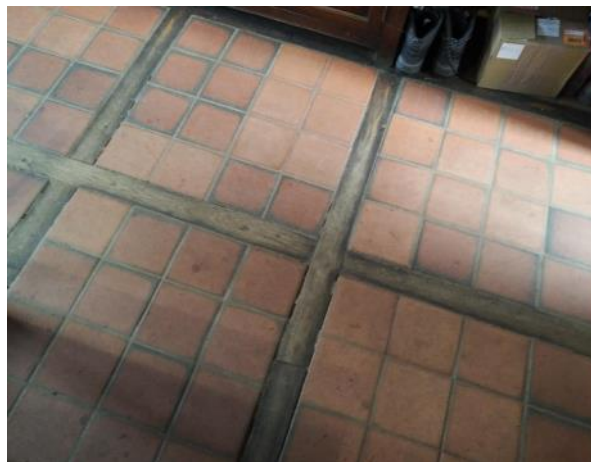
The floor is formed of oak framing infilled with red clay quarry tiles sourced by the client in the late 1970s. These elements are sympathetic but are not historic fabric and are not considered to contribute towards the significance of the listed building. We understand that the room had flagstones (laid onto earth) covering the floor in the mid-late 1970s, some of which were used to line the hearth in the Sitting Room fireplace. The current tiles were fitted over concrete, which is likely leading to rising damp in the wall facing onto the covered walkway.

Figure 5.82: Showing the oak framed floor inset with red clay quarry tiles.

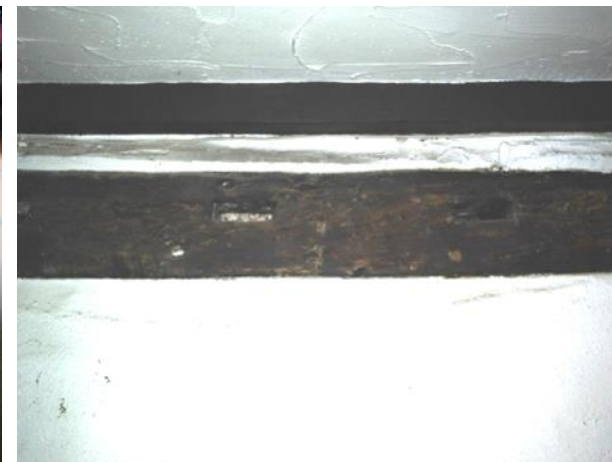
We can see from a review of the ceiling beams in the room that the ceiling was once marginally lower. The mortise joints for the joists and beams can be seen on the beam that lies at the top of the dividing wall between the Breakfast Room and the Dining Room. We know therefore that the existing ceiling is not original. Moreover, the present owner distressed the current

Figure 5.83: Showing the mortise joints for the previous lower ceiling joists in the Breakfast Room.

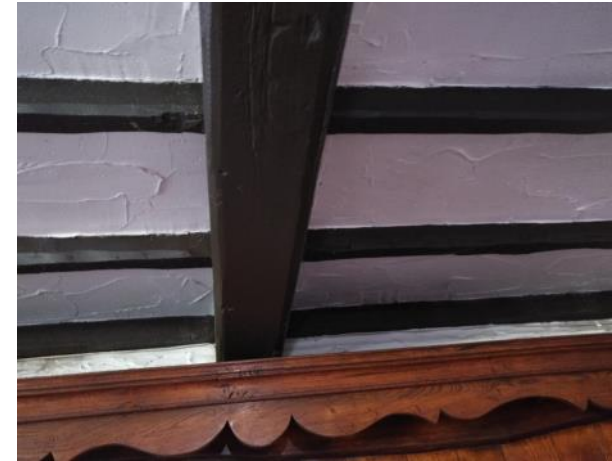
beam in the 1970s. The current plastering between the joists dates to the 1970s with the characteristic wavy striations popular at the time. This plastering is unsympathetic to the character of the building and detracts from significance.

Figure 5.85: Showing the beam and joists on the Breakfast Room's ceiling and the unsympathetic plastering.

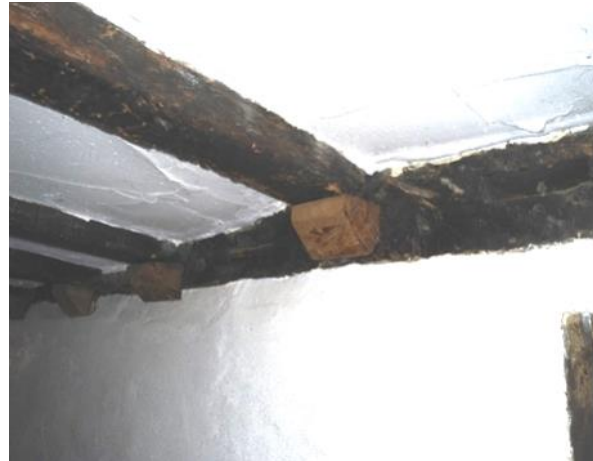
Figure 5.88: Showing the temporary supports where the joists meet the northern beam in the Dining Room.

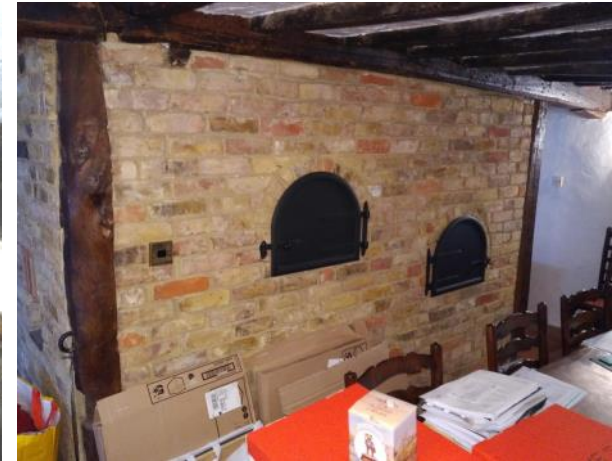
The rear side of the Sitting Room fireplace lies to the southern side of the Dining Room. This fireplace was rebuilt or refaced by the present owner. We can see that the sides are faced with buff/brown brick in stretcher bond. We can also see two bread ovens inserted into the northern fireplace wall, which are faux and both inserted in the late 1970s. The bread ovens, their semi-circular heads above, the modern vertical timber beams to the fireplace sides and the unsympathetic buff brick refacing of the fireplace all detract from significance. There are also alcoves with soldier bond brick heads to the western and eastern fireplace jambs. These also detract from significance as they are non original and not to an original or historic design and therefore blur legibility of significance.

Figure 5.89: Showing the bread ovens to the southern side of the Dining Room on the fireplace's rear wall.

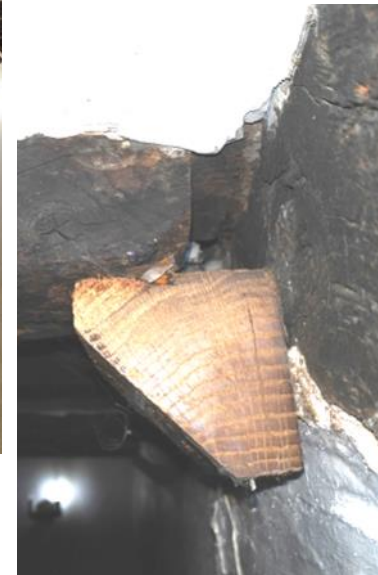
Figure 5.91: Showing how the joists to the Dining Room ceiling are dislocating from the joists.

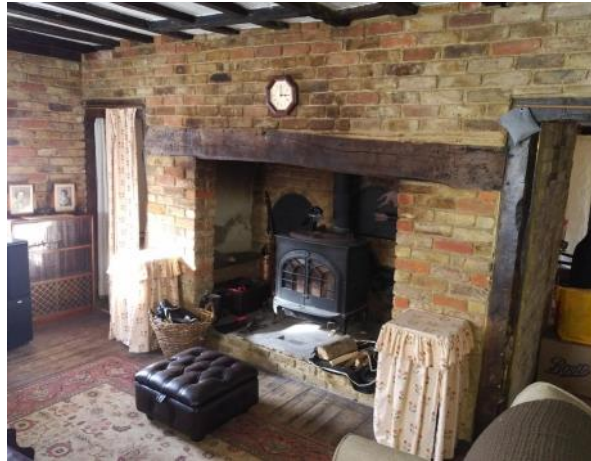
The fireplace as discussed during the assessment of the Dining Room has been refaced/rebuilt in buff reclaimed bricks in stretcher bond. We understand that the lintel beam itself is historic which is borne out by inspection. The fireplace was discovered we understand in the 1970s when various historic fireplaces were removed, each superimposed in front of the other until a 17th century fireplace was likely discovered. We understand it was in deplorable condition and was largely rebuilt. The fireplace at that time apparently had no fire window or spice window and therefore was unlikely to have been an inglenook.

Figure 5.92: Showing the largely rebuilt fireplace on the northern side of the Sitting Room.

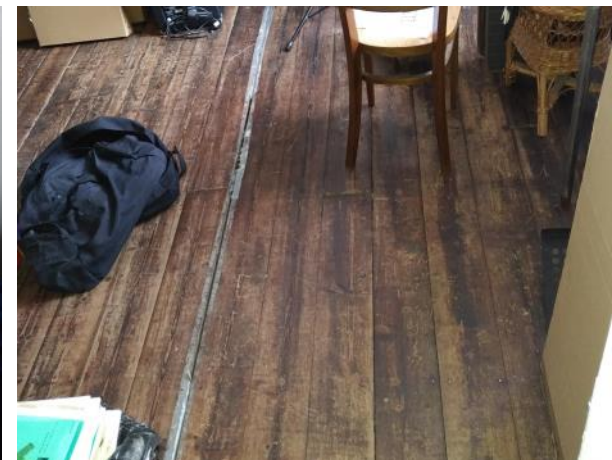
Figure 5.108: Showing the boarded floor to the Music Room and the portion of the floor that has partially subsided (right). Note the duct tape.

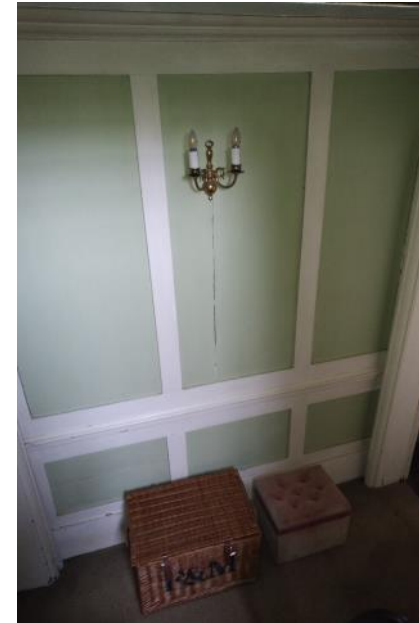
This area has full height panelling similar to the Music Room and a dado rail and cornice of matching profiles to those in the Music Room. A timber cornice runs above. Some of the panelling on the southern wall contains cracks. The door architraves into the Music Room and into the Office are both matching internal doorcases, noticeably proud of the walls and highly ornate for the status of the house.

Figure 5.115: The panelled wall on the southern side of the Main Staircase Hallway.

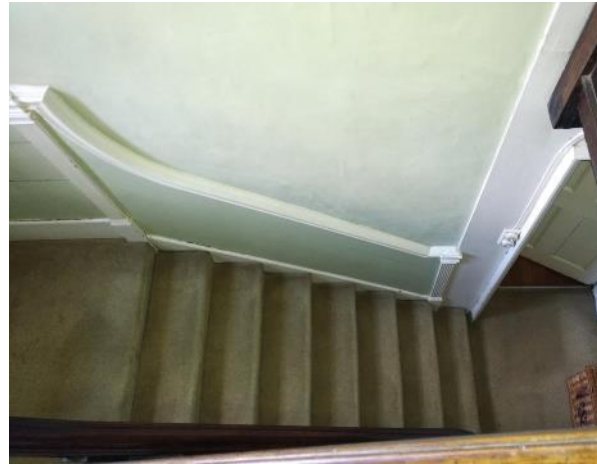
The walls to the stairs have skirting boards, a ramped dado rail, and fluted Doric pilasters from skirting boards to dado rails. Some of the panelling between skirting board level and dado level has cracked or separated due to the structural movement in the staircase.

At ceiling level is a prominent, deep timber cornice that has also cracked and/or become separated from the walls in a number of places due to structural movement. There is also cracking evident on the northern wall of the stair

Figure 5.118: Showing the lower flight of steps to the Main Staircase.

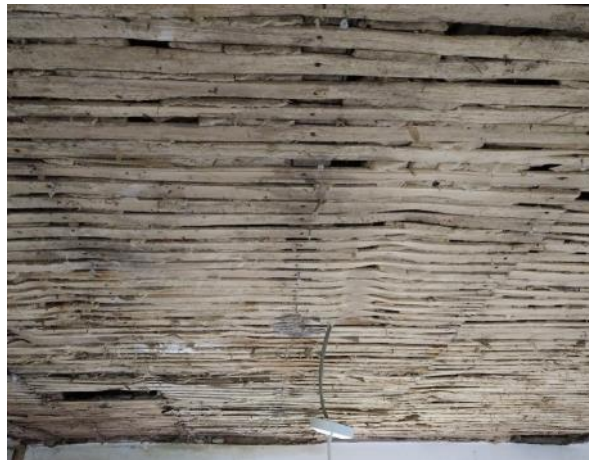
The ceiling above is lath and plaster and has been exposed to view due to a leak in recent times.

Figure 5.133: Showing the lath and plaster ceiling to the W.C. ante-room.

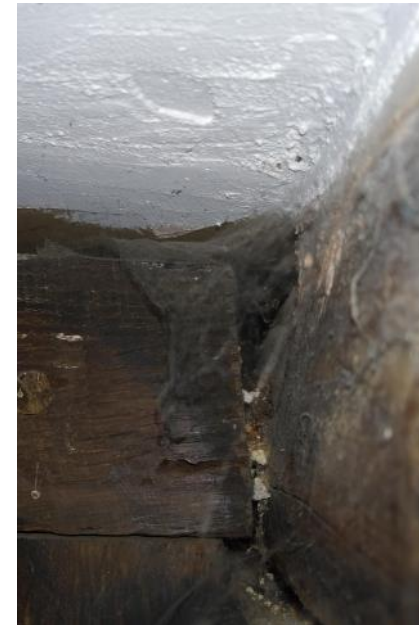
Figure 5.140: Showing how the timber framing in the location marked in red at Figure 5.139 is not tied into the historic frame.

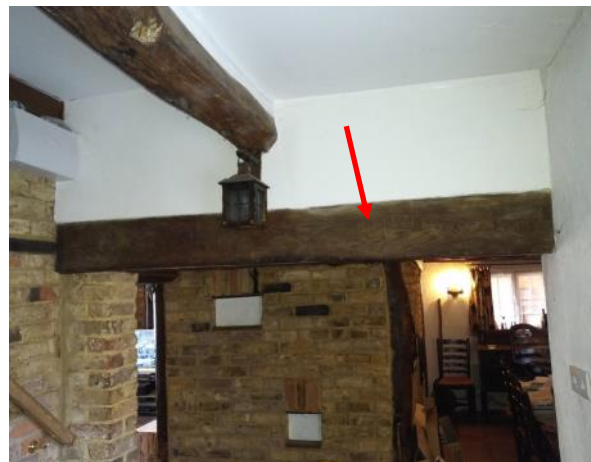
The wall between the Rear Range and the mid 20th century stairs has largely been removed, likely when the stairs were inserted in the mid 20th century. Above is a steel RSJ inserted structurally and then faced with timber to resemble a beam (marked in red at Figure 5.141).

The staircase opening itself we understand was formed in the 1960s. The present stairs are a later installation added in the past 20 years approximately. They are open with no treads, stringer, or handrail to the northern side. They terminate at their base with exceptionally low head room due to the RSJ shown at Figure 5.141. The present

Figure 5.141: Showing the RSJ between the Mid C20 Staircase and the Dining Room.

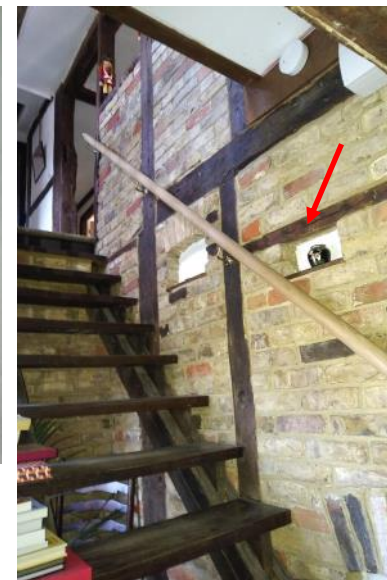
To the southern wall of the stairwell reclaimed buff bricks were inserted in Flemish bond by the present owners we understand in the late 1970s. Historically this wall might have possessed wattle and daub infill panels between the timber framing. The present modern brick infill is considered to detract from the legibility of the building's phasing and significance and detracts from significance. All timber members to this wall are original, save for one narrow horizontal member (see Figure 5.142), which forms the lintel to a small niche created in the late 1970s. This specific timber member likewise detracts from significance.

Figure 5.142: Showing the brick infill to the northern wall of the Mid C20 Staircase. The modern timber member is marked in red. Note the fuse box in the top right hand corner.

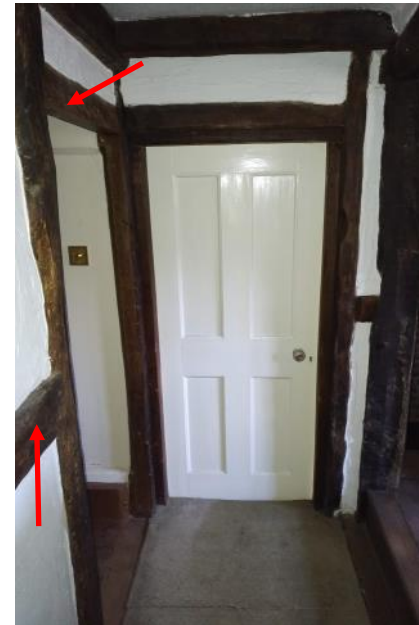
On the southern side of this corridor the house used to have Victorian moulded timber architraves to the doorways on the corridor sides of the doors until the late 1970s. These matched those present on the internal side of the Western Bedroom and Centre-West Bedroom. Therefore all the timber framing to the southern wall of the corridor (including posts, rails and lintels) is modern faux framing inserted by the present owners, except for the historic timber posts either side of the new corridor to the loft staircase and the doorway into the Western Bedroom. Please see Figures 5.148 and 5.149.

The modern timber framing referred to is proud of the walls as it is a surface finish applied as a modern representation of this area, rather than being flush with the walls as one would expect with historic timber framing. Figure 5.151 shows one section of this modern timber that has split showing the wall behind, and therefore showing how shallow a depth the timber members are. These modern areas of faux timber framing are considered to blur the legibility of the building's significance and detract from significance.

Figure 5.148: Showing the Western Bedroom doorway and the modern corridor doorway to the loft. The modern timbers are marked in red.

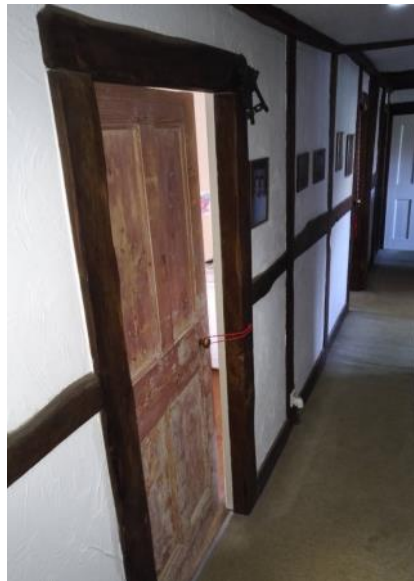
Figure 5.149: Showing the southern side of the Rear Corridor. All timber framing shown is modern except the historic elements shown at Figure 5.148.

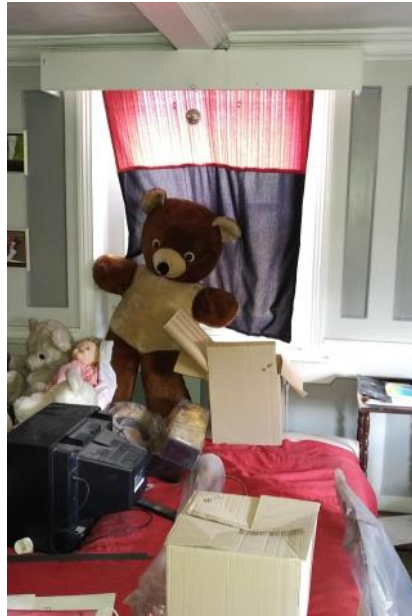
The eastern window has a moulded timber architrave, which is marginally truncated on ceiling level. The window has a modern internal pelmet to hang curtains. This element marginally detracts from significance as it obscures the window architrave.

Figure 5.163: Showing the pelmet to the eastern bedroom window.

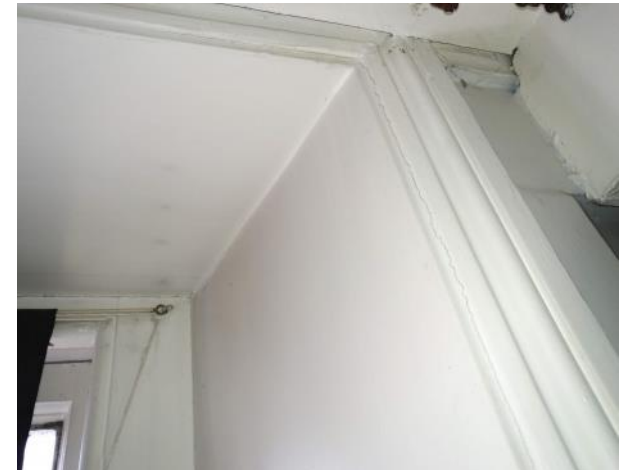
Figure 5.164: Showing how the eastern window's architrave is slightly truncated where it meets the ceiling.

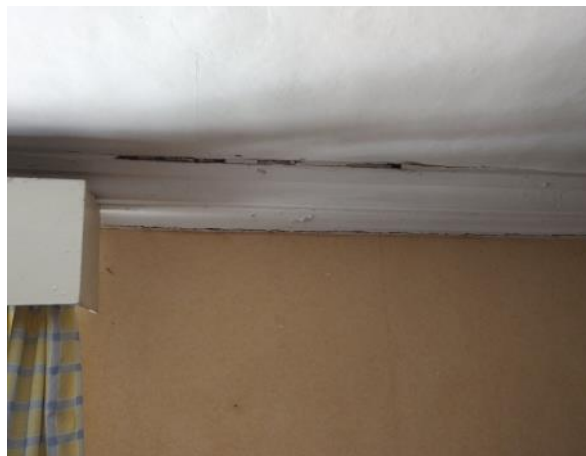
Damp appears to have penetrated from a blocked gutter at some stage and caused disrepair to the cornice close to the window.

Figure 5.173: Showing the area of disrepair to the cornice on the southern wall.

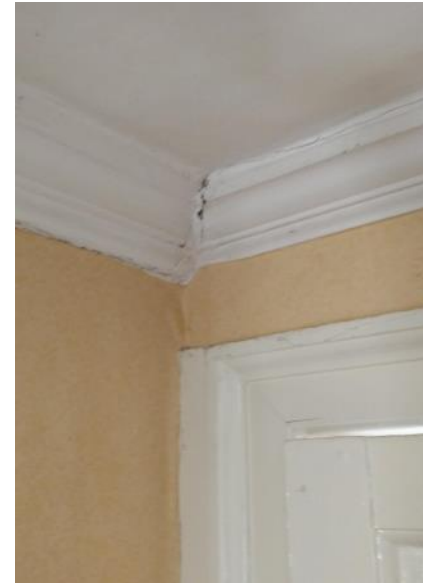
The cornice to the room is a later addition from its original 17th century construction. It appears to have been installed in phases as the profiles don't quite match up in profile design and at their junctions from one wall to another. This is likely either because of movement in the building before installation which made properly aligning the cornices problematic or more likely movement since and subsequent sub-optimal repairs.

Figure 5.174: Showing the unevenness of the cornices to the room.

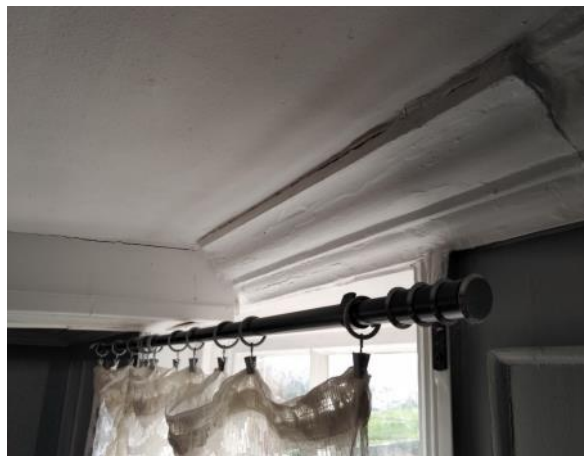
To the centre of the room is a large central beam. This has been lined to the sides and underside with chipboard or the like. We understand that the historic timber beam above was in significant disrepair in the late 1970s and was replaced by a RSJ and then the timber beam pinned to the underside and then the combination lined as described. As seen today this central beam extends across the top of the western window's architrave and sits visually rather awkwardly. The low-grade chipboard lining is unsightly and part of it has become detached adjacent to the western window.

Figure 5.185: Showing how the central ceiling beam sits awkwardly against the western window's architrave.

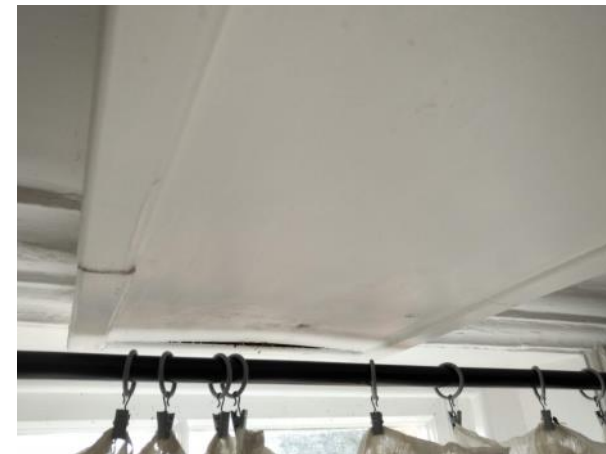
Figure 5.186: Showing how the central ceiling beam sits awkwardly against the western window's architrave.

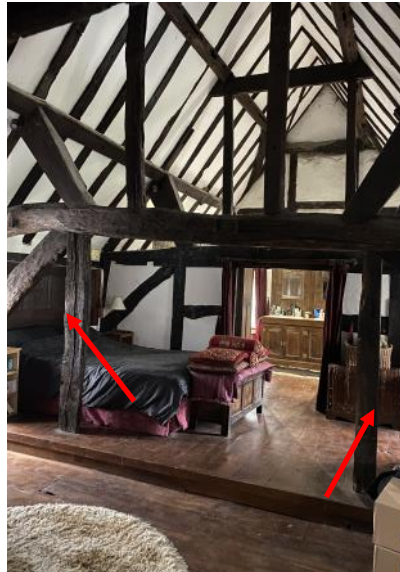
The room is visually dominated by exposed timber framing. We can see three truss bays formed by the Queen (2) Post trusses. The middle example has two additional posts introduced on the underside by the present owners in the late 1970s (see Figure 5.187). This element detract from significance as it blurs the legibility of the room's significance and phasing.

Figure 5.187: Showing the Master Bedroom as seen from the entrance doorway. The two modern posts added by the present owners are marked in red.

The timber members proposed to be removed are those marked in red at Figure 5.187. These members blur legibility of the historic building as they appear historic. Their removal will enhance the legibility of the building's construction and its significance. The acceptability of removing these elements from a structural perspective will be confirmed in due course by the scheme's Structural Engineer to ensure the remaining structure would have sufficient strength to support the roof loads.

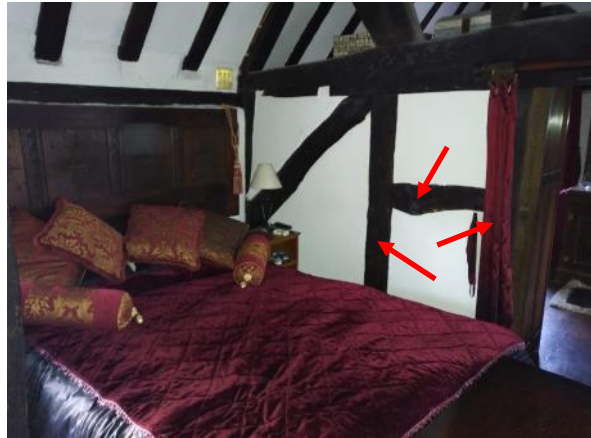
In the middle bay of the room the present owners installed several timber members to partially separate off the bathroom from the bedroom. The members added are indicated on Figures 5.191 and 5.192. These elements blur legibility of the building's phasing and significance and therefore detract from significance.

Figure 5.191: Showing the middle bay of the room (western side). The timber members added by the present owners are marked in red.

The timber members proposed to be removed are those marked in red at Figures 5.191 and 5.192. These modern members blur legibility of the historic building as they appear historic. Their removal will enhance the legibility of the building's construction and its significance.

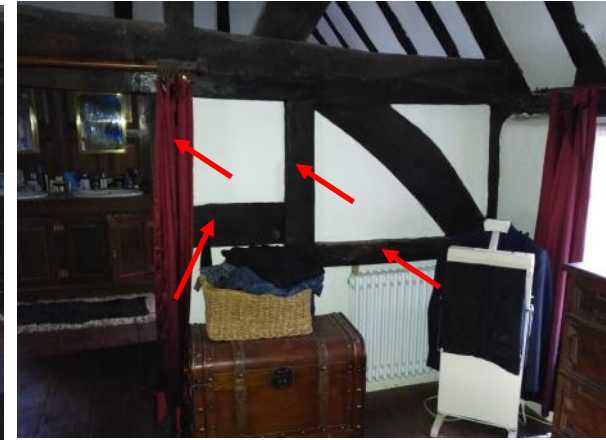
Figure 5.192: Showing the middle bay of the room (eastern side). The timber members added by the present owners are marked in red.
