Arboricultural Impact Assessment

116 Low Road, Burwell

OAS 24-023-AR01

February 2024

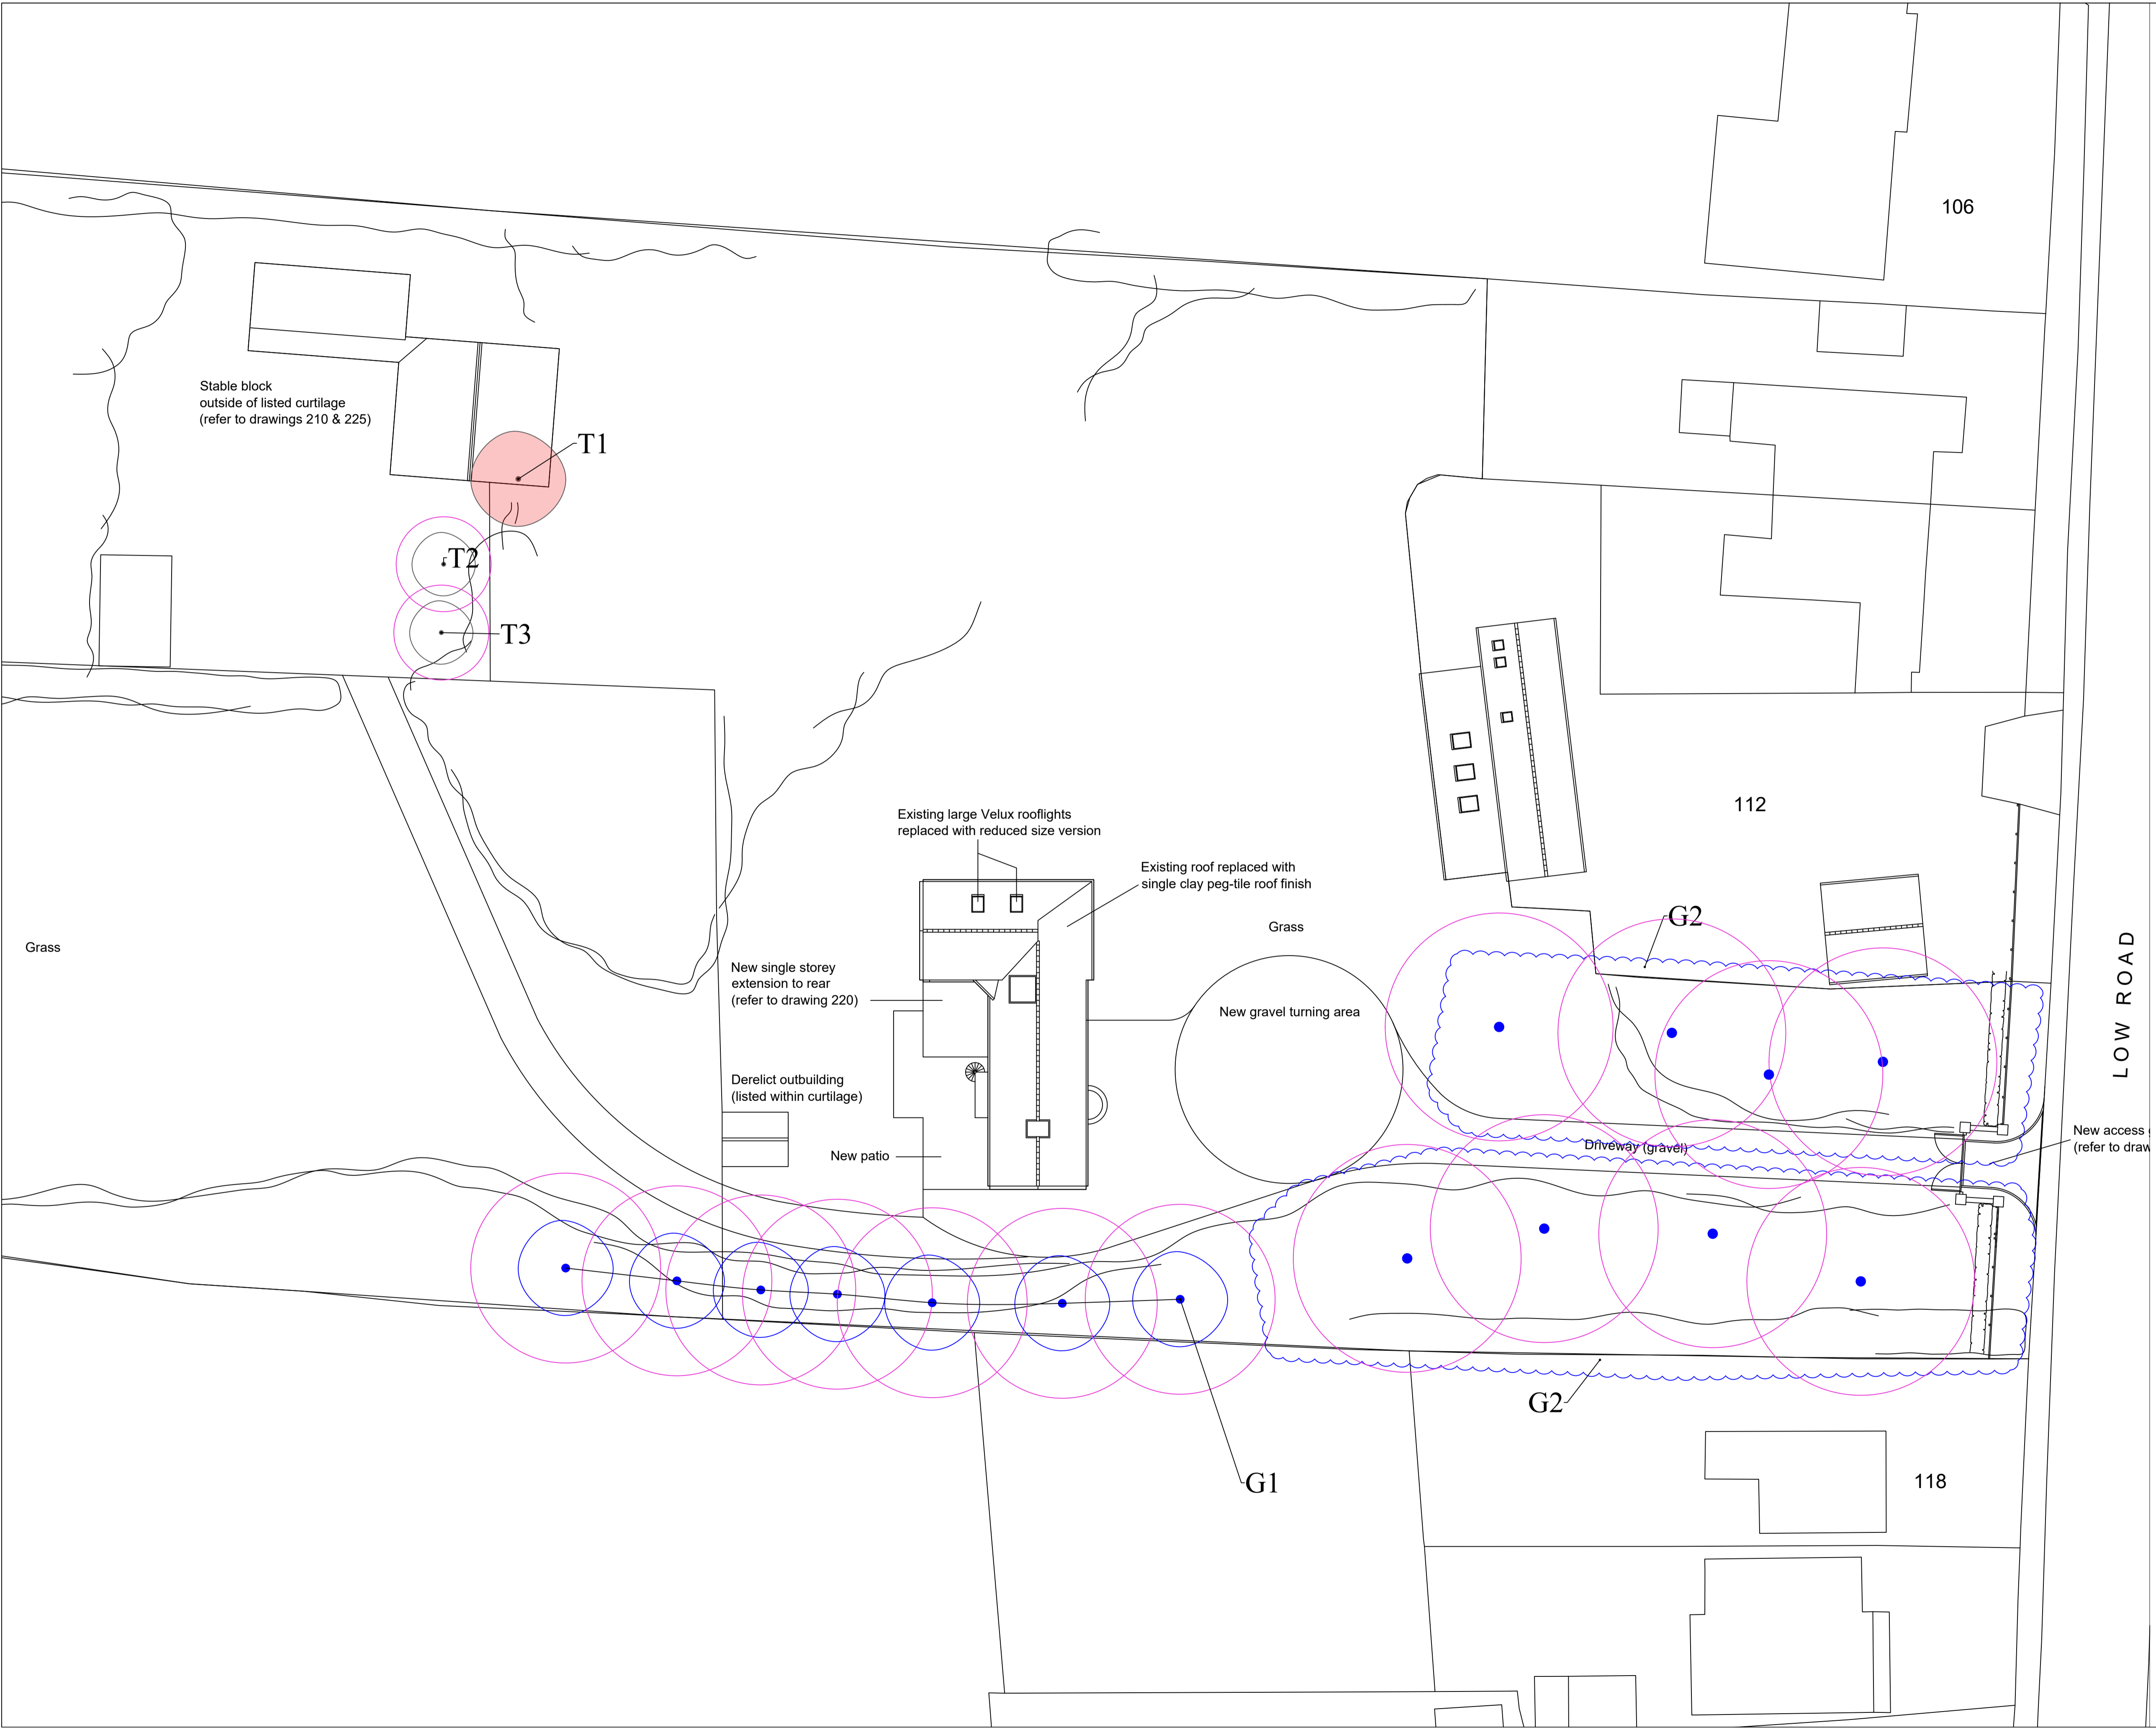
REV.	DATE	INITIALS	DETAILS				
CLIENT Mr S Thomas				DWG. TITLE Tree Layout Plan			
SITE: 116 Low Rd, Burwell							
DRAWN BY SPM	CHECKED BY SPM	SCALE 1:200 @A1	DATE Feb 2024	DWG NO. OAS 24023-TS02	REV.

3.1.2 The proposal will see the removal of T1 to accommodate the layout. Of low value this should not be considered a constraint however there is ample space within the site boundary to mitigate its loss via replacement planting. Any replanting is recommended to be of native species such as Oak and or Field Maple
