Engineers Report

Risk Address Penbryn, Green Street
Eye
Hoxne
IP21 5AX

360 Reference LIV-SN-22-006110
Insurer Reference 800-08-001206
Policy Holder Miss Jo Chimes

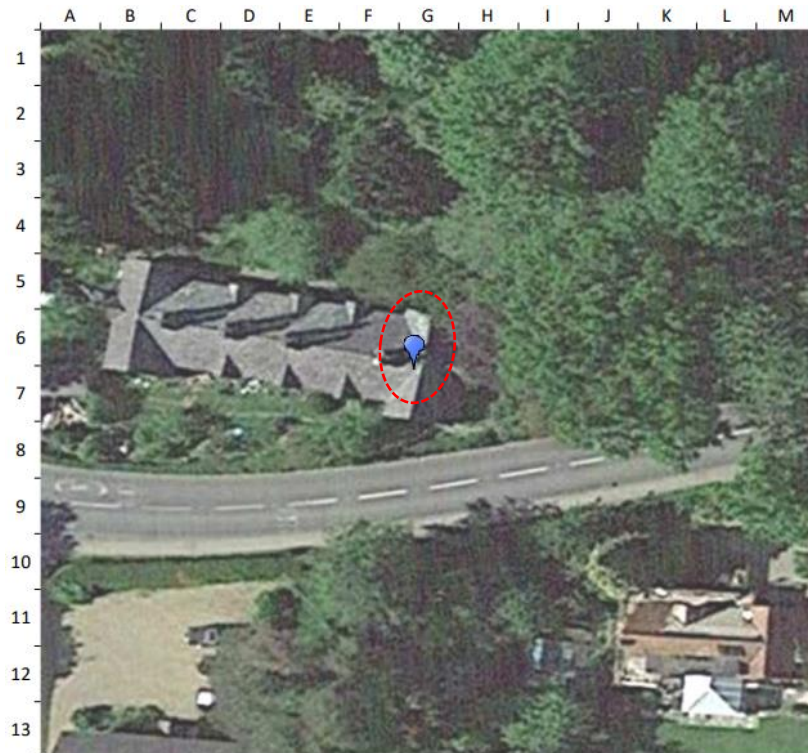
16-11-22

This document addresses damage notified to Insurers in relation to internal and external cracking to the house, generally orientated towards the right-hand side of the property. All directions are stated when viewing the property from the front.
