INFORMATION SCHEDULE RELATING

LISTED BUILDING CONSENT
REFERENCE 21/0317/LBC
CONVERSION OF AGRICULTURAL BUILDING TO
DWELLING

UNDERDOWN FARM,
RAWRIDGE
UPOTTERY
DEVON
EX14 9QR

February 2024

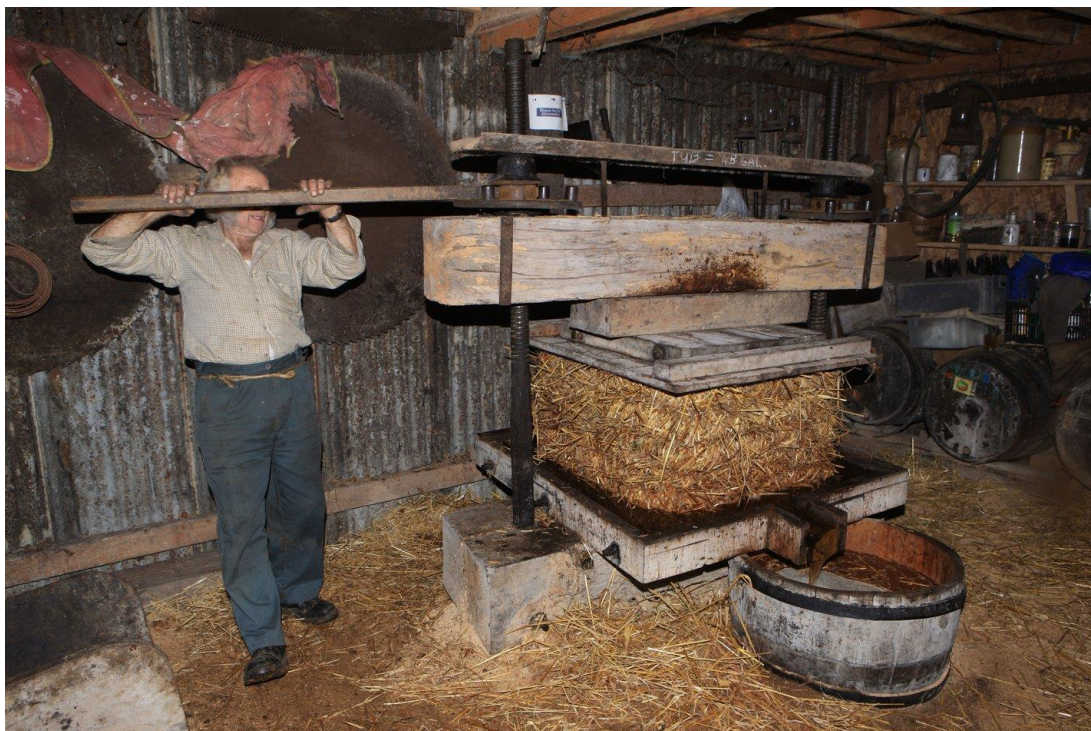
The Cider press is clearly not in its original position and may not have been installed in this barn. It is thought that the cider house formed the west most barn of the range attached to the adjacent farmhouse. This press is thought to date from the late C19th to a standard design, see photograph below.

Photograph of similar Devon cider press in operation.

The cider press is to remain in its current safe position until the garage is constructed, to where it will be temporarily relocated until the barn conversion is complete. Once restored as above the press will be relocated in the new dining room as a feature.
