DESIGN STATEMENT  
ROOFS 5 & 6

41 - 43 HAY'S MEWS, LONDON

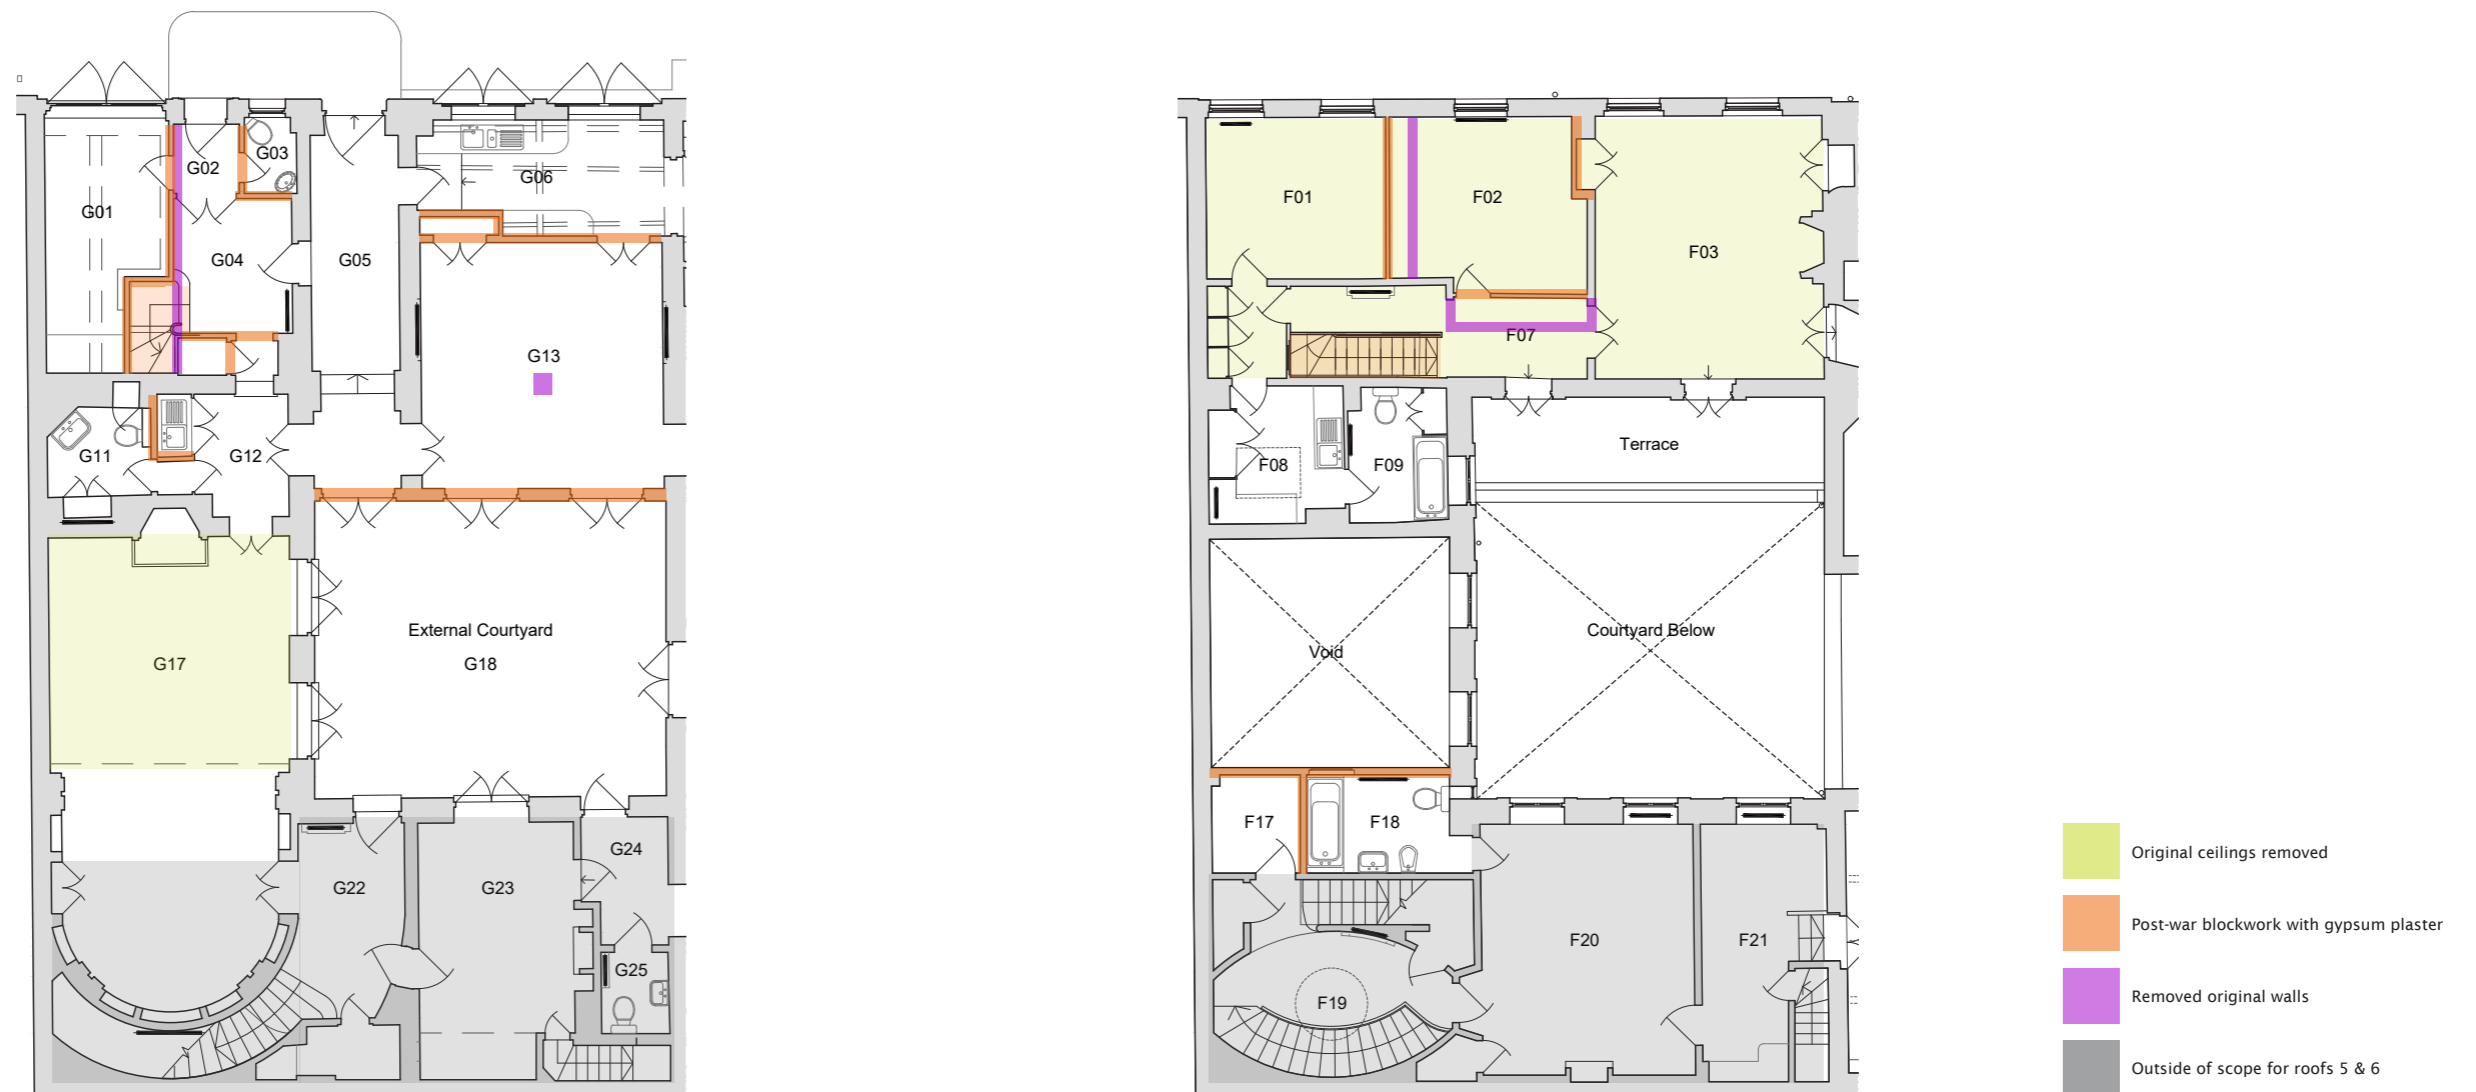
The historical alterations and their effect on the structure is evident now that the consented ceilings have been removed above F01, F02, F08 and F09 and the roofs fully stripped. There are supports for the purlins missing where historic walls were removed in previous schemes. As a result the purlins are spanning up to four times longer than their capacity. It has also been noted that the historic works undertaken at No43 Hay's Mews did not have sufficient underpinning works carried out, and as much the structure is now failing in these areas.
