**41-43 Hayes Mews, Roof**  
Roof timber condition investigation - revisit  
November/December 2023

Hutton + Rostron Environmental Investigations Ltd  
Netley House, Gomshall, Surrey, GU5 9QA Tel: 01483 203221  
159-31 Site Note 9 -Not to scale- © Copyright Hutton+Rostron 2023

**41-43 Hayes Mews, Roof**  
 Roof timber condition investigation  
 July 2023 (initial visit)

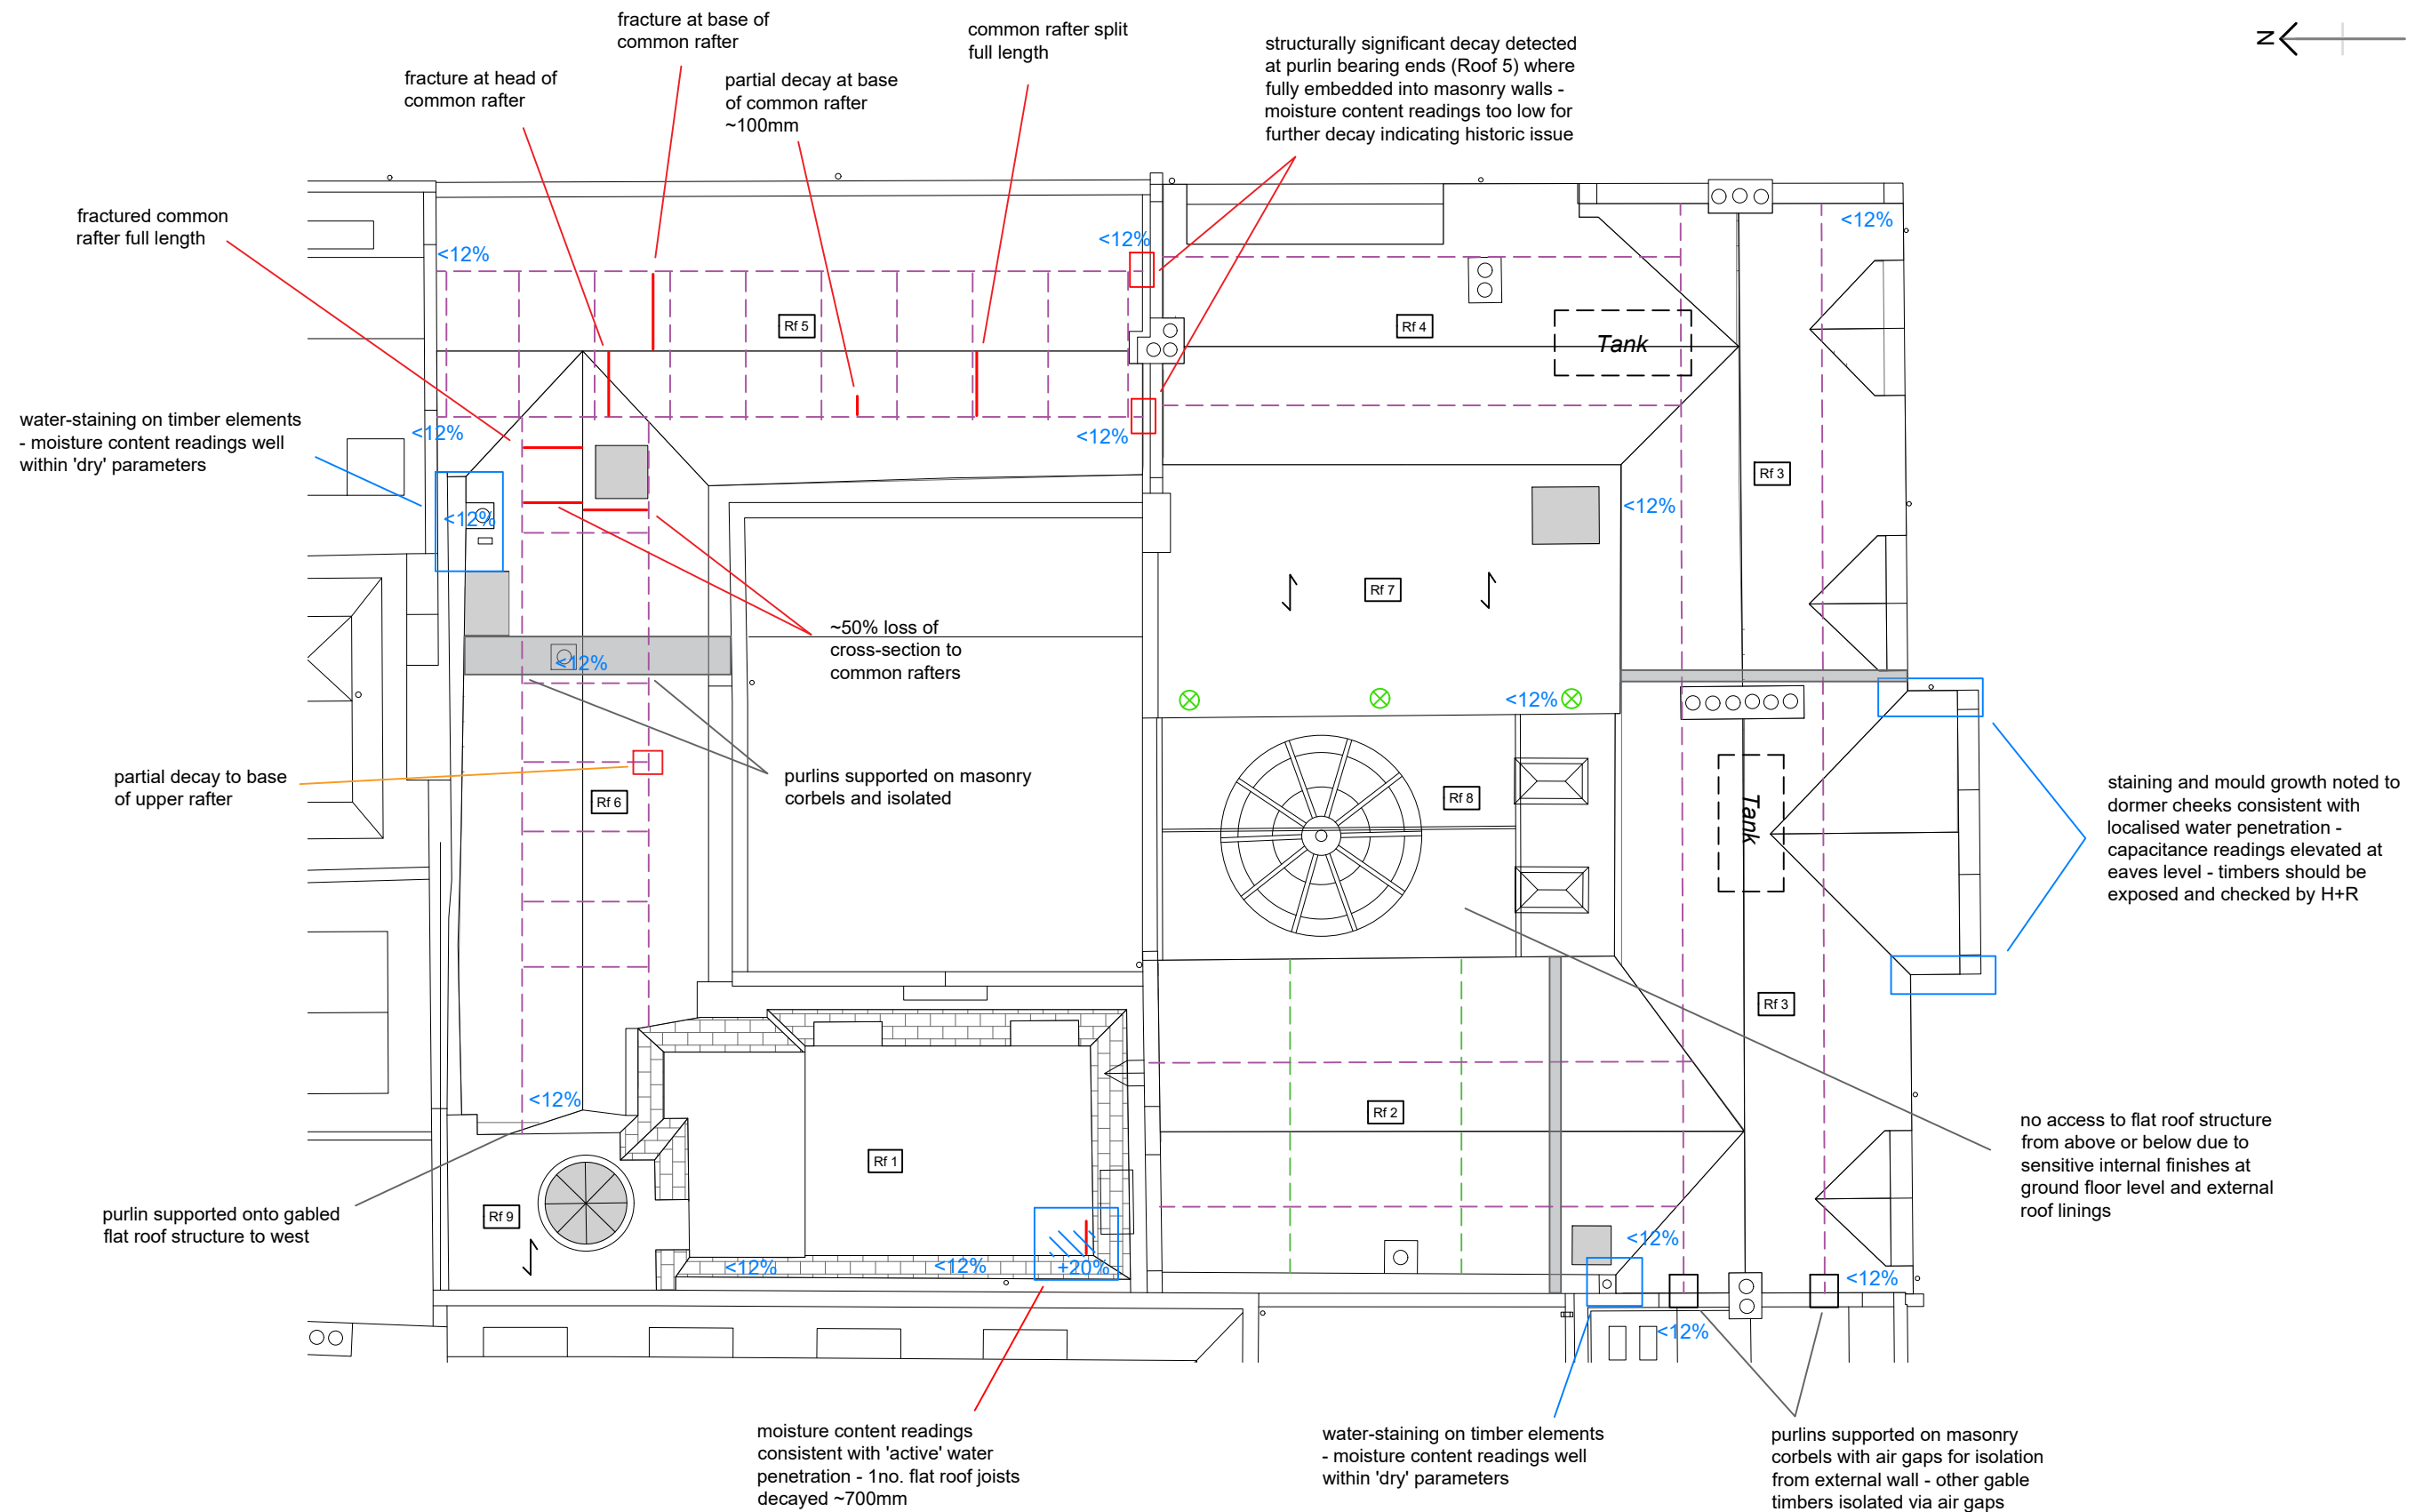
Hutton + Rostron Environmental Investigations Ltd  
 Netley House, Gomshall, Surrey, GU5 9QA Tel: 01483 203221  
 159-31 Site Note 1 -Not to scale- © Copyright Hutton+Rostron 2023

Multiple defects identified to upper and lower common rafters of both pitches. See attached schedule for further details

Mycelial growth over masonry and section of rafter plate

Section of rafter plate decayed for ~400mm. See drawings in Attachment A for further details

Rafter plate partially decayed along external edge for ~1m. See attached schedule for further details

2 no. noggings decayed ~150/200mm. See attached schedule for further details

1 no. flat roof joist decayed

~50% loss of cross-section to common rafters  
purlins supported on masonry corbels and isolated
