Engineers Report

Risk Address Helios House
Clarkes Lane
Barsham
NR34 8HN

360 Reference LIV-SN-22-006091
Insurer Reference 610-11-000307
Policy Holder Mrs. Ann Gaskin

Date Notified 11th November 2022
Date of Assessment 16th January 2023
Report Date 16th January 2023

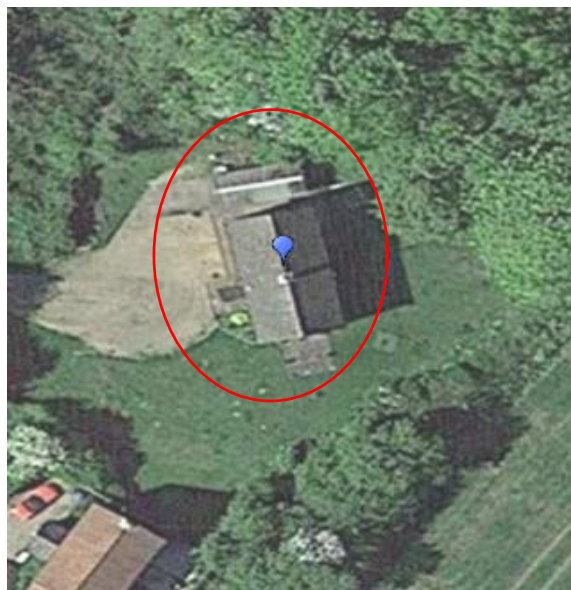
Internal Damage – All rooms

- Tapering cracking above and below windows up to 10mm wide.
- Tapering cracking above doors.
- Cracking to floor tiles.

External Damage – Front and rear elevations

- Tapering cracking above and below windows.
- External render is in a poor state of repairs.

It is common practice to categorise the damage in accordance with B.R.E. Digest 251 “Assessment of Damage in Low-Rise Buildings”. In this case, the damage to the property falls into Category 3 “Moderate”.

The pattern and nature of the cracks is indicative of an episode of subsidence, The cause of movement appears to be clay shrinkage. Although the cause of the movement needs to be dealt with, we note the potential involvement of a Local Authority trees and or Tree preservation orders. Unfortunately, they will require certain investigations to be carried out to demonstrate the influence of their vegetation.

- Contact policyholder and arrange for site investigations to be undertaken at a suitable date.
- Set up a period of level monitoring for an initial 12-month period.
- Once we have received and reviewed the site investigations then an arborists report will be obtained.
- A repair schedule has been drawn up, although this will be finalised following completion of any mitigation measures, as applicable.
