| Client: | Richard Leak |
| Address: | 10 Rowan Garth, Skidby, HU165TT |
| Date: | 10 th February 2024 |
| Туре: | BS5837;2012 |

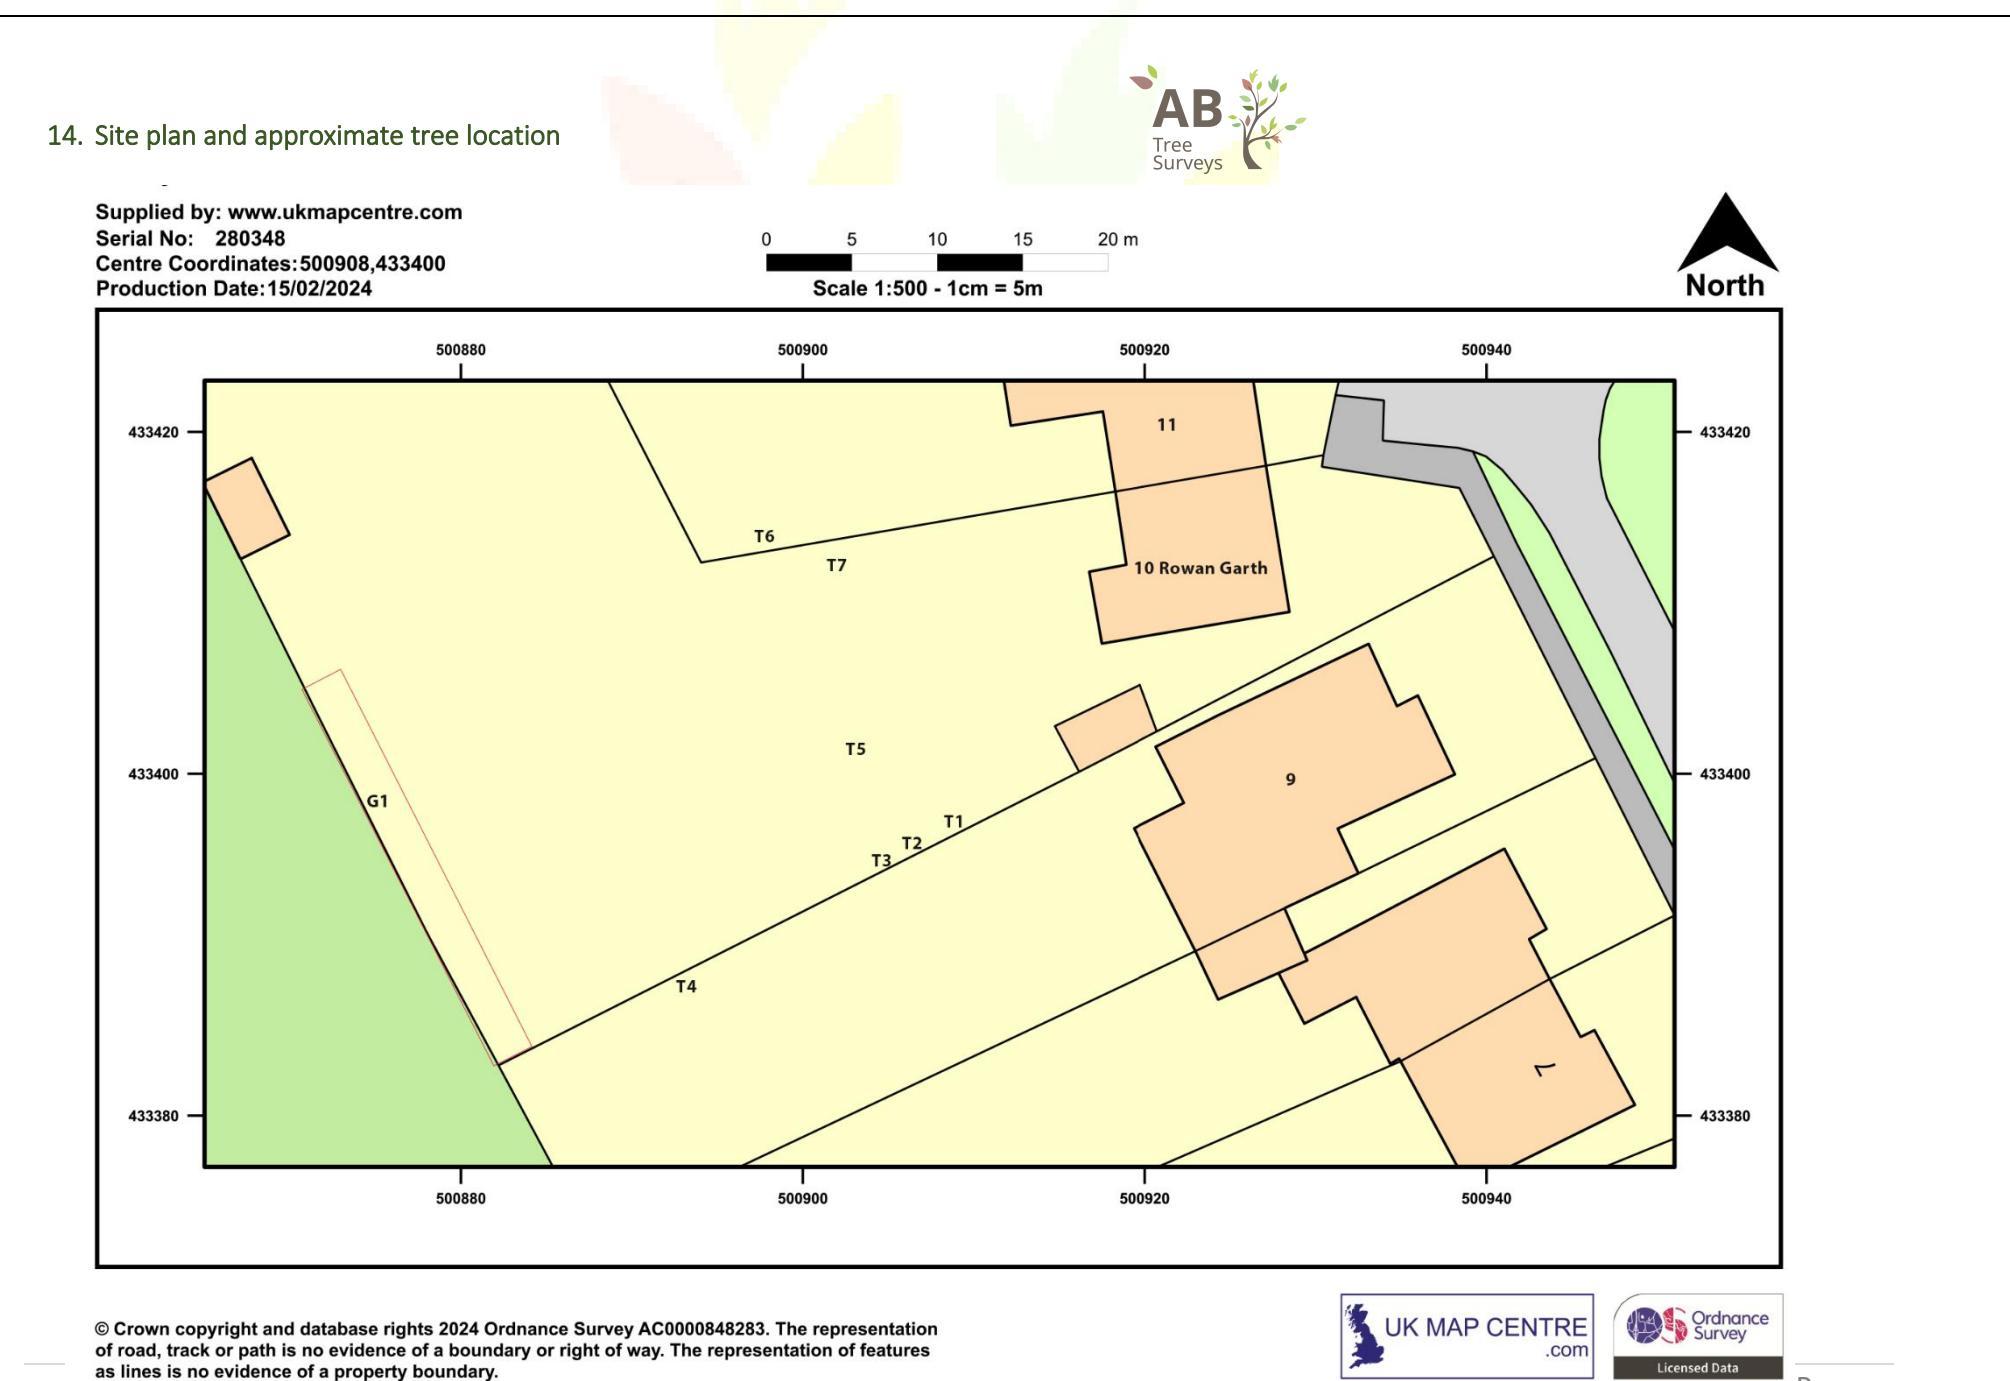
| No | Species | Height | DBH | RPA | Crow <mark>n</mark> spread | | <mark>SU</mark> LE | Grade | Physiological condition | Cutting requirements | | |
|---|---|---|---|---|---|---|---|---|---|---|--|--|
| 5 | Cherry | 8 | 40 | 4.80 | 6 | 6 | 6 | 6 | 5 | U | History of pollarding at 7m or severely storm damaged and in poor form Covered in Ivy | Fell for development |
| 7 | Cedar | 6 | 90 | 10.80 | 0 | 5 | 6 | 5 | 5 | U | Poor form with either storm damage or severe hard crown reduction work Covered in Ivy | Fell although not essential for development |

Image 2: Looking NW showing T5-7
