MASONRY DAMP INVESTIGATION OF BASEMENT AT THE OLD RECTORY

JOB NO. 157-85 **Rev A**

10 AND 11 JANUARY 2023

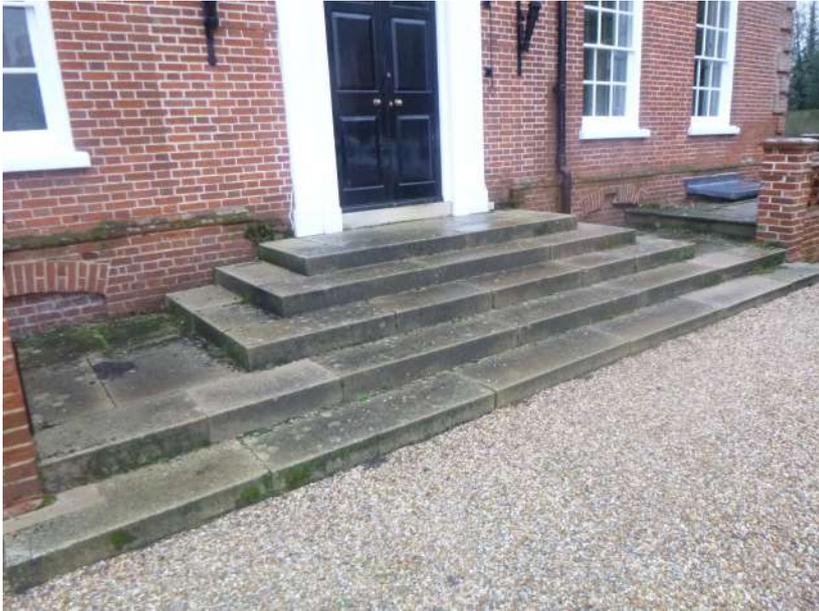
Fig 3:

Exterior, west elevation; showing a view of 20th century modern landscaping to the front door in reconstituted stone. Note this is significantly raised external ground levels relative to the basement below and adjacent to this front porch area

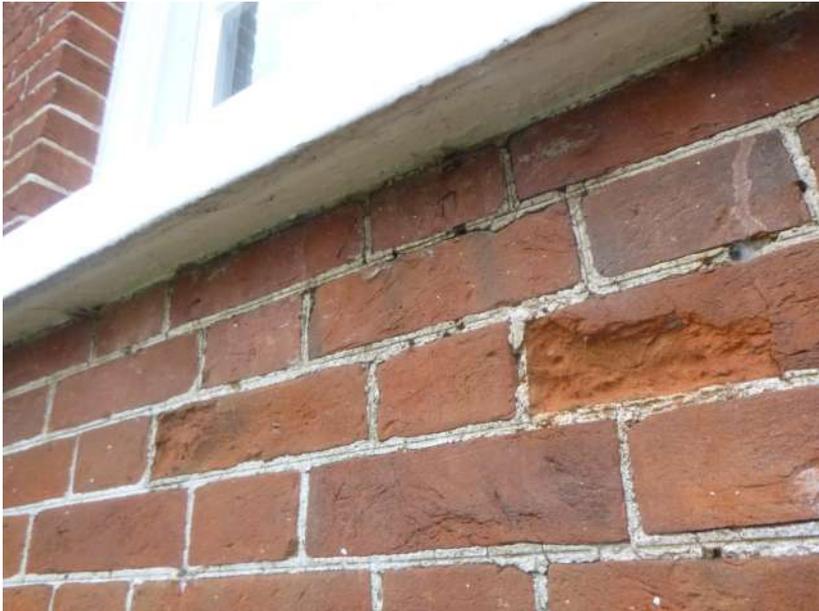
Fig 9:

Exterior, west elevation; showing a close up view of window sills which appeared to have drip rebates that had previously been overpainted thereby reducing their effectiveness. Note localised erosion of brickwork potentially due to damp masonry from external detailing

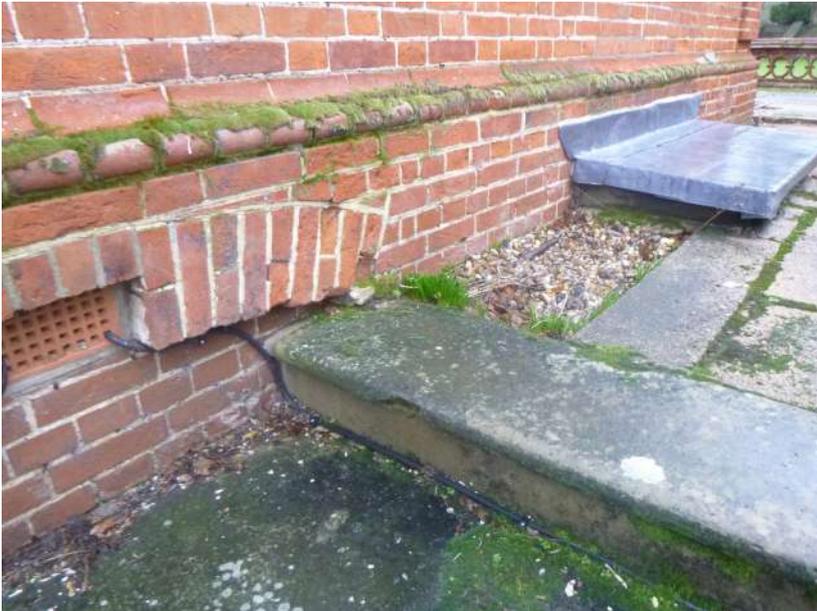
Fig 11:

Exterior, west elevation; showing a view of modern provision for background ventilation. Also showing lead capping over a historic opening which would have previously provided ventilation into the basement structure

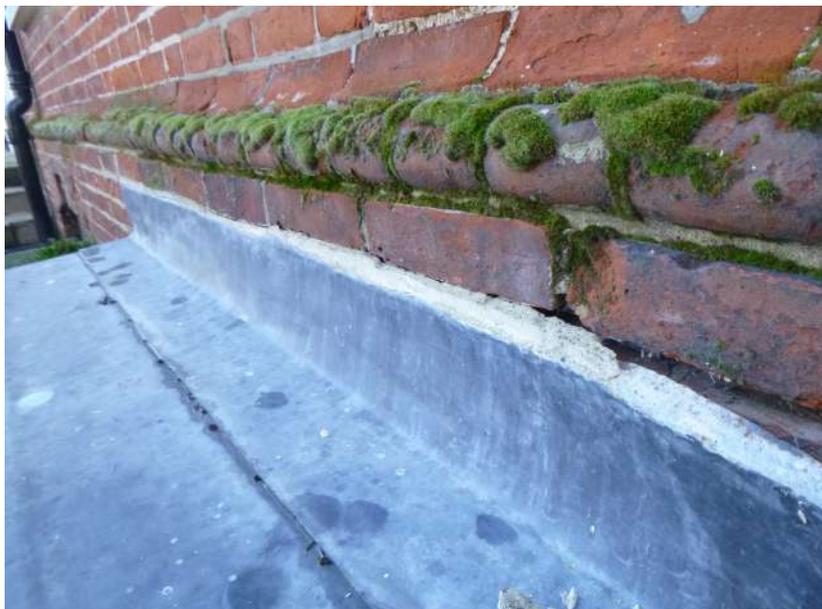
Fig 13:

Exterior, west elevation; showing a close-up view of a lead chase joint displaced and locally allowing water penetration at the open joint

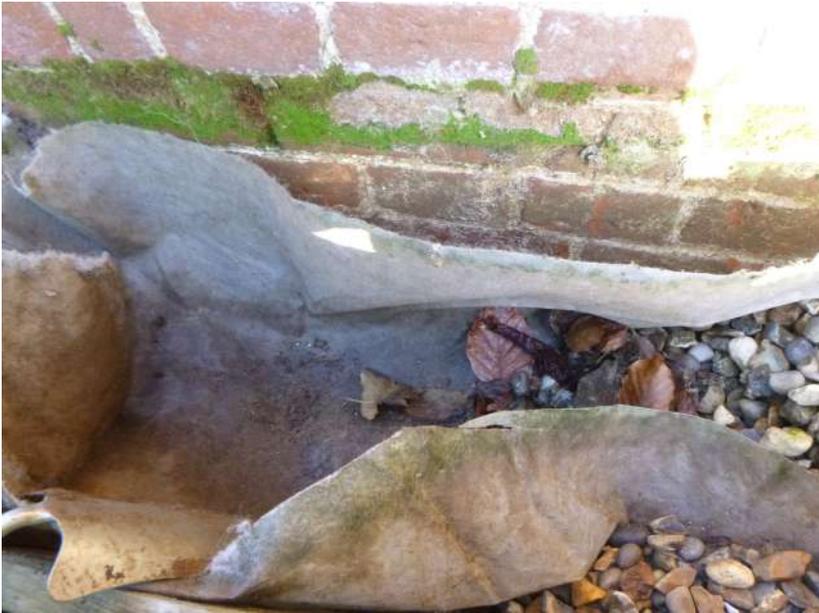
Fig 15:

Exterior, south elevation; showing a close-up view of the geo-textile sheeting and gravel laid against the property

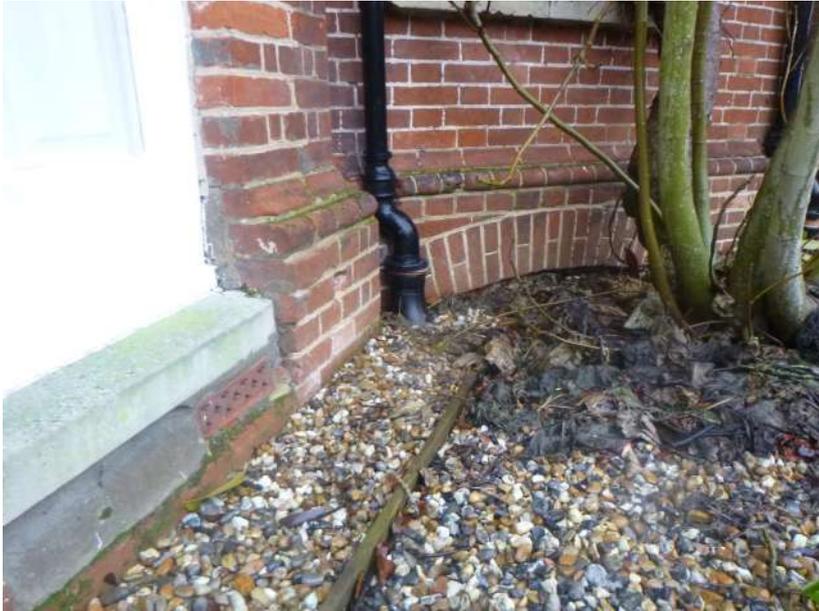
Fig 19:

Exterior, south elevation; showing a view of provision for ventilation via a retrofitted air brick. Also showing the downpipe to ground drainage connection as well as a brick arch over a previous historic opening at basement level

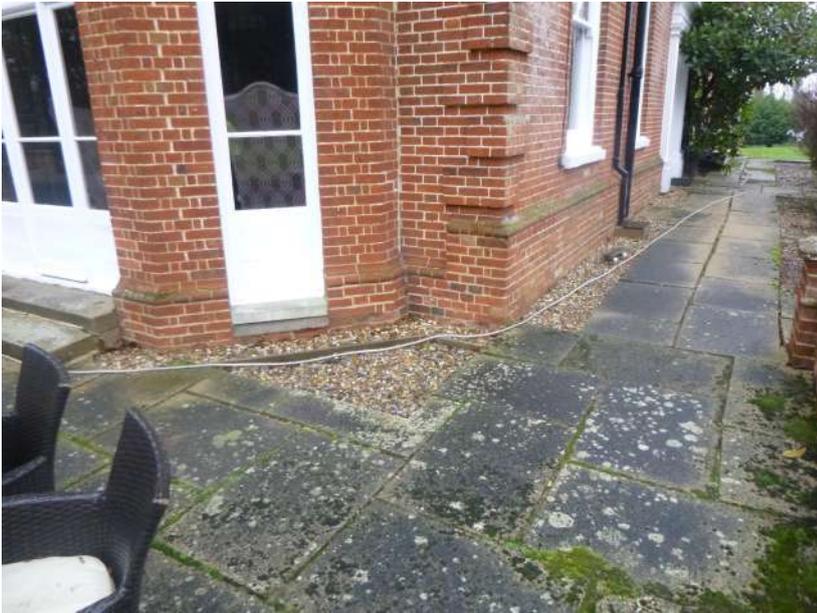
Fig 21:

Exterior, south-east corner; showing a view of raised external ground due to modern landscaping

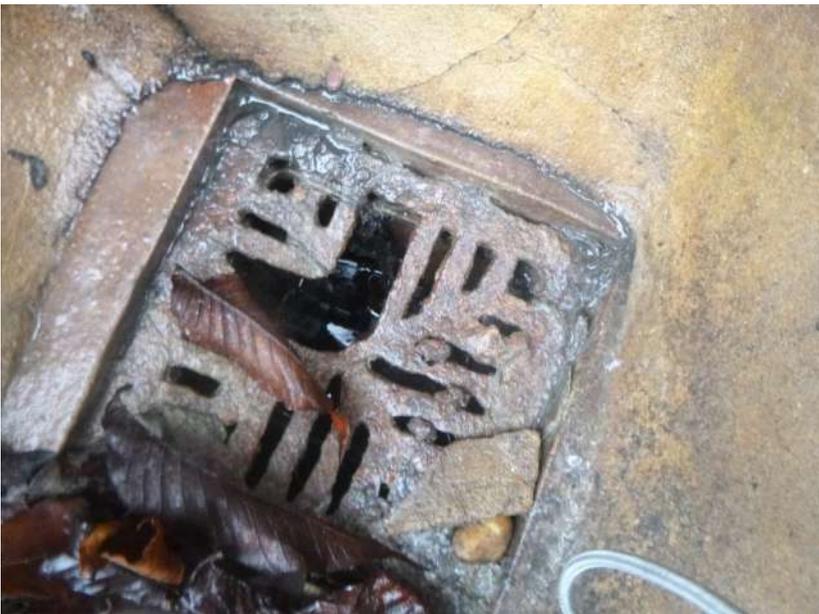
Fig 24:

Exterior, east elevation; showing a view of the surface gully in the south-east corner which appeared to contain standing water at the time of survey, suggesting that below ground drainage was not adequately draining away

All below ground pipework serving surface drains should be inspected in detail, using CCTV as required and allowance should be made for all necessary cleaning, repair and upgrading to ensure that surface water is drained clear of the masonry and foundations of the structure at all times

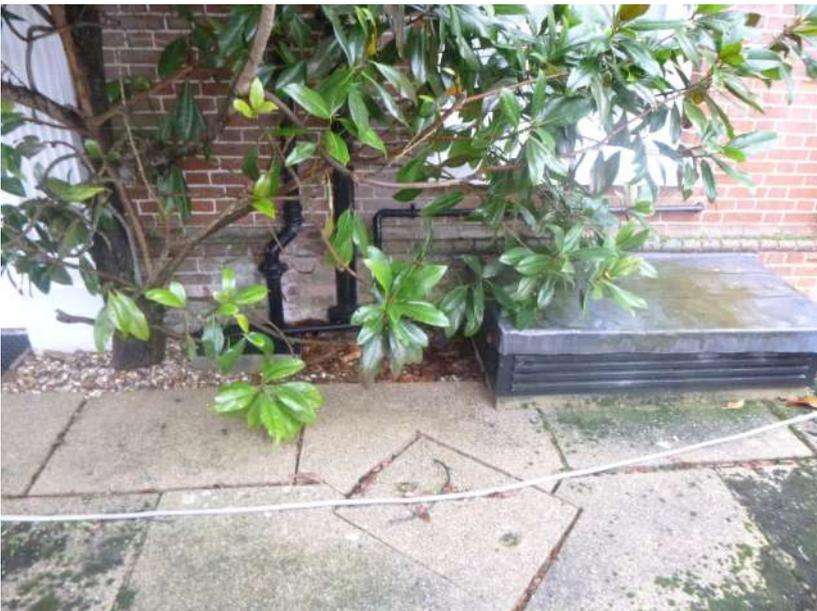
Fig 26:

Exterior, east elevation; showing a view of a tree growing in close proximity to the property. Also showing the location of a historic ventilation grate to the basement. Note the current modern structure over the grate provided limited ventilation into the basement

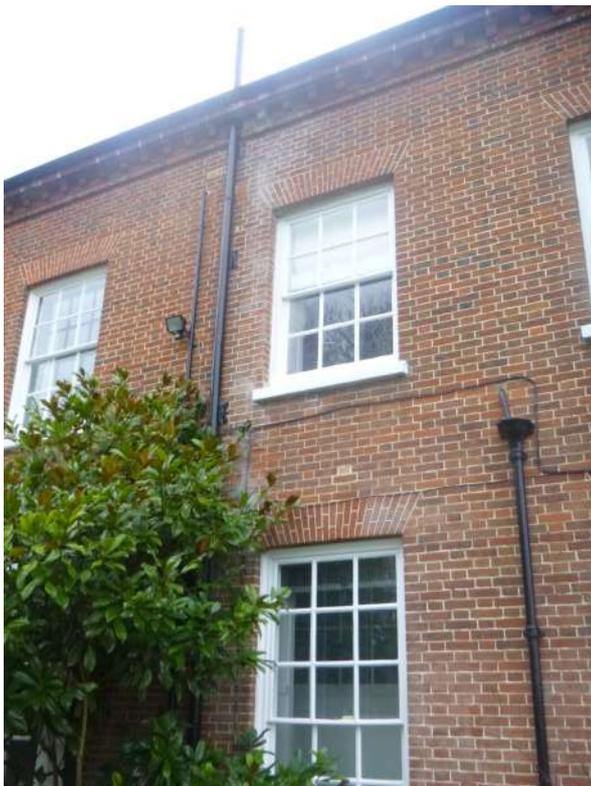
Fig 28:

Exterior, east elevation; showing staining and local brick erosion to masonry at high level adjacent to the soil vent stack. Note it is possible that guttering has locally leaked from above

Roof drainage should be repaired/replaced and inspected for blockages and cleared to restore function, where necessary. Consideration should be given to a general re-design of the roof drainage system to ensure that there is formal provision for the bay roof structures, as well as to improve provision for access, cleaning and maintenance. Consideration should also be given to undertaking roof drainage calculations based on up-to-date meteorological data to ensure that adequate drainage capacity is provided to discharge surface water clear of the structure at all times

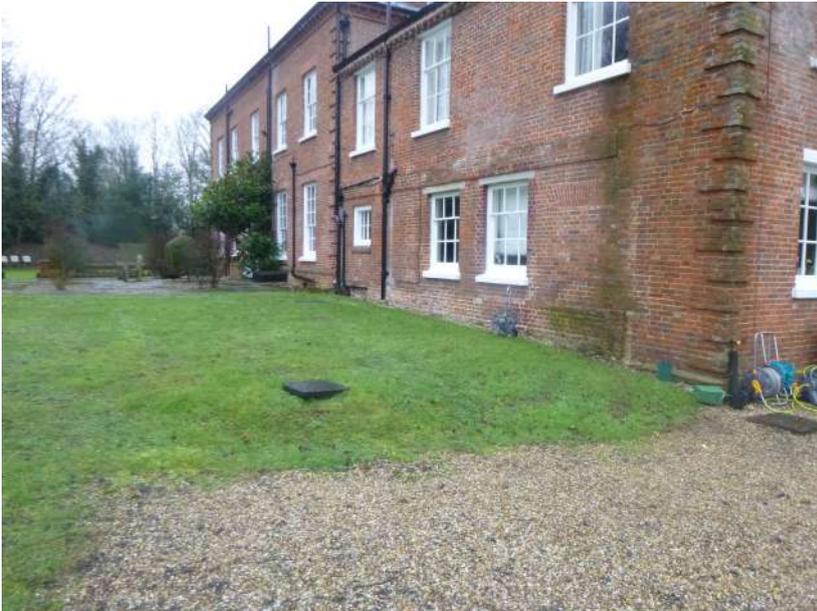
Fig 31:

Exterior, east elevation; showing a general view of the elevation. Also showing the gradient of the landscaping, which appeared to fall back toward the property

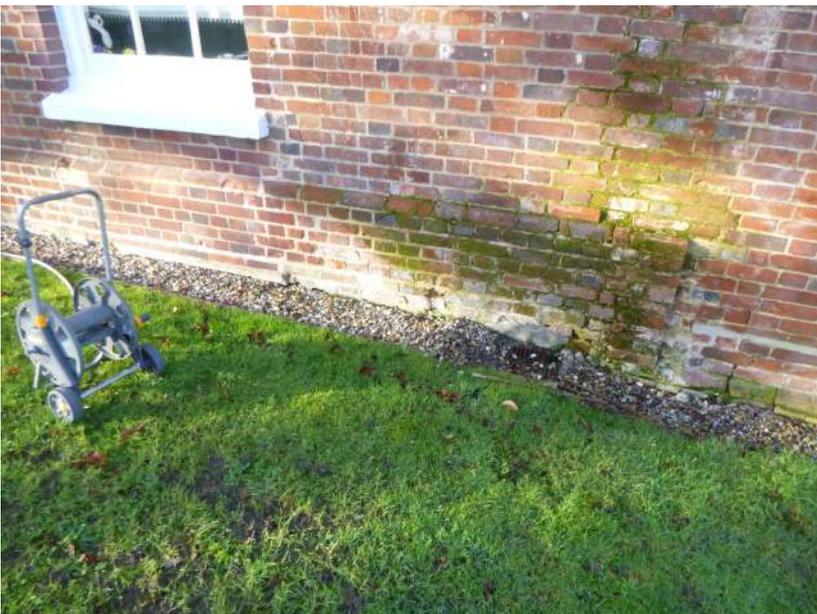
Fig 32:

Exterior, east elevation; showing a close-up view of biological growth, open mortar joints and areas of repointing

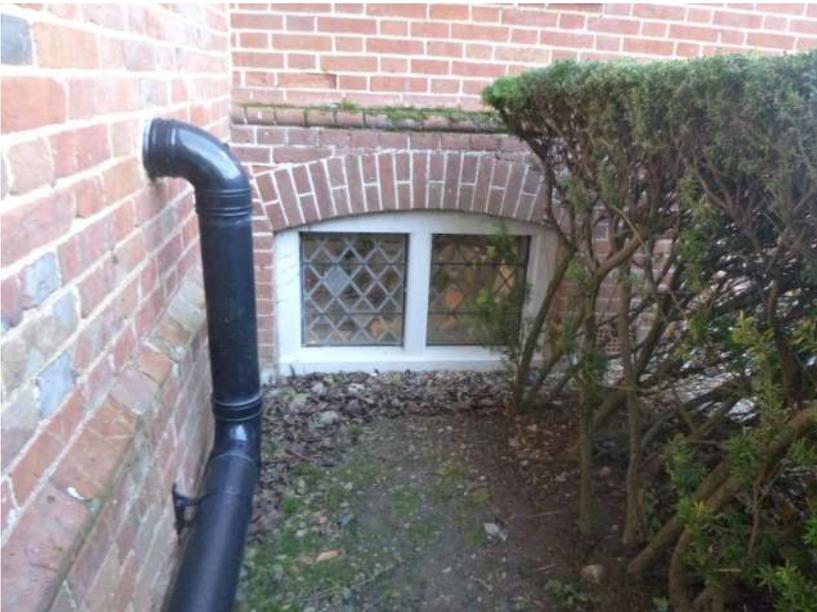
Fig 36:

Exterior, west elevation; showing one of the existing basement windows which appeared to be vulnerable to surface flooding due to the fall of landscaping and lack of drainage provision

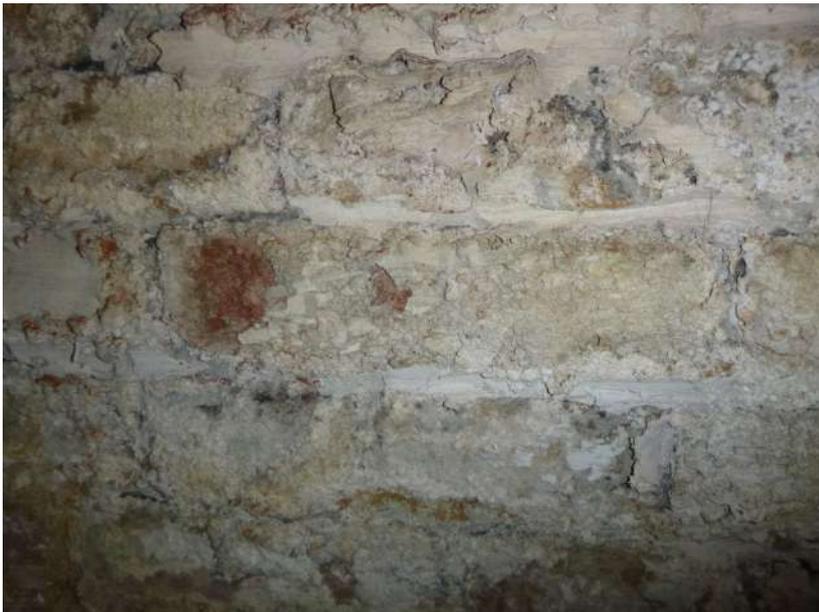
Fig 44:

- 2 Plant room (room 1): The walls within room 1 were exposed brickwork finished with a limewash and/or modern paint. Soiling of masonry and surface migration of hygroscopic salts was noted in several areas with varying severity; with masonry in the south-west corner adjacent to an actively leaking services pipe being the worst affected. Adjacent masonry was affected on both faces of walls, with associated defects seen in room 2 and the vaulted archway into room 1. A sump and pump had been installed in the south-east corner and appeared to be connected to and serve plant installations. Historic water staining was noted north of the sump, though the pump appeared to be operational at the time of survey

Interior, basement, boiler room;
showing a view of soiling to brickwork
due to the migration of hygroscopic
salts and associated with the active
services leak on the other side of the
masonry mass (see Fig 52 below)

The source of the active water leak should be addressed urgently. Allow for brushing down of soiled brickwork and for applying a new coat of limewash or breathable paint

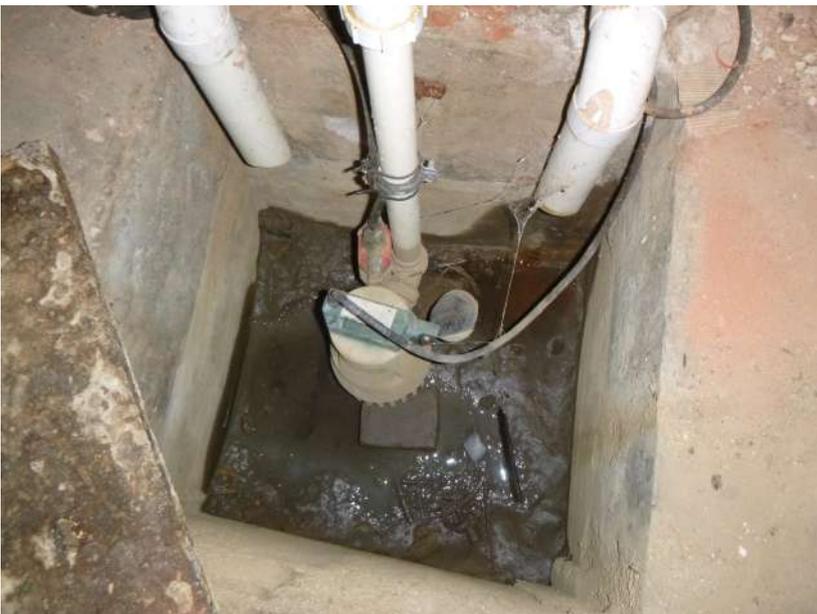
Fig 48:

Interior, basement, boiler room; showing a close-up view of the sump and pump, which appeared to be operational at the time of survey

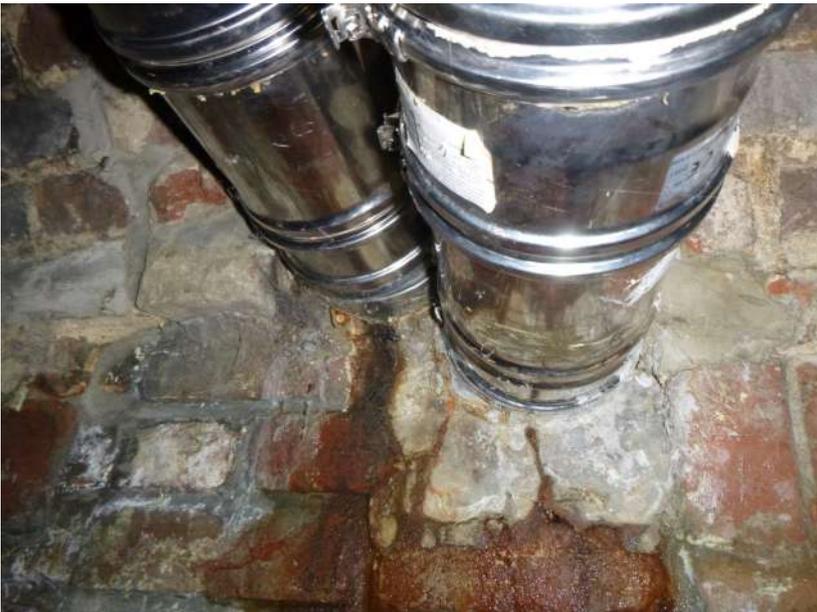
Fig 52:

Interior, basement, boiler room; showing a close-up view of a leaking services pipe, which was saturating adjacent masonry and causing soiling to brickwork

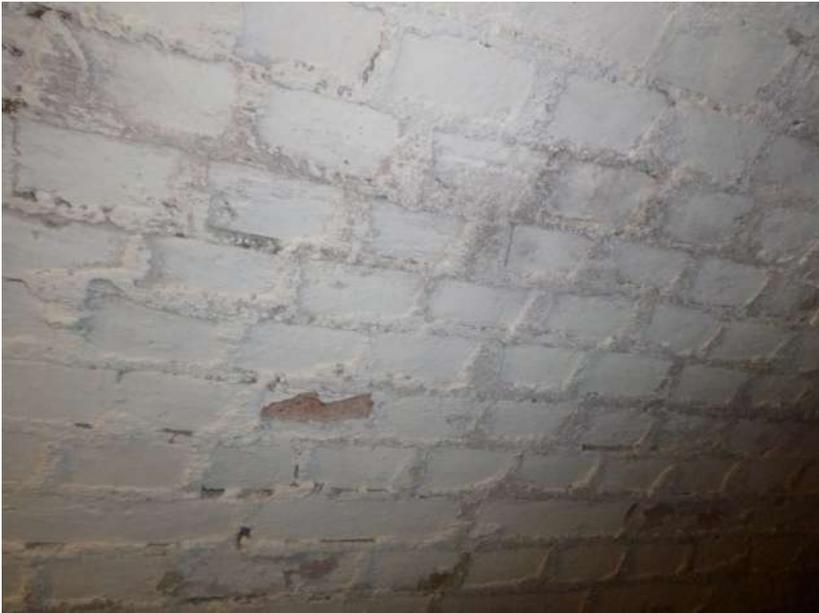
Fig 57:

Interior, basement, wine cellar;
showing a view of salt-affected
cementitious mortar

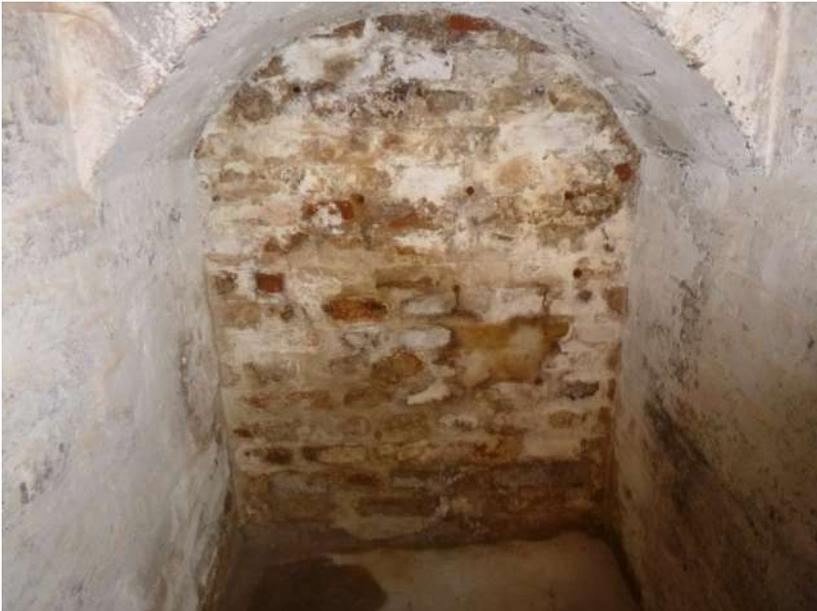
Fig 59:

Interior, basement, wine cellar; showing a view of soiling to brickwork. Also showing evidence of multiple penetrations through the brickwork, which may be from previous inspections or attempted chemical injections

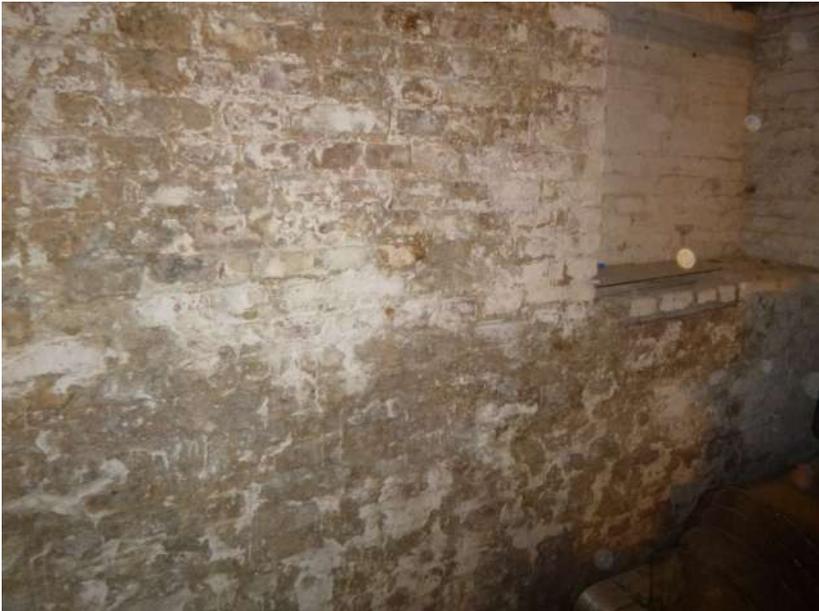
Fig 61:

Interior, basement, south room;
showing evidence of a cement slurry
wash applied to the external wall

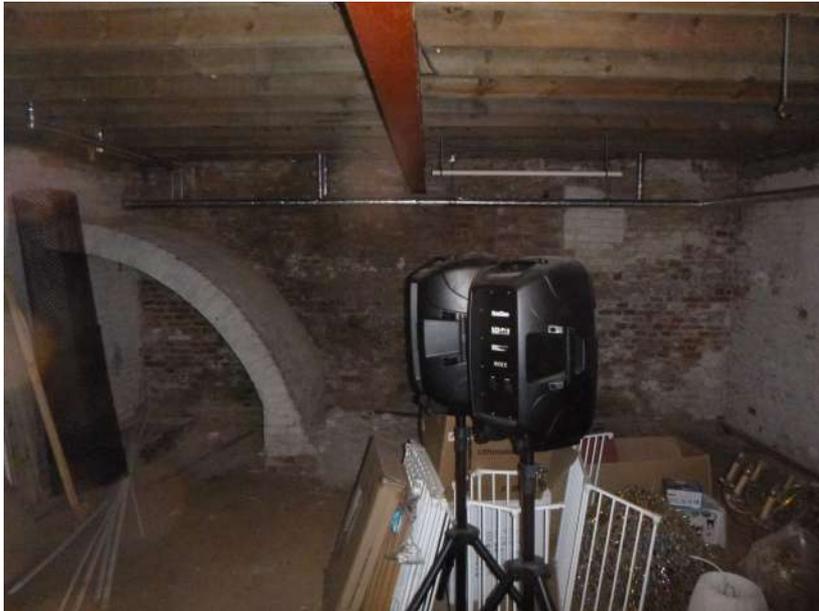
Fig 63:

Interior, basement, south-east room;
showing a general view

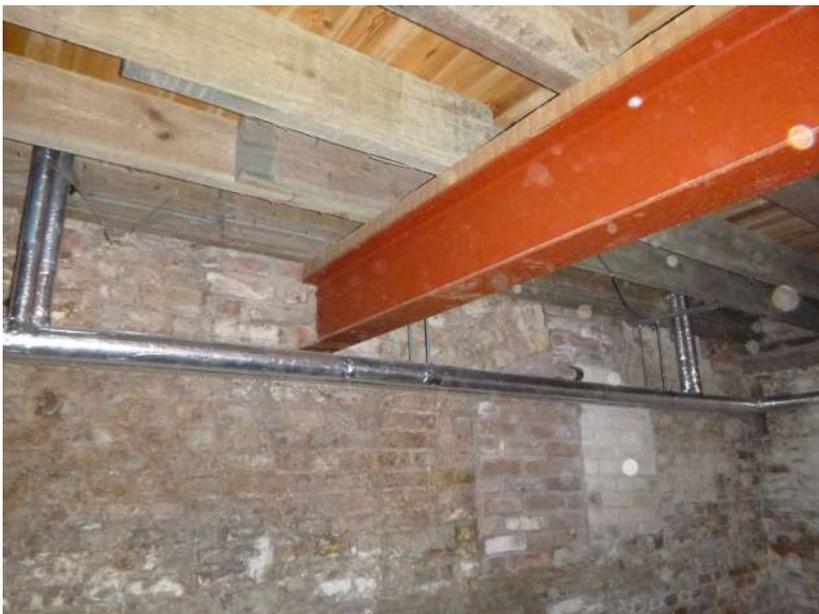
Fig 64:

Interior, basement, south-east room;
showing a view of the east wall where
secondary access is proposed. Note
the existing historic opening which has
previously been infilled with brick

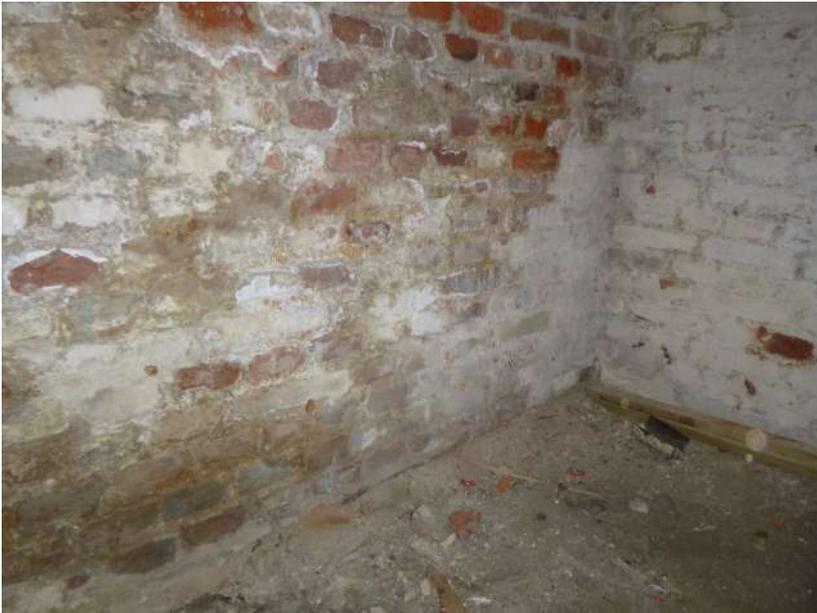
Fig 65:

Interior, basement, south-east room;
showing a view of soiling to brickwork
at low level in the south-east corner

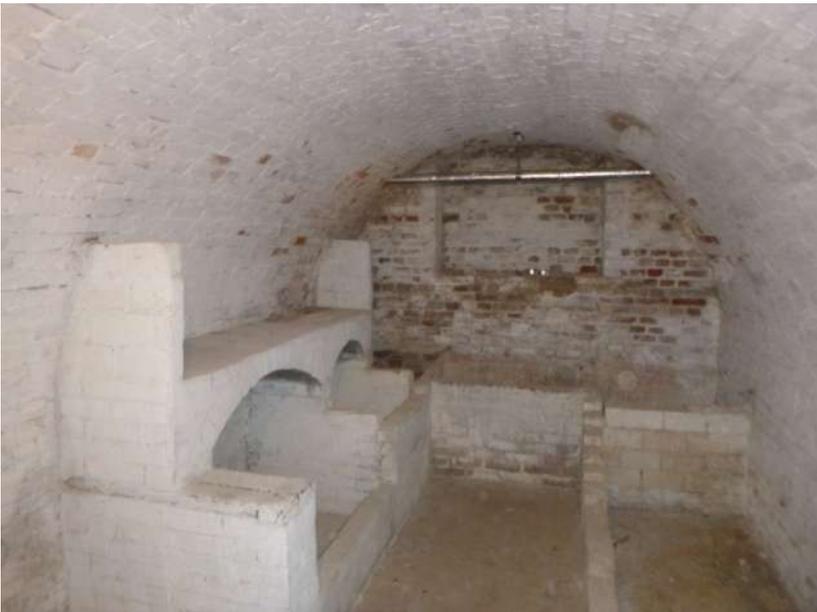
Fig 66:

Interior, basement, vaulted east room;
showing a general view

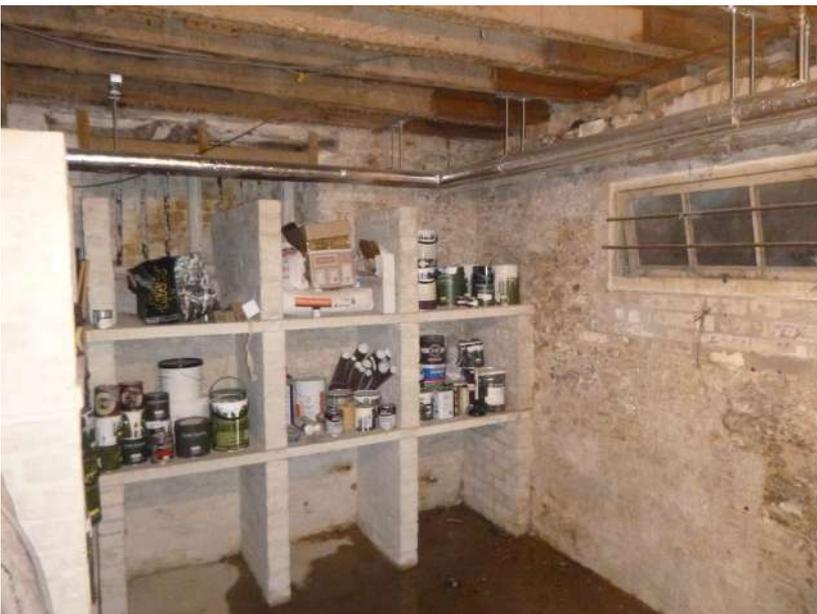
Fig 68:

Interior, basement, south-west room;
showing a general view

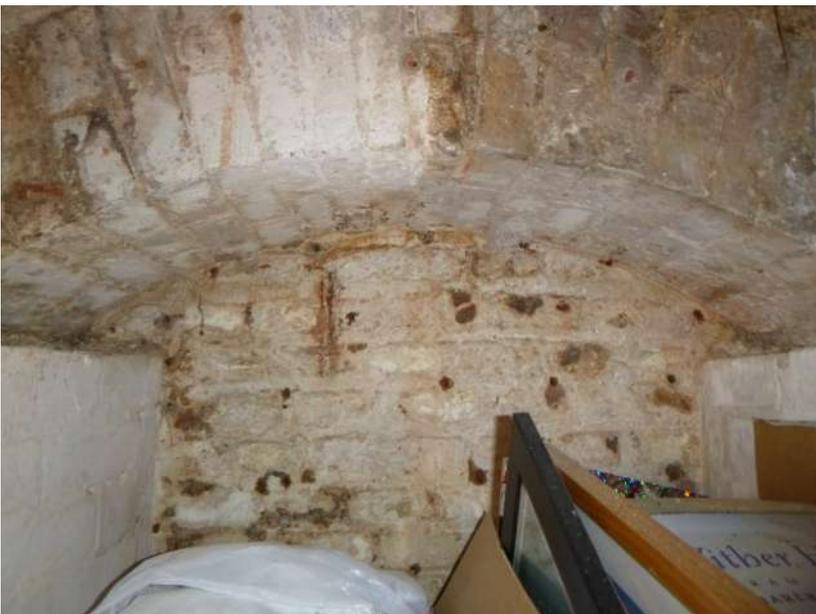
Fig 70:

Interior, basement, south-west room;
showing a view of soiling to brickwork.
Also showing evidence of multiple
penetrations through the brickwork,
which may be from previous
inspections or attempted chemical
injections

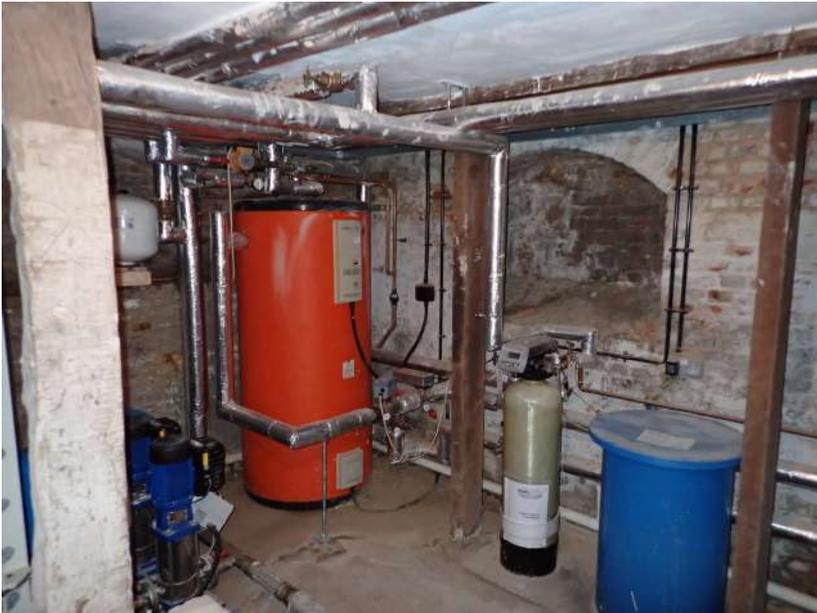
Fig 71:

Interior, basement; showing a view within the plant room. Walls were generally earth retaining and of solid wall construction with no insulation visible. Generally walls were free from significant damp although there was evidence of intermittent superficial water ingress which was unsurprising due to the earth retaining nature of the wall

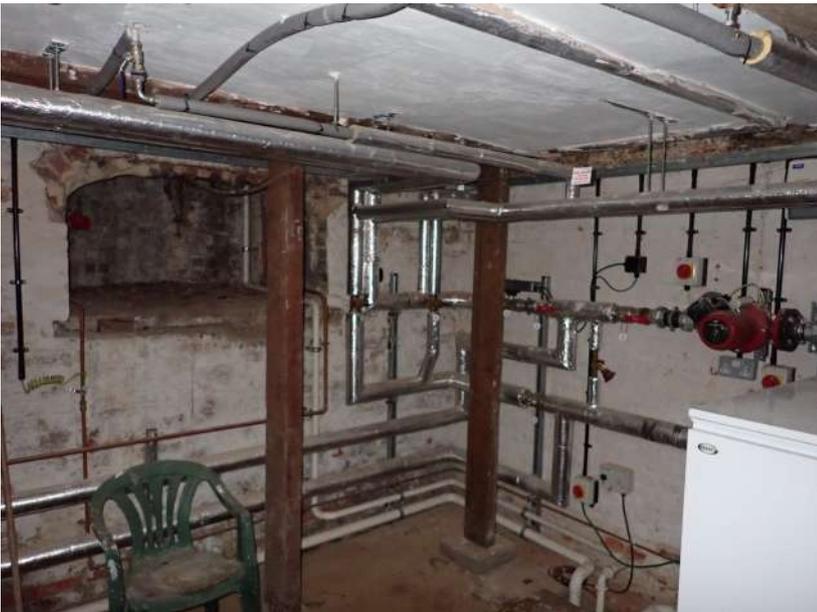
Fig 72:

Interior, basement; showing a view within the plant room. Walls were generally earth retaining and of solid wall construction with no insulation visible. Generally walls were free from significant damp although there was evidence of intermittent superficial water ingress which was unsurprising due to the earth retaining nature of the wall

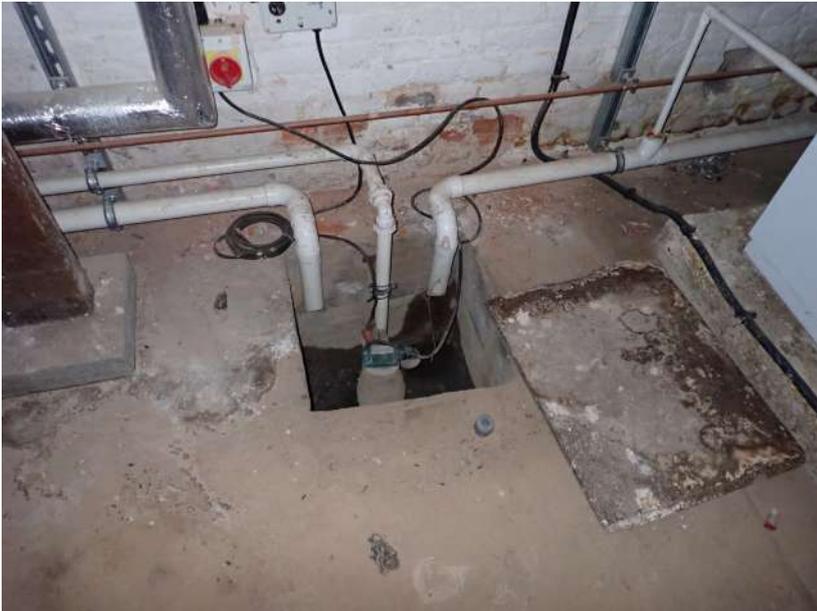
Fig 73:

Interior, basement; showing a view of the sump pump serving the plant room

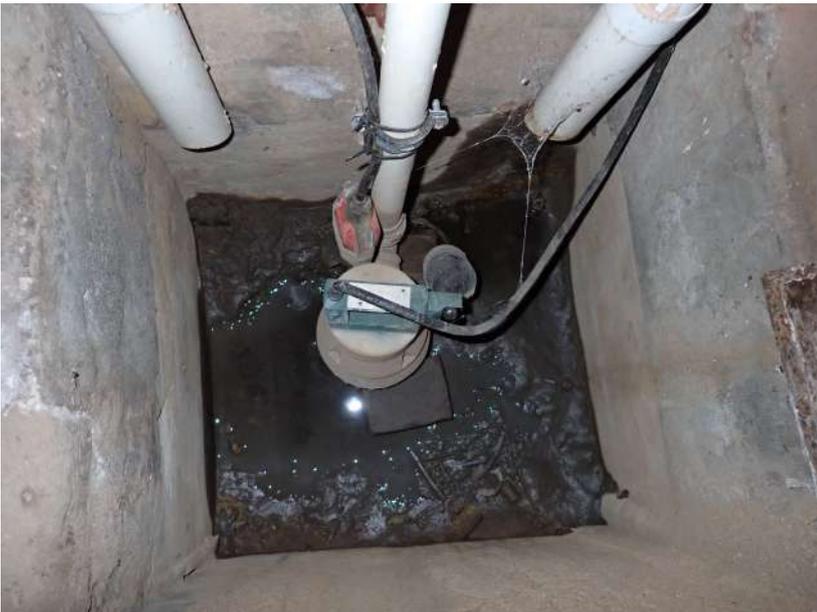
Fig 74:

Interior, basement; showing a close up view of the single sump pump within the plant room. Although not seen working at the time of the survey the homeowner stated that it was functioning correctly

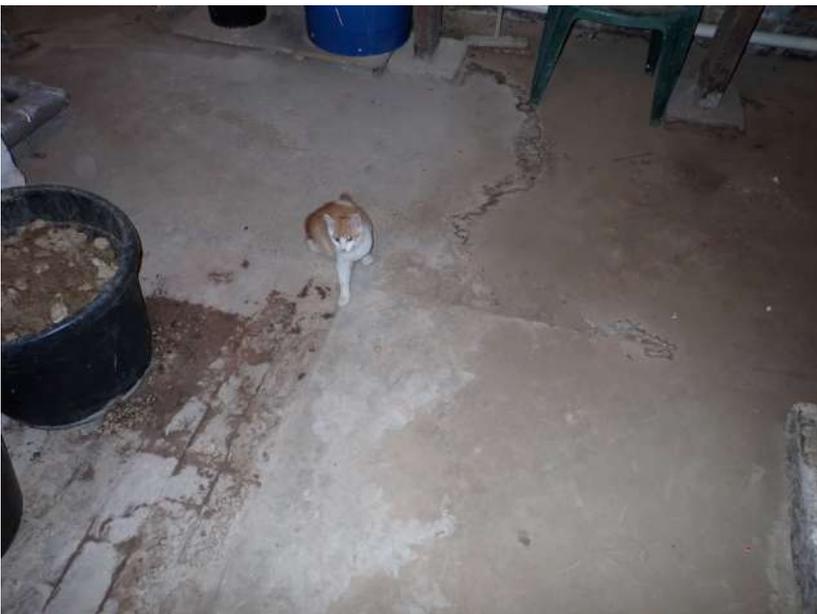
Fig 76:

Interior, basement; showing a view of the floor structure of the plant room which was a mixture of brick sets and solid concrete

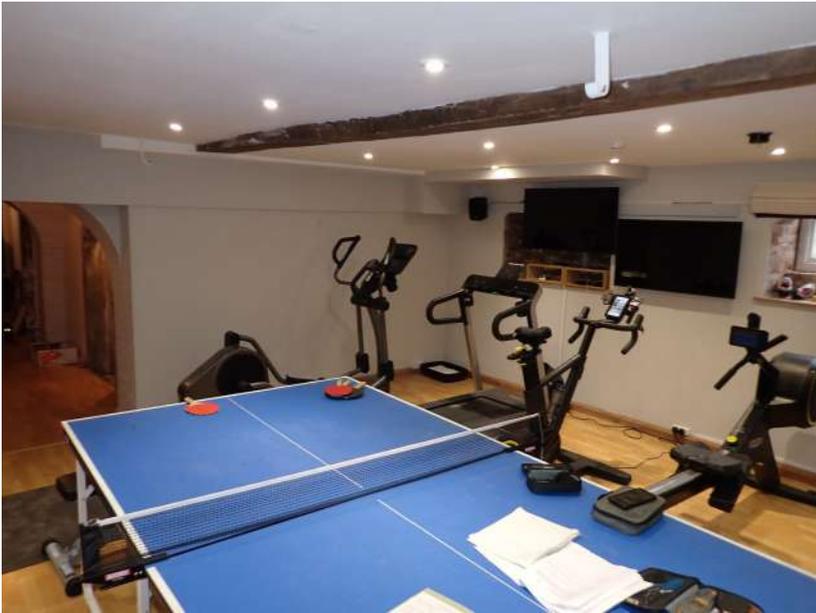
Fig 77:

Interior, basement; showing a general view of the room at the north-west corner. The room was generally dry-lined and had a suspended timber floor over the solid concrete floor structure. Both features separate the internal finishes from potentially damp masonry/concrete floor however, these features also prevented viewing of any damp or ventilation problems

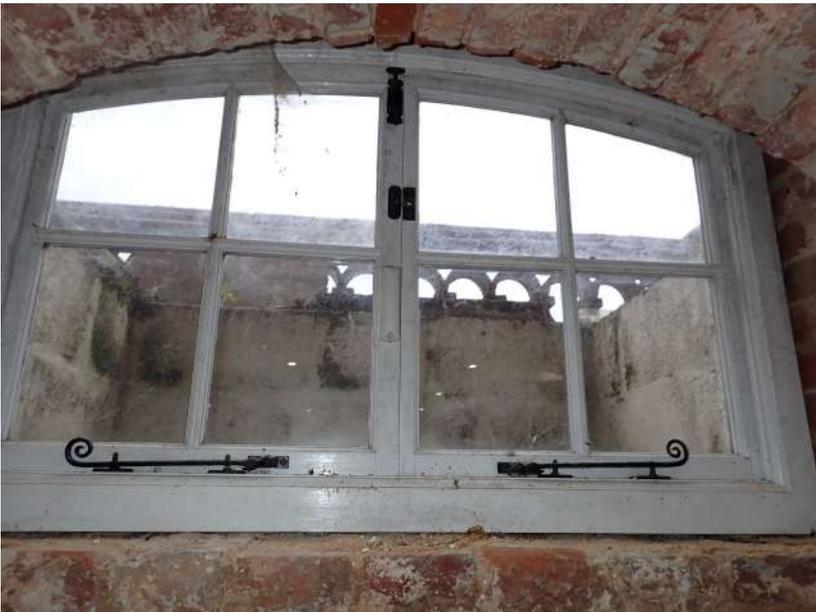
Fig 78:

Interior, basement; showing a view of a typical window found within the basement. There was no provision for ventilation including trickle vents around the window frame

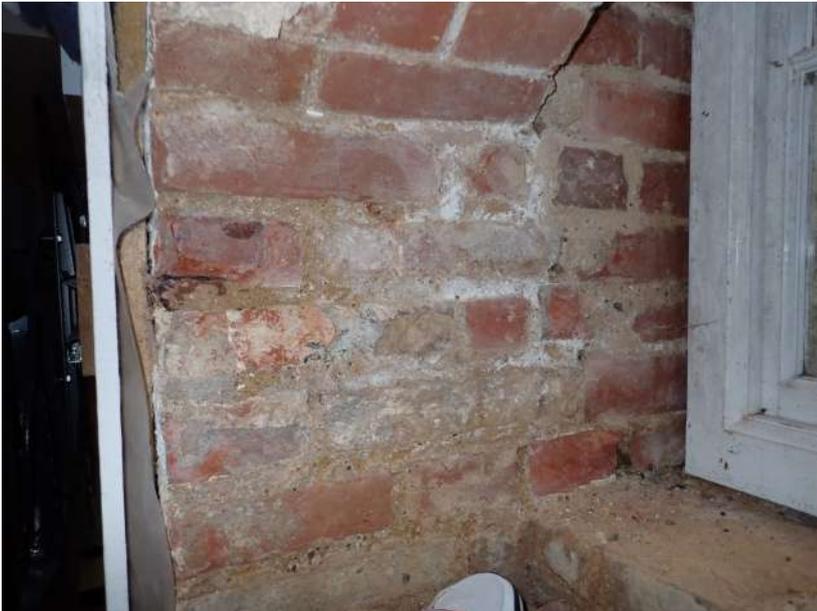
Fig 79:

Interior, basement; showing a view of the reveal of one of the windows which was of fair faced brickwork which was understood to be of solid construction with no cavity

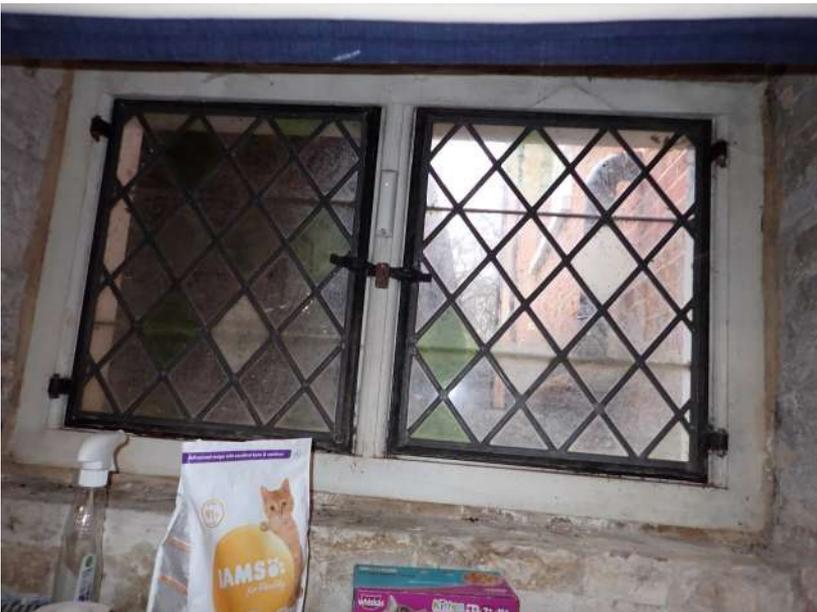
Fig 80:

Interior, basement; showing another window type within the basement which also did not feature any provision for ventilation although to the age and construction adventitious ventilation may be occurring through poor fittings between the window casements and frame

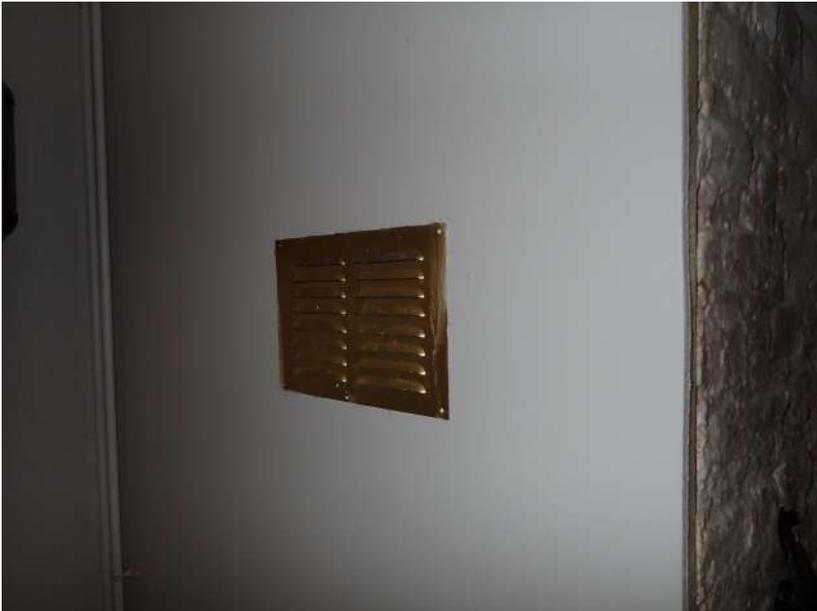
Fig 81:

Interior, basement; showing a view of a grille to the plasterboard. It was not understood if there was any ventilation behind providing air exchange between the exterior and the interior

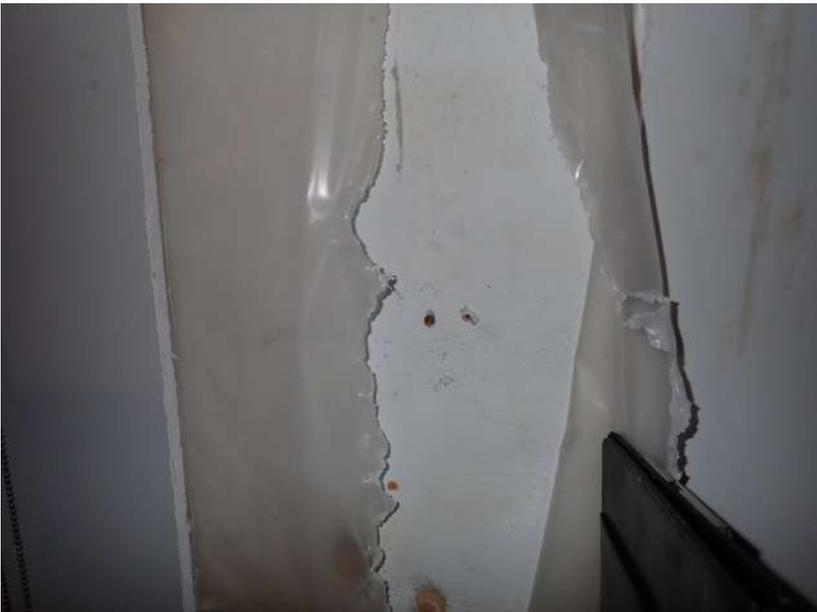
Fig 82:

Interior, basement; showing a view within an opening made prior to H+R's survey. The plasterboard was backed with plastic sheeting onto timber batons secured to the wall. There appeared to be cementitious tanking over the brickwork which was failing/past its useful service life

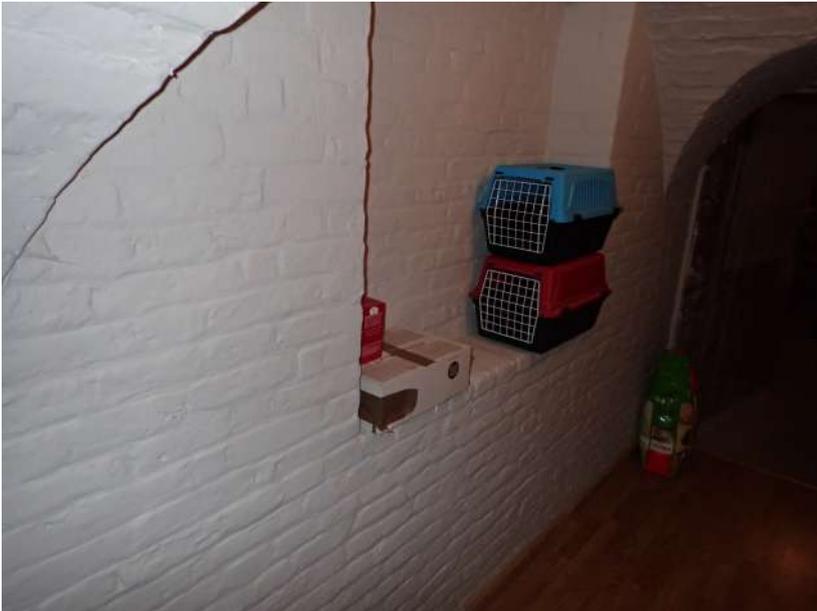
Fig 83:

Interior, basement; showing a view of masonry within the corridor which was painted brickwork

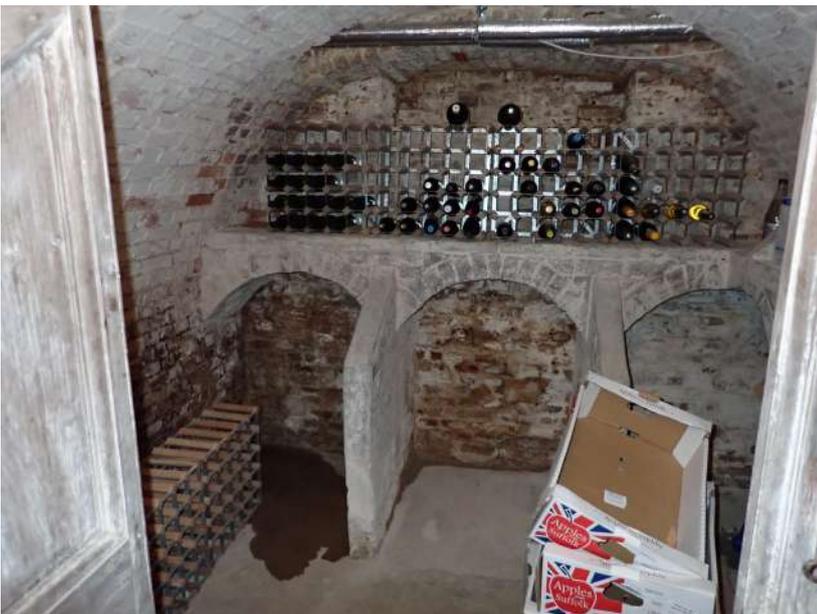
Fig 84:

Interior, basement; showing a view within the cellar room. There was no provision for any forms of ventilation. The ongoing water ingress into the area will be increasing the water vapour content within the room which may lead to timber decay and other defects

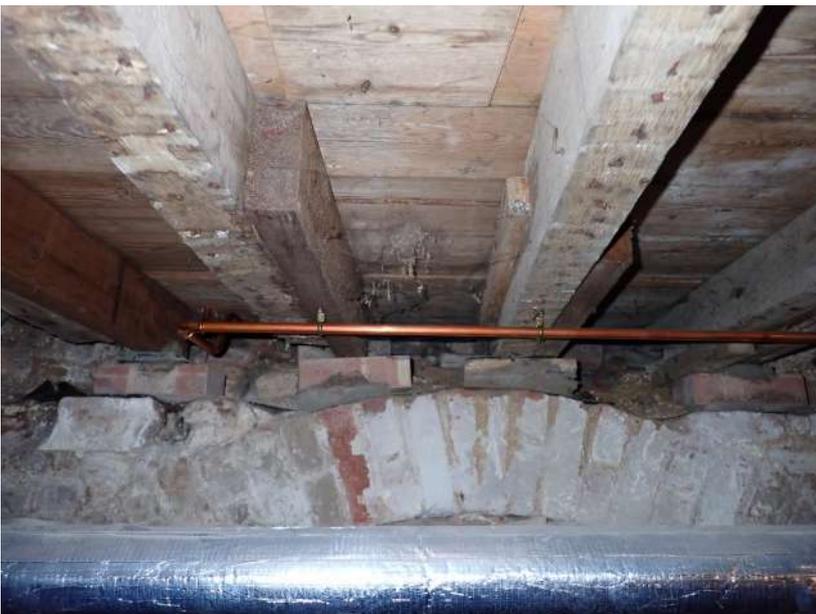
Fig 86:

Interior, basement; showing a view along the ground floor floor joists. A breeze was felt and there may be ventilation occurring through openings at the bearing ends of the floor joists. However, if open this may be allowing water ingress into the structure from wind driven rain and other periods of damp weather

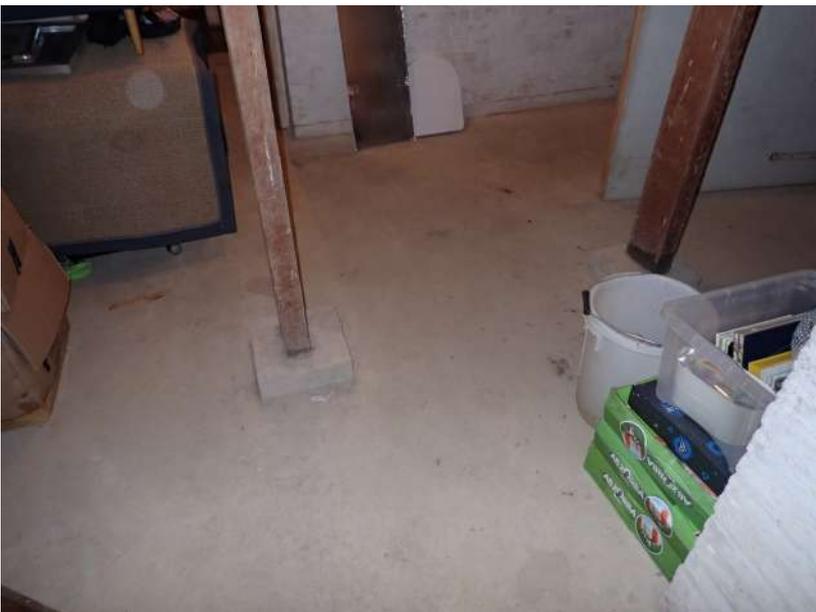
Fig 88:

Interior, basement; showing a view of the solid floor structure which was believed to be poured concrete but the construction was not known and it was not known if there was insulation or damp-proof membrane beneath
