MASONRY DAMP INVESTIGATION OF BASEMENT AT THE OLD RECTORY

JOB NO. 157-85 **Rev A**

10 AND 11 JANUARY 2023

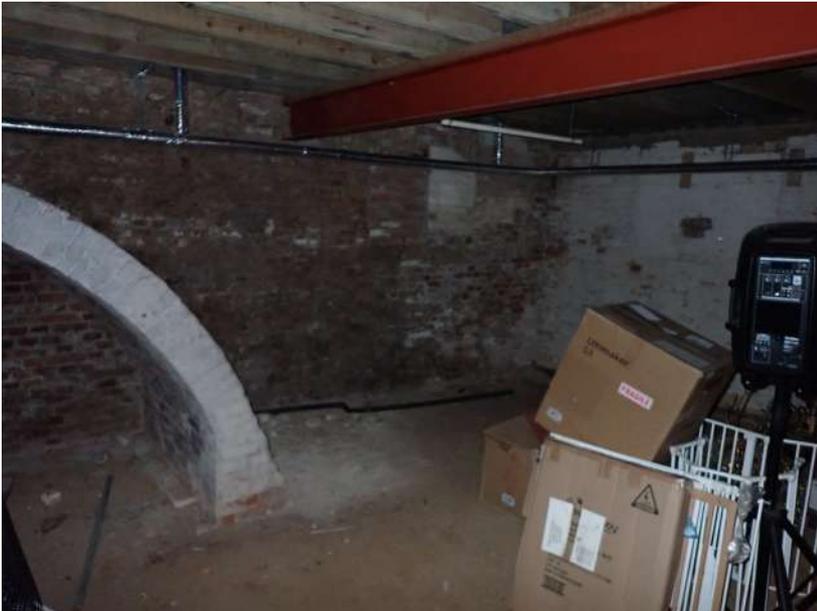
Fig 89:

Interior, basement; showing a view of the room at the south-east corner. Again there was no provision for ventilation and fair faced brickwork showed signs of damp and salt efflorescence which may impact design solutions for the interior decoration

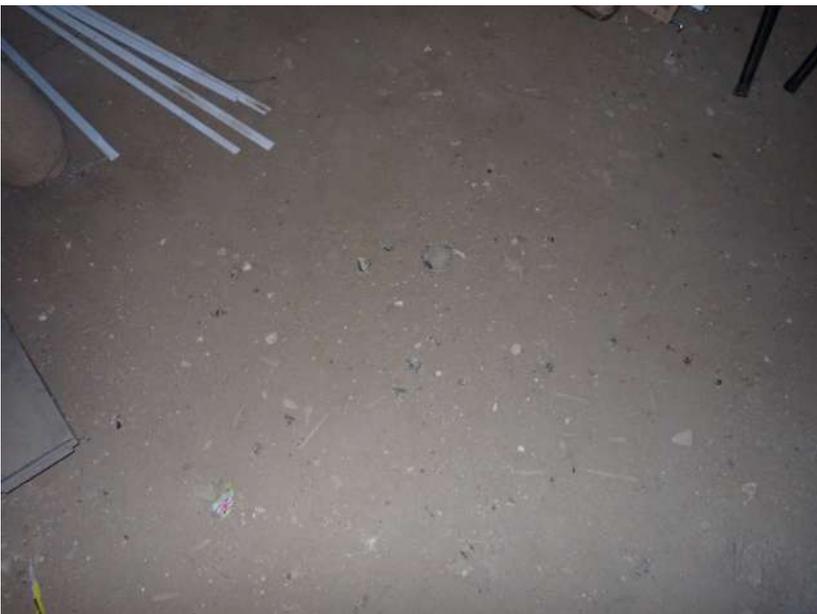
Fig 90:

Interior, basement; showing a view of the unmade ground/dirt floor within the room which left it vulnerable to damp penetration from beneath

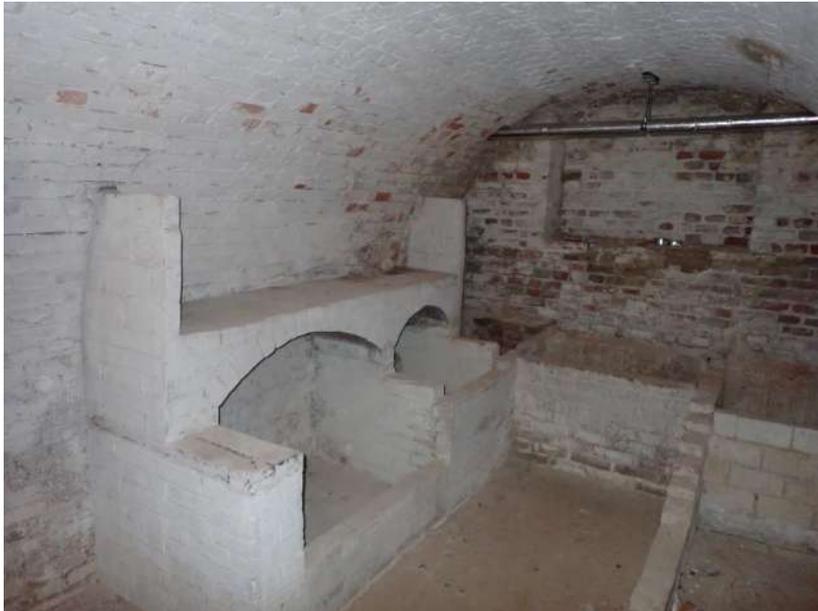
Fig 91:

Interior, basement; showing a further view of the room at the south-east corner which was constructed in the same way as described previously

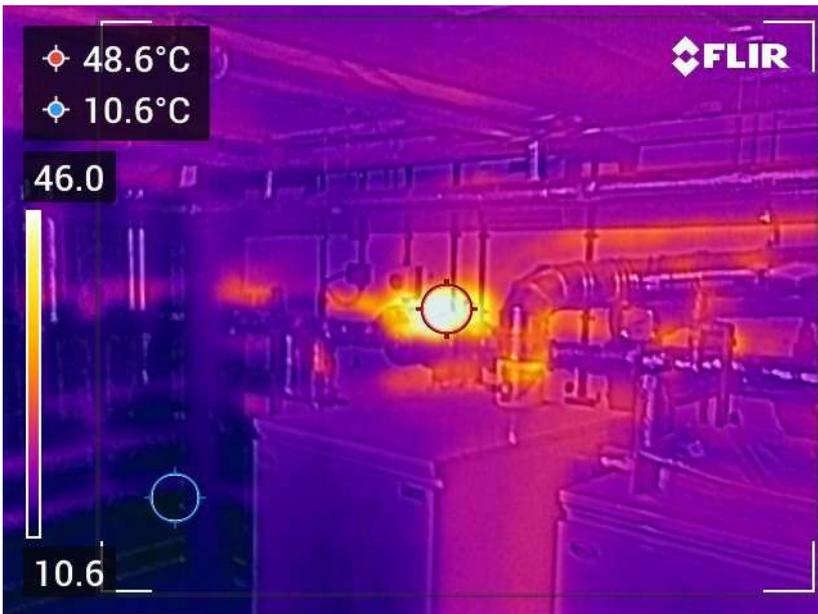
Fig 92:

Interior, basement; showing a thermal image within the plant room with no obvious areas of cold-bridging

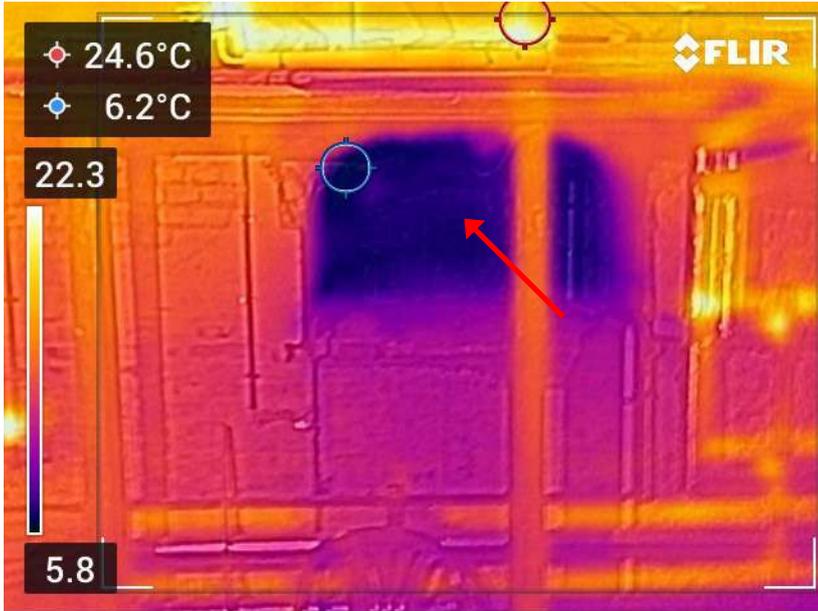
Fig 93:

Interior, basement; showing a thermal image within the plant room with cooler masonry which may pose a condensation risk with increased occupancy

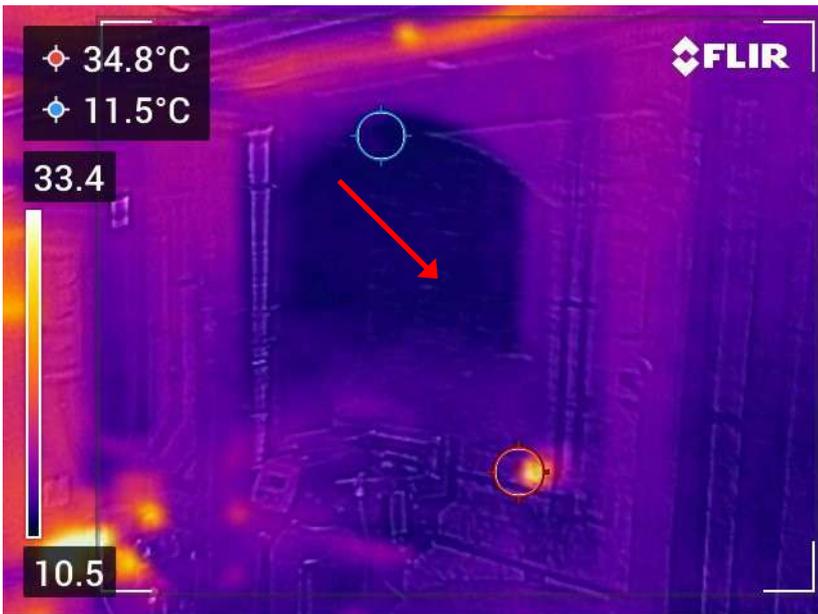
Fig 94:

Interior, basement; showing a thermal image within the plant room with cooler masonry which may pose a condensation risk with increased occupancy

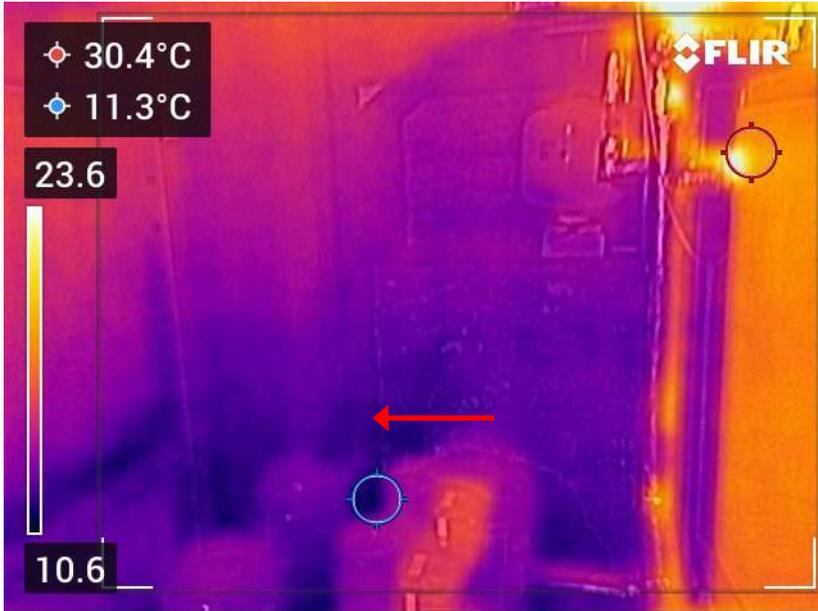
Fig 95:

Interior, basement; showing a thermal image of cooler temperatures at low level

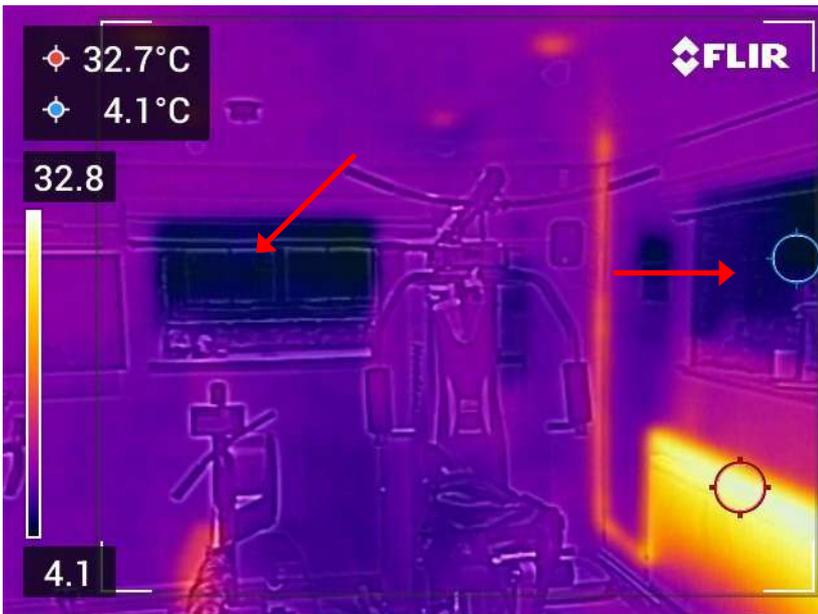
Fig 96:

Interior, basement; showing a thermal image within the gym room with cooler temperatures at the glazing which may pose a condensation risk with increased occupancy

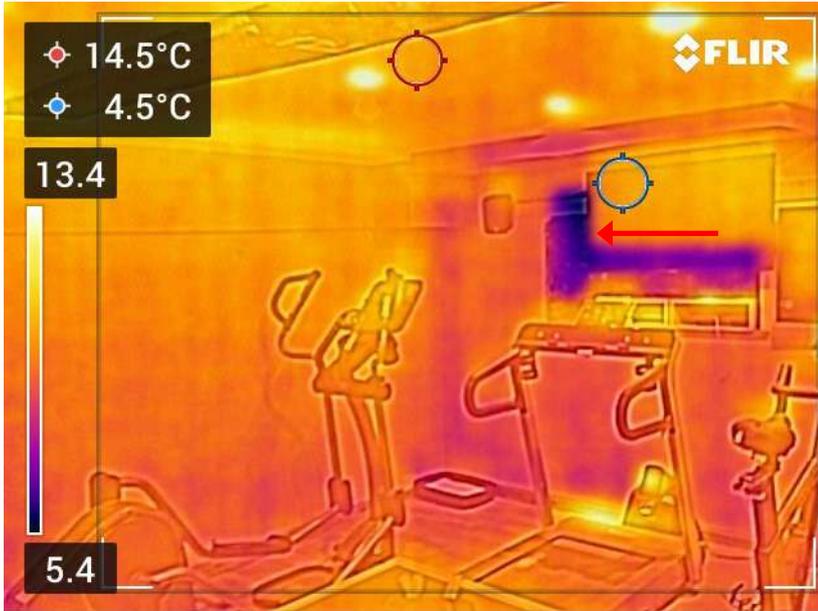
Fig 97:

Interior, basement; showing a thermal image of cooler temperatures at low level

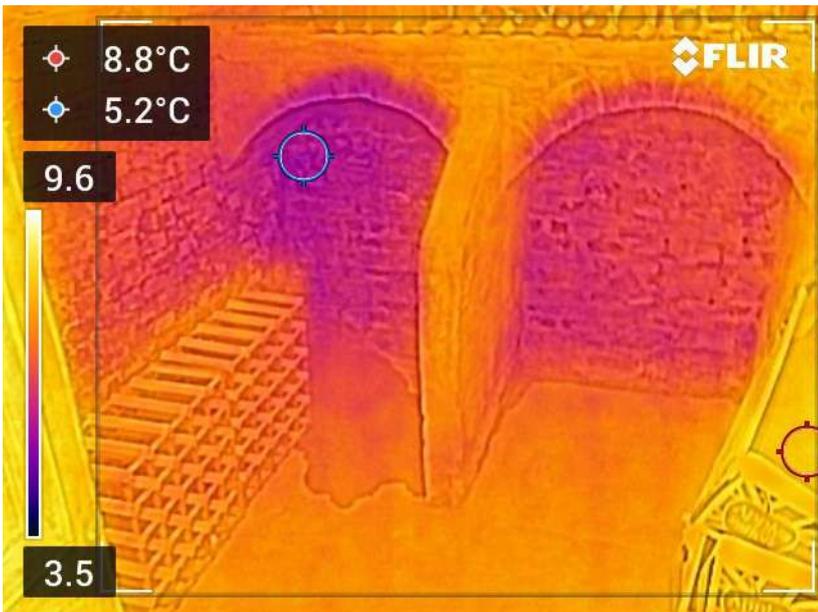
Fig 98:

Interior, basement; showing a thermal image of masonry with no significant variation in temperature

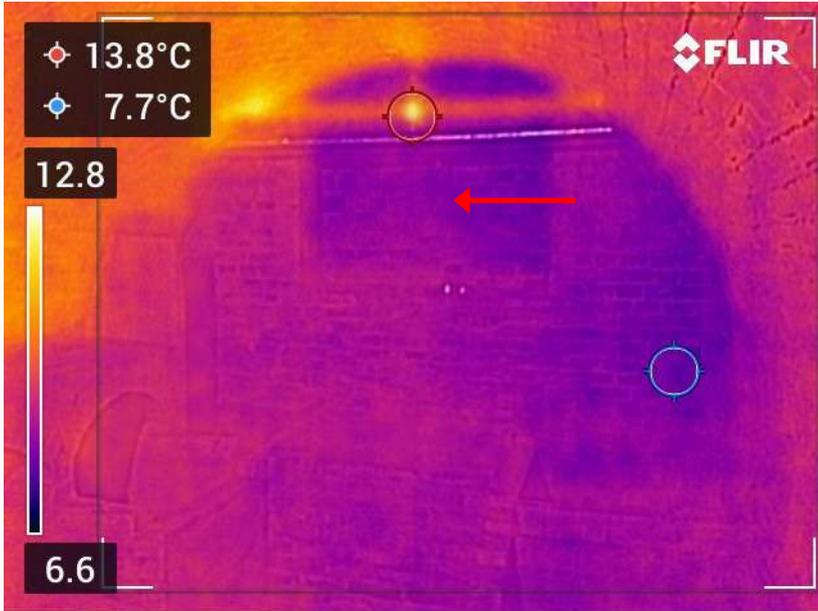
Fig 99:

Interior, basement; showing a thermal image within the plant room with cooler masonry which may pose a condensation risk with increased occupancy

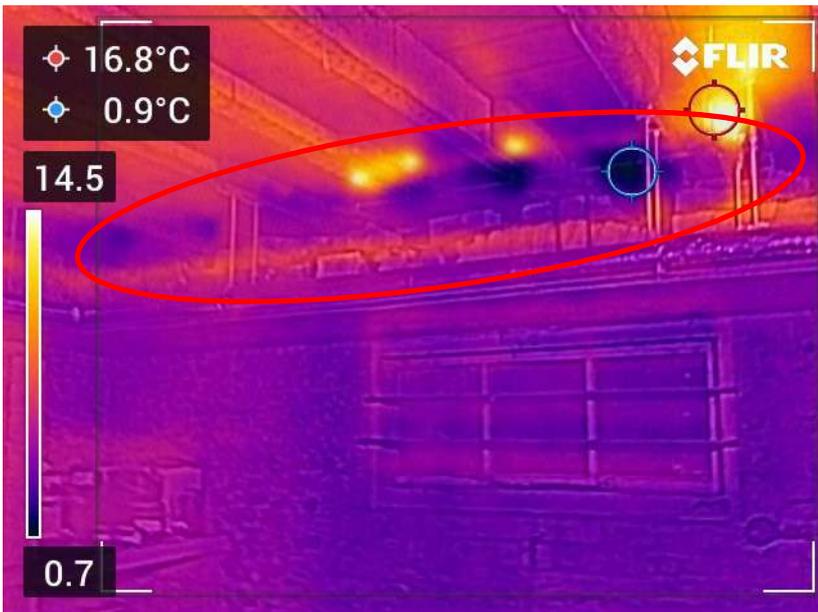
Fig 100:

Interior, basement; showing a thermal image of cooler areas likely to be a result of cooler air from the outside entering the basement through openings in the wall

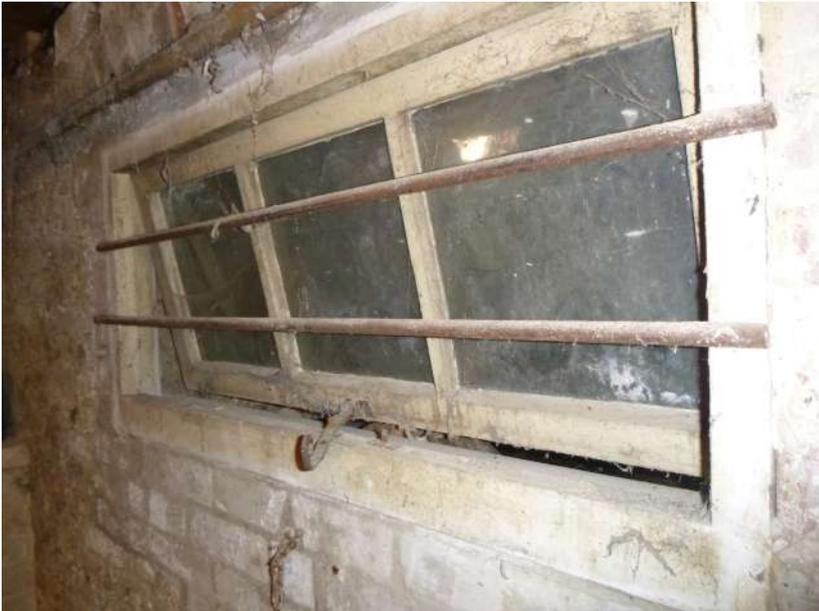
Fig 101:

Interior, basement, south-west room; showing a historic casement window, which was operational and able to provide necessary ventilation into the structure

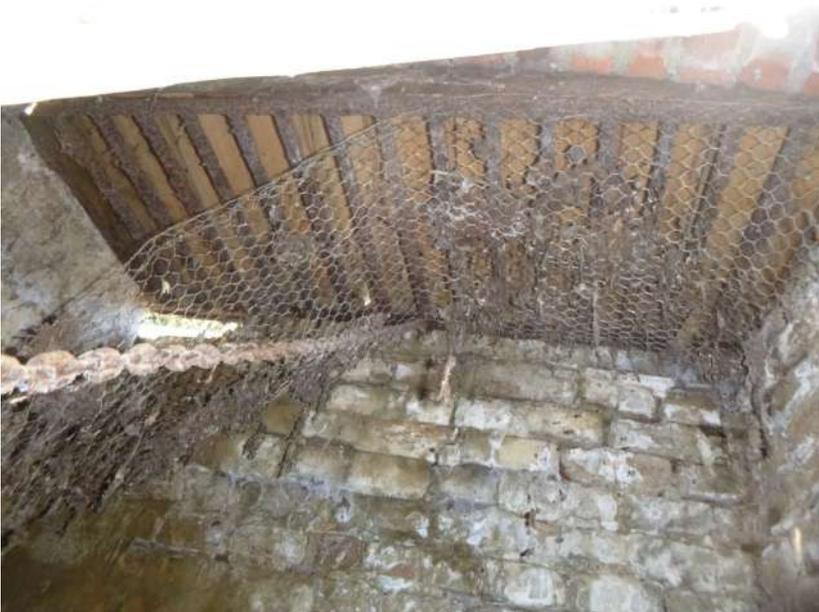
Fig 102:

Interior, basement, south-west room; showing a view of the historic grate over the lightwell. Note this had been enclosed in the recent past, reducing airflow into the basement

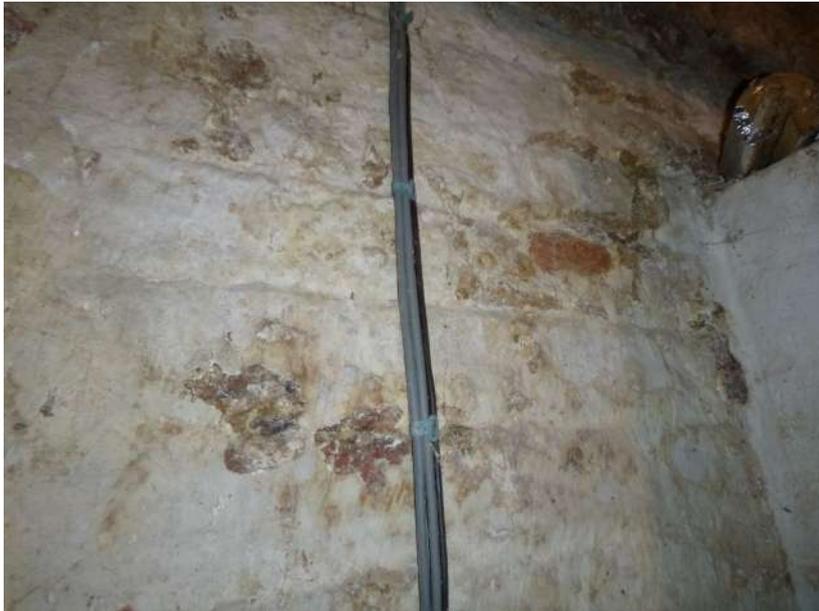
Fig 103:

Interior, basement, south-west room;
showing a close-up view of salt
damage to paint finishes at high level
