**PROJECT**  
**Scotland England Green Link 2**

**TITLE**  
**Figure 2**  
**Otter Habitat Assessment & Survey**

**REFERENCE**  
 SEGL2\_T\_WVO\_2\_v3\_20220209

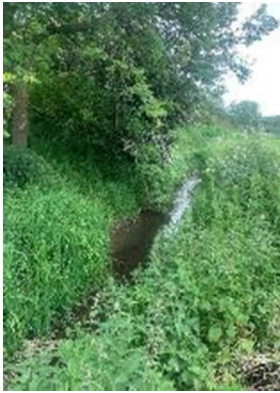
WC11 (Gransmoor Drain)	TA 10386 60270 to TA 10821 60192  TA 11000 59649 to TA 11008 59728  TA 11090 59515 to TA 11013 59625	10.6.21 and 14.7.21	A slow flowing stream with a typical width of 1.5m and a depth of 20cm. Shallow sloping banks less than 45 degrees, with dense bankside vegetation including reed canary grass, meadowsweet, yellow flag and common nettle, with occasional stands of in-channel common reed. There is occasional shading from bankside trees, albeit limited in nature. No evidence of recent management.	Yes, latrines, feeding remains and burrows.	Yes - spraint	Route alignment has changed since survey undertaken, so impacted section not surveyed. Water vole and otter considered likely to be present. Manager at adjacent Clifford Watts Quarry gave anecdotal evidence of an otter sighting on his arrival at work one morning.

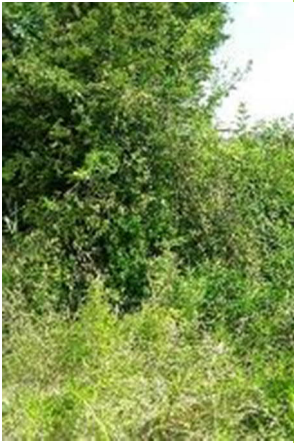
WC25, WC26, WC27 & WC28		N/A	N/A	N/A	N/A	Not accessed/ surveyed. However, further assessment may be required for haulage routes (HDD is planned for these watercourses in close proximity to River Hull Headwaters SSSI).	N/A
WC113	TA 05528 55800	25.8.21	Heavily shaded ditch from unmanaged hawthorn and blackthorn boundary.	No	No	Habitat considered sub-optimal for water vole and considered likely absent; potential for otter to be present as connected to WC28 and River Hull (WC27)

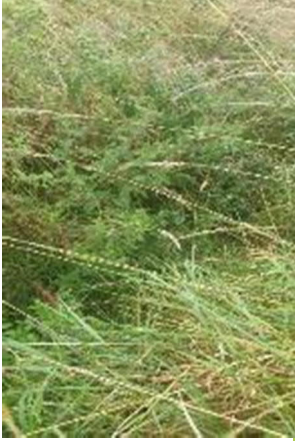
Watercourse Reference (and name if applicable)	Survey start & end points (OS Grid Reference)	Survey date	Description of watercourse	Evidence of Water Vole Found?	Evidence of otter found?	Comments	Photograph (representative of habitat)
						further survey. Ditch within the planning application boundary.	
WC132	N/A	N/A	(Limited notes from Phase 1) Wet overgrown ditch with earth banks and food and cover for water vole.	N/A	N/A	Requires further survey; within the planning application boundary.

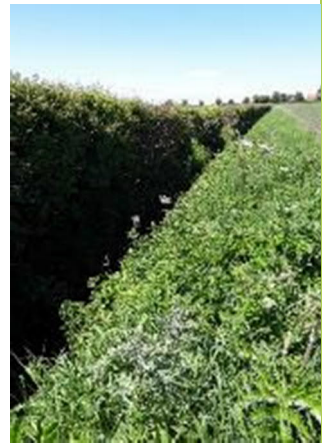
Watercourse Reference (and name if applicable)	Survey start & end points (OS Grid Reference)	Survey date	Description	Evidence of Water Vole Found?	Evidence of otter found?	Comments	Photograph
WC46	N/A	N/A	N/A	N/A	N/A	Not surveyed, further assessment required.	N/A
WC47	N/A	N/A	N/A	N/A	N/A	Not surveyed, further assessment required.	N/A
WC48 (Beil's Beck)	N/A	N/A	N/A	N/A	N/A	No impact predicted to this section of Beil's Beck, so scoped out from further assessment.	N/A
WC49	N/A	9.6.21	Drainage ditch at base of hedgerow, dense algal matting over shallow water (less than 5cm deep). Ditch is shaded by hedgerow.	No	No	Likely absent - scoped out from further assessment as habitat unsuitable.

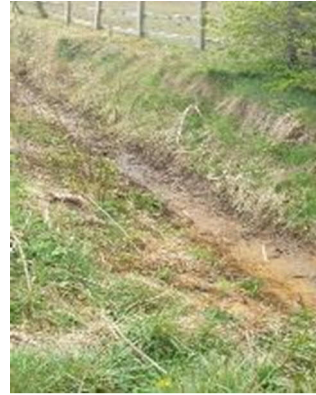
Watercourse Reference (and name if applicable)	Survey start & end points (OS Grid Reference)	Survey date	Description	Evidence of Water Vole Found?	Evidence of otter found?	Comments	Photograph
WC50	N/A	9.6.21	Ditch found to be dry during assessment with little vegetative cover.	No	No	Scoped out from further assessment, in addition ditch avoided by HDD.

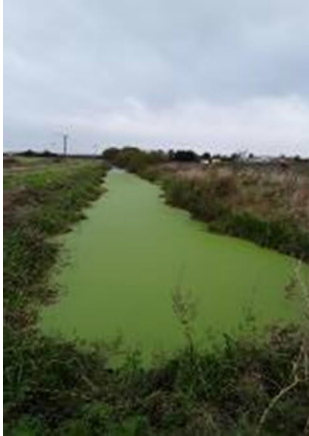
Watercourse Reference (and name if applicable)	Survey start & end points (OS Grid Reference)	Survey date	Description	Evidence of Water Vole Found?	Evidence of otter found?	Comments	Photograph
P99 (Pond 99)	N/A	N/A	A former canal approximately 10m in width with depth likely to exceed 1m. Densely vegetated banks provide cover and food for water vole with fool's watercress, reed canary grass and great willowherb.	N/A	N/A	Further assessment required if haul road impacts are anticipated. Otter potentially present.

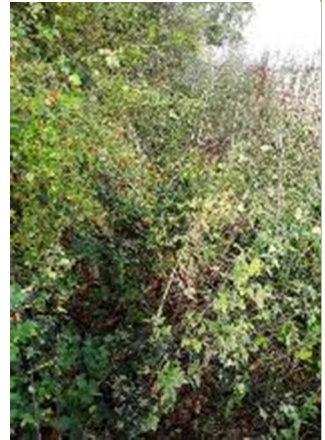
Watercourse Reference (and name if applicable)	Survey start & end points (OS Grid Reference)	Survey date	Description	Evidence of Water Vole Found?	Evidence of otter found?	Comments	Photograph
WC134	N/A	N/A	Mapped as dry ditch on Field Mapper.	N/A	N/A	Likely to be a dry ditch and unsuitable for water vole. Will require further assessment as within the planning application boundary.	N/A
WC53	N/A	N/A	A hedgerow with an associated dry ditch, only likely to hold water during autumn and winter and isolated from wider ditch network.	N/A	N/A	Unsuitable habitat for riparian mammals, scoped out from further assessment.

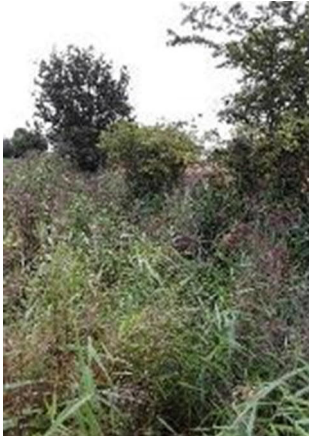
Watercourse Reference (and name if applicable)	Survey start & end points (OS Grid Reference)	Survey date	Description	Evidence of Water Vole Found?	Evidence of otter found?	Comments	Photograph
WC135	N/A	N/A	Not surveyed, Isolated section of ditch, likely to be dry.	N/A	N/A	Likely to be dry and unsuitable for water vole/ otter. Requires further assessment as ditch is within the planning application boundary.	N/A
WC57	N/A	26.8.21	Ditch which held water at the time of the scoping assessment but was not readily visible due to dense in-channel vegetation dominated by common reed.	N/A	N/A	Further assessment required.

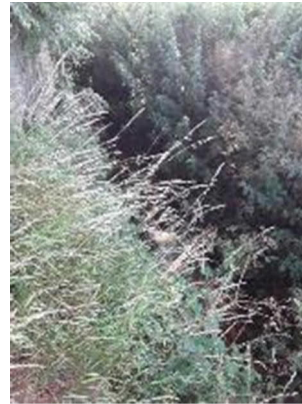
Watercourse Reference (and name if applicable)	Survey start & end points (OS Grid Reference)	Survey date	Description	Evidence of Water Vole Found?	Evidence of otter found?	Comments	Photograph
WC58		26.8.21	Ditch dry at time of survey, with sparse aquatic vegetation and bare earth in channel. Tall ruderal and improved grassland on steep banks with scattered bramble.	No	No	Unsuitable habitat, scoped out from further assessment.

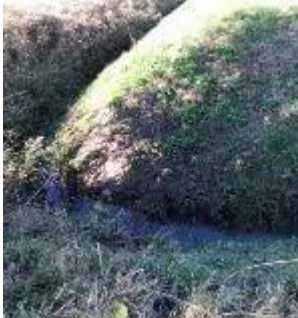
Watercourse Reference (and name if applicable)	Survey start & end points (OS Grid Reference)	Survey date	Description	Evidence of Water Vole Found?	Evidence of otter found?	Comments	Photograph
WC63	SE 80446 34511 to SE 80577 34639	21.10.21	Wet ditch approximately 30cm x 50cm with bankside vegetation dominated by perennial rye grass with occasional hogweed and common nettle. Banks have wooden planks at water level.	No	No	Ditch would require further assessment to scope out water vole. Otter likely absent.

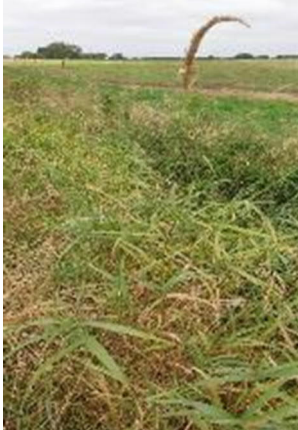
Watercourse Reference (and name if applicable)	Survey start & end points (OS Grid Reference)	Survey date	Description	Evidence of Water Vole Found?	Evidence of otter found?	Comments	Photograph
WC65	SE 79726, 33885 to SE 79797, 33997	8.9.21	Densely vegetated wet ditch with reed canary grass and meadowsweet.	No	Yes - spraint	Water vole likely absent and scoped out from further assessment. Otter spraints under culvert adjacent to River Foulness WC66.

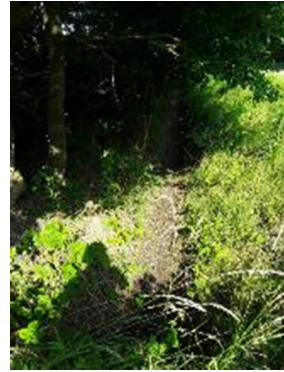
Watercourse Reference (and name if applicable)	Survey start & end points (OS Grid Reference)	Survey date	Description	Evidence of Water Vole Found?	Evidence of otter found?	Comments	Photograph
WC139	N/A	11.08.21	Dry ditch with improved grassland verges with species including cocksfoot, perennial ryegrass and hogweed.	No	No	Unsuitable for otter or water voles. Scoped out of further assessment. Within the planning application boundary.

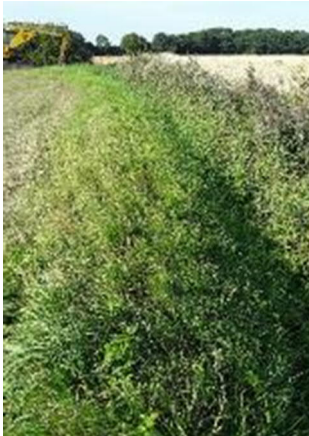
Watercourse Reference (and name if applicable)	Survey start & end points (OS Grid Reference)	Survey date	Description	Evidence of Water Vole Found?	Evidence of otter found?	Comments	Photograph
WC71	N/A	8.11.21	Dry ditch with common reed, perennial ryegrass and false oatgrass.	N/A	N/A	Unsuitable habitat, scoped out from further assessment.

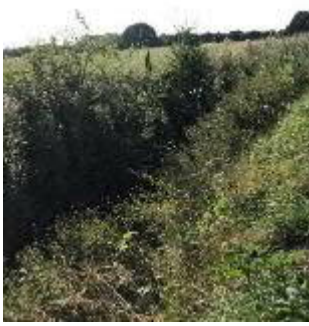
Watercourse Reference (and name if applicable)	Survey start & end points (OS Grid Reference)	Survey date	Description	Evidence of Water Vole Found?	Evidence of otter found?	Comments	Photograph
WC72	N/A	N/A	Predominantly dry ditch with occasional standing water. Earth banks with tall ruderal vegetation.	N/A	N/A	Unsuitable habitat, scoped out from further assessment.

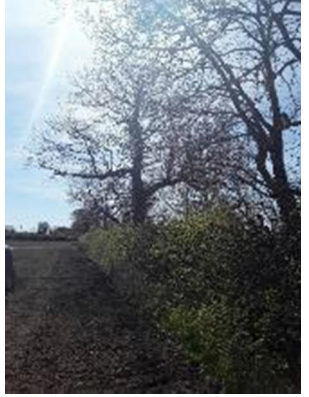
Watercourse Reference (and name if applicable)	Survey start & end points (OS Grid Reference)	Survey date	Description	Evidence of Water Vole Found?	Evidence of otter found?	Comments	Photograph
WC74 (east of Wood Lane B1228)	N/A	N/A	Dry drainage ditch beneath with hawthorn hedgerow with trees. Overshaded, no aquatic vegetation or water present.	N/A	N/A	Unsuitable habitat, scoped out from further assessment.

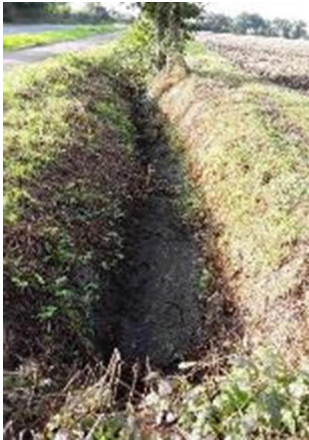
WC75	N/A	N/A	N/A	N/A	N/A	Further assessment required.	N/A
WC119	N/A	N/A	Dry managed ditch with steep vegetated banks.	No	No	Unsuitable habitat, scoped out from further assessment.

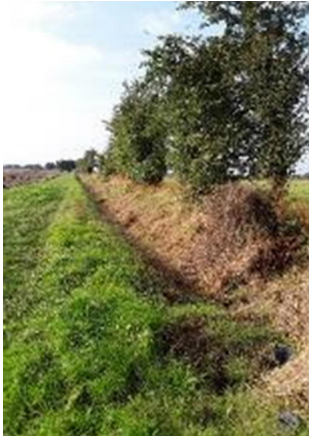
Watercourse Reference (and name if applicable)	Survey start & end points (OS Grid Reference)	Survey date	Description	Evidence of Water Vole Found?	Evidence of otter found?	Comments	Photograph
WC120	N/A	N/A	N/A	N/A	N/A	Not impacted by scheme, scoped out from assessment.	N/A
WC76	SE 74682 30301	9.10.21	Dry, tree-lined managed ditch	N/A	N/A	Habitat not suitable for riparian species and scoped out from further assessment.

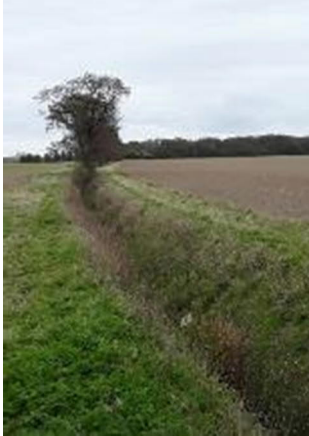
Watercourse Reference (and name if applicable)	Survey start & end points (OS Grid Reference)	Survey date	Description	Evidence of Water Vole Found?	Evidence of otter found?	Comments	Photograph
WC77	SE 74219 30359	21.4.21	Dry ditch lined with semi-mature oaks	N/A	N/A	Habitat unsuitable for riparian species and scoped out from further assessment.

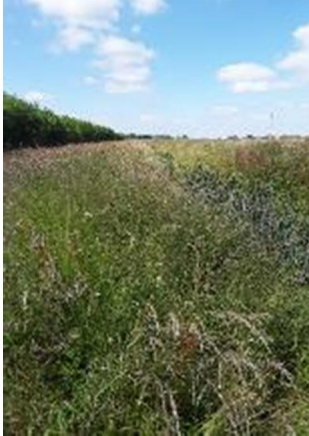
WC78	SE 73264 30165 to SE 73293 30030	15.7.21	A shallow static ditch approximately 0.4m wide and up to 0.1m deep. Tussocky grass banks with occasional dense in-channel vegetation with common reed and bulrush. Ditch unmanaged at the time of the survey, but other ditches under same land ownership had been flailed.	No	No	Shallow water depth unsuitable for riparian species and scoped out from further assessment.

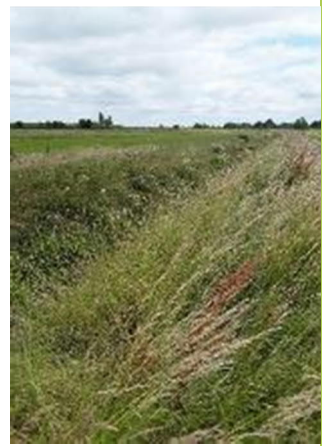
WC80	SE 72334 29141 to SE 72176 29187	15.7.21	Slow flowing ditch approximately 3m wide and up to 40cm deep. Steep earth banks with grasses and ruderals. The ditch is subject to management.	Possible.	No	Small vole (bank or field) feeding remains. Potential water vole burrows, but presence not confirmed through latrines/ droppings. Further assessment required.

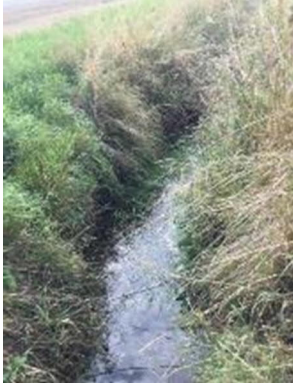
WC83	SE 70886 27970	22.10.21	A field drain with 2m sloping banks vegetated with common reed and rank grasses. A 15cm deep channel is overgrown with common reed and duckweed cover. The ditch shallows towards the proposed crossing point becoming dry.	No	No	Habitat unsuitable for riparian species and scoped out from further assessment.

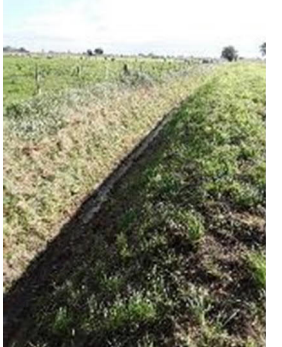
Watercourse Reference (and name if applicable)	Survey start & end points (OS Grid Reference)	Survey date	Description	Evidence of Water Vole Found?	Evidence of otter found?	Comments	Photograph
WC122	N/A	N/A	Managed shallow ditch approximately 0.3m wide and 5cm deep.	N/A	N/A	Unsuitable riparian mammal habitat and ruled out from further assessment.

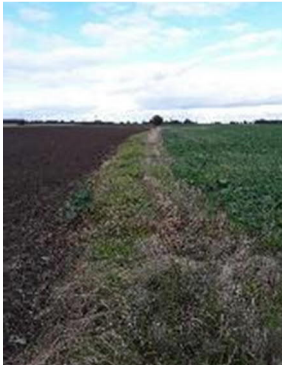
WC84	N/A	22.10.21	Former field boundary, not a ditch.	N/A	N/A	Habitat unsuitable for riparian species and scoped out from further assessment.

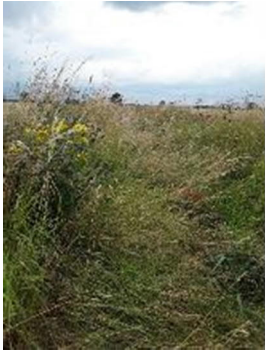
Watercourse Reference (and name if applicable)	Survey start & end points (OS Grid Reference)	Survey date	Description	Evidence of Water Vole Found?	Evidence of otter found?	Comments	Photograph
WC85	SE 69950 27456 to SE 70127 27412	30.7.21	An overgrown ditch with common reed, field bindweed and rank grasses including false oat grass.	Possibly	No	Ditch surveyed in Oct 2021 following management, with potential aged water vole feeding remains. Resurvey in optimal window. Otter likely absent.

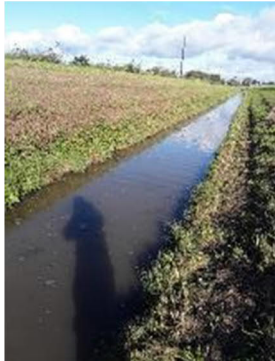
WC86 (Lowfield Drain)	SE 69647 27545 to SE 69604 27331	22.10.21	Recently managed tidal ditch, approximately 2.5m wide with a maximum depth of 0.5m. Identifiable plants present include Yorkshire fog, water figwort, duckweed, cow parsley, broad-leaved dock, common nettle, meadowsweet and coltsfoot.	Yes	No	Numerous water vole burrows, latrines and feeding remains along surveyed length. Otter likely absent.

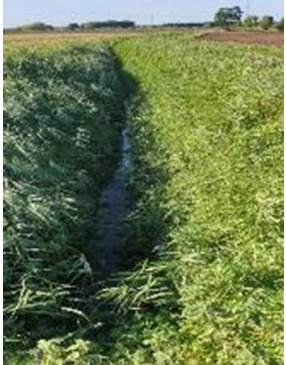
Watercourse Reference (and name if applicable)	Survey start & end points (OS Grid Reference)	Survey date	Description	Evidence of Water Vole Found?	Evidence of otter found?	Comments	Photograph
WC87	SE 69252 27324 to SE 69042 27451	21.10.21	Field drain linked to WC86 with a width of 40cm and a depth of approximately 20cm. Vegetation present comprises cow parsley, cocksfoot, red clover, ribwort plantain, false oat grass, hogweed and reed canary grass.	No	No	Habitat appears suitable for water vole, potentially present as ditch linked to WC86. Further assessment required. Otter likely absent.

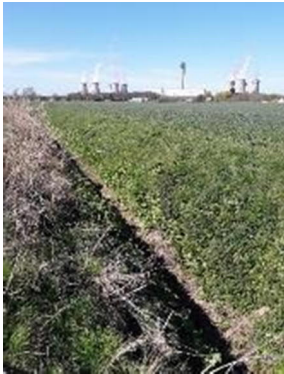
Watercourse Reference (and name if applicable)	Survey start & end points (OS Grid Reference)	Survey date	Description	Evidence of Water Vole Found?	Evidence of otter found?	Comments	Photograph
WC88 (River.Ouse)	N/A	N/A	Major tidal river.	N/A	N/A	Unsafe to survey, otter likely to be present. Tidal activity/ strength of flow likely to preclude water vole. River Ouse subject to HDD so scoped out from further assessment.	N/A
WC89	SE 68091 27196		Dry ditch with lesser celandine, common nettle, hogweed, cow parsley, white dead nettle and rank grasses within and on bank. small patch of reed canary grass on bank.	N/A	N/A	Unsuitable habitat for riparian species. Scoped out from further assessment.

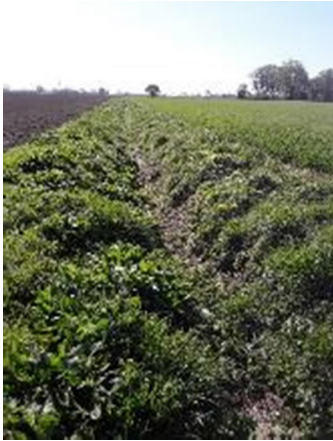
Watercourse Reference (and name if applicable)	Survey start & end points (OS Grid Reference)	Survey date	Description	Evidence of Water Vole Found?	Evidence of otter found?	Comments	Photograph
WC90	SE 67928 27034	N/A	Dry ditch, likely to be temporarily wet with invading ruderal species.	N/A	N/A	Unsuitable habitat for riparian species. Scoped out from further assessment.
