**BANFF CASTLE, CASTLE STREET,
BANFF**

**Archaeological Watching Brief
and Recording**

Report by
J Charles Murray

September 2003

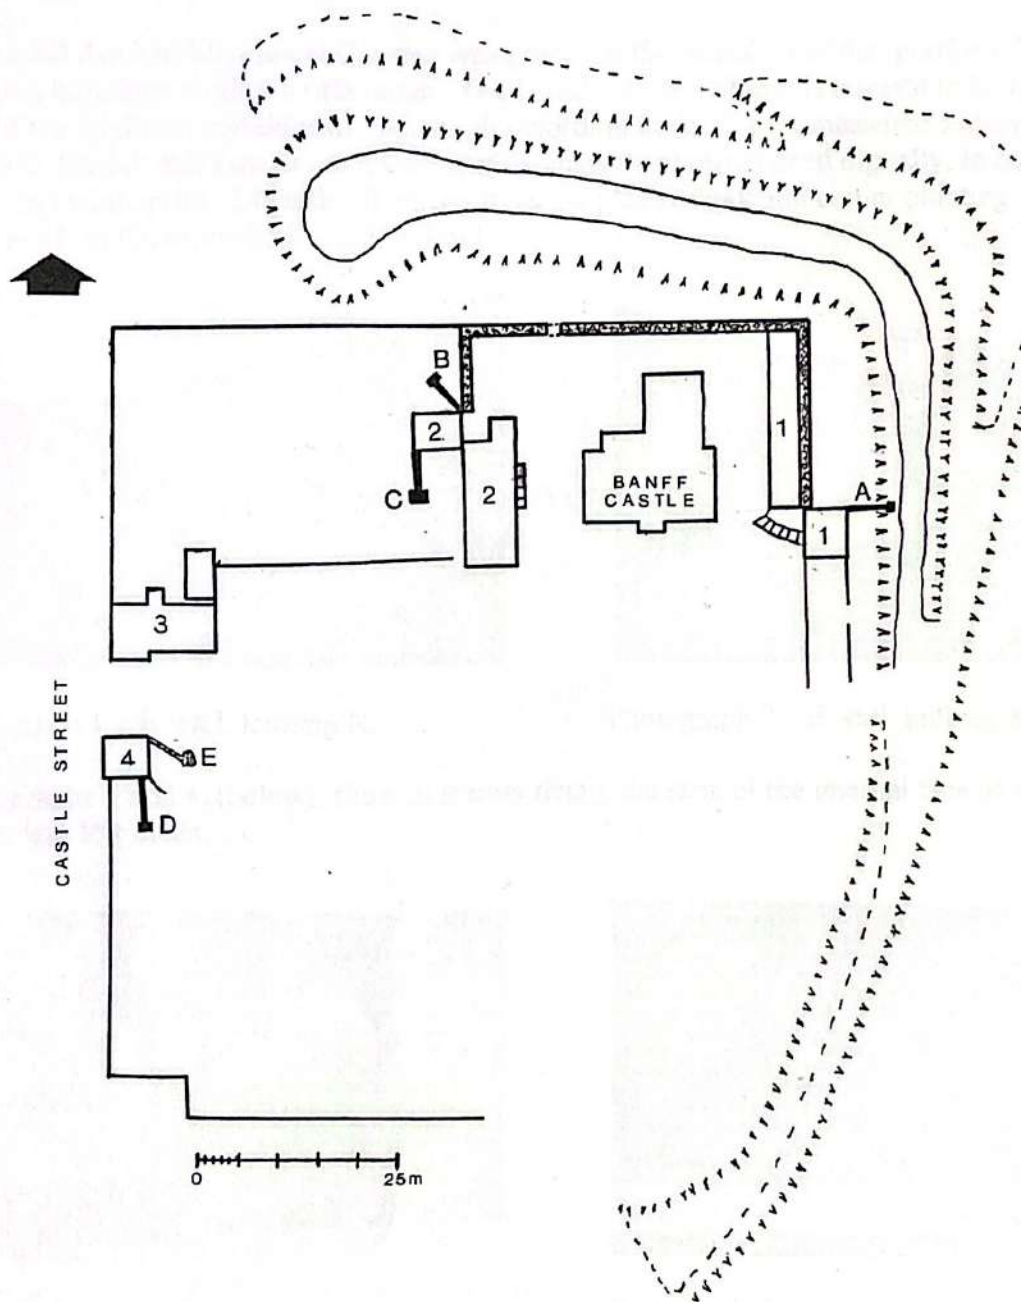
Banff Castle – Site Plan

The only visible remains of the castle are now the N wall and parts of the E and W walls. The N wall is c.44m long, while the E is c.25m and the W is c.11m. In general the walls are c.5m high by c.1.8m thick [see Site Plan, p.3].

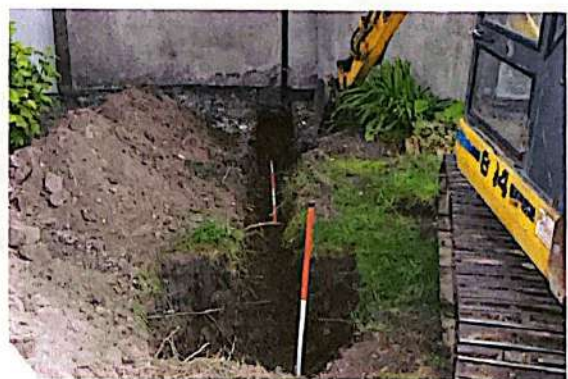
Photograph 13

Below a 100mm layer of grass and topsoil was a 200mm layer of pea-gravel, which extended the length of the drainage trench and overlay a brown soil with much tree root. In the soakaway itself, a 300mm layer of mixed earth and stone overlay the natural sand.

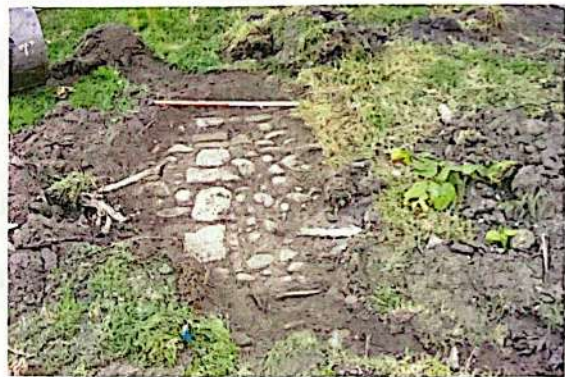
Photograph 15.

It was not possible to positively date the cobbling, but it is likely to date to 19th/20th century ground improvements.
