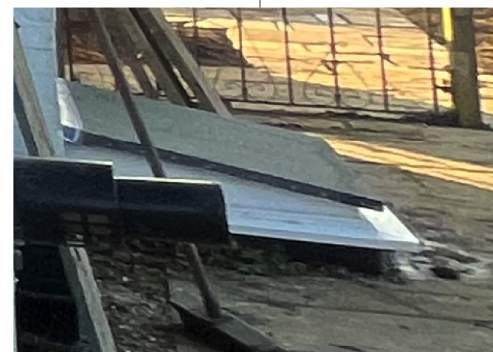
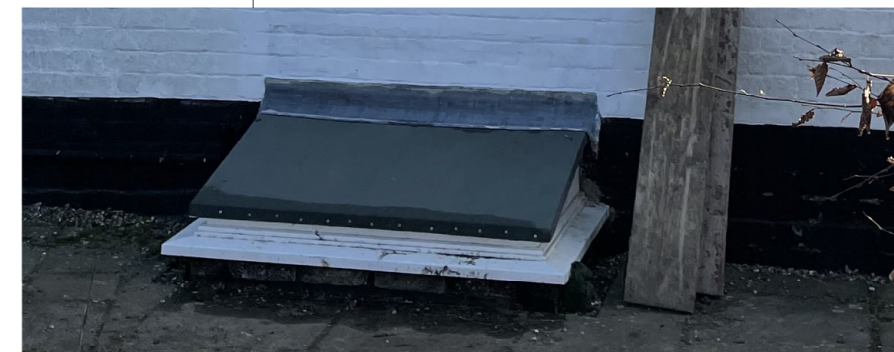
EXISTING WEST ELEVATION
Scale: 1:100

The west brick gable currently bows outwards, past the roof boundary line at second floor level. This needs to be rectified.

Covered UPVC basement window to be replaced with a more appropriate timber window well.
