**CCTV REPORT FOR: 4 MILL DRIVE
FORTON HEATH
MONTFORD BRIDGE
SY4 1HP**

Insured: Mr K and Mrs L Selman
Reference: 084474139

Site Visit: 22-Dec-22
Report Date: 27-Mar-23

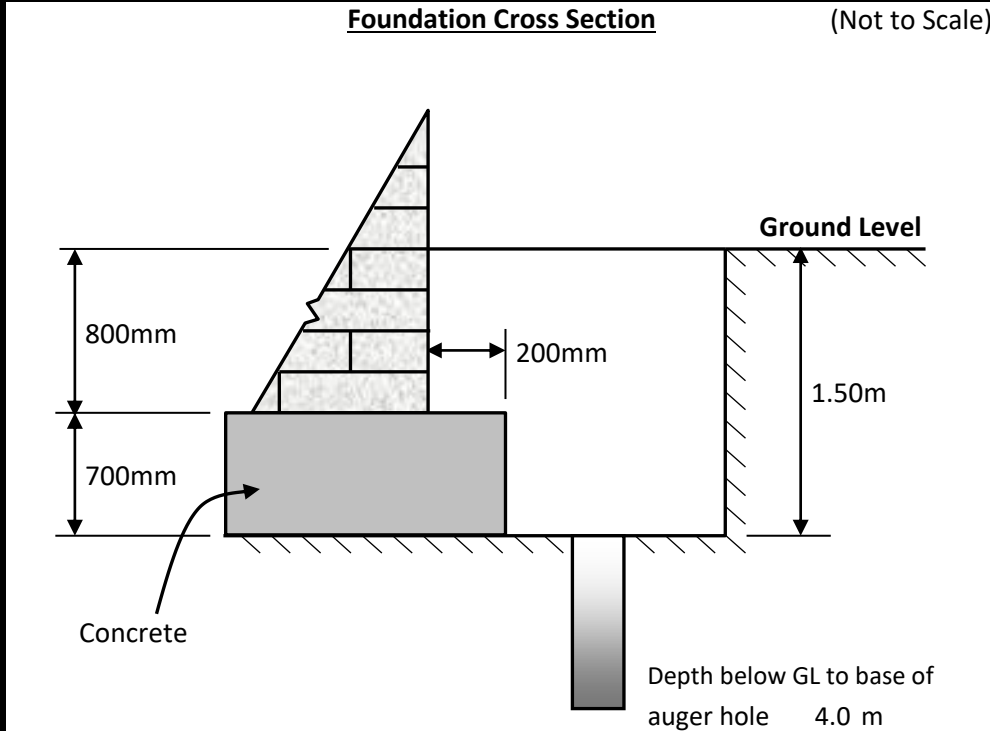
Location: **Front Left Corner** T/H No. **1**
 Ground Surface: **Damp** Weather: **Dry** Date: **22-Dec-22**

Roots Depth & Diameter:
 From 1.5m
 Down to 2.5m
 up to 2mm diameter

Water Depth Hit & Rise:
 Hit at 1.5m

Reason for Termination :
 Hole at instructed depth

Depth (m)	Soil Descriptions <i>(NB: Field crew description only)</i>	Test Type	Depth (m)	
			From	To
G.L.				
1.50	Soft/firm dark brown/brown CLAY with rare medium gravel & roots	V(n) 70	1.500	
2.00	Soft firm brown CLAY with rare medium gravel & roots	V(n) 80	2.000	
2.50	Soft/firm light grey/brown CLAY with rare medium gravel & roots	V(n) 91	2.500	
3.50	Soft/firm light grey/brown CLAY with rare medium gravel	V(n) 97	3.000	
4.00	End of Borehole	V(n) 105	3.500

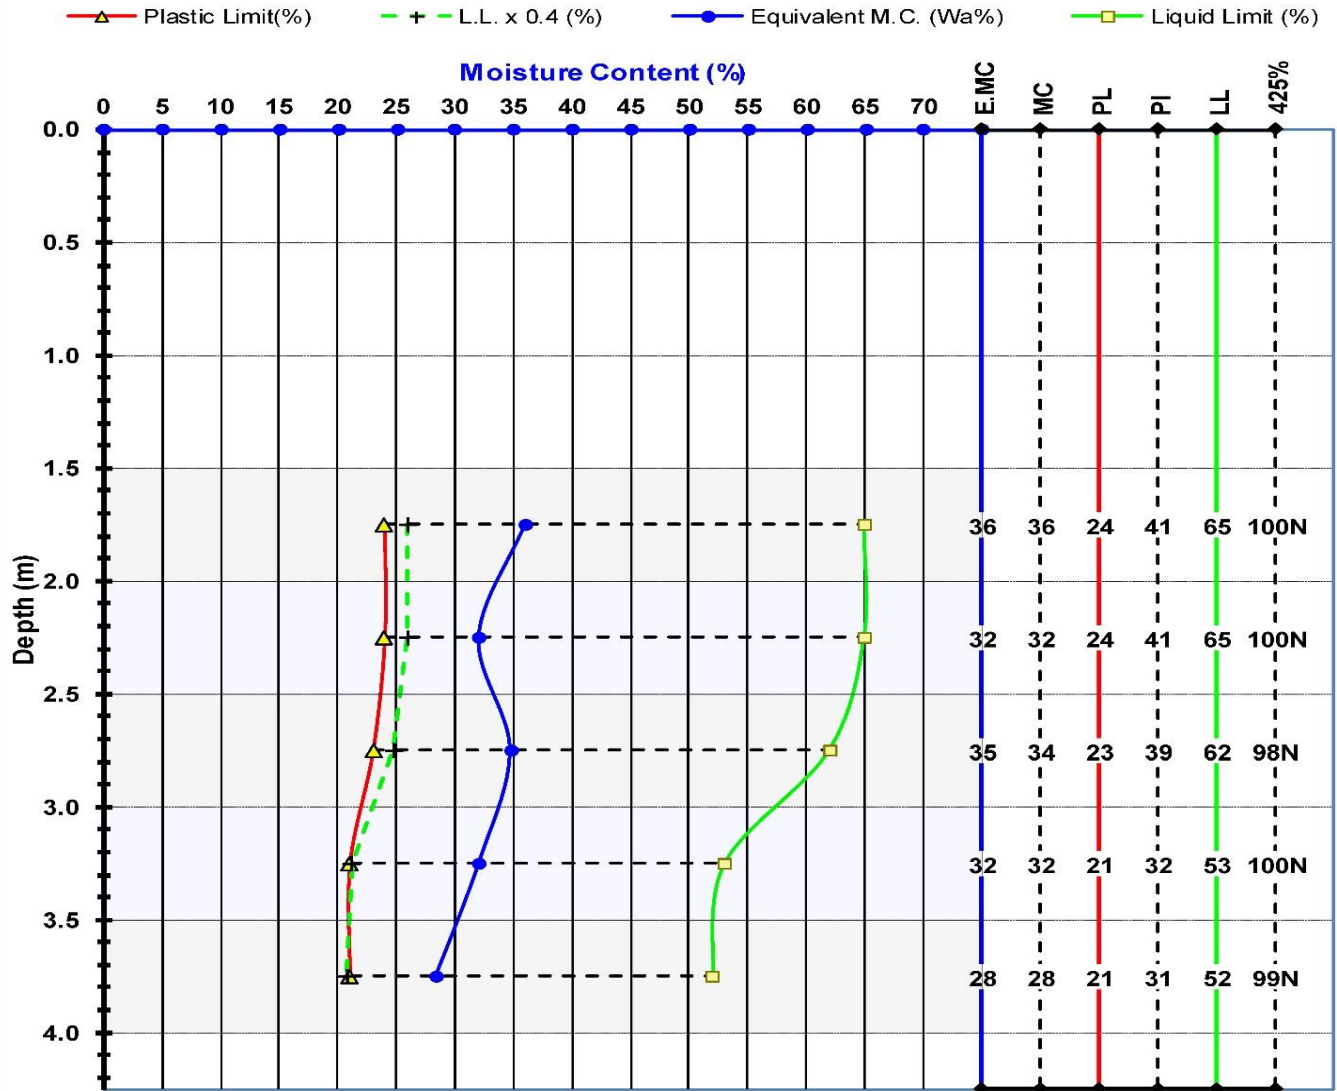
Depth T (m)	Depth B (m)	1 - LH elevation (below cracking)	Plasticity (BS 5930)	Volume Change (BRE 240)	
		Brief Soil Description		M.PI	(%)
1.5	2	Soft/firm dark brown/brown CLAY with rare medium gravel & roots	High CH	41%	High
2	2.5	Soft firm brown CLAY with rare medium gravel & roots	High CH	41%	High
2.5	3	Soft/firm light grey/brown CLAY with rare medium gravel & roots	High CH	38%	Medium
3	3.5	Soft/firm light grey/brown CLAY with rare medium gravel & roots	High CH	32%	Medium
3.5	4	Soft/firm light grey/brown CLAY with rare medium gravel	High CH	31%	Medium
