**CCTV REPORT FOR: RUSSELL COTTAGE
BRIDGNORTH ROAD
HIGHLEY
BRIDGNORTH
WV16 6JG**

Insured: Mr Alan Matthews
Reference: LIV-SN-22-005195 Ins Ref: 100-50-194734

1st Site Visit: 04-Jan-23
1st Report Date: 09-May-23

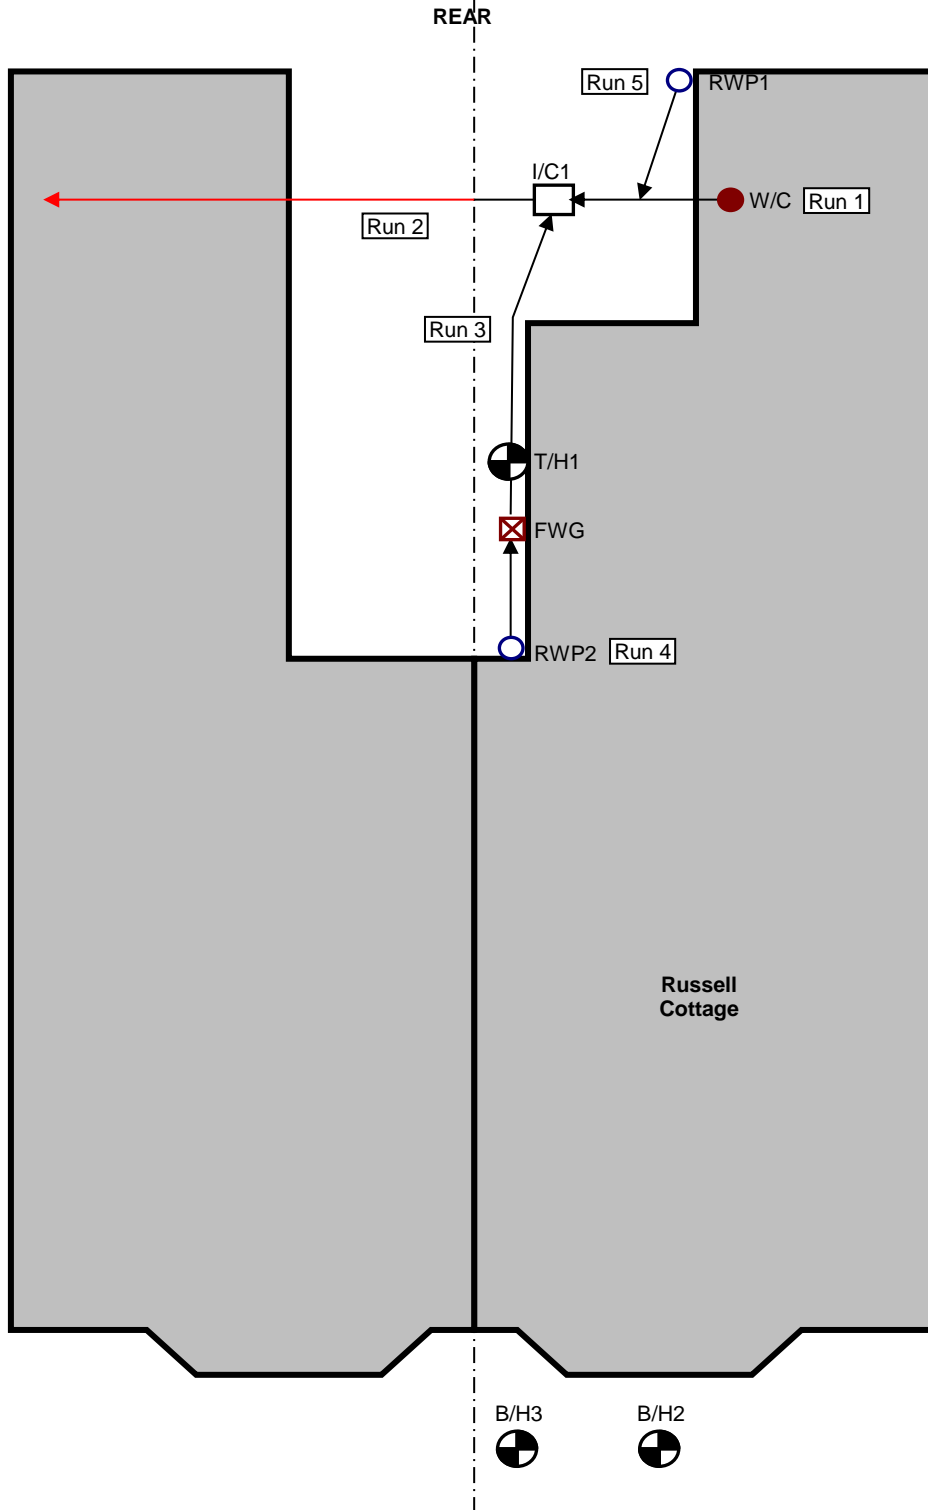
(This plan is not to be scaled and is provided to illustrate general layout only)

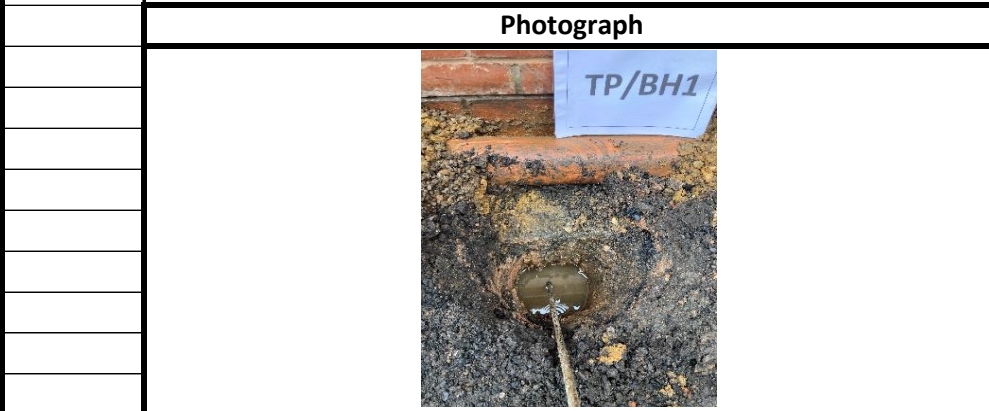
Roots Depth & Diameter:
None observed on site
Water Depth Hit & Rise:
Hit at 0.5m
Reason for Termination :
Suction

Depth (m)	Soil Descriptions <i>(NB: Field crew description only)</i>	Test Type	Depth (m)	
			From	To
G.L.				
0.65	Very soft brown CLAY with some medium gravel	V(n) 16	0.650	
1.00	Soft/firm brown CLAY with rare medium gravel	V(n) 44	1.000	
2.50	Soft brown CLAY with occasional medium gravel	V(n) 54	1.500	
3.20	End of Borehole	V(n) 40	2.000	
		V(n) 82	2.500	
		V(n) 68	3.000
