**CCTV REPORT FOR: RUSSELL COTTAGE
BRIDGNORTH ROAD
HIGHLEY
BRIDGNORTH
WV16 6JG**

Address: **RUSSELL COTTAGE, BRIDGNORTH ROAD, HIGHLEY, BRIDGNORTH, WV16 6JG**

Brief:	The Drainage Repair Company Ltd were commissioned to undertake a CCTV survey / inspection of the drainage at the property.
Specific Area of Interest:	Drainage as instructed by attending engineer.
System Access:	Inspection chamber in rear garden.
Visual Survey:	N/A
Water Pressure Test:	No

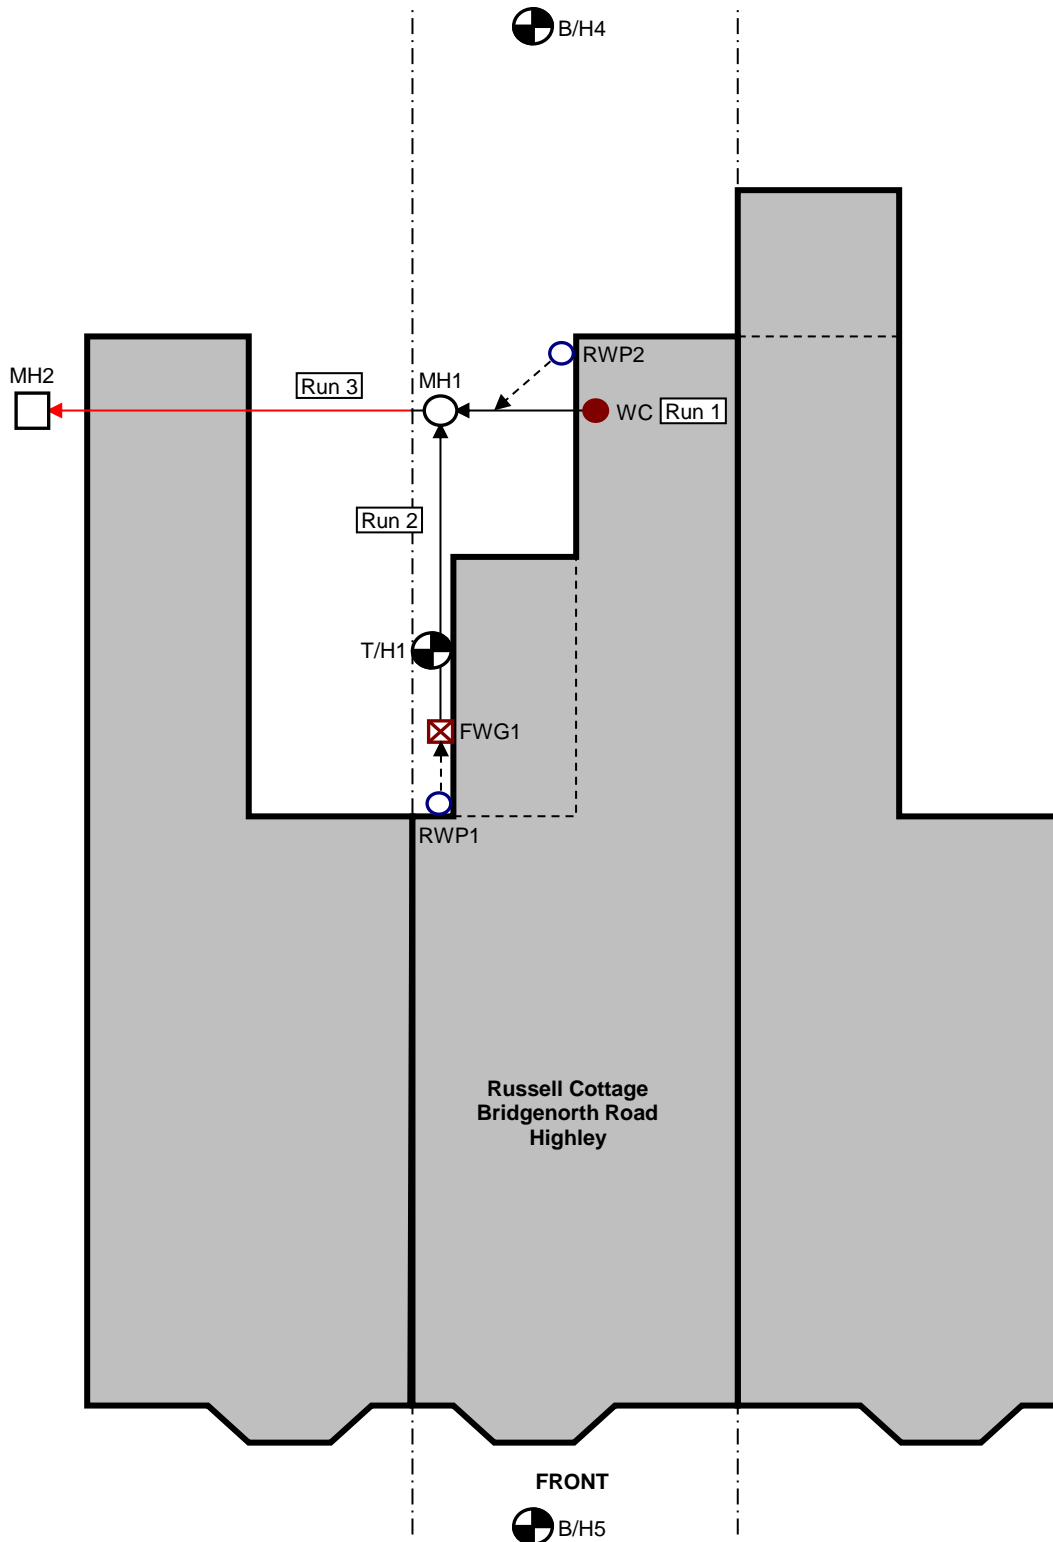
Metres	Faults / Defects	Remarks
0.00		At MH1
0.10		At boundary
0.34	Medium Displaced Joint	
1.86	Medium Displaced Joint	
2.43		Inlet at 9 o'clock
3.27		Inlet at 9 o'clock
4.80		At MH2
		End of survey

Medium displaced joints beyond property boundary.

The only defects observed are in Run 3 and are beyond the property boundary.

One the pipework leaves the boundary responsibility transfers to the local water authority.

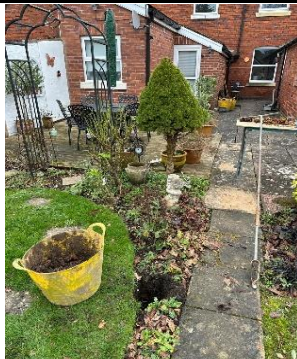
Photograph

Location: **Rear Garden** B/H No. **4**
 Ground Surface: **Dry** Weather: **Dry** Date: **08-Jan-23**

Roots Depth & Diameter:
None observed on site

Water Depth Hit & Rise:
None observed on site

Reason for Termination:
Encountered obstruction
Friable ground

Depth (m)	Soil Descriptions <i>(NB: Field crew description only)</i>	Test Type	Depth (m)	
			From	To
G.L.				
0.50	Firm light brown slightly silty CLAY with occasional medium gravel	P.P. 3.5	0.500	
1.00	Firm light brown slightly sandy/silty CLAY with occasional medium gravel	P.P. 4.0	1.000	
1.50	Firm light grey/brown slightly sandy/silty CLAY with occasional medium gravel	P.P. 4.5	1.500	
1.70	End of Borehole	P.P. 4.5	1.700

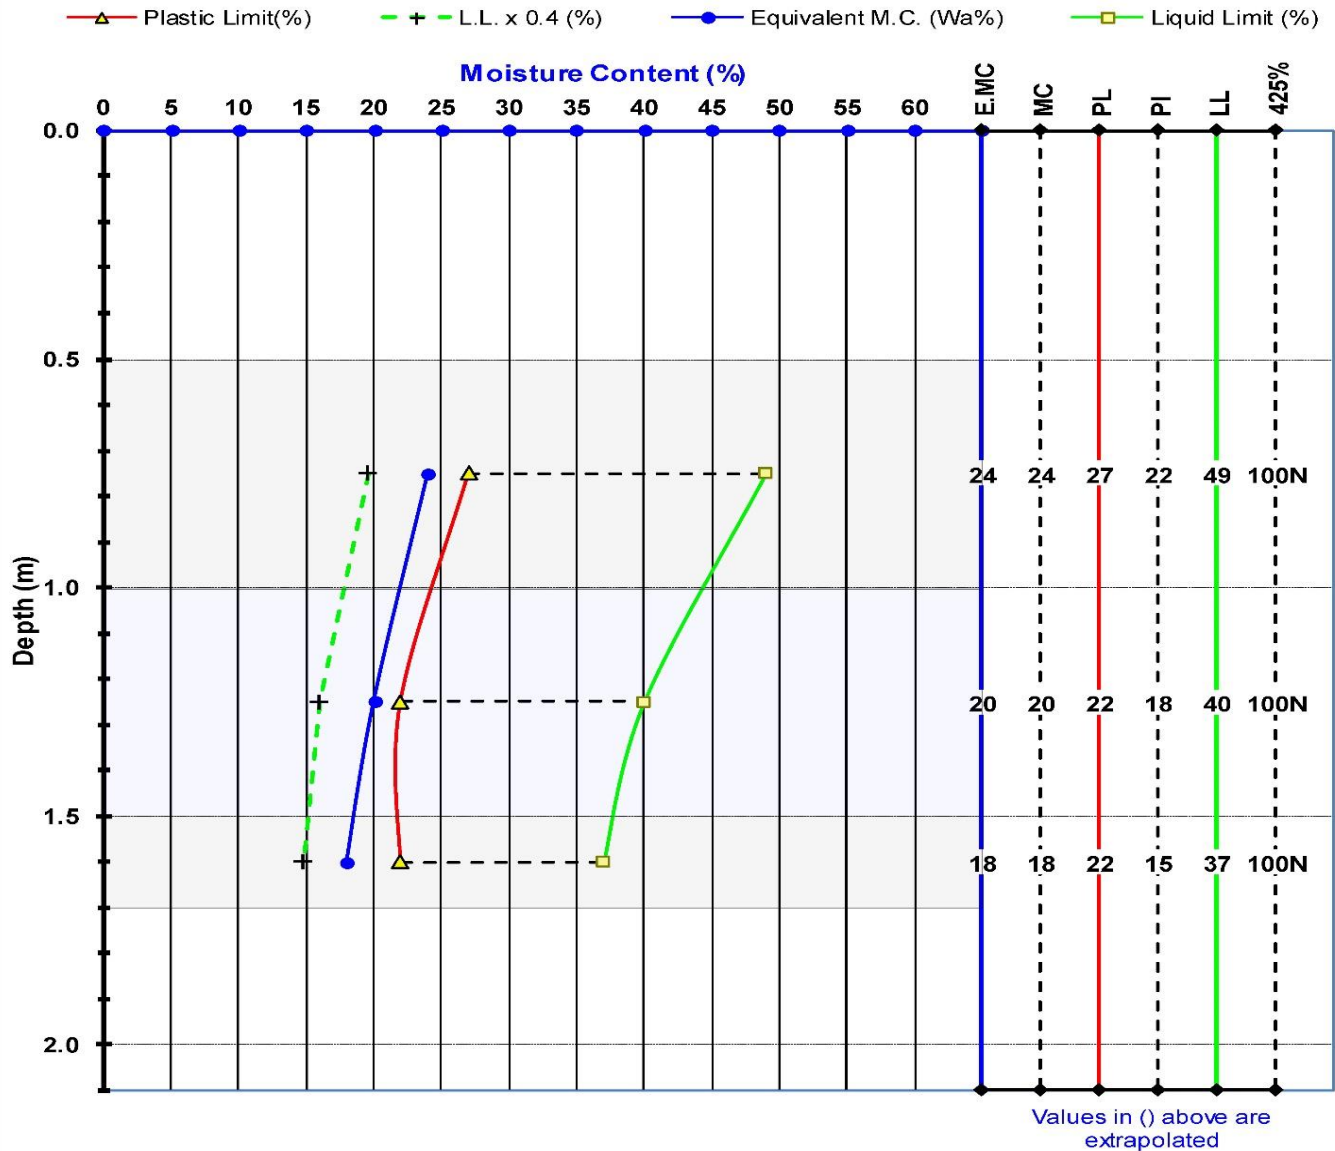
Depth T (m)	Depth B (m)	4 - Rear Garden		Plasticity (BS 5930)	Volume Change (BRE 240)
		Brief Soil Description			
0.5	1	Firm light brown slightly silty CLAY with occasional medium gravel		Intmd. CI	22% Medium
1	1.5	Firm light brown slightly sandy/silty CLAY with occasional medium gravel		Intmd. CI	18% Low
1.5	1.7	Firm light grey/brown slightly sandy/silty CLAY with occasional medium gravel		Intmd. CI	15% Low

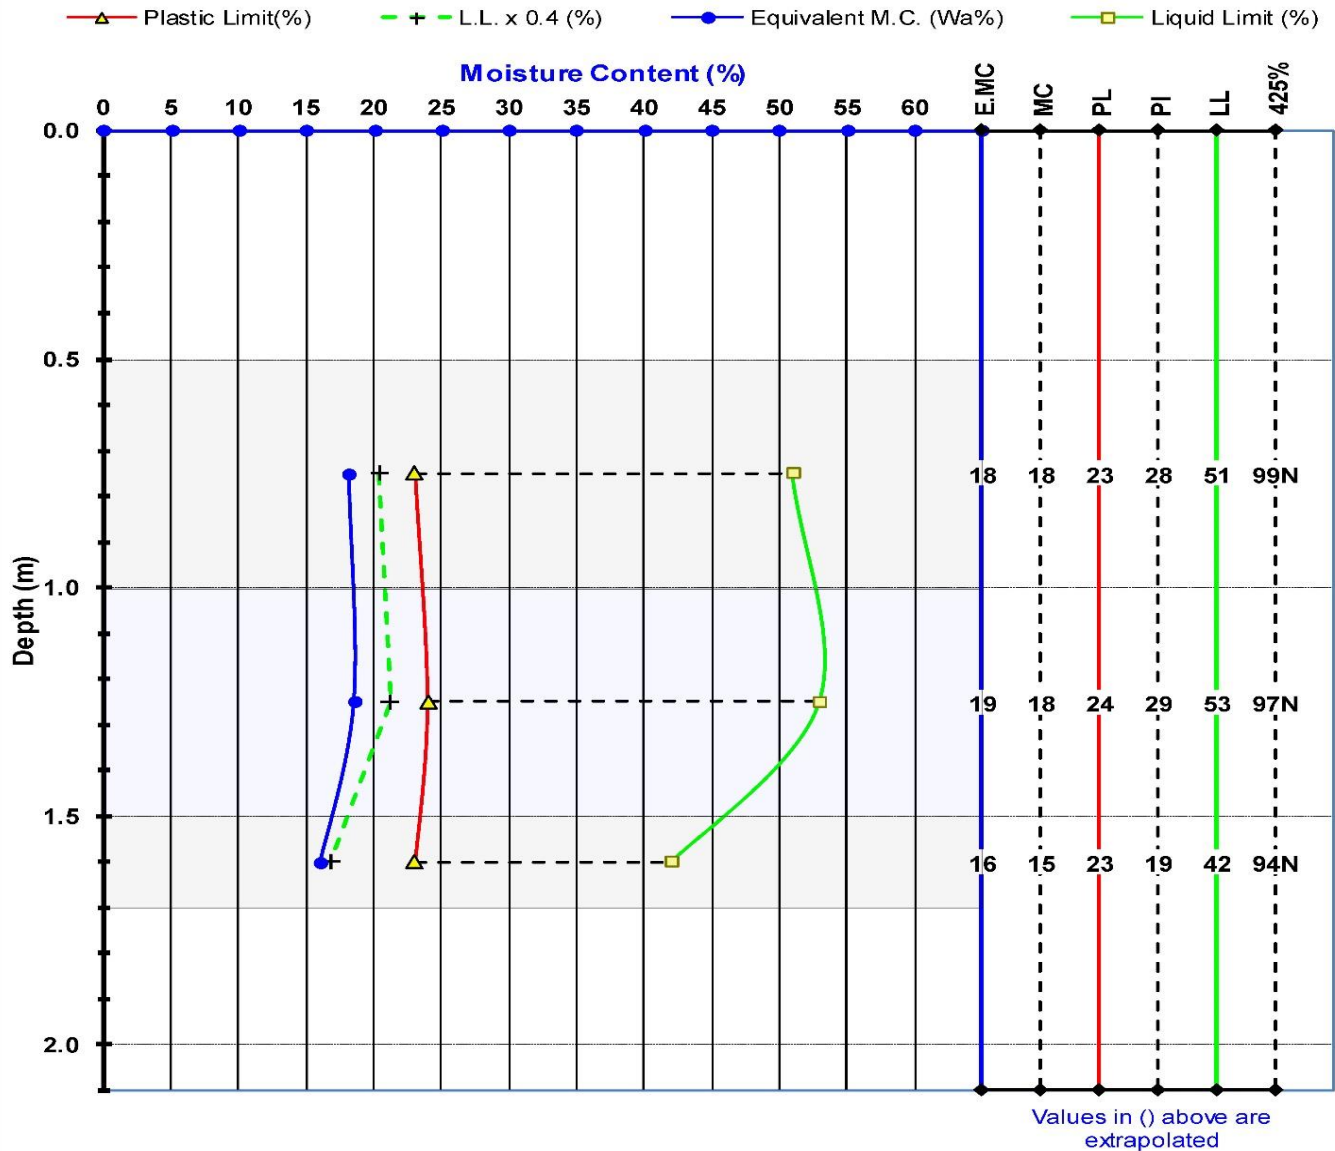
Depth T (m)	Depth B (m)	5 - Front Garden		Plasticity (BS 5930)	Volume Change (BRE 240)
		Brief Soil Description			
0.5	1	Firm light grey/brown slightly sandy/silty CLAY with occasional medium gravel		High CH	28% Medium
1	1.5	Firm light grey/brown slightly sandy/silty CLAY with occasional medium gravel		High CH	28% Medium
1.5	1.7	Firm light grey/brown slightly sandy/silty CLAY with occasional medium gravel		Intmd. CI	18% Low
