# Engineers Report

**Risk Address** Russell Cottage  
Bridgnorth Road  
Highley  
BRIDGNORTH  
WV16 6JG

**360 Reference** LIV-SN-22-005195  
**Insurer Reference** 100-50-194734  
**Policy Holder** Mr Alan Matthews

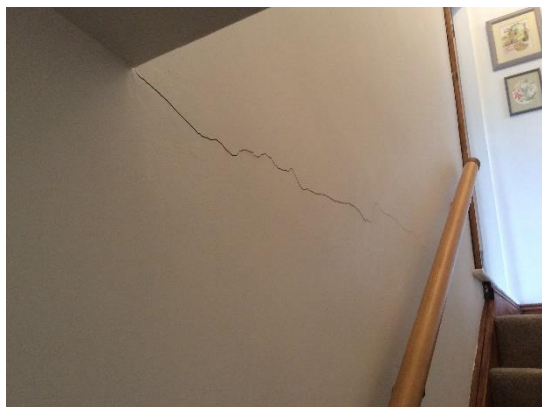
There is tapered vertical cracking at the junction of the rear extension and main house, varying in width up to approximately 5mm wide.

“Assessment of Damage in Low-Rise Buildings”. In this case, the damage falls into Category 2 “Slight” as there is cracking up to approximately 5mm wide.

- Instruct an Arborist to survey and identify extent of tree works required to mitigate further damage.
- Liaise with the relevant owners of any implicated vegetation to arrange any recommended tree removal to be undertaken as soon as possible.
- Following completion of above mitigation, allow ground to rehydrate, before proceeding with repairs to the property.
- Undertake any relevant drain repairs necessary, to the rear of the risk address.
