**Poole Barton including  
adjoining wall to north (NHLE  
1170421), Cheriton Fitzpaine,  
Devon**

**Built Heritage Assessment and  
Impact Statement**

ISCA Report: **R01-0065-2**

**February 2024**

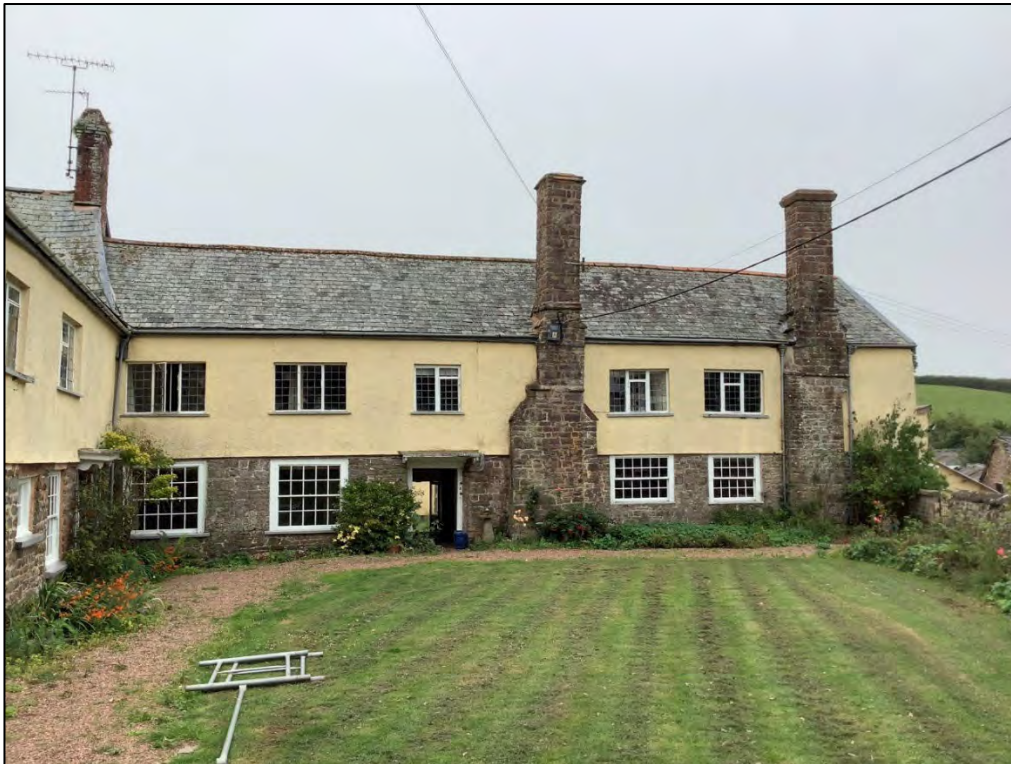
- 6.10. Analysis of the walls externally demonstrates that main range has exposed volcanic rubble to the first floor and plastered cob above (Fig. 7). However, given the contemporary roof structure, it is not thought that the ground floor and the first floor demonstrate two separate construction episodes; rather, the main block was built in a single construction episode at the end of the 15th century or the beginning of the 16th century.

**Figure 7:** North elevation of the east to west axis main block demonstrating the construction of exposed volcanic rubble wall to the first floor, plastered cob above, three chimney stacks and 19th century slate roof tiles. View to the south.

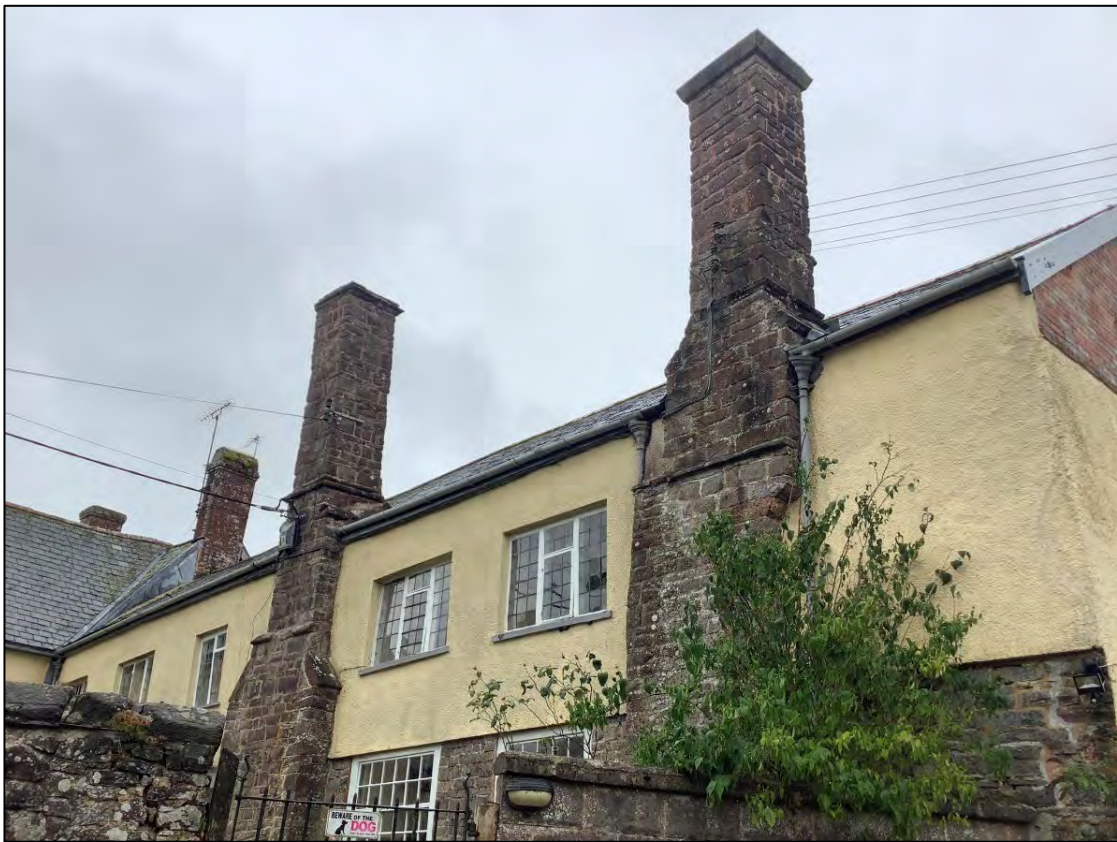
- 6.11. The northern elevation of the main block is fronted to the east by two chimney stacks that jut out externally from the building's frontage. The two stacks are not likely to be contemporary with the building's original construction and appear to have been built without too much planning. For example, the eastern chimney stack undercuts itself to the west in order to avoid a cruck beam within the halls structure (Photo 3). The upper masonry of the stacks may also suggest that they were extended vertically years after their prior construction. Industrial revolution period brick masonry within the internal structure of these stacks would suggest that this extension/rebuilding occurred during the 19th century. Both stacks also appear to have also been repaired/remodelled to the first-floor elevation (Figs. 8 and 9).

**Figure 8:** The two chimney stacks to the western end of the north facing elevation and the third stack to the east of the main block. View to the south east.

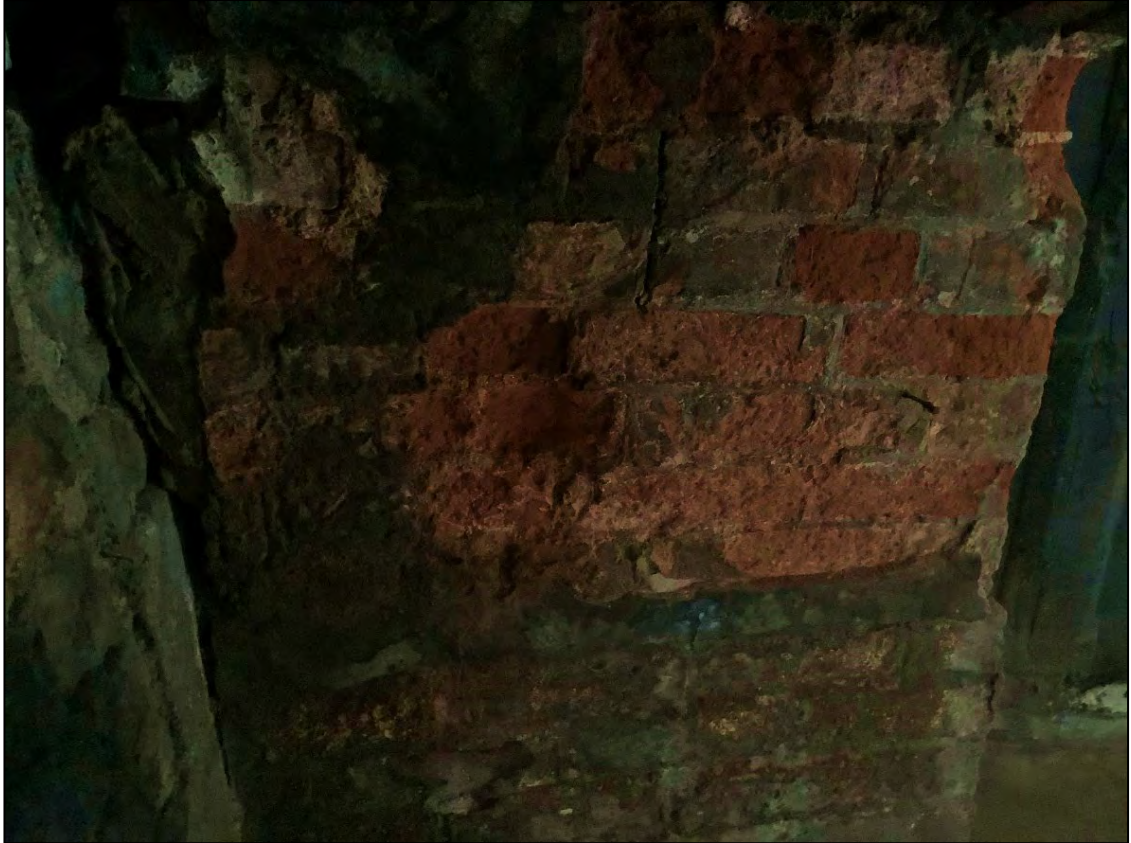
**Figure 9:** Internal 19th century brickwork within the central chimney stack.

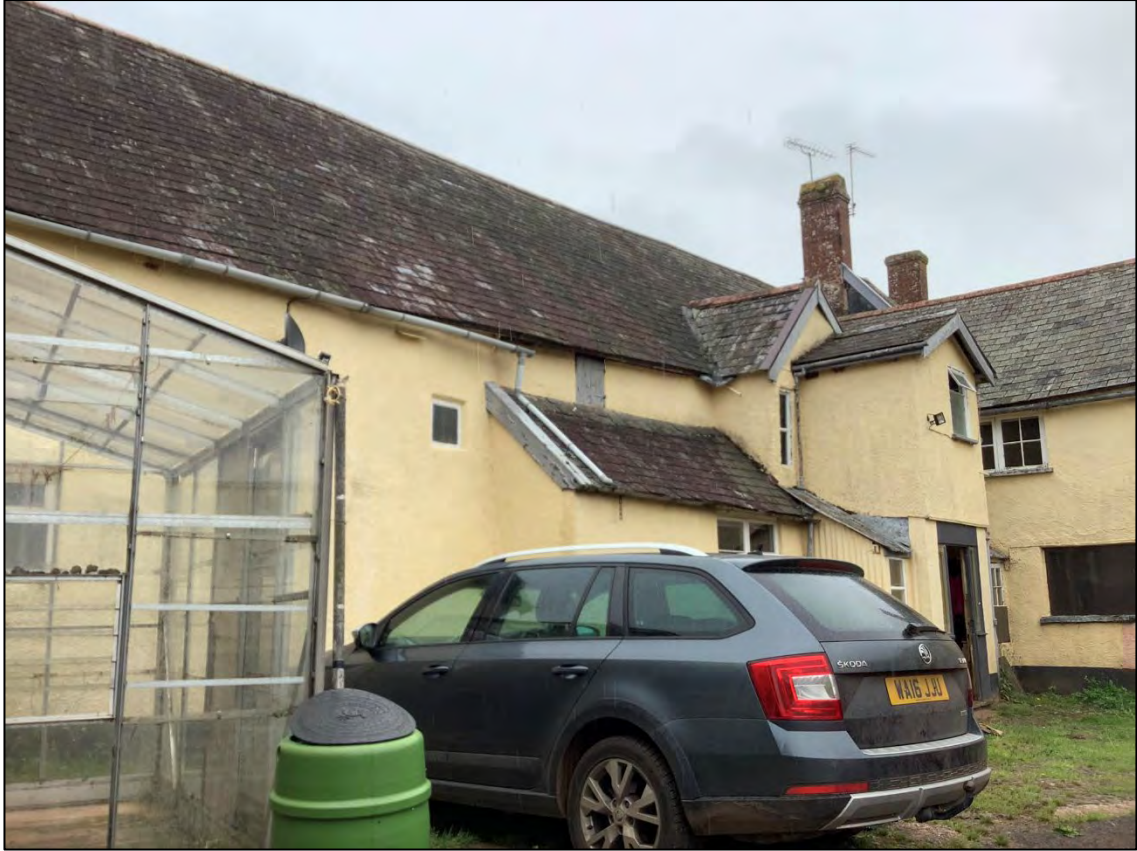
- 6.15. The rear (southern) elevation of the main block is similar in character to that of the front, albeit with a number of smaller window openings which appear to house 20th century frames and panes (Fig. 10).

- 6.16. A group of lean-to/porch annexes is present on the eastern side of the southern elevation of the main block (Fig. 10). These are thought to have been added and extended at different times throughout the 18th to 20th centuries. The 1839 Parish of Cheriton Fitzpaine Tithe Map does suggest that the earliest two phases of these porches/annexes were present in the early 19th century although they are not illustrated on later, or even modern, maps (Fig. 4). It is likely that the most southerly porch structure, which functions as a utility area and as a corridor to the rear block is largely 20th century owing to its corrugated iron roofing and wall panels.

**Figure 10:** The southern elevation of the main block from the internal courtyard with later small lean-to porches jutting out from the main block. View to north east.

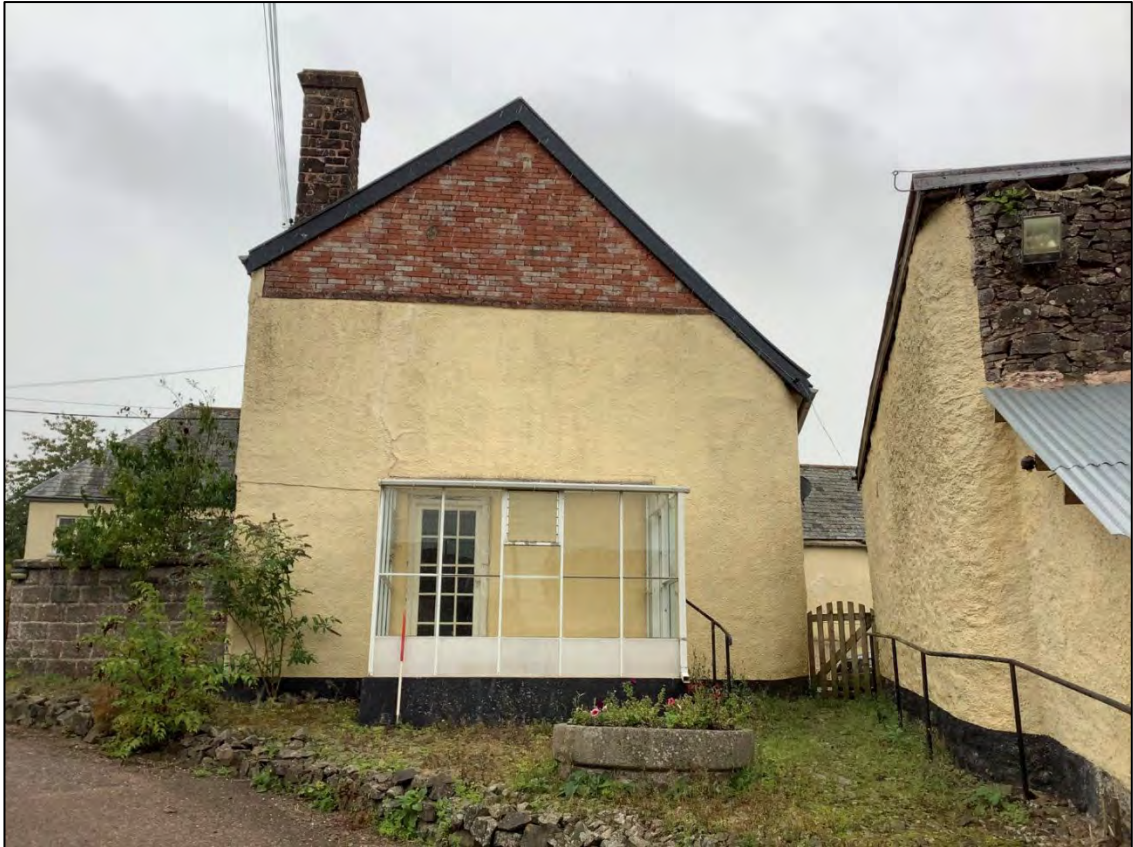
**Figure 11:** The western gable end of the hall house. View to the east.

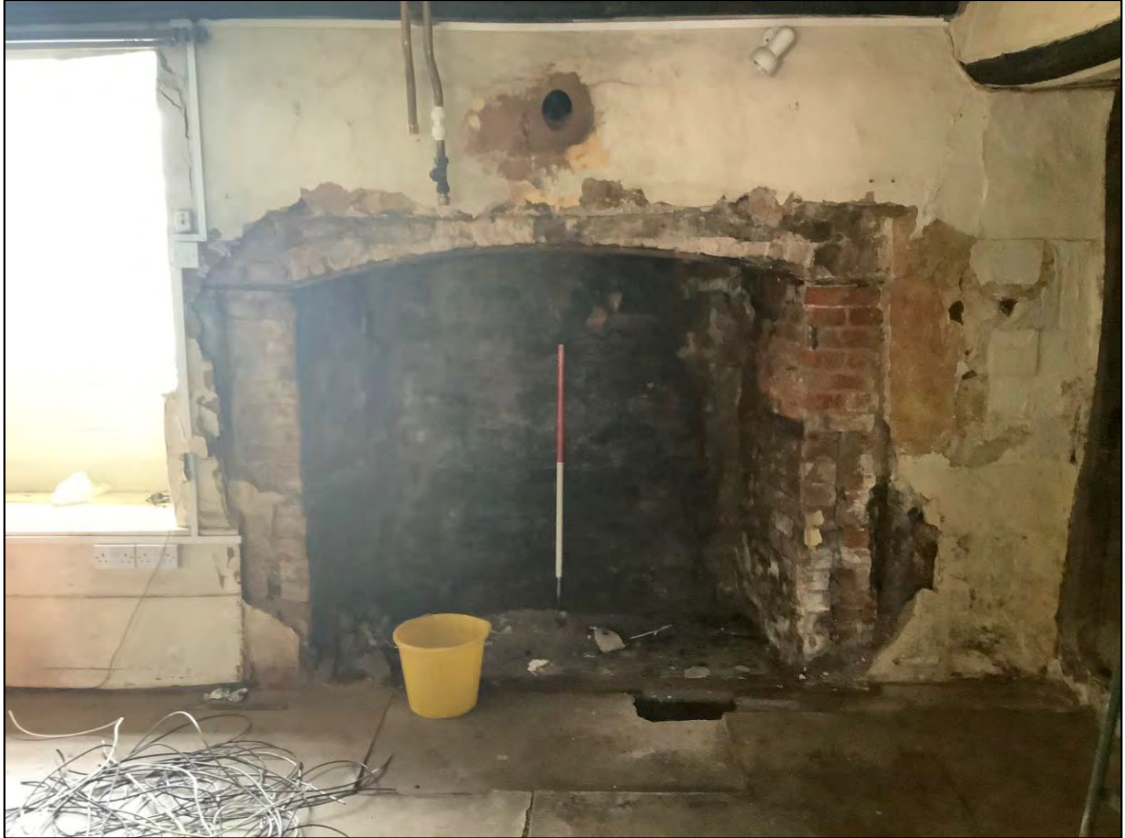
- 6.20. Room 1 (the original kitchen/hearth room) contains the hearth opening for the 17th century central chimney stack which appears to have been heavily modify in the 19th century (Fig. 12). The 19th century adjustments include a brick arched lintel. An exposed hole within the floor in front of the fireplace cavity displays no evidence of any tiles associated with a hearth structure.

**Figure 12:** Brick-and-mortar lined fireplace cavity with arched brick lintel and cast-iron former.

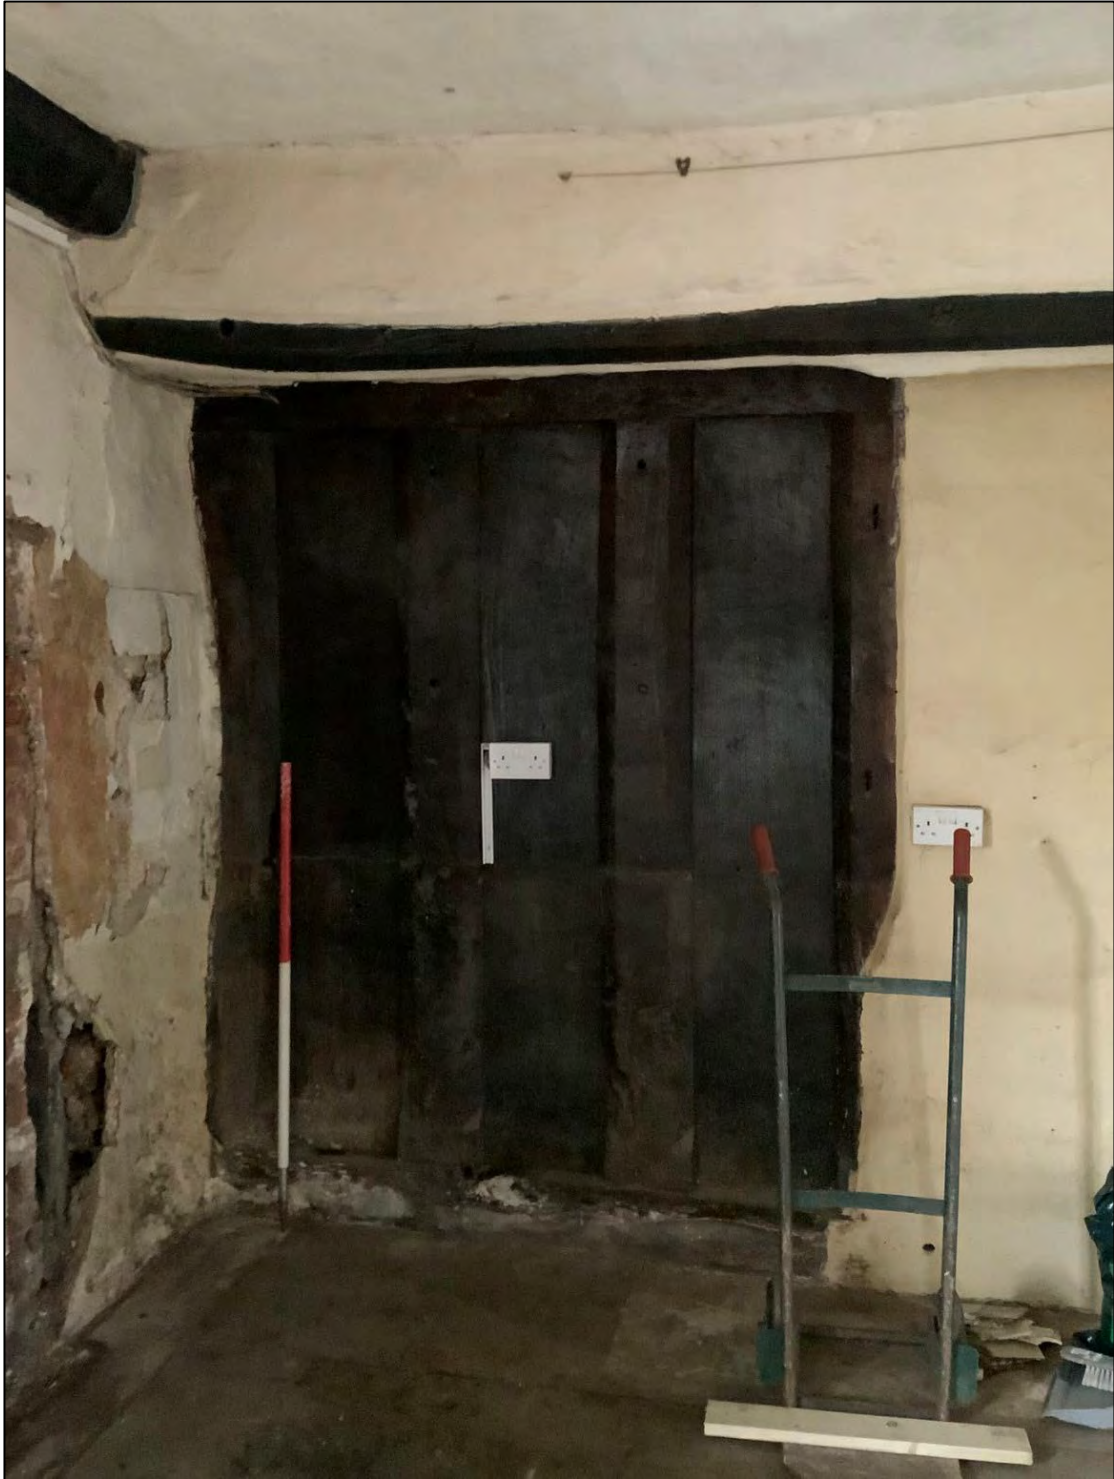
- 6.22. The ground floor through passage plan of the main block is separated into three rooms by two oak plank-and-muntin screens. Both screens, which separate Room 1 to the entrance corridor (Fig. 13) and Room 1 from Room 2 (Fig. 14) are likely to date to soon after the hall houses original construction. They are of a late medieval type that was common in the west country during the late 15th and early 16th centuries.

**Figure 13:** Oak plank-and-muntin screen separating room 1 with the entrance corridor.

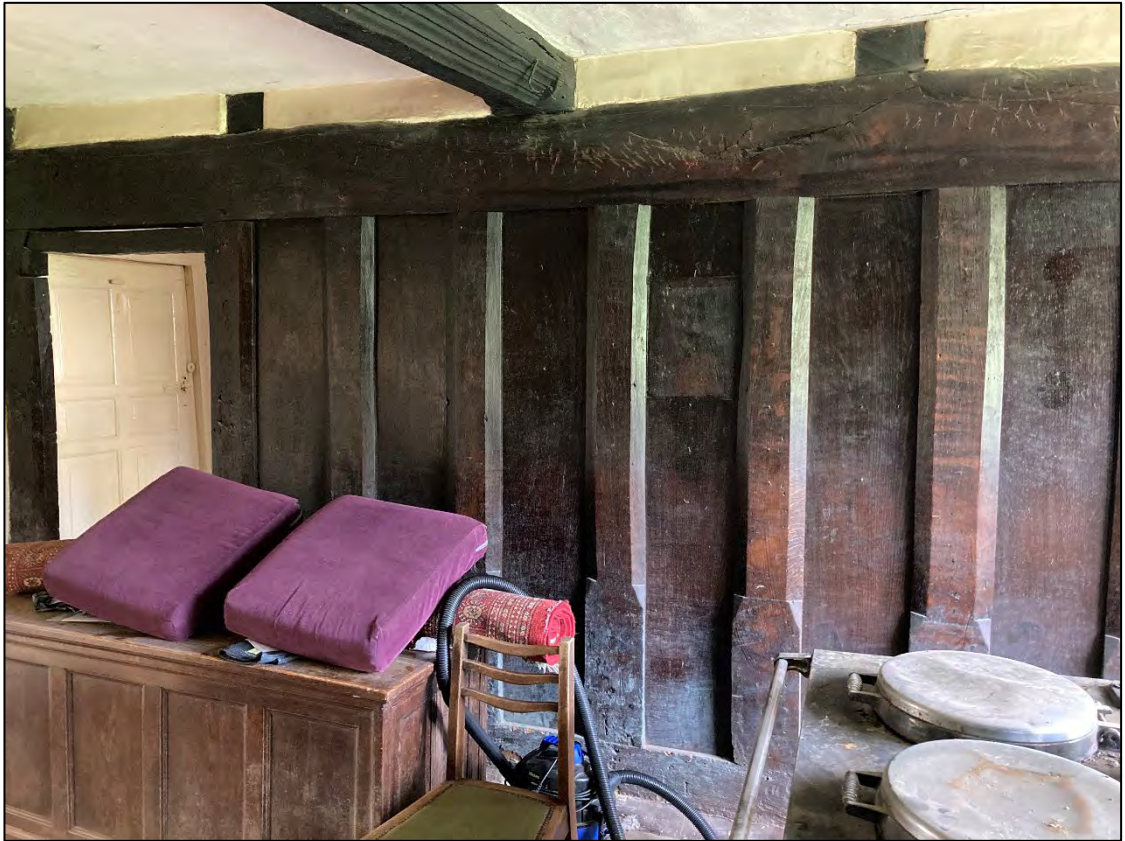
**Figure 14:** Oak plank-and-muntin screen separating Room 1 from Room 2. Note how the screen is installed into the large oak crossbeam running through the centre of the hall.

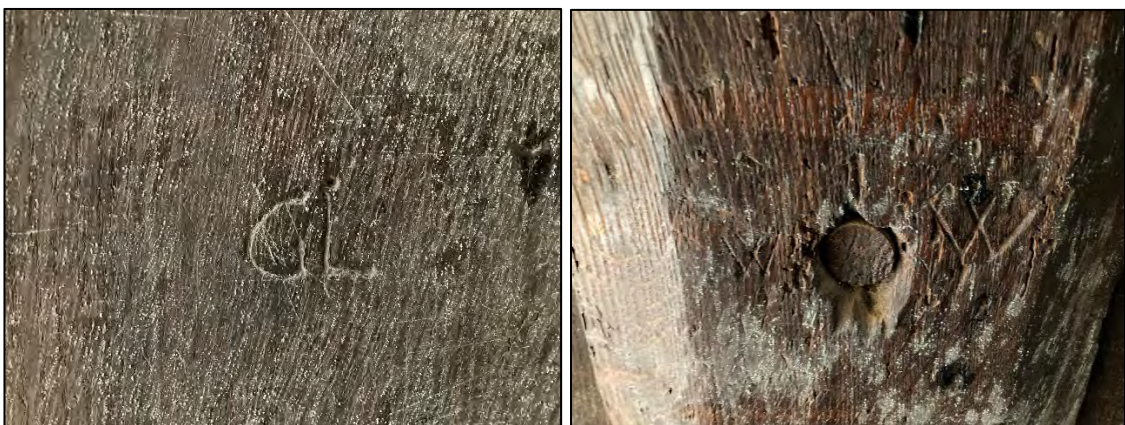
- 6.25. There is also some Graffiti present on both of the screens which may be relate to the initials of previous owners of Poole Barton (Fig. 15).

**Figure 15:** Graffiti on the plan and muntin screen separating Room 1 from the entrance corridor. GL (left) may relate to “George Lake”; the original owner of Poole Barton or a makers mark c. 1480 (per-comms).

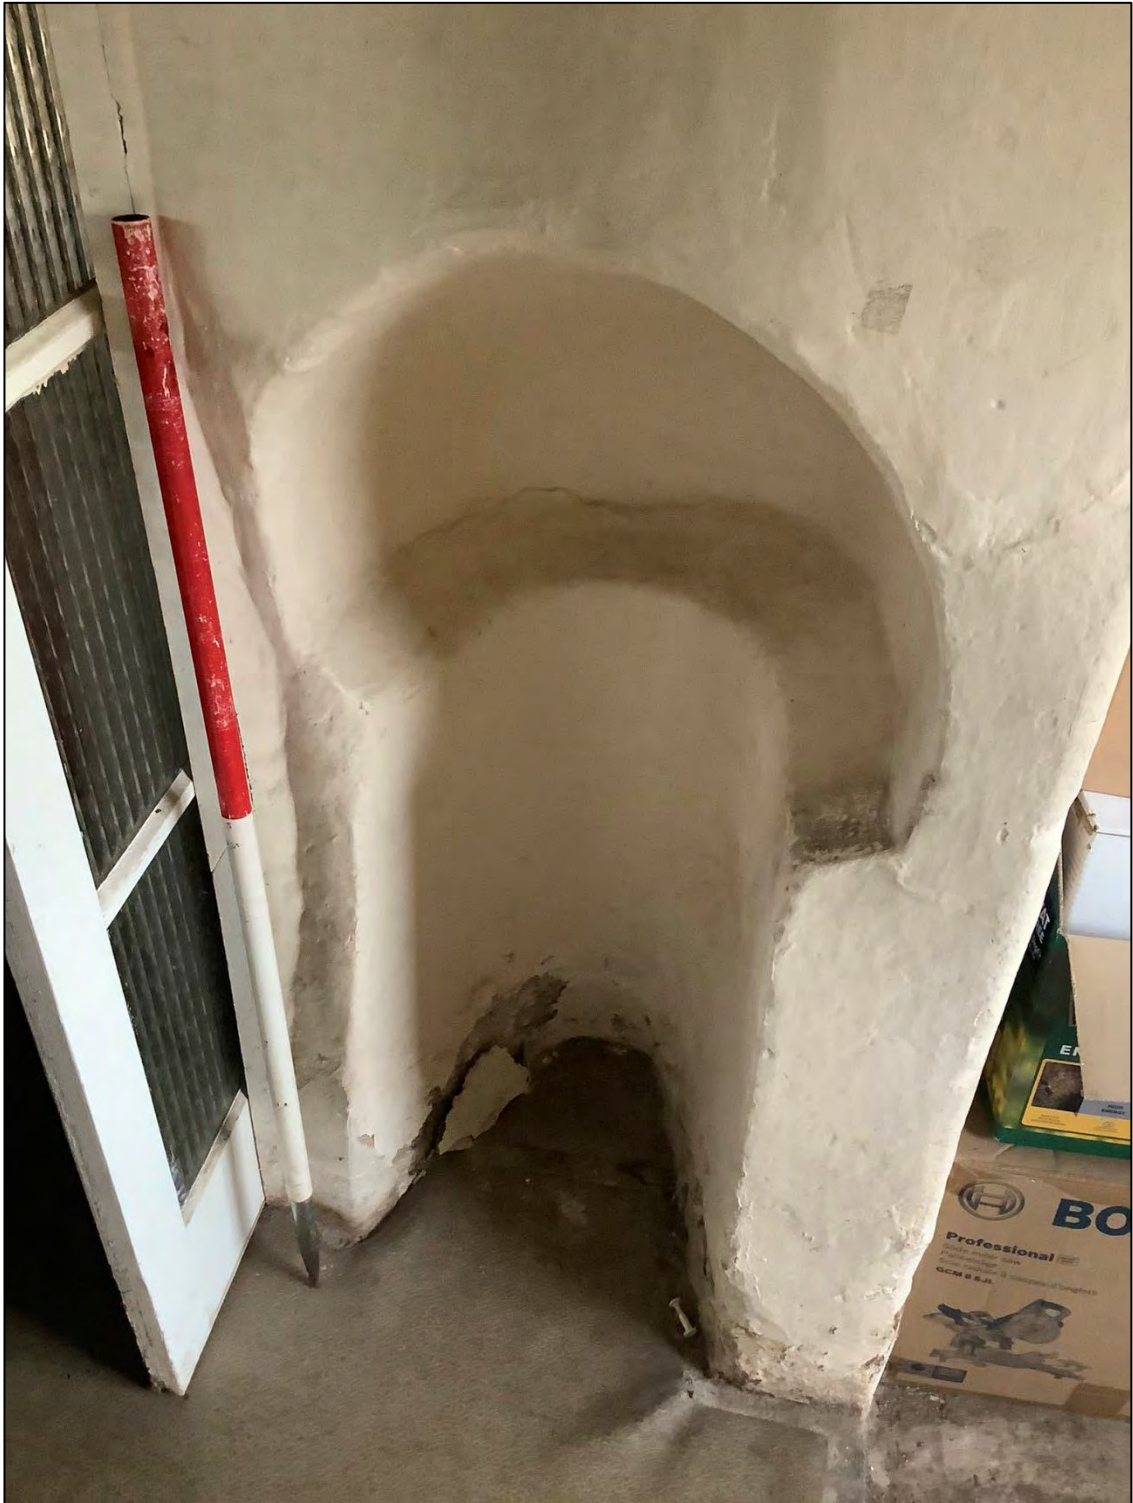
- 6.27. A feature of this extension that is of some interest is shaped cavity cut into the rubble and cob wall in the rooms entrance (Fig. 16). Given that the cavity shows some signs of soot blackening, it is thought to represent either a small space for a stove, perhaps a bread or cloam oven, or a space for a small personal (bedroom) fire of Victorian date. The lack of chimney stack in this location would likely suggest the location of a former cast iron bread oven.

**Figure 16:** Cavity cut into former external wall that now separates Room 1 from the small extension to the south. Possibly the location of a Victorian bread oven.

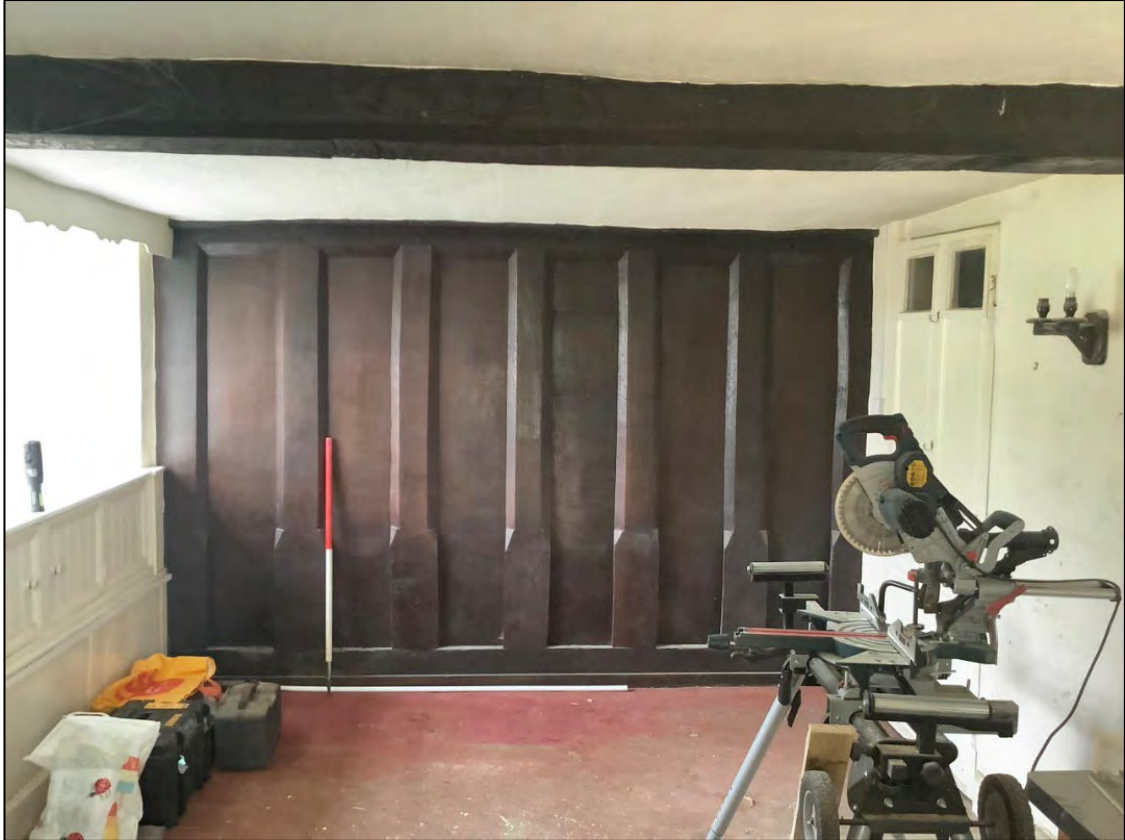
- 6.28. Room 2, to the western end of original hall house consists of the oak plan-and-muntin screen separating the section from Room 1 (Fig. 17), a 19th century window, a modern late 20th century fireplace and internal 20th century internal walling related to the installation of toilet and shower room.

**Figure 17:** Oak plank-and-muntin screen separating Room 2 from Room 1, large Victorian window cavity (left) and oak crossbeam (top). There is no evidence of the original hall house superstructure beyond the west of this crossbeam suggesting that the photograph is taken from the likely 19th century extended end of the building.

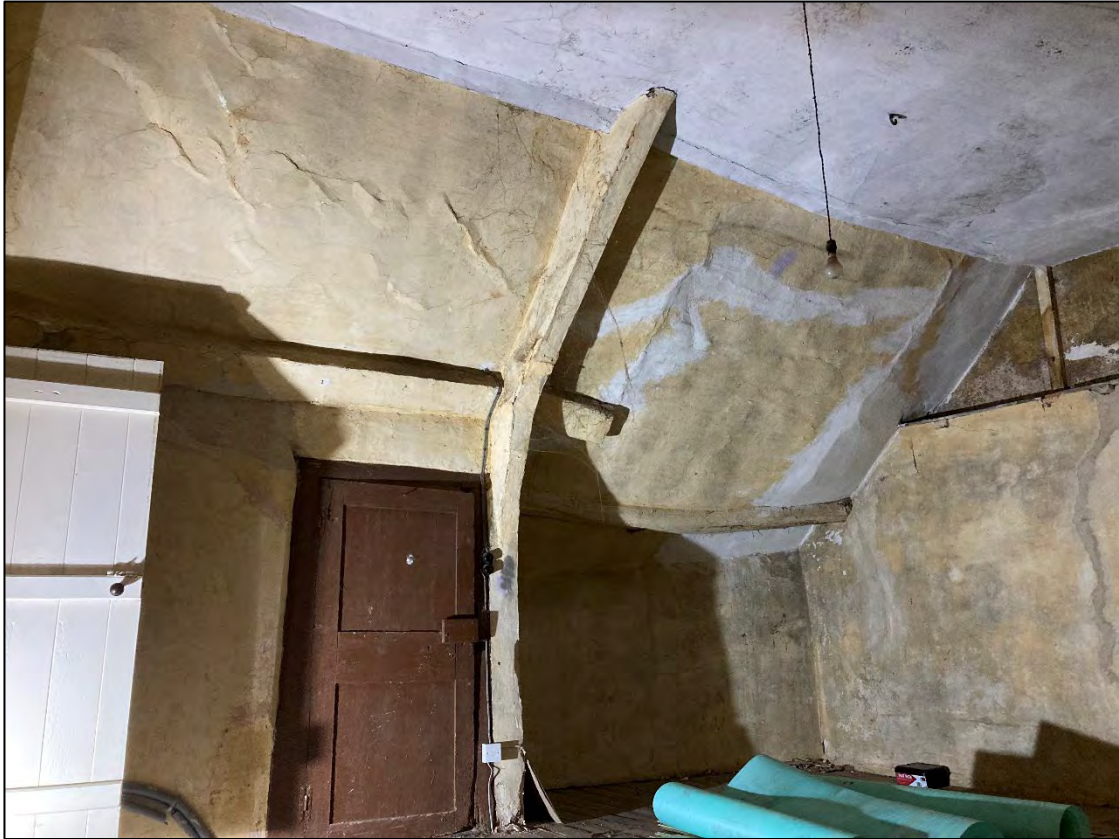
- 6.32. Further evidence that original hall house did not extend as far as what is currently present on the western gable end of the building is located in the first floor Room 4 (Fig. 18). At this point, a true cruck truss is visible which represents the end of the original medieval hall house. West of this point, the original hall house would likely have been hip-ended. Evidence from the brick work in the western gable end (Fig. 11) would suggest that this addition occurred in the 19th century,

**Figure 18:** The cruck blade in the western end of the hall house first floor, Room 4. Beyond this the hall house has been extended from its original hipped roof to a gable end. The further timber beyond the cruck is of elm (right).

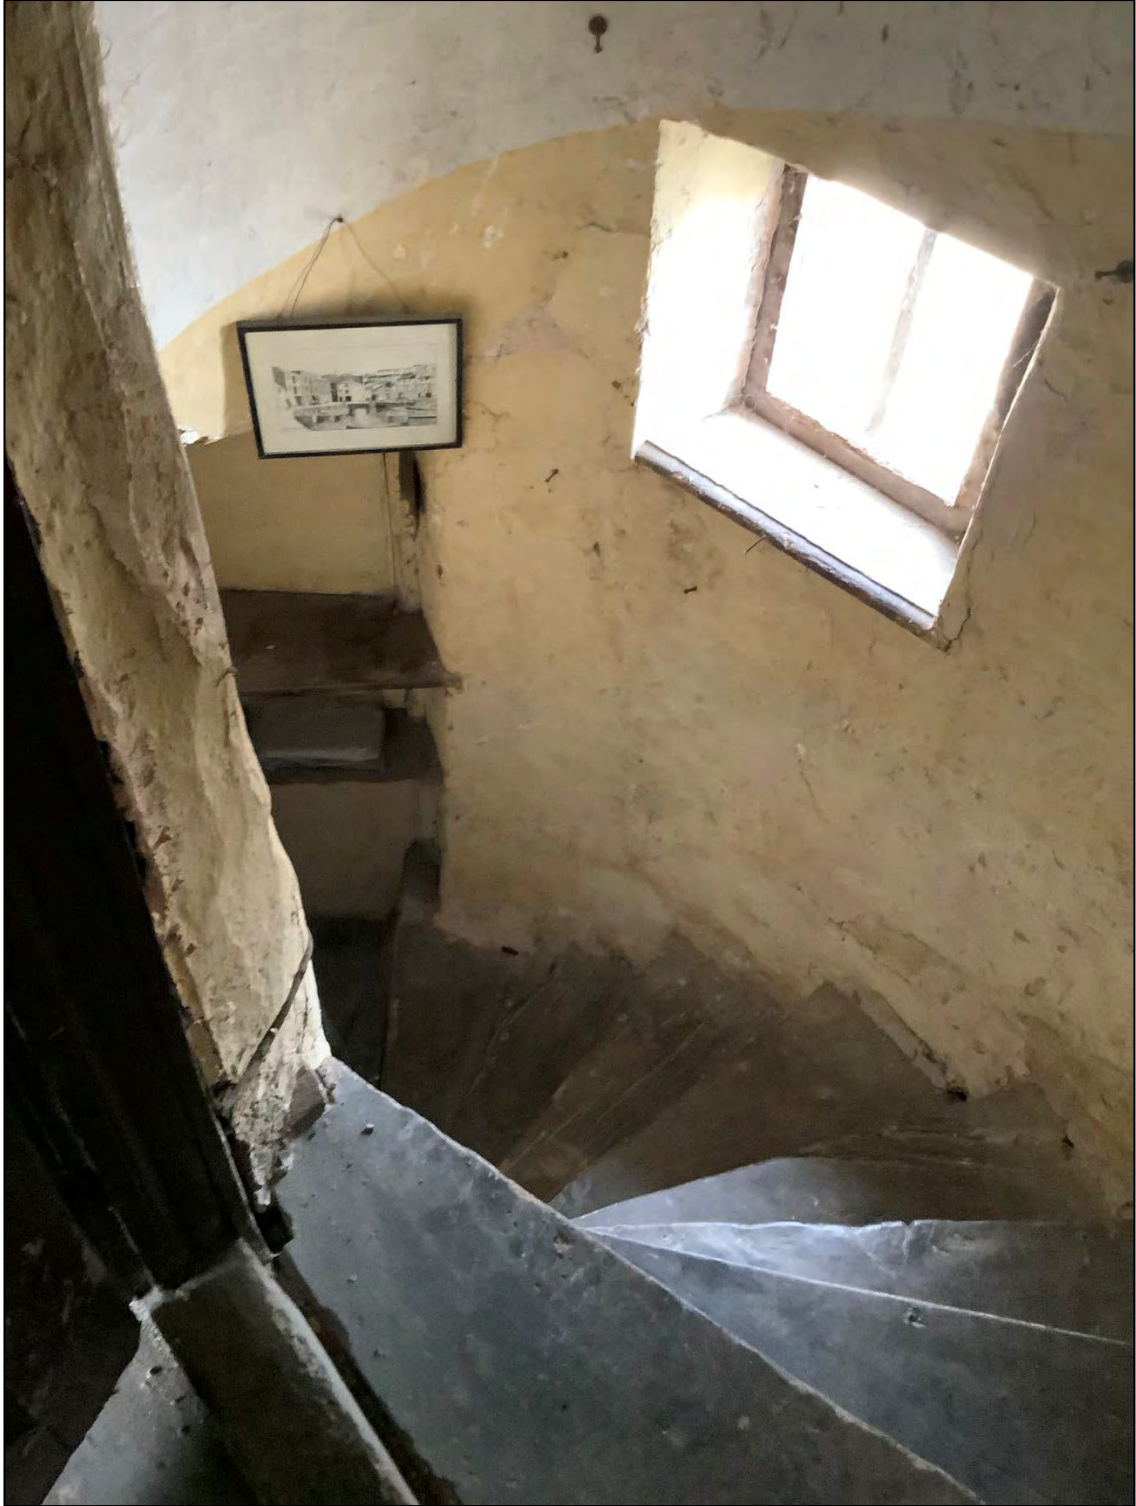
- 6.33. A neweled stair with solid oak steps staircase to the west of this wing is constructed to the south of the original cob external wall and is likely to be of late 16th construction (Fig. 19). The western staircase almost certainly represents the earliest constructed route to a newly installed first floor that was erected above Room 2. Given the probable late 16th century date of this staircase, it is probable that Room 4 (Fig. 18) represents the first installation of the flooring along what is now the first floor. This Room was likely to have been added as living space above that of what was

**Figure 19:** Likely late 16th century stairwell with oak stairs to the south west of the hall house. Built as an extension beyond the southern external rubble and cob wall to the newly installed Room 4.

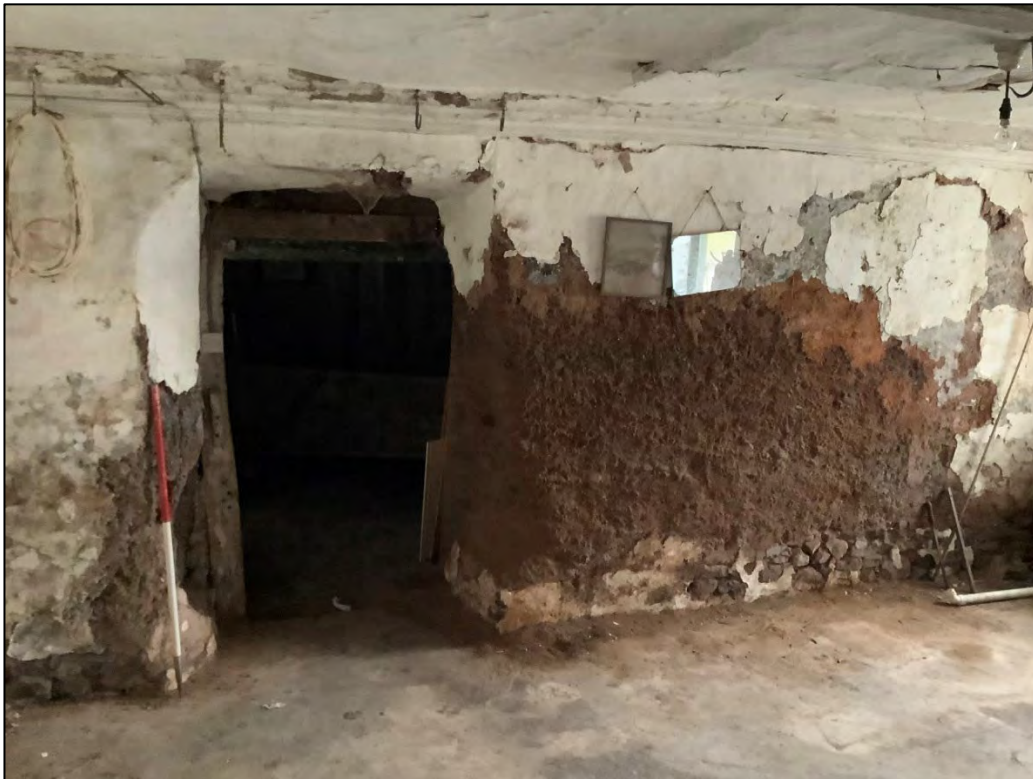
- 6.64. This wall is heavily eroded from approximately head height to near ground level. This erosion may well have taken place due to the doorway being used for livestock. Meat hooks hammered into the roof timbers of this Room also suggest that this section of the block was once used for hanging meat. The carrying of large carcasses through the door and rubbing against the cob walling may have also contributed to this erosion.

**Figure 34:** Cob wall dividing Room 8 with Room 9 to the south. Meat hooks can be seen within the oak crossbeams (top).

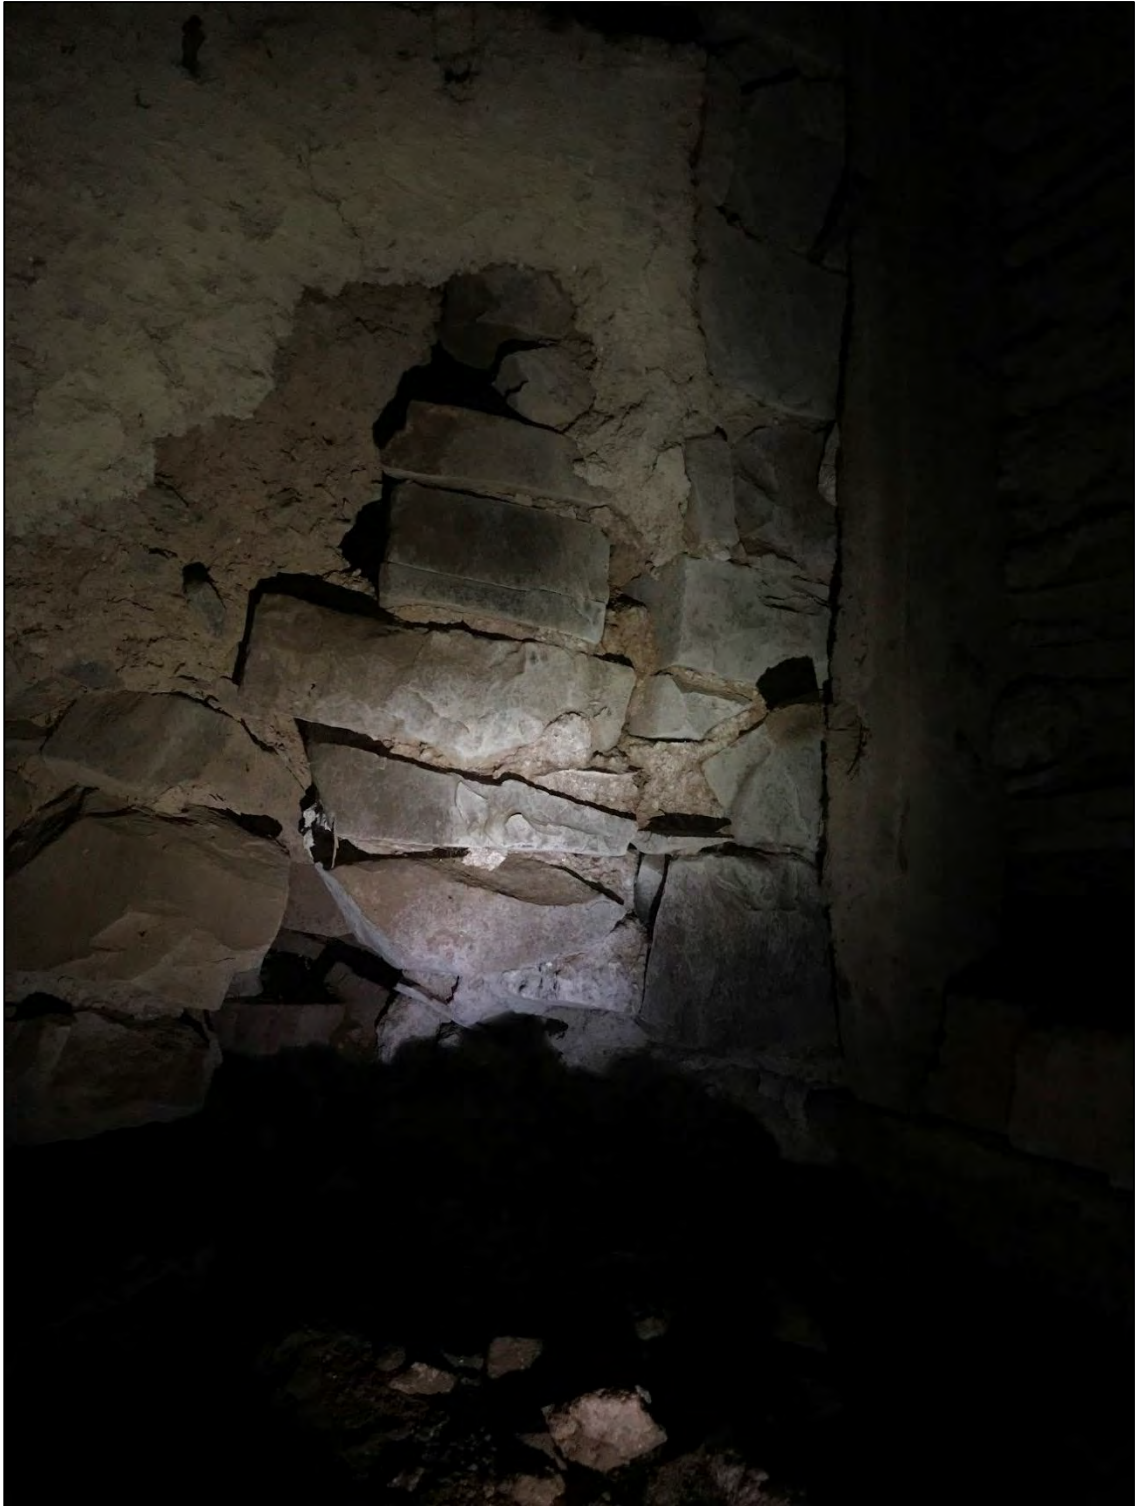
- 6.66. The northern wall, that separates Room 8 from the main hall house Room 7, once housed a door between the two that has since been blocked. Internally, this wall is of cob over rubble and represented the former external wall of the main hall house to the north (Fig. 36). Further evidence that Room 8 dates to the 17th century is located in the north west corner, where a storage space is located directly underneath the 17th century central staircase of the main block (Fig. 37).

**Figure 36:** Cob over rubble wall to the north of Room 8 likely represents the original external wall of the hall house.

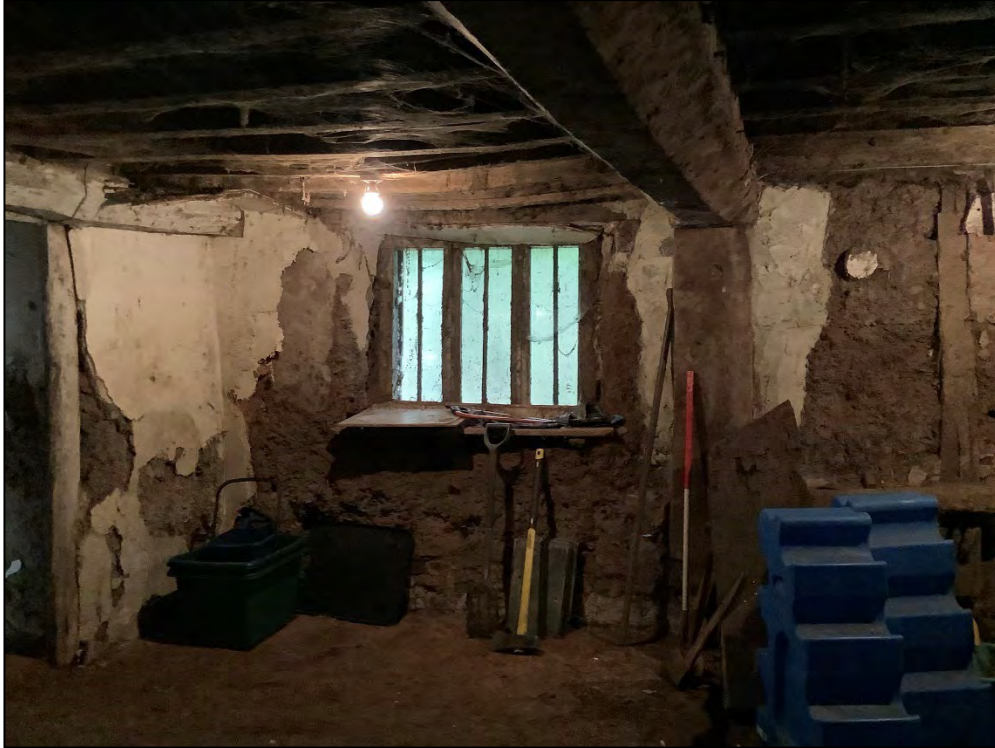
- 6.68. Large crossbeams within the ground floor ceiling are thought to be original and act as tie beams between the jointed cruck blades (Fig. 39). Within one of these Within Room 9, to the north of one such tie beam is a window cavity which is possibly an original window. Although the window frame itself has been replaced, the vertical iron bars within the window are built deep into the cob wall (Fig. 39). There is also some evidence to suggest there was a further window to the south of this that has since been filled in (Fig. 40).
- 6.69. Rooms 9 and 10 are divided by a full height partition comprising an unchamfered oak plank-and-muntin screen with large framing above (Fig. 40). Blackening of the roof timbers above Room 10 would suggest that it was originally open to the roof and contained a central hearth.

**Figure 39:** Possible original window opening. East of Room 9. The window has been re-framed and painted, however, the iron bars are thought to be original. The Horizontal oak tie beam is also thought to be original.

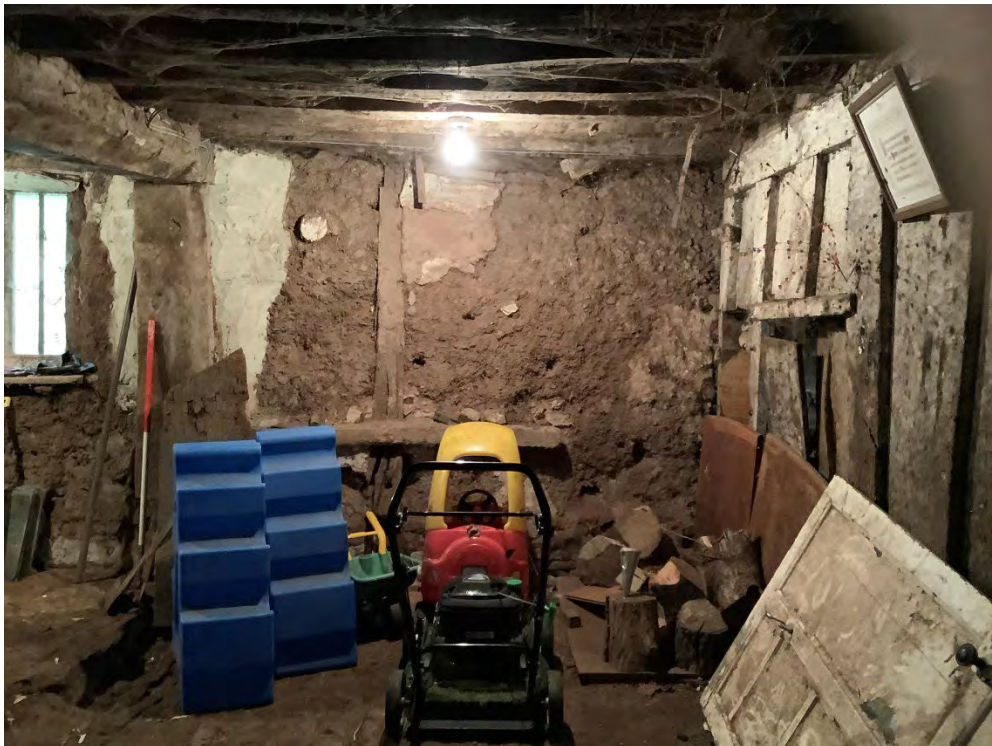
**Figure 40:** Possible window opening to the south of Room 9. Now filled in. Oak plank-and-muntin screen (right) separating Rooms 9 and 10.

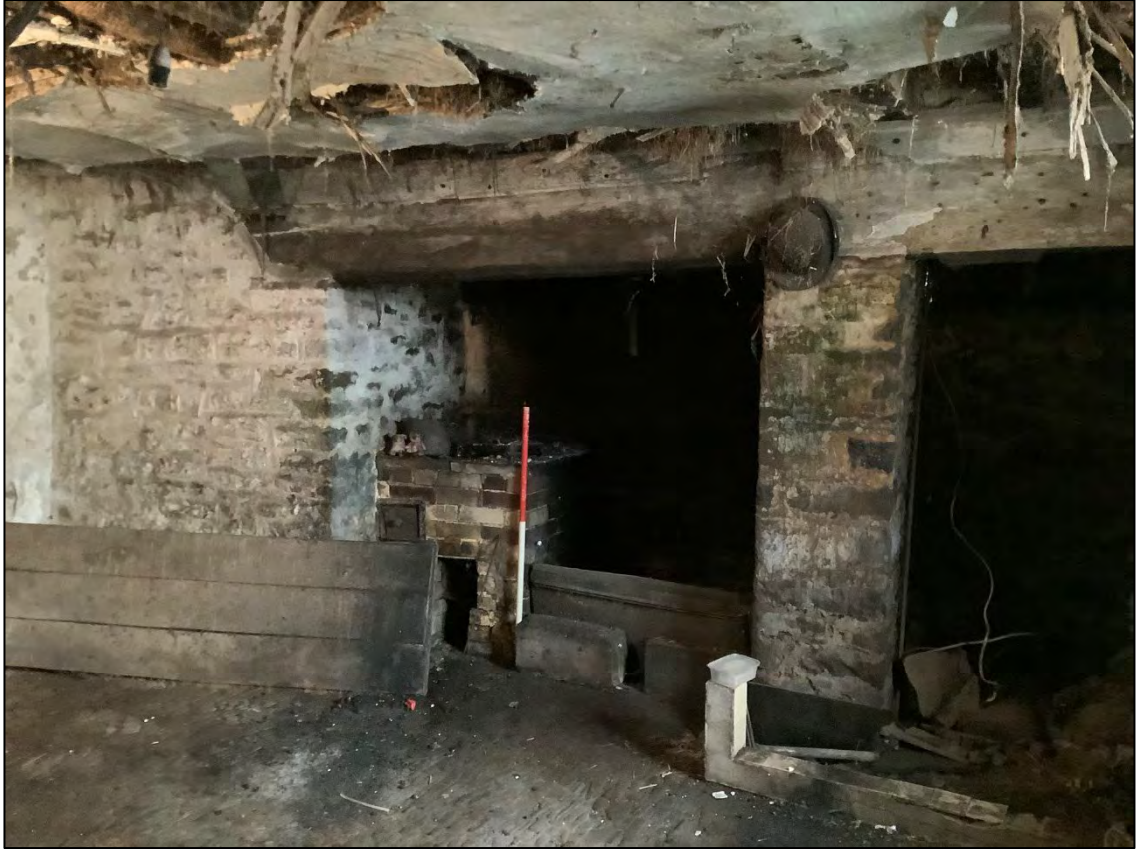
- 6.72. A large walk in smoker and stack within Room 10, as well as the entire stone southern end of the block, is likely to date to 17th century additions throughout Poole Barton (Fig. 42). The existence of a hearth of this size is not in keeping with purely domestic function. The hearth opening is likely to represent a meat smoker, and the presence of an internal horizontal bar for hanging meat would support this theory.

**Figure 42:** The large walk-in smoker hearth in the south of Room 10. A Victorian laundry wash is present within the hearth opening (left).

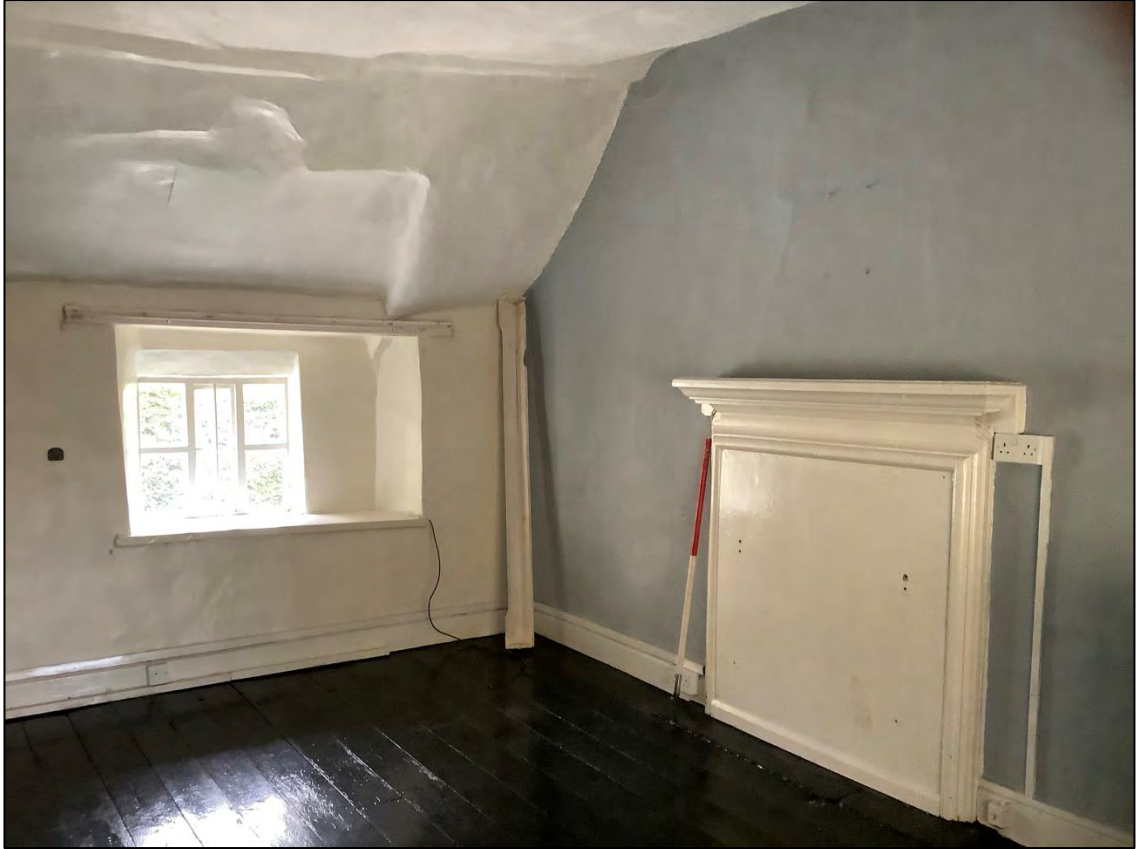
- 6.76. Room 11 is located above Room 8 and is in a good state of repair, showing signs of being well-maintained throughout the 20th and 21st centuries. A door between Room 11 and the rest of the first-floor area has now been blocked. Given that the Room 8 below is thought to represent a 17th century extension to the southern block and the room is accessible by the central staircase in the main block, this room is thought to date to the 17th century (Fig. 43). Within the room is a 19th century fire surround serving a small chimney stack of likely 17th century date, and contemporary window fittings. The chimney stack does not reach to Room 8 below.

**Figure 43:** Interior of Room 11.
